# An Updated Perspective of the Impact of the 1940 Vrancea Earthquake on Design and Construction Practices in Romania

Florin Pavel

**Abstract:** This study presents an updated view of the effects of the 1940 Vrancea earthquake. Recently compiled studies in the literature from the time of the event, as well as other studies, present the opportunity to gain additional and relevant information regarding this large-magnitude event. The effects of this earthquake on various locations in Romania are compared to those observed after the subsequent large Vrancea earthquake of 1977. An assessment of the economic losses caused by the seismic event is also attempted. The seismic vulnerability of some building typologies commonly used before 1940 is assessed by employing the earthquake damage data and the well-known macroseismic method. The impact of this event on the design and construction practices in Romania is evaluated using the collected information as well. Finally, the policy of repair and strengthening of buildings applied after the event is also discussed, and case studies are presented.

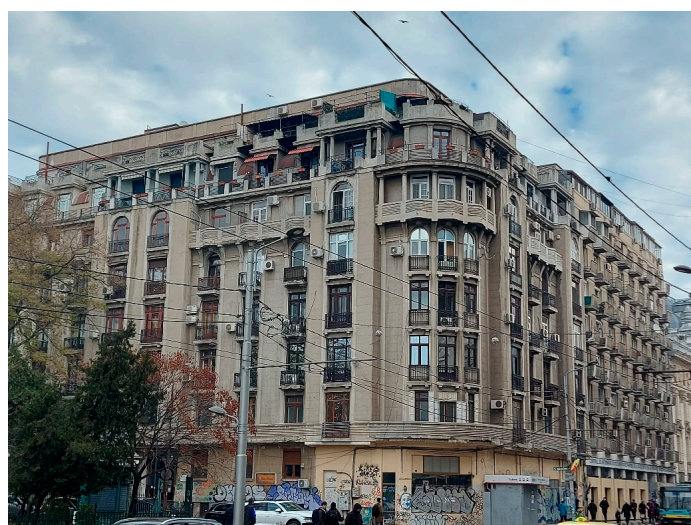
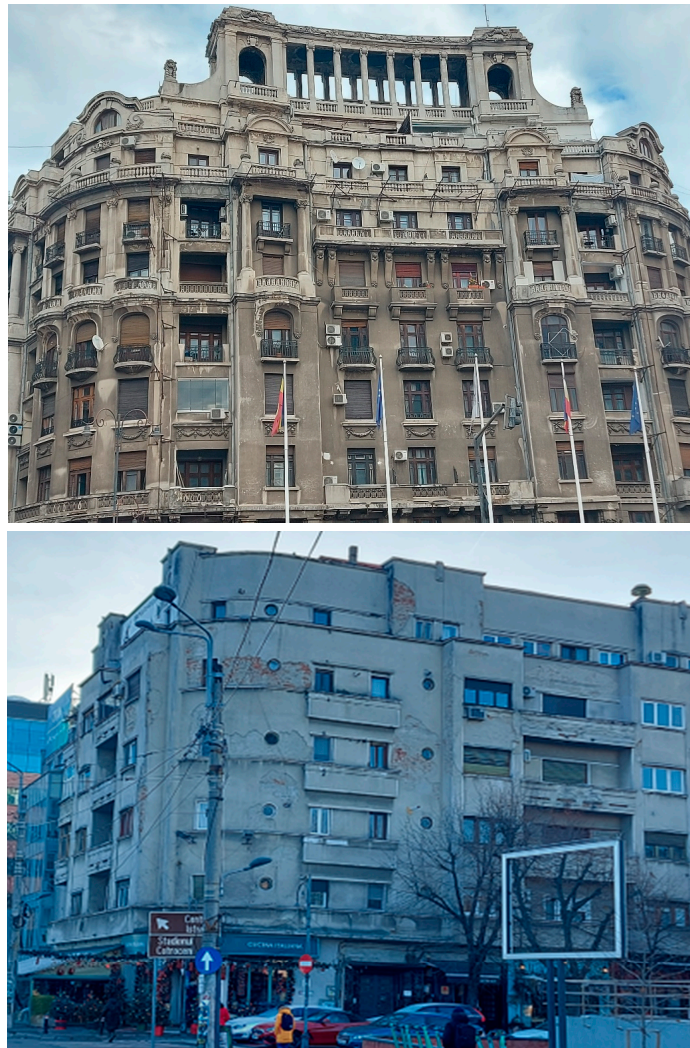
**Figure 1.** Typical high-rise structural typologies used before 1940 for residential buildings in Bucharest.

Examples of the above-mentioned typical structural typologies located in Bucharest are given in Figure 1. It can be observed that their current states from the point of view of maintenance and current repair works are not adequate at all. Figure 2 shows the typical structural layout of a high-rise reinforced concrete building that was constructed before 1940 in Bucharest [28]. Other examples of typical low-rise structures located in Bucharest are shown in Figure 3.

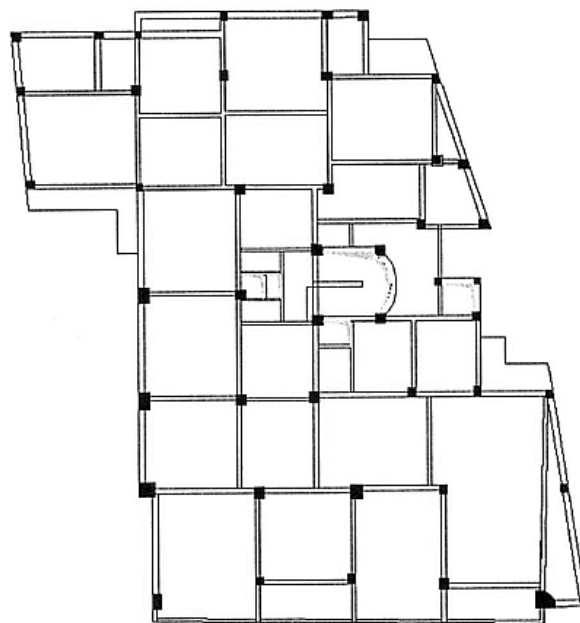
**Figure 2.** Typical layout of high-rise reinforced concrete structure built before 1940 in Bucharest [28].

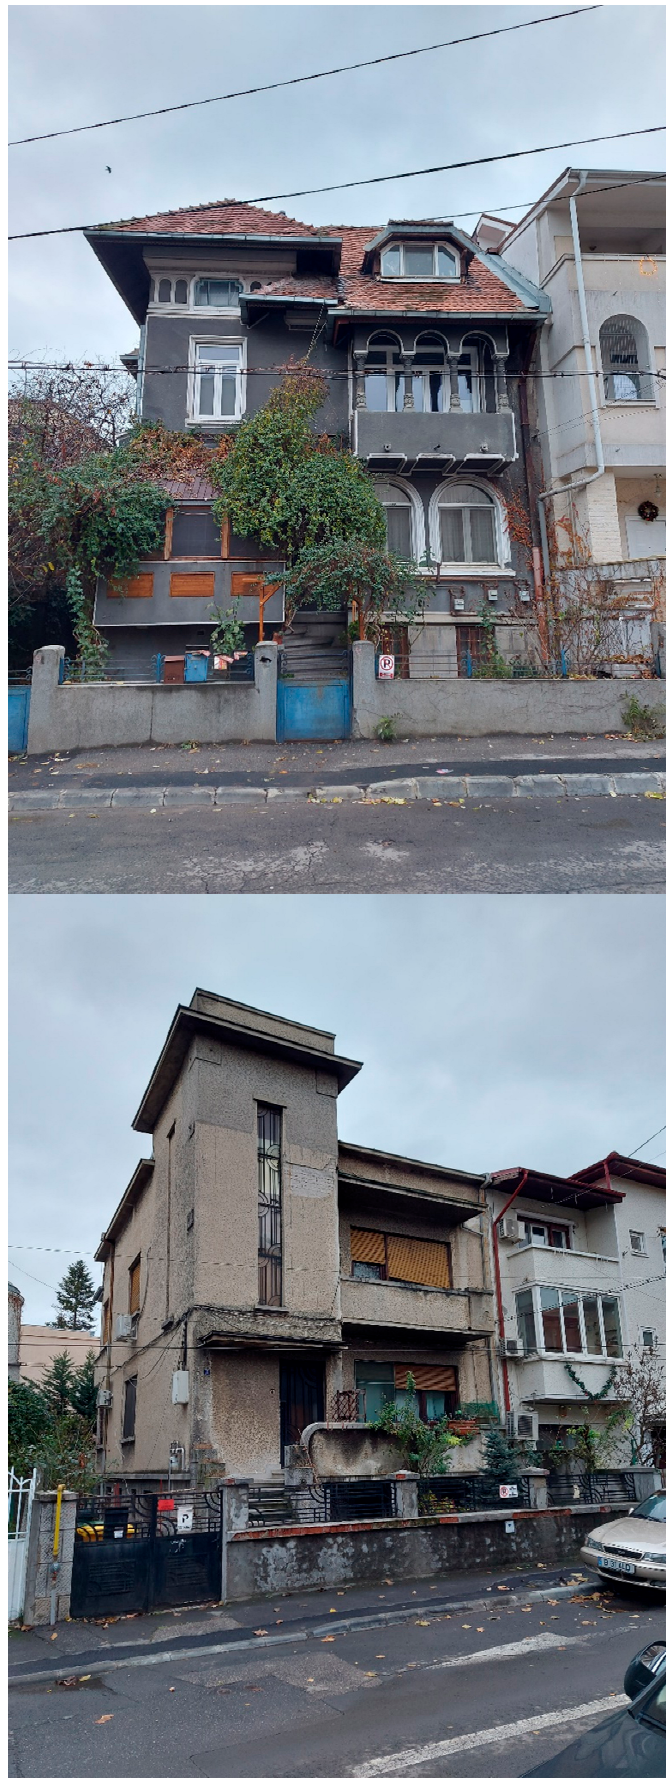
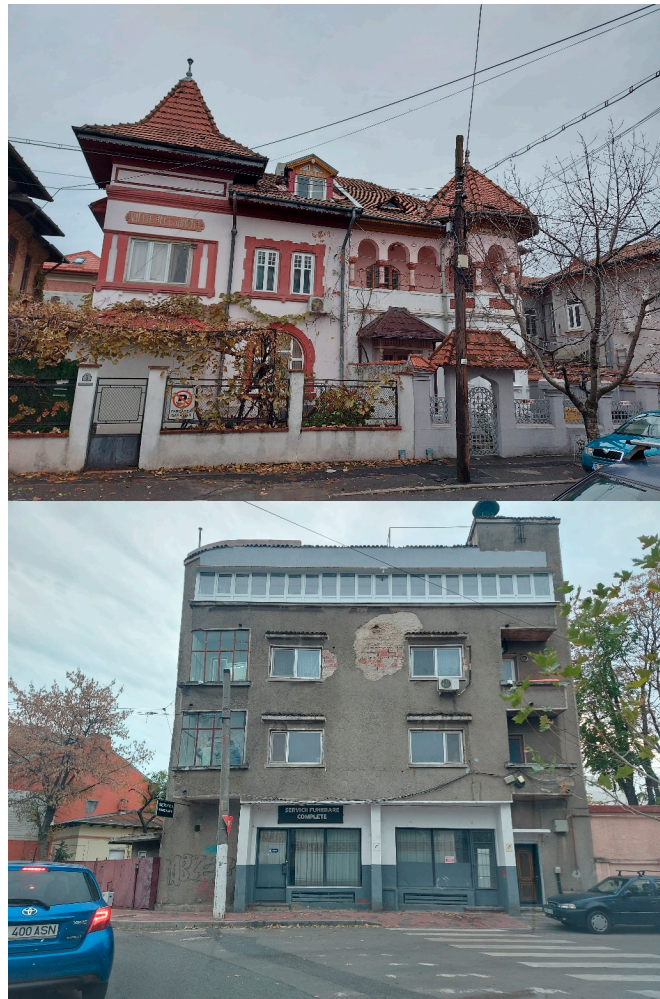
**Figure 3.** Typical low-rise structural typologies used before 1940 for residential buildings in Bucharest.

Figure 3 illustrates some common structural typologies for low-rise buildings with unreinforced masonry structures that were built before 1940.

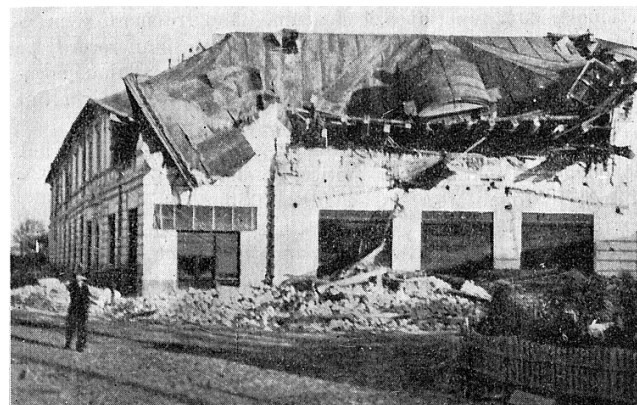
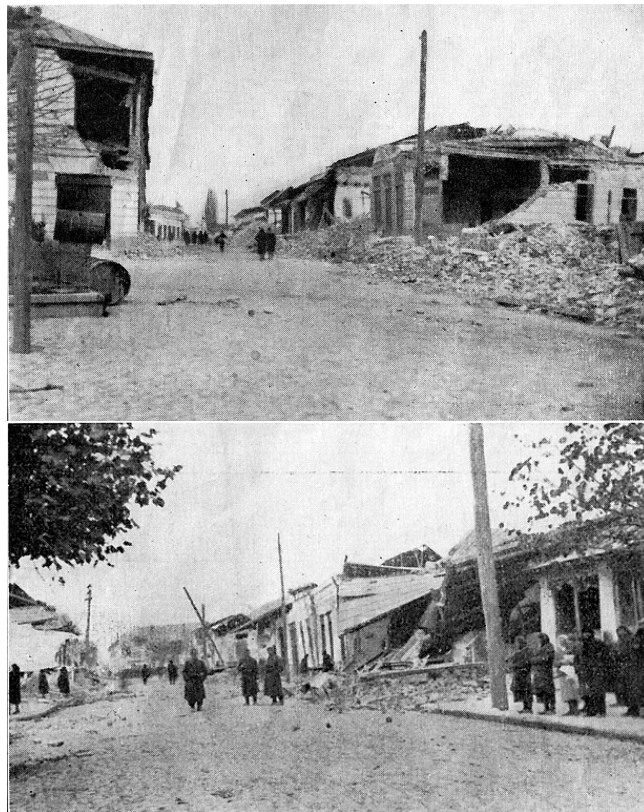
**Figure 4.** Typical damage of unreinforced masonry buildings in Panciu [21].

Some photos showing the damage in various publications from the time of the event highlight both the effects and the common structural typologies described previously. Figure 4 shows the damage sustained by unreinforced masonry buildings located in Panciu (near the earthquake epicentre), where 338 buildings sustained heavy damage or collapsed [29].

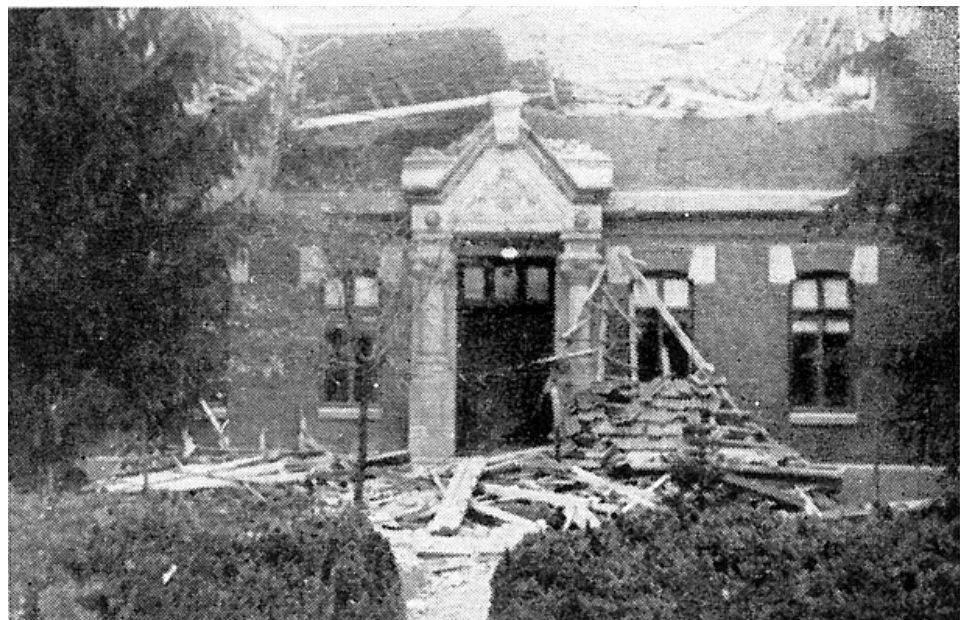
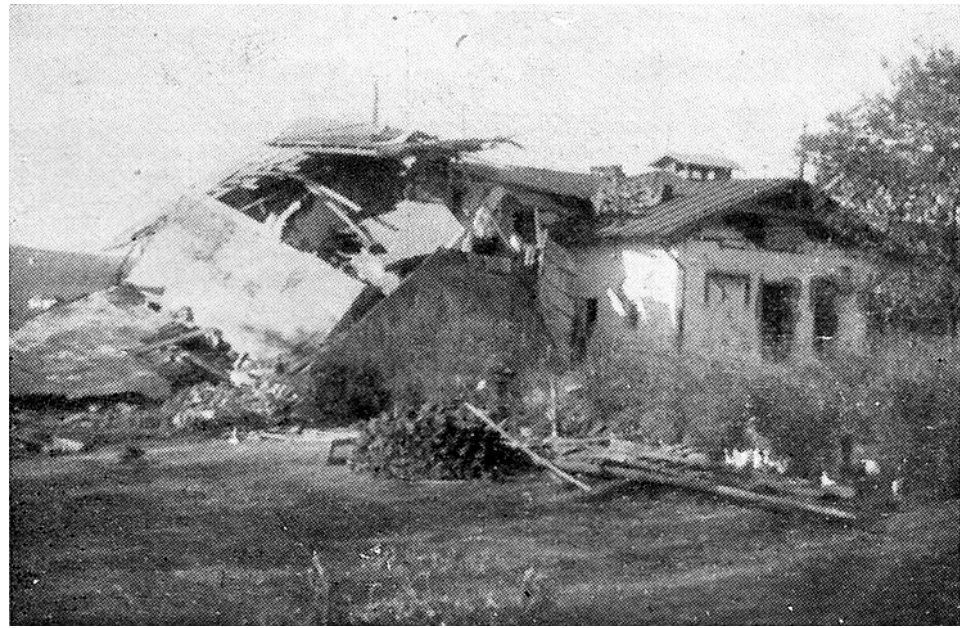
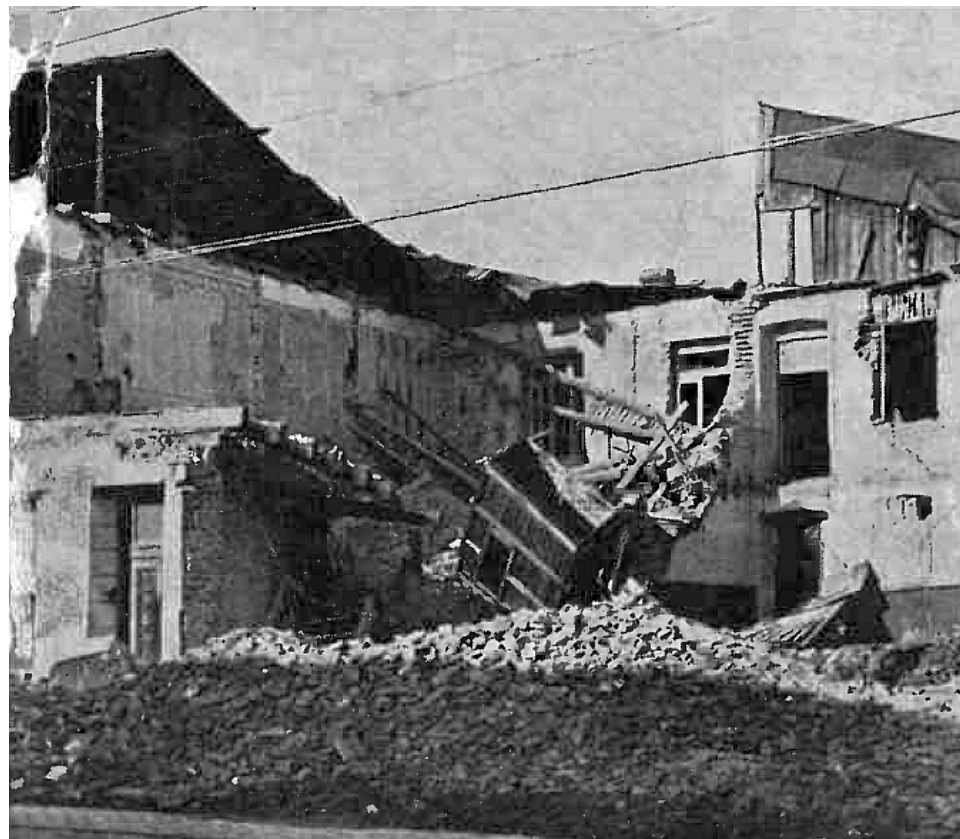
**Figure 5.** Typical damage of unreinforced masonry structures located in (a) Focsani [25], (b) Tecuci [25] and (c) Galati [30].

Figure 5 displays other failures of similar unreinforced masonry structures in other areas located near the epicentre of the earthquake (Focsani, Tecuci and Galati) [25,30].

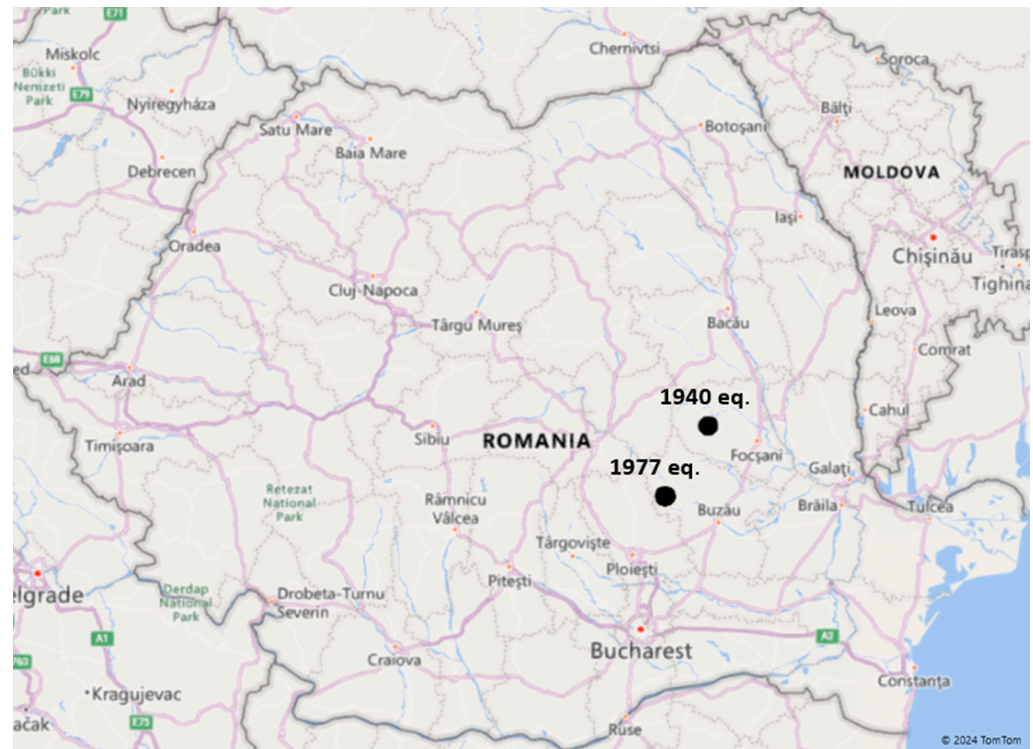
**Figure 6.** The epicentre locations of the two Vrancea intermediate-depth earthquakes in 1940 and 1977.

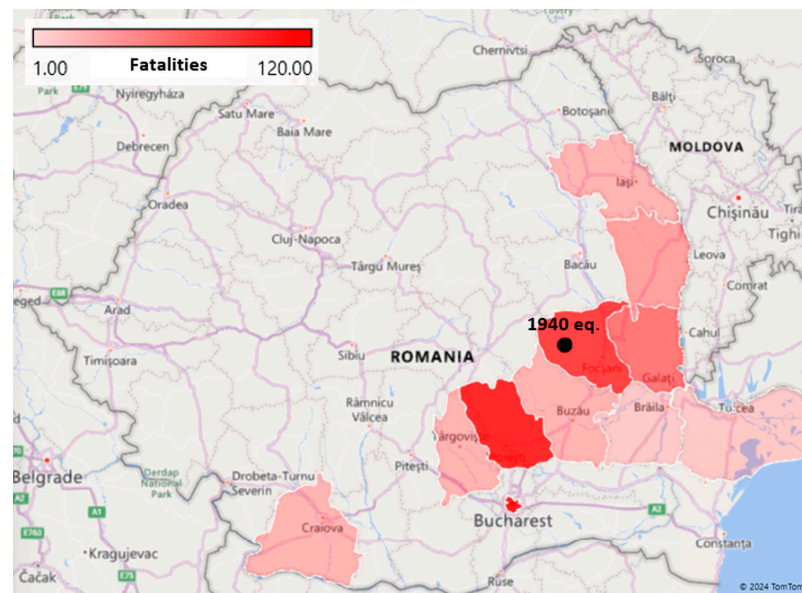
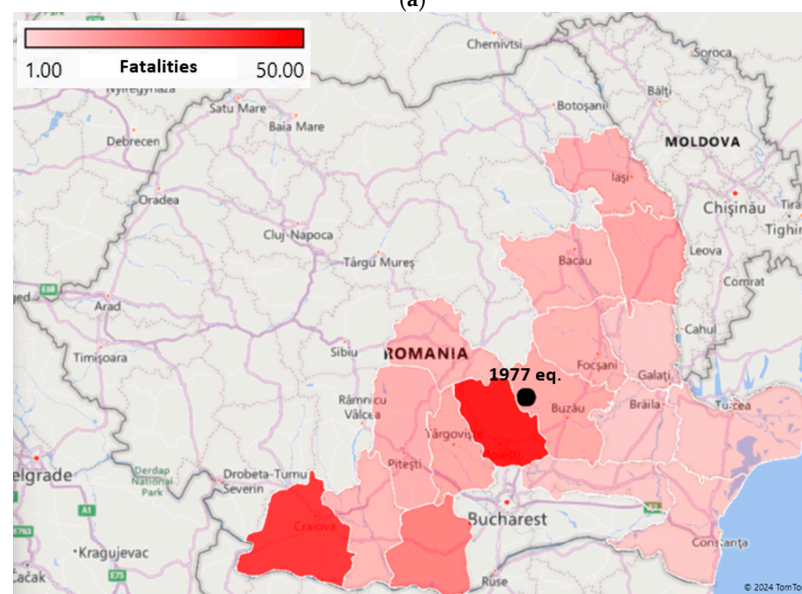
**Figure 7.** Fatalities evaluated for the (a) Vrancea 1940 earthquake and (b) Vrancea 1977 earthquake.

Based on the available literature (mainly journal articles from *Universul* and *Curentul*), in this study, the estimated numbers of fatalities and injuries for the 1940 event are 423 and 1456, respectively. Figures 7 and 8 show a comparison performed at county level of the fatalities and injuries caused by the two seismic events. In total, fatalities and/or injuries during one or both the 1940 and 1977 earthquakes were identified in 19 counties. In the case of the injured people as a result of the 1977 earthquake, about 12% were unaccounted for in terms of their location. The representation for the 1977 event does not include Bucharest since 90% of the deaths and 70% of the injuries were located here.

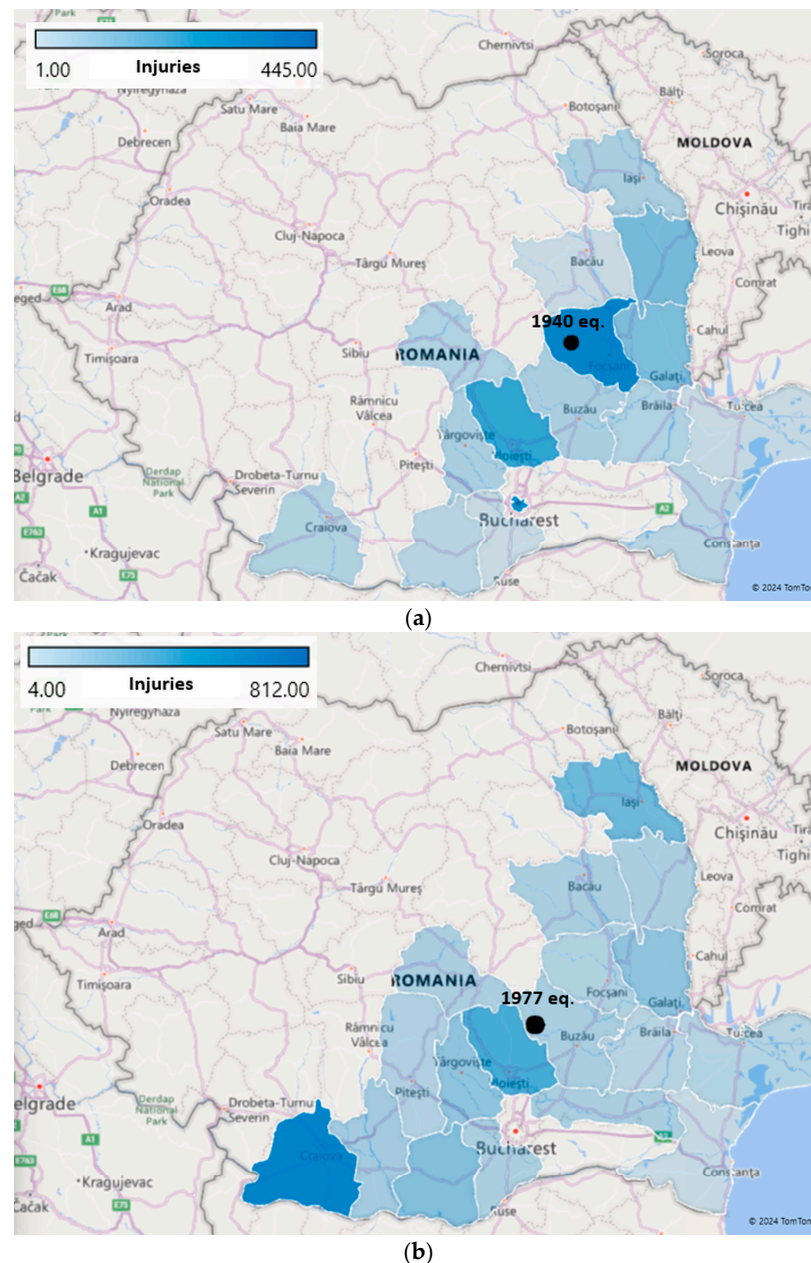
**Figure 8.** Injuries evaluated for the (a) Vrancea 1940 earthquake and (b) Vrancea 1977 earthquake.

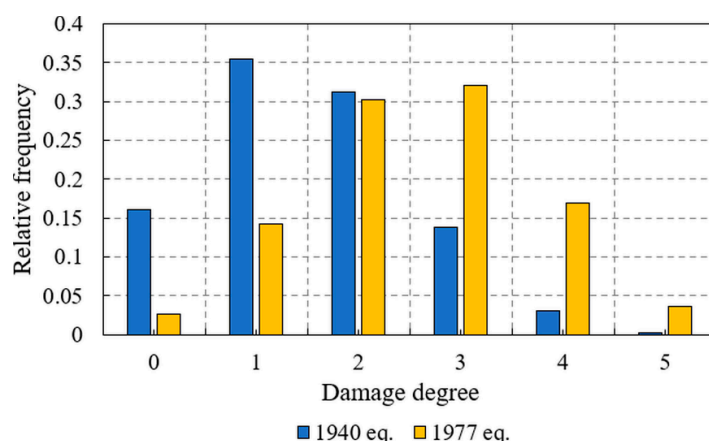
**Figure 9.** A comparison of the empirical damage probability histograms for medium- and high-rise RC buildings in Bucharest that were constructed before 1940 regarding the 1940 and 1977 Vrancea earthquakes.

The mean damage degree for the entire dataset is 1.53 (assuming a macroseismic intensity level of VII–VIII), while the resulting values of the vulnerability parameters are  $V = 0.75$  and  $Q = 2.30$ . A comparison of the binomial probability mass functions for the 1940 and 1977 earthquakes (assuming a macroseismic intensity level of VIII–IX) is shown in Figure 9 for the dataset of medium- and high-rise buildings constructed before 1940. It can be seen that the proportion of buildings with low or medium damage degrees is significantly larger in the case of the 1940 earthquake. The reasons for the larger damage degrees observed during the subsequent 1977 event can be the larger ground motion intensity in Bucharest coupled with the previous 1940 earthquake damage.

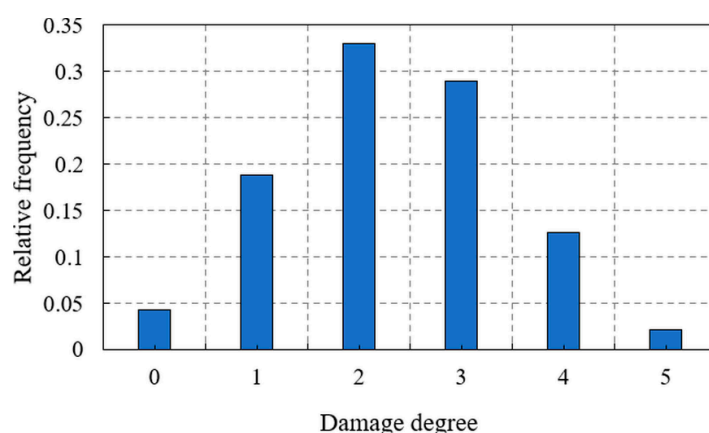
**Figure 10.** Empirical damage probability histograms for the unreinforced masonry structures in Barlád regarding the 1940 earthquake.

The sample of masonry buildings with flexible floors for which the damage data are available consists of about 1200 buildings [57]. The data shown in the paper by Mandrescu [57] highlight a much larger percentage of damaged buildings that were observed for the structures with more than one storey in height. The mean damage degree for the entire dataset is 2.33 (assuming a macroseismic intensity level of VIII), while the resulting values of the vulnerability parameters are  $V = 0.79$  and  $Q = 2.30$ , which are practically identical with the previous results obtained for Bucharest. This observation highlights the similarity in terms of the seismic vulnerability of unreinforced masonry structures constructed before 1940 irrespective of their location (Barlád or Bucharest). The empirical damage probability histograms for unreinforced masonry buildings located in Barlád for the 1940 earthquake are shown in Figure 10.

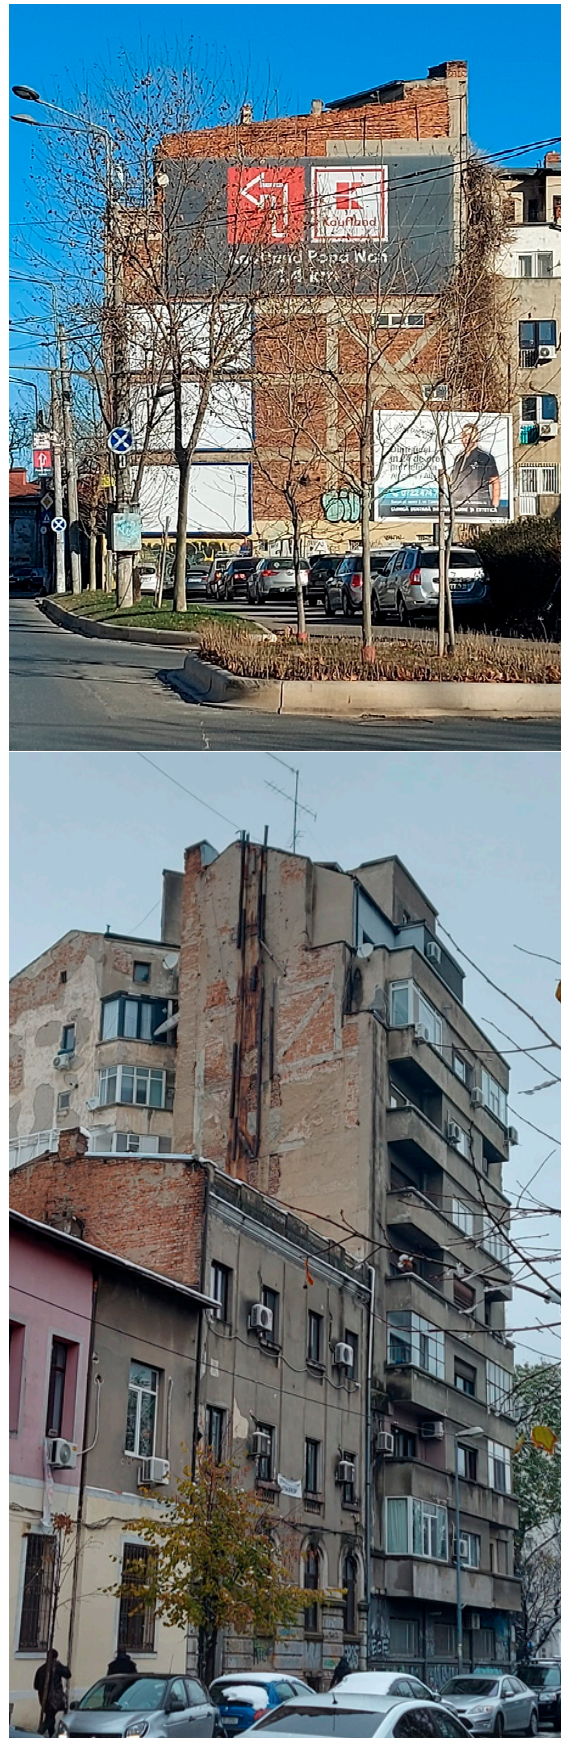
**Figure 11.** Examples of buildings with RC-braced frame structures that were constructed after the Vrancea 1940 earthquake.

An interesting consequence of the 1940 event is the use of braced reinforced concrete frames as structural systems for some residential buildings that were constructed in the aftermath of the event. Some examples of such structures still existing in Bucharest today are shown in Figure 11.

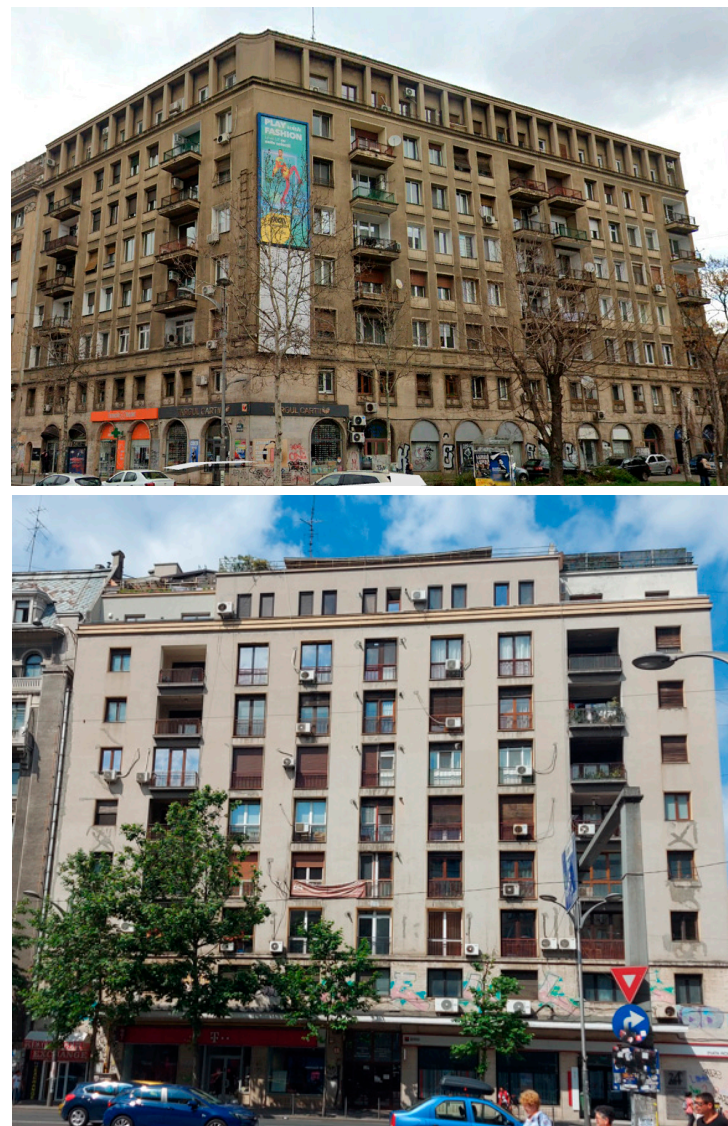
**Figure 12.** Examples of buildings with RC frame structures that were constructed after the Vrancea 1940 earthquake.

And a final and critical observation was that the structural layout should not depend on various architectural criteria [67] with more emphasis on the structure itself. This aspect led to an improved generation of residential buildings with a reinforced concrete frame structure being constructed in Bucharest until the introduction of the P13-63 code [68] and which performed well during the 1977 earthquake (better than some of the frames built in the 1970s). Some examples of such buildings are shown in Figure 12.
