# Shear Strengthening of Stone Masonry Walls Using Textile-Reinforced Sarooj Mortar

**Keywords:** strengthening; historical; stone masonry wall; textile-reinforced mortar; rehabilitation

**Citation:** Al-Saidi, Y.; Al-Saidy, A.H.; El-Gamal, S.; Sohel, K.M.A. Shear Strengthening of Stone Masonry Walls Using Textile-Reinforced Sarooj Mortar. *Buildings* **2024**, *14*, 2070. <https://doi.org/10.3390/buildings14072070>

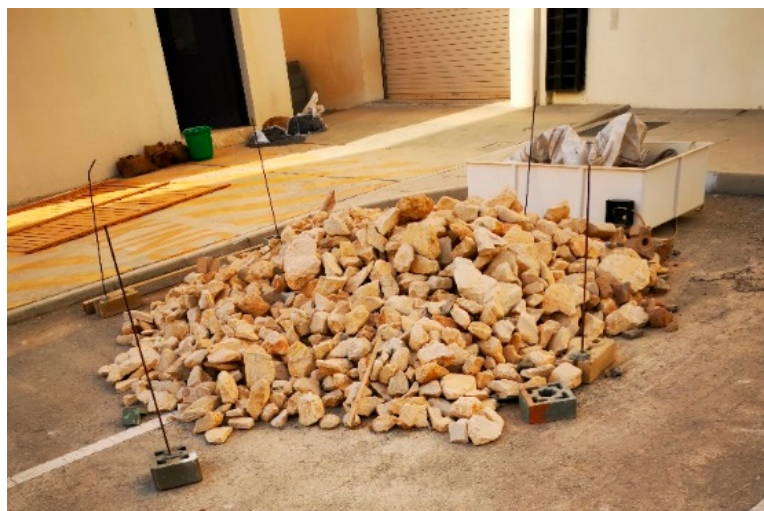
**Figure 1.** Limestone.

Historical buildings in Oman are widely constructed of limestone, as it provides good humidity and heat insulation, it is aesthetically pleasing, it is widely available in all regions of the country, and it can be cut easily. For this research, limestone was obtained from Wadi Al-Khoud, Oman, in random crushed sizes, as shown in Figure 1. ASTM standard C51-18 [21] defines limestone as an initially sedimentary rock consisting mainly of calcium carbonate or the carbonates of calcium and magnesium. Limestone may be high in calcium and magnesium or dolomite. Al-Saidy et al. [22] tested limestone for mechanical properties such as compressive strength and water absorption. Compressive strength was measured according to ASTM D7012, 2004 [23]. It was found at an average of 57.8 MPa based on several 70 mm × 70 mm × 70 mm cubes, and water absorption was determined according to ASTM D6473, 2010 [24] and averaged at 2.20%.

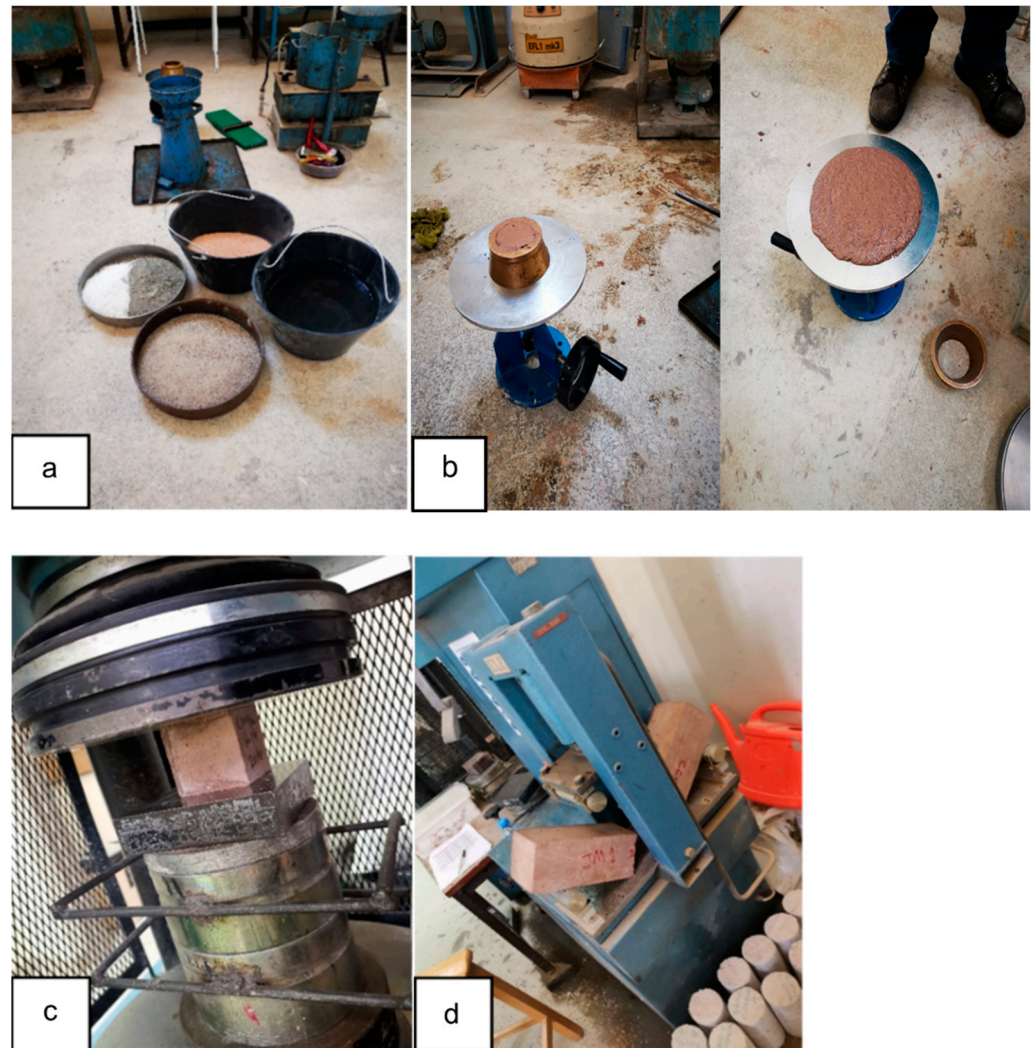
**Figure 2.** Jointing mortar (a) materials used; (b) flow table test; (c) compression test; (d) flexural test for plaster mortar.

The cementing materials used in the matrix were sarooj (passed through a 2.36 mm sieve), ordinary Portland cement (OPC), white cement, and lime. Cement was included to improve the binding properties of the mortar, as advised by Hago et al. [20]. White and gray cements were used in the jointing mortar; however, just white cement was utilized in the plaster mortar to maintain the genuine color of sarooj. Fine sand (passed through a 2.36 mm sieve) was utilized to avoid shrinkage and micro-cracking in all mixtures. The matrix of the bed jointing mortar consisted of sarooj, sand, ordinary Portland cement, white cement, lime, and water with a ratio by weight of 1:0.5:0.24:0.24:0:0.5, respectively (see Figure 2a). This mixture was chosen from various mixtures based on its mechanical properties and workability. Each mixture was cast into steel molds, creating three identical cubes with dimensions of  $70 \times 70 \times 70$  mm and prisms with dimensions of  $100 \times 100 \times 500$  mm. All mixtures were cured at a lab temperature of  $22 \pm 2$  °C and a relative humidity of 20–30%. The workability was determined using a flow table test and measured to be 81% (Figure 2b). Sarooj absorbs more water in comparison with sand and this results in low slump. The compressive strength of the cubes was determined using a uniaxial compressive test according to ASTM 349 [28] (Figure 2c). The average result for the 28-day compressive strength was recorded as 13.84 MPa.

Hago et al.'s [20] recommendations were embraced in selecting the ideal design mixture ratio of sarooj, sand, and cement to give the maximum strength. The plaster mortar mixture comprised sarooj (passed through a 0.6 mm sieve), sand, white cement, lime, and water with a ratio by weight of 1:0.5:0.5:0.375:0.85, respectively. The workability of the plaster mortar was determined using a flow table test and measured to be 80%. This mixture was chosen from several based on its mechanical properties and workability. The same process was followed as used in the jointing mortar for casting and curing the specimens. The average 28-day compressive strength and tensile strength were measured to be 14.30 MPa and 3.1 MPa, respectively, using a uniaxial test of the cubes. Note that a flexural test was performed for plaster mortar only.

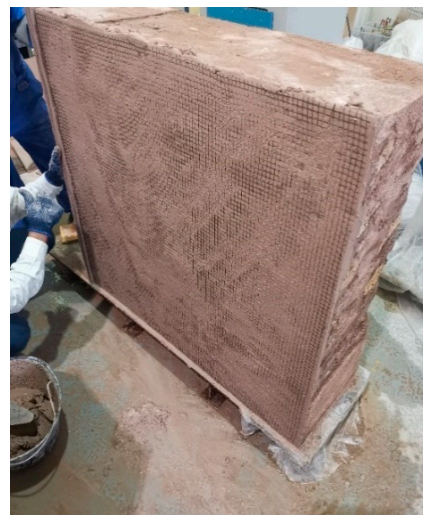
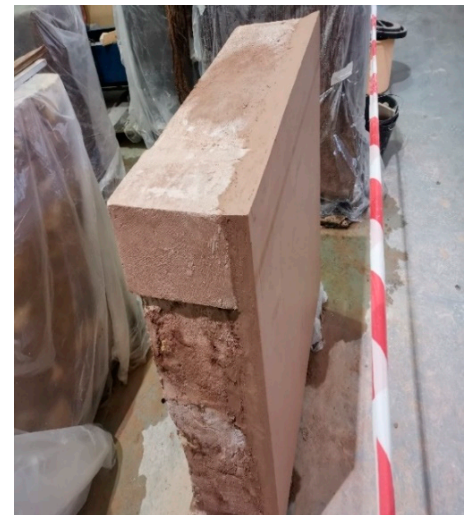
**Figure 11.** Construction of one-sided basalt mesh reinforcement: (a) applying basalt mesh to the wall; (b) applying the covering layer of plaster.

After construction and curing using hessian cloth for all walls, the specimens were plastered and strengthened. For the second wall, plastering was carried out on one side in two layers along with basalt mesh. An initial layer of plaster mortar between 2 and 3 cm thick was applied, depending on the irregular shape of the stones. After placing the basalt mesh, another plaster layer 0.5 cm thick was applied and left to cure for 60 days. The procedures can be seen in Figure 11 below.

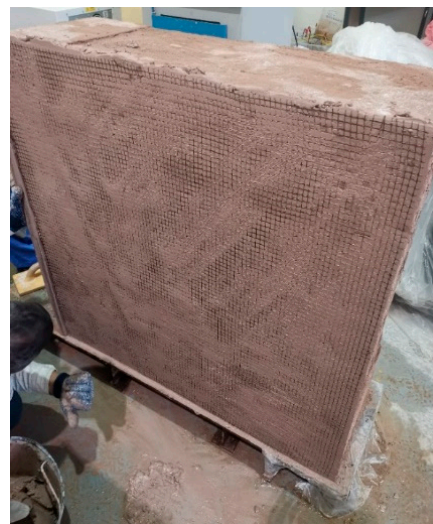
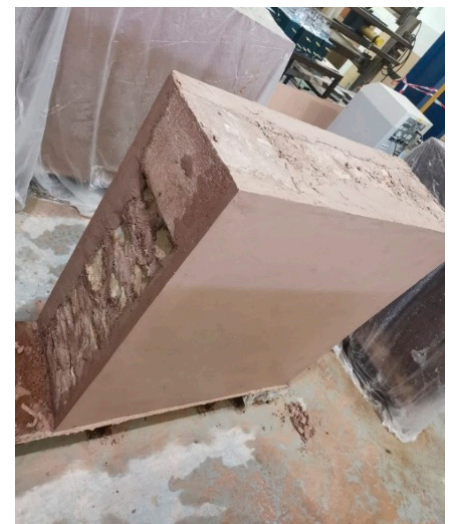
**Figure 12.** Construction of a two-sided reinforced wall with basalt mesh: (a) applying basalt mesh on both sides; (b) applying the covering layer of plaster on both sides.

Similar to the second wall, the same methods were used on the third wall. In addition, both sides of this wall were strengthened with plaster and basalt mesh and then left to cure for 60 days. Construction pictures can be seen in Figure 12.

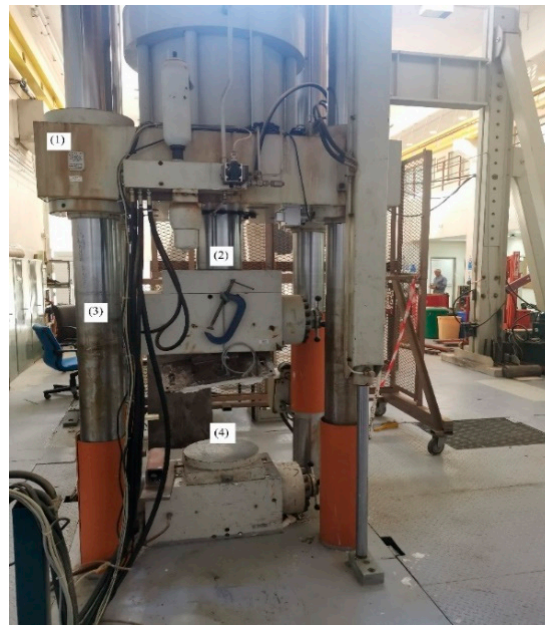
**Figure 16.** Photograph of Universal Testing Machine: (1) moving crosshead; (2) top actuator loading; (3) load support column; and (4) bottom loading plate.

The wall specimens were tested under compression (monotonic load) at a 45-degree angle using a 4000 kN Universal Testing Machine. The load was applied at the rate of 0.3 kN/s, and the loading and displacement were controlled by the attached computer. The load was measured using the machine load cell. Displacements were measured using an LVDT attached to the machine loading head and two LVDTs directly attached to the walls. The test setup is illustrated in Figure 16, and the wall arrangement with LVDTs is illustrated in Figure 17.

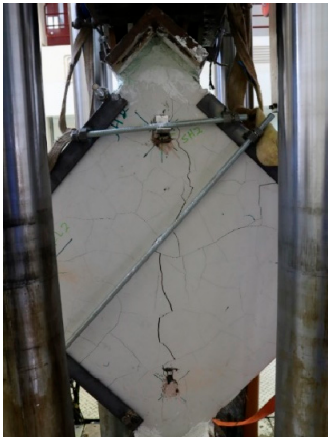
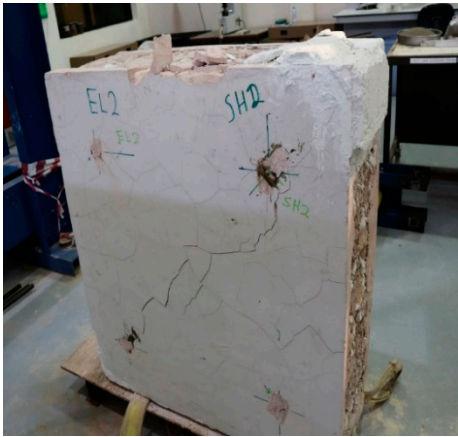
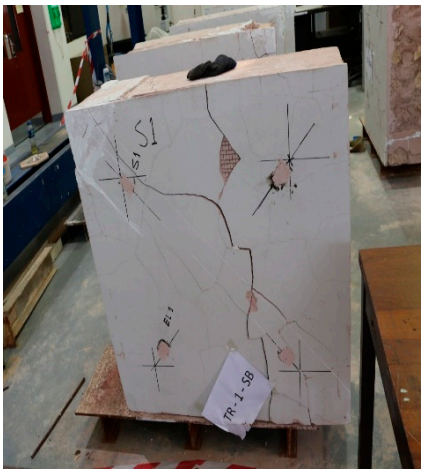
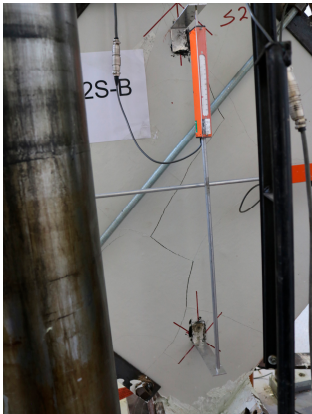
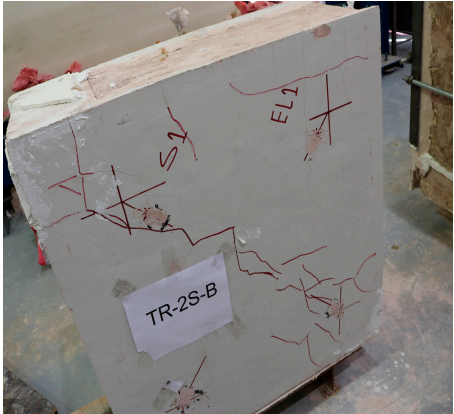
**Figure 18.** Failure modes and crack patterns. (a) Failure mode of UC wall; (b) Failure mode of TR-1SB wall; (c) Failure mode of TR-2SB wall; (d) Failure mode of TR-2SB-2L wall; (e) Failure mode of TR-2SB-S wall; (f) Failure mode of TR-2SG wall.

For the unreinforced control wall (UC), the shear stress–strain behavior in the initial stage was linear, with no cracks observed. Cracks started when the load had almost reached a maximum of 360 kN; then, a sudden failure occurred (Figure 18a), and cracks developed in the wall. The cracks occurred in a diagonal pattern across the mortar–masonry interface. No separation was observed between the plaster mortar and the masonry.

The wall strengthened on one side with basalt mesh (TR-1SB) showed linear behavior in the initial stage. With the force increasing, cracks started from the unreinforced side at the mortar–masonry interface (since it was the weaker side) and propagated to the reinforced side (see Figure 18b). Once a maximum force of 317 kN was reached, which was lower than for the UC specimen, the stress started decreasing gradually, showing some elongation in the textile mesh, until the basalt mesh ruptured. Note that the unreinforced side was not plastered, which marked a difference compared to the control wall (UC), which was plastered on both sides; this may have contributed to the higher capacity of the UC wall.

The second strengthened wall with basalt mesh on both sides (TR-2SB) demonstrated similar behavior. Cracks started at a load level of 655 kN. The stress then started decreasing gradually, providing some elongation before complete failure (Figure 18c). Compared to the UC specimen, this wall provided almost double the capacity, at approximately 1.82 times that of the control specimen.

The wall specimen strengthened with double layers of basalt on both sides (TR-2SB-2L) illustrated the same initial behavior. Cracks started at a load level of 528 kN (Figure 18d). Stress then started decreasing gradually to a certain point, after which elongation reached approximately 5 mm before complete failure. Both layers of the textile ruptured. This wall had a capacity of 1.47 times higher than that of the UC specimen. The main advantage of doubling the layers of reinforcement provided is increasing the ductility rather than the capacity, which still results in improved strength.

The wall strengthened from both sides with basalt and screws for anchorage (TR-2SB-S) exhibited similar initial behavior. Once the load reached a maximum of 542 kN, the stress decreased gradually to a certain point, providing some elongation before complete failure (Figure 18e). Compared to the UC specimen, this wall provided almost 1.5 times the capacity of the control specimen. Two modes of failure were observed in this wall. It cracked a diagonal pattern across the mortar masonry interface, and toe crushing also occurred when the stress at a corner equaled the masonry compressive strength [31]. We surmise that drilling holes for screws in the stones may have effectively reduced the wall's compressive strength.

The last reinforced wall was strengthened using fiberglass mesh from both sides (TR-2SG), and in the initial stage, we noted linear behavior with no cracks observed. However, when the load had almost reached a maximum of 774 kN, the stress started decreasing gradually to a certain point, followed by a sudden failure (Figure 18f). This wall

All walls resulted in a diagonal crack pattern across the mortar–masonry interface, with no dependence observed between the plaster mortar and the masonry. Adding screws in the case of TR-2SB-S did not provide any benefits to the matrix since there was no separation. Figure 19 illustrates the shear stress vs. shear strain for all walls, and the results for all specimens are reported in Table 3 below.
