# Tornado Impact on Public Infrastructure in the Czech Republic: A Case Study of the 2021 Moravia Event

## Abstract

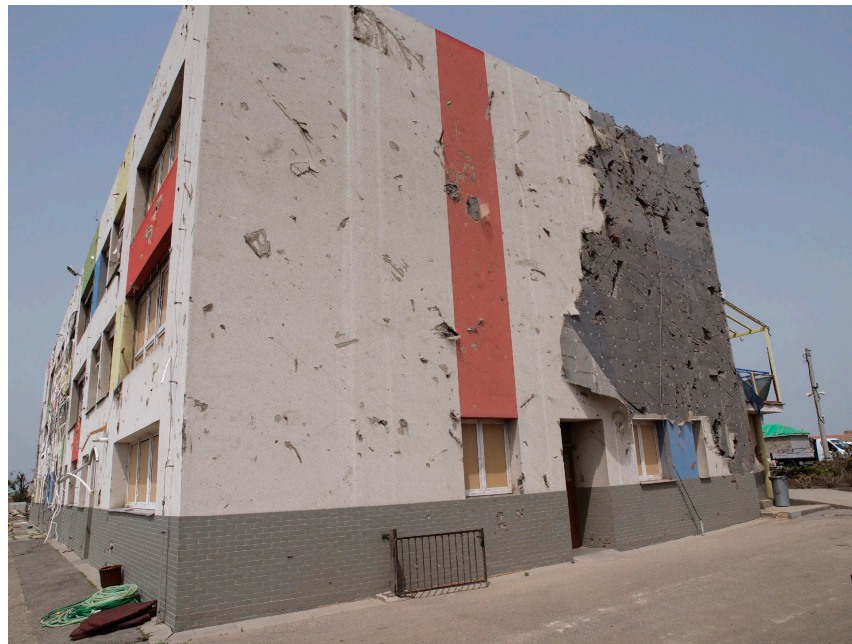
**Figure 3.** Elementary school in Moravska Nova Ves; authors' own elaboration.

The photographs document damage to public infrastructure from the 2021 tornado. The following images Figures 3 and 4 compare different structural systems subjected to the same IF2 intensity.

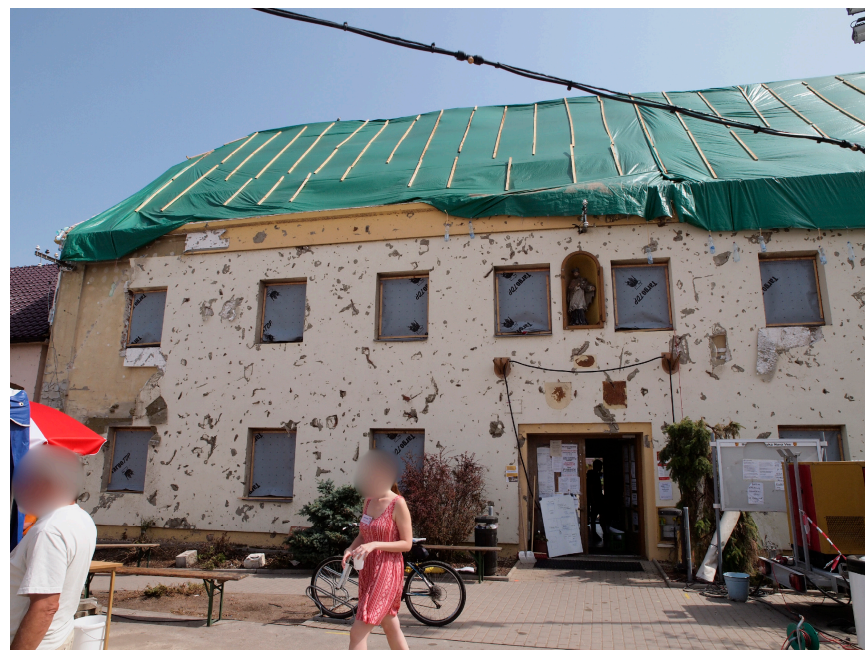
**Figure 4.** Municipal office in Moravska Nova Ves; authors' own elaboration.
