# Integrated Geotechnical and Structural Resilience: A 25-Year Case Study of Slope Stabilization and Infrastructure Rehabilitation in Madeira Island

The stabilization of public infrastructure on active volcanic slopes presents significant geotechnical challenges, particularly in coastal regions exposed to extreme hydrological stressors. This paper presents a forensic diagnosis and the structural rehabilitation of the Porto da Cruz Cemetery (Madeira Island, Portugal), which suffered severe progressive failure following localized, shallow-founded interventions in 2004. Historical inclinometer data (2015–2022) revealed continuous deep-seated creep within the volcanic colluvium (Geotechnical Zone 2–ZG2) at rates up to 0.17 mm/day, triggered by basal fluvial undercutting. To mitigate these kinematic drivers, a systemic “Toe-to-Crest” stabilization paradigm was implemented. Following the hydraulic confinement of the slope’s lower boundary, a high-capacity deep foundation network—comprising 26 m rock-socketed micropiles and 600 kN active multi-strand anchors—was executed to bypass the failure plane and encastre directly into the competent basaltic bedrock (Geotechnical Zone 1–ZG1). The s

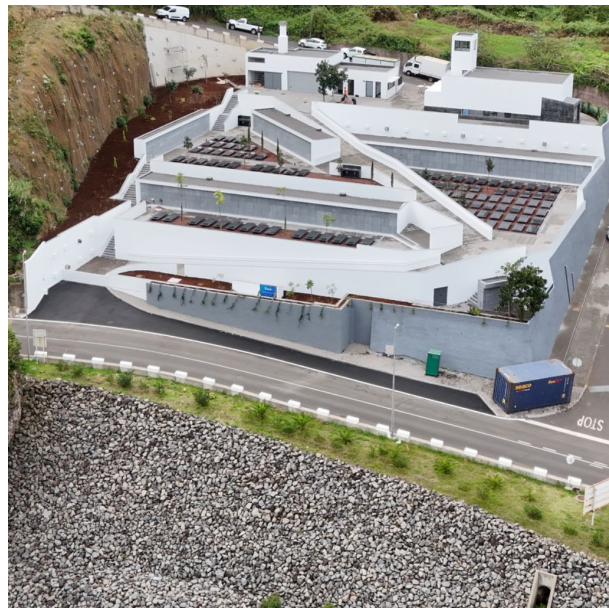
**Figure 1.** Panoramic view of the Porto da Cruz slope, illustrating the spatial interdependence between the cemetery (crest), the Regional Road ER110 (toe), and the Junçal Stream. The image highlights the high exposure to hydraulic erosion and the steep geomorphology typical of Madeira's northern coast (Source: Photographic survey adapted from CMM technical reports).

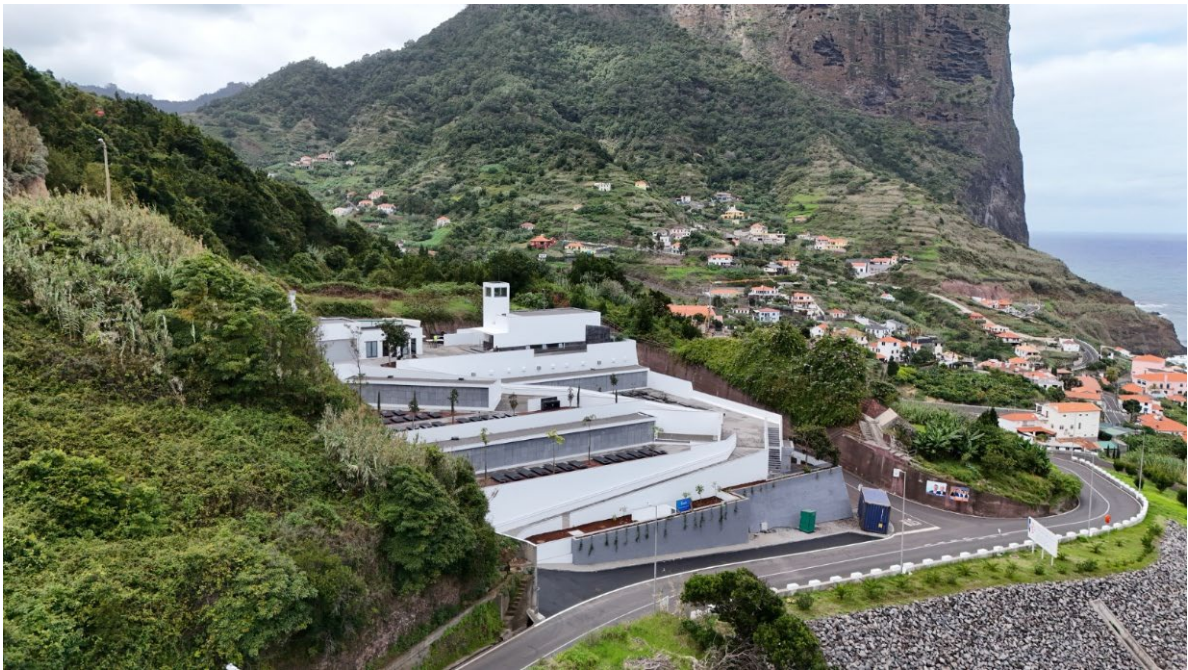
**Figure 3.** Detailed view of the Porto da Cruz slope infrastructure. The proximity of residential and religious structures to the unstable volcanic deposits necessitates a shift from localized repairs to systemic stabilization to ensure long-term resilience (Source: Photographic survey adapted from CMM technical reports).

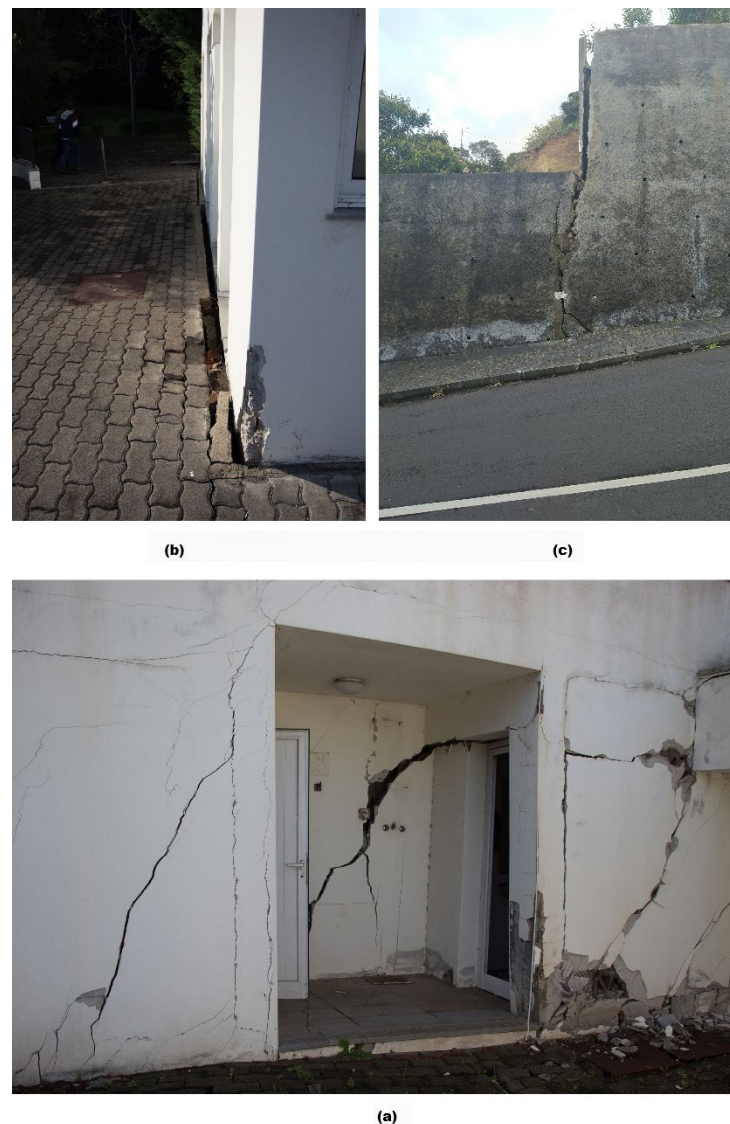
**Figure 5.** Forensic documentation of structural pathologies (2013–2022): (a) Severe diagonal tension and shear cracks in masonry structures; (b) Ground surface rupture and pavement settlement caused by active deep-seated creep; (c) Structural separation and outward tilting of legacy retaining walls (Source: Photographic survey adapted from CMM technical reports).

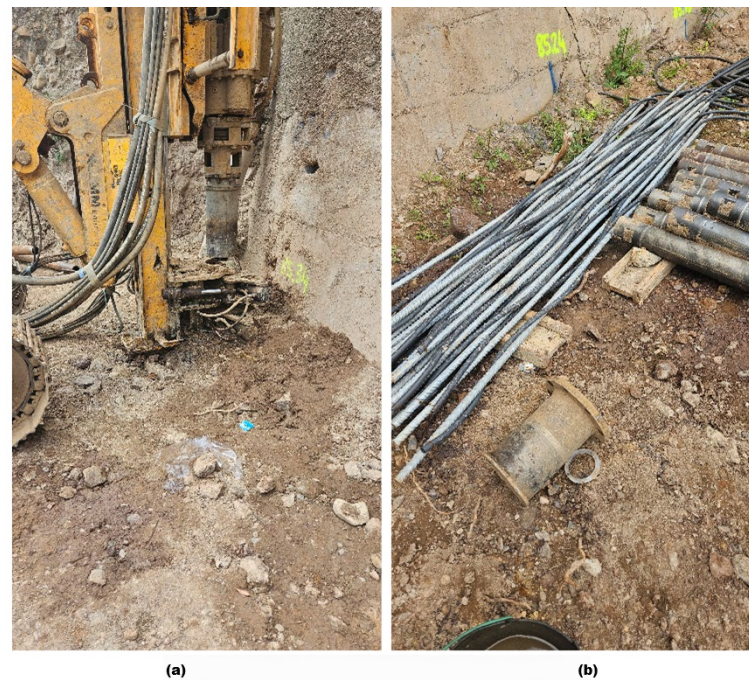
**Figure 6.** Execution of the 26 m micropile system. (a) Drilling operations in restricted spaces; (b) Handling of drilling equipment adjacent to existing structures. The design prioritized subsurface bypass over surface aesthetics to ensure structural stability (Source: Photographic survey adapted from CMM technical reports).
