# Experimental Investigations and Probabilistic Risk Assessment of Failure in Masonry Buildings with Load-Bearing Walls

Yerken Aldakhov <sup>1</sup>, Zhassulan Omarov <sup>1</sup>, Nurakhmet Makish <sup>1</sup>, Serik Aldakhov <sup>1</sup>, Zhangazy Moldamuratov <sup>2</sup> and Vladimir Lapin <sup>3,\*</sup>

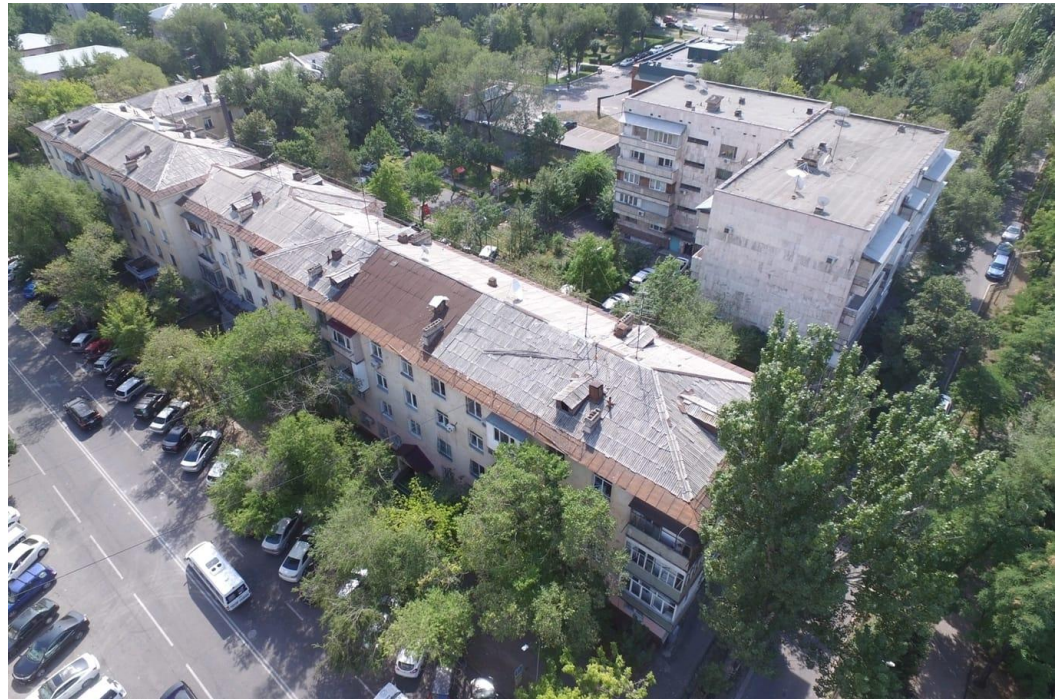
**Figure 1.** Four-story building with load-bearing brick walls.

The 308 series was developed in 1958. The buildings in this series have three or four floors with a basement (Figures 1 and 2). The foundations are made of rubble concrete, and the basement walls are made of precast concrete blocks. The floors were made of pre-fabricated multi-cavity reinforced concrete slabs with reinforced concrete bindings.

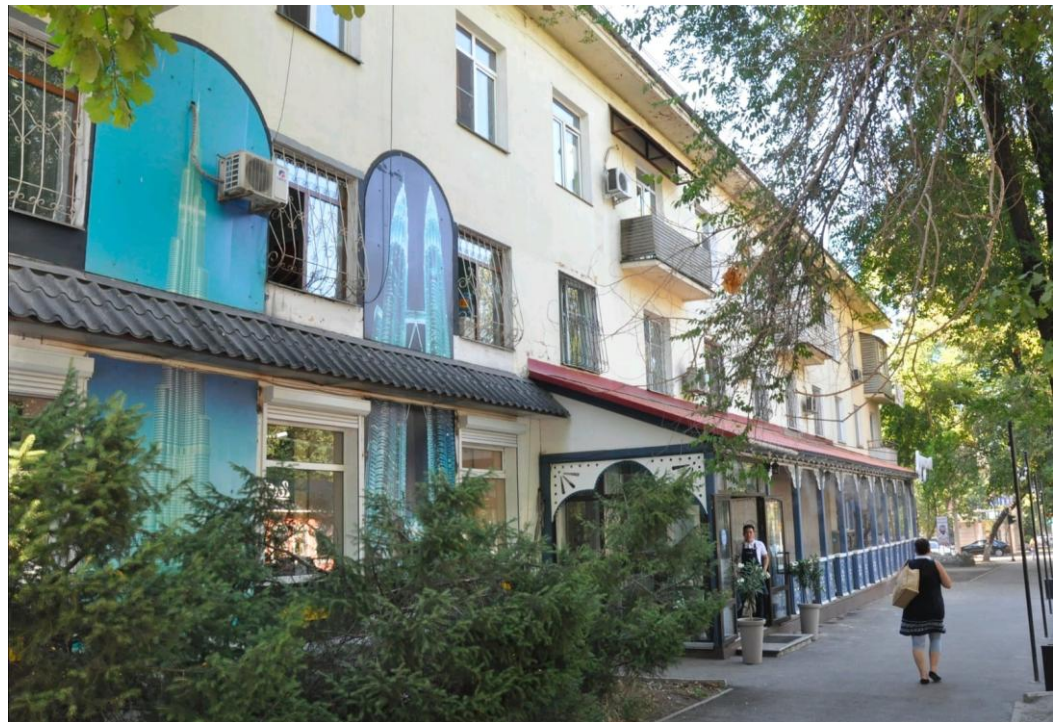
**Figure 2.** A three-story building with load-bearing brick walls.

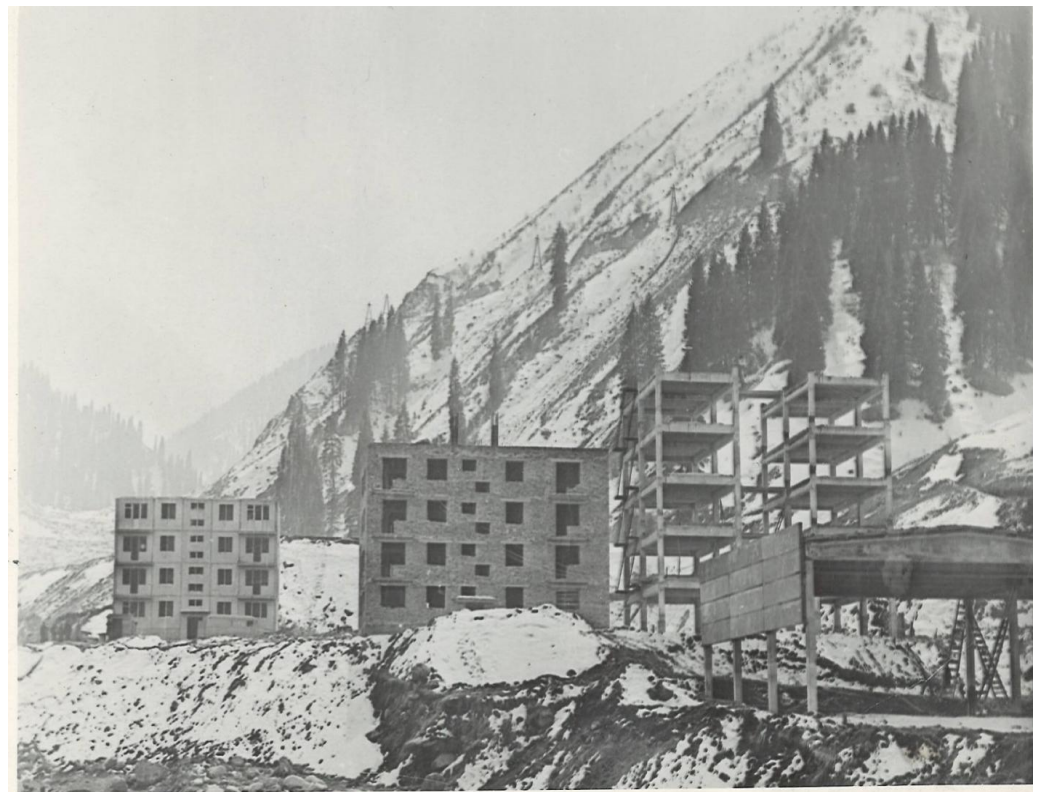
**Figure 3.** Experimental test site in Medeo, in the center of a 4-story brick building.

During the second explosion, the vibrations of a 4-story brick building of the 308 series, erected at a special landfill near the epicenter of the explosion, were instrumentally measured. At the building's foundation level, an acceleration of 600 cm/s<sup>2</sup> was recorded, while at the level of the 4th-floor slab, the acceleration reached 900 cm/s<sup>2</sup>. The building fluctuated with an oscillation period of 0.3–0.5 s; therefore, the oscillation period under high-intensity exposure changed by at least 2 times. The logarithmic decrement was 0.38–0.52.

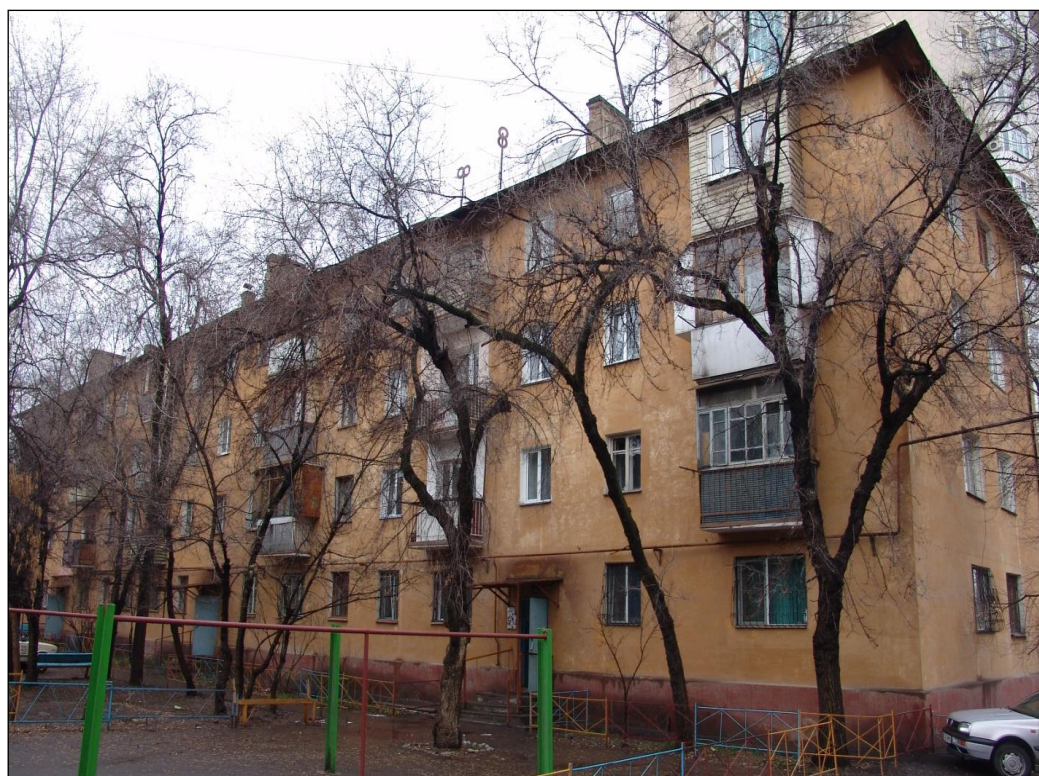
**Figure 4.** A four-stores version of the 308 series brick building.

The general view of the four-story building of the 308 series is shown in Figure 4.

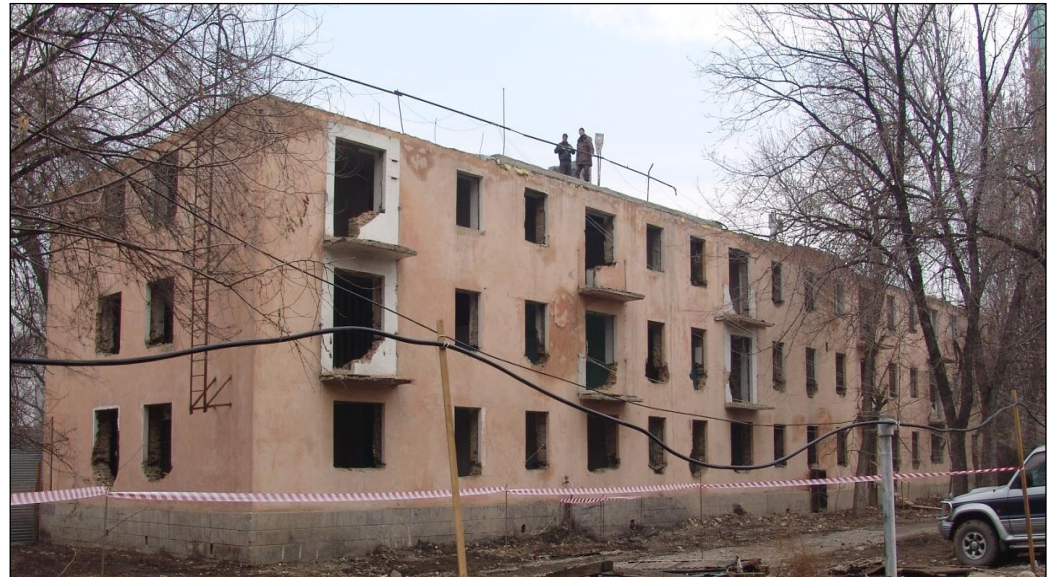
**Figure 5.** Experimental object.

The height of the basement and residential floors is 2.8 m. The dimensions of the building in the extreme axes are  $53 \times 12$  m.

The general view of the test object is shown in Figure 5.

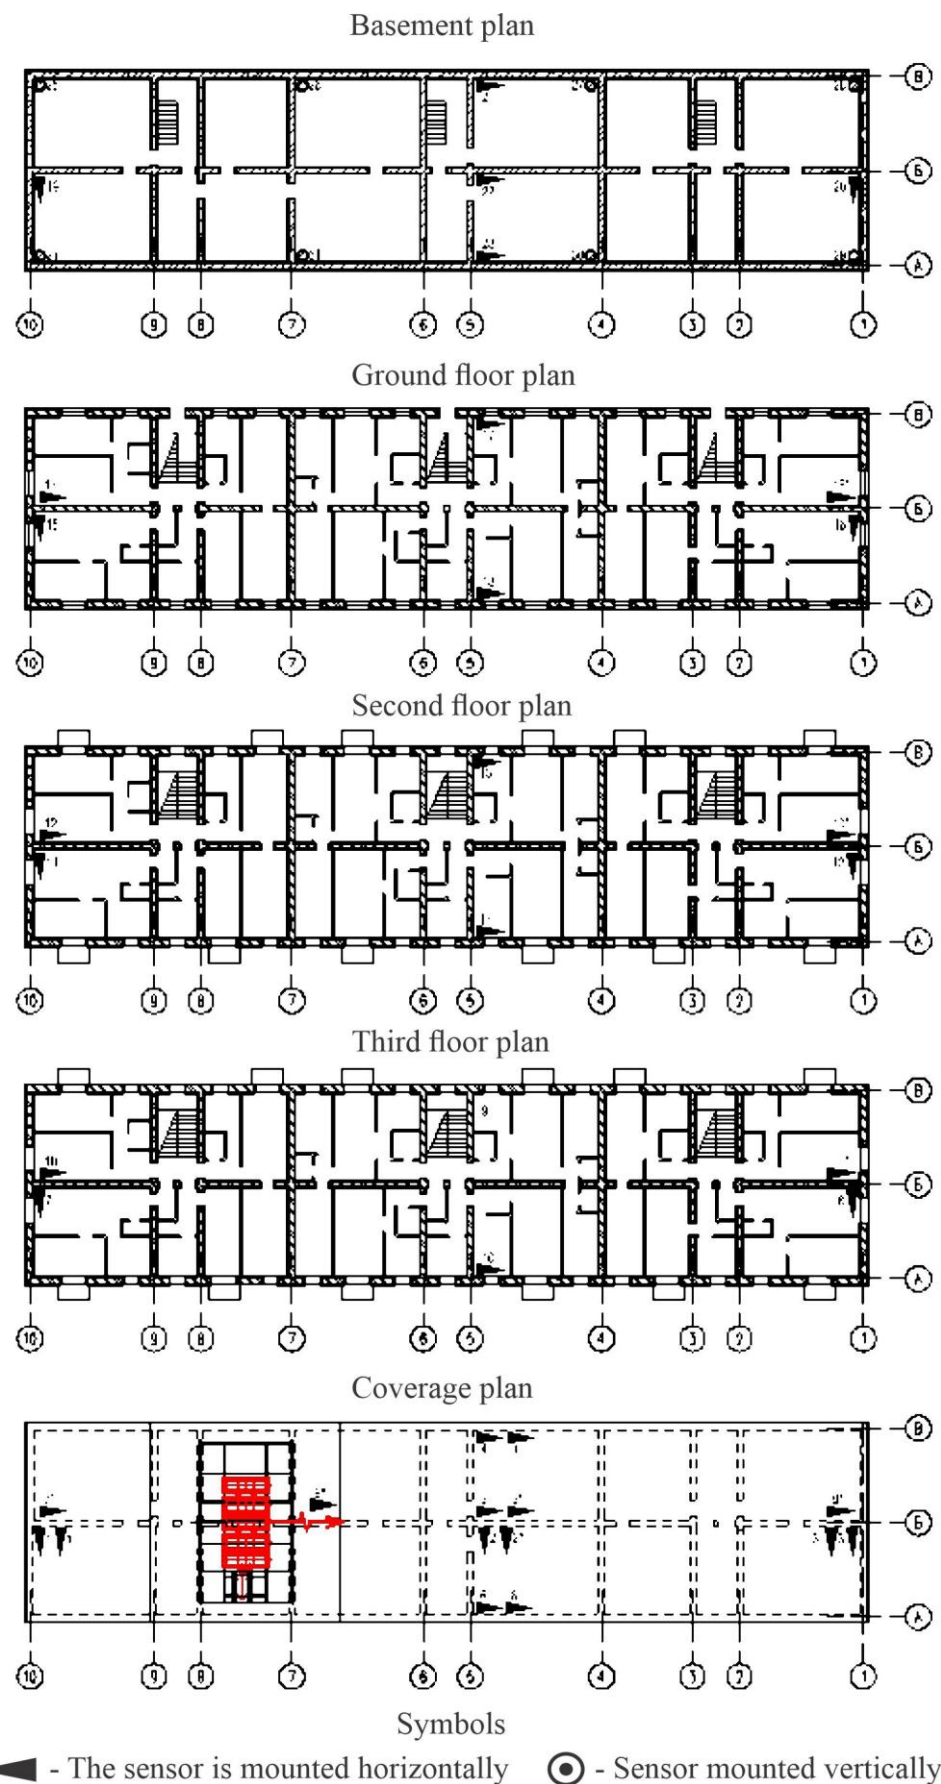
Figure 6. Arrangement scheme of devices.

Vibrations are recorded using the digital recording system RCM-16. Measurements are carried out with a sampling frequency of 156.25 Hz (sampling step 0.0064 s) and frequency filters in the range of 0.5 Hz—25 Hz. ADX accelerometers, designed for measuring linear accelerations, are employed.

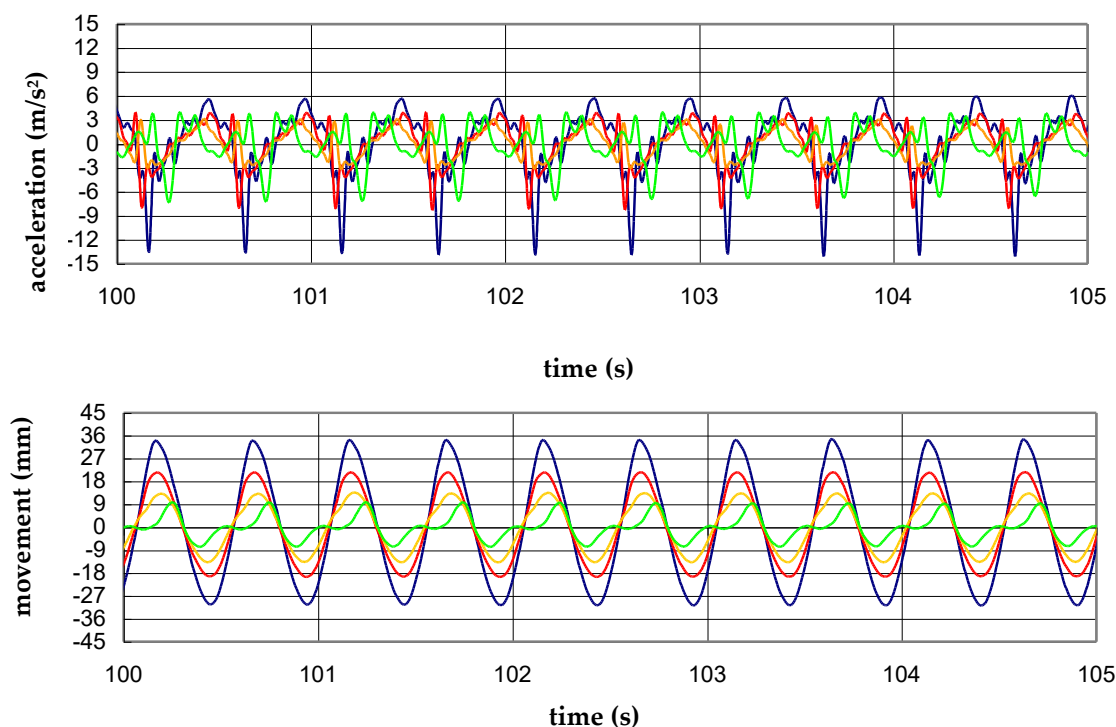
**Figure 8.** Experimental recordings of accelerations and displacements, different colors correspond to different stages of testing

In particular, with the simple harmonic nature of the external effects from the vibrating machine, the vibrations of all fragments had a complex periodic (i.e., inharmonic) character, most clearly observed on the acceleration recordings.

- a component in the form of a simple harmonic having the frequency of the disturbing force of the vibrating machine; the frequency of this component of periodic oscillations was the lowest (main);
- a component in the form of short pulses, repeated with the frequency of the disturbing force of the vibrating machine, and small oscillations between them.

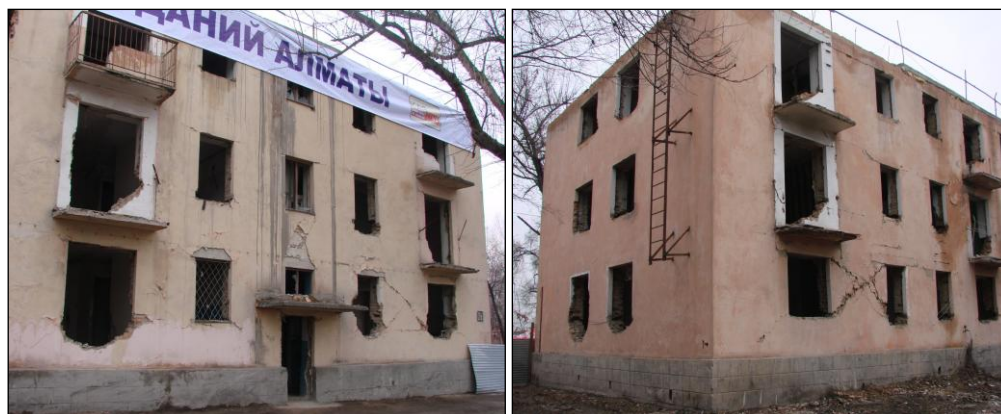
Figure 9. Experimental object after the test.

During the testing phase IV, the building was severely damaged:

- Diagonal and horizontal cracks with large openings appeared in the load-bearing walls of the exterior walls;
- Diagonal cracks formed in almost all the lintels above the window openings of the exterior walls;
- The end wall along the 10 axis was separated by cracks from the longitudinal walls;
- Cracks formed in the inner longitudinal wall, separating it from the transverse walls;
- Many of the partitions on the second and third floors collapsed or sustained significant damage; some of the partitions on the first floor were damaged;
- The mortar had partially or completely fallen out of the joints between most floor slabs.

The condition of the building structures after test phase IV is shown in Figure 9–12.

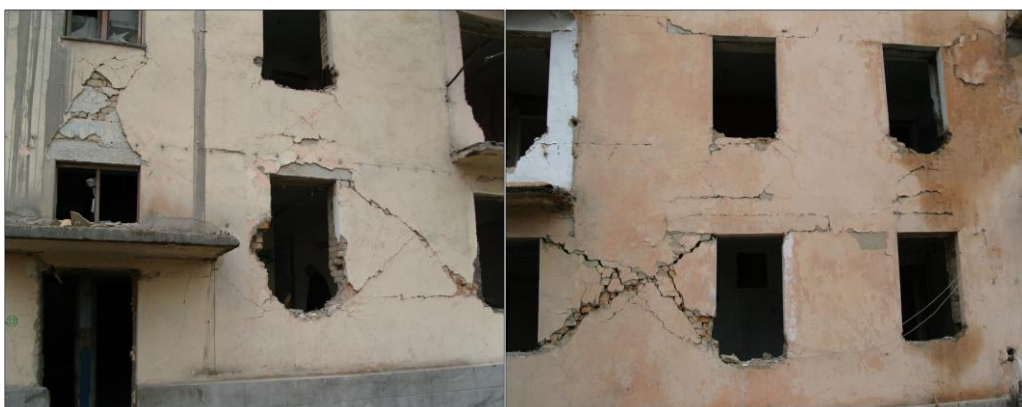
Figure 10. Typical object damage (diagonal cracks).

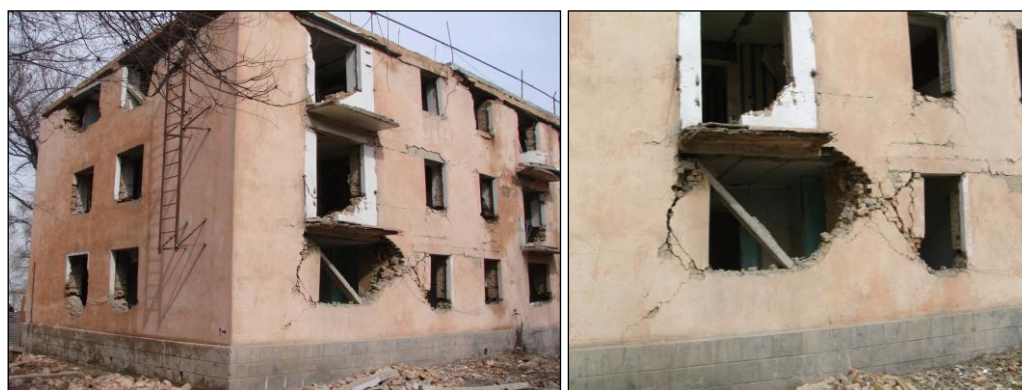
Figure 11. Typical object damage.

The characteristic damage to the building after the completion of the tests is shown in Figure 11–12.

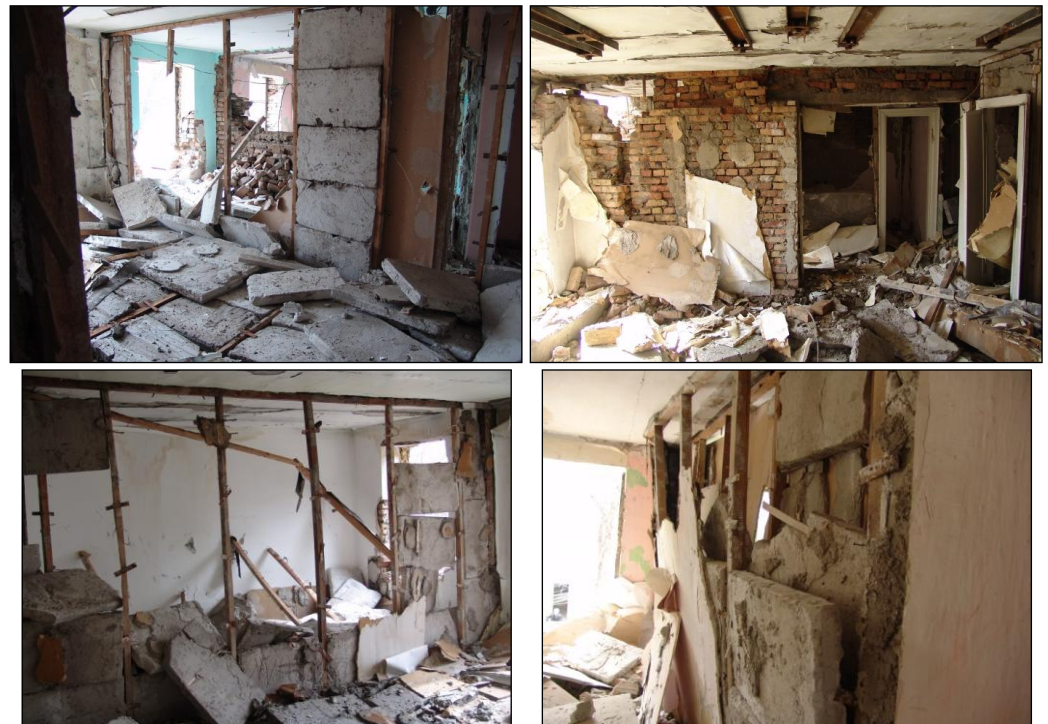
**Figure 12.** Damage inside the building.
