# Experimental Investigation on Seismic Performance of the Masonry Structure with Reinforced Concrete Walls and Large Openings at Its Bottom Floor

In view of the key problems such as the weakened seismic performance and reduced safety caused by the expansion of openings at bottom floor of masonry structure to meet the functional requirements, a 1:4 scale model of a four-story brick-concrete masonry structure was designed and fabricated. Based on the principle of stiffness equivalence, the partial masonry walls on the side of the bottom floor with large openings were replaced by reinforced concrete walls, and then the pseudo static test was conducted on the model. Through the test, the seismic performance indexes such as the failure mode of each floor, the displacement, hysteresis curve, skeleton curve, and stiffness degradation were obtained. The results showed that the masonry structure can form a close connection with the reinforced concrete walls and then the whole structure exhibits the characteristic of ductility. There is no sudden change in bearing capacity during the loading and the hysteresis curves show that the structure retained a certain energy dissipation capacity du

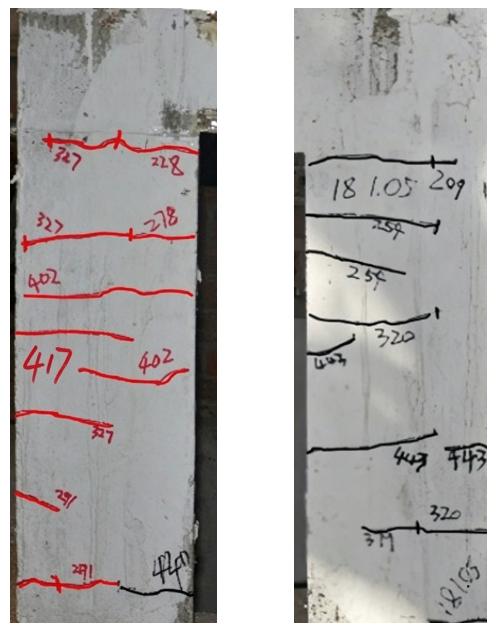
(a) Cracks in wall Q1 (b) Cracks in wall Q5

**Figure 8.** Cracking patterns on the surface of walls Q1 and Q5 (note: the unit of the cracking load in this figure is kN).

The walls Q1 and Q5 are situated at the left and right extremities of the structural model, respectively. The fissures on both walls manifest a horizontal distribution, exhibiting analogous propagation processes. When loaded to  $-3.2$  mm and  $-5.2$  mm, the upper right corner and lower left corner of the Q1 wall crack, respectively. As displacement increases, the number of horizontal cracks on the wall continues to grow. When loaded to  $4.4$  mm and  $8.0$  mm, horizontal cracks caused by thrust appear at the lower right corner of the wall Q1; all cracks on the wall Q5 are caused by thrust. At loads of  $2.0$  mm, the upper left and lower right corners of the wall Q5 crack, and as displacement increases, cracks gradually appear in the middle of the wall. The cracking patterns on the surface of walls Q1 and Q5 are shown in Figure 8.

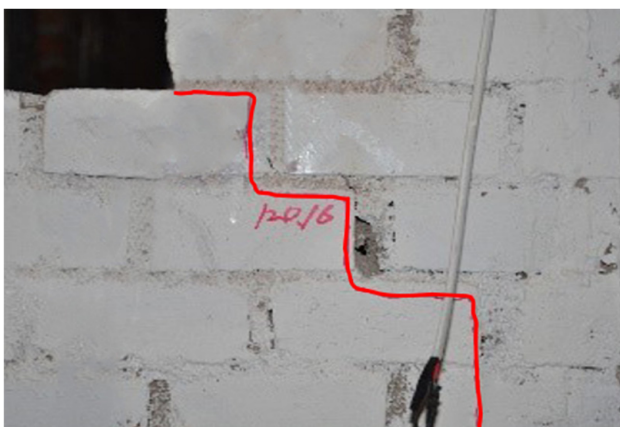
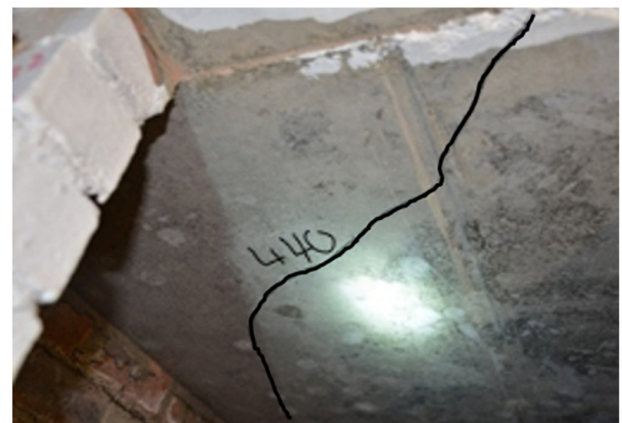
(a) Cracking on the longitudinal wall

(b) Cracks extended to the slab

**Figure 11.** Cracking patterns of the longitudinal walls at the second floor along the A-axis (note: the unit of the cracking load in this figure is kN).

The cracking patterns of the longitudinal wall at the second floor along the A-axis are shown in Figure 11. Subsequent to the loading of  $-1.4$  mm, step-like cracks began to emerge at the corners of each window along the mortar joints in the second-floor longitudinal wall of the A-axis, as illustrated in Figure 11a. Subsequent to loading to  $8.0$  mm, diagonal cracks became apparent in the window partition wall on the second floor, with a relatively rapid crack development rate. The cracks in the wall beneath the window were also gradually extended to the slab, as illustrated in Figure 11b. As displacement continued to increase while the load increased relatively slowly, the test was terminated at a displacement of  $12$  mm for safety reasons and to observe the structural damage after the test. At the conclusion of the test, the longitudinal wall surface exhibited severe damage, characterized by the formation of dense cracks. However, the wall and structural columns remained stable and did not collapse. The damage process of the entire wall surface lagged behind that of the reinforced concrete wall.

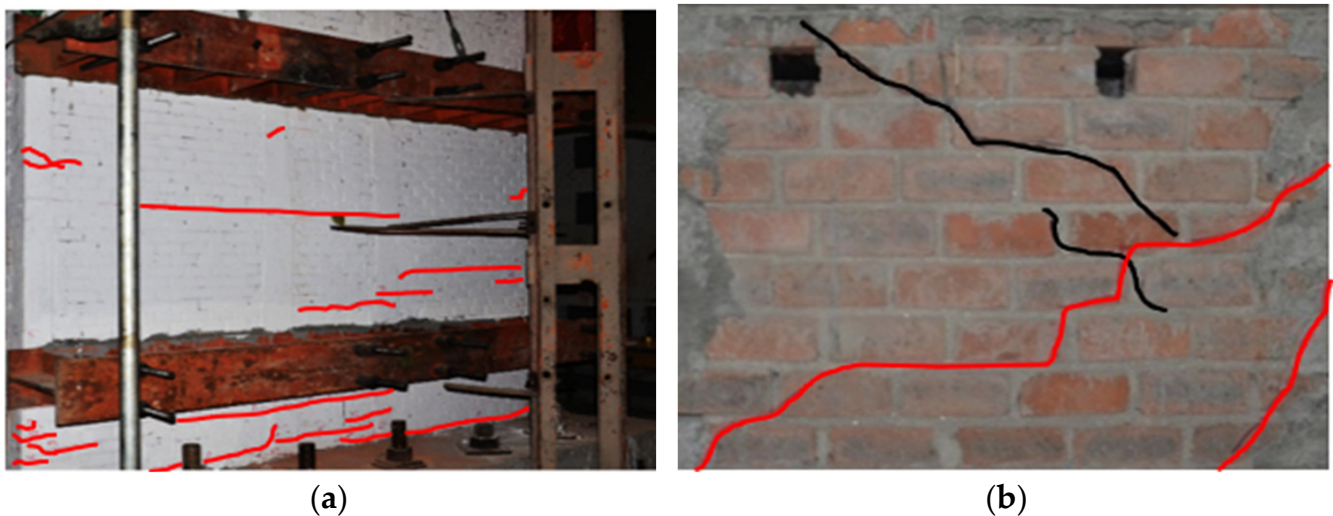
**Figure 13.** Cracking patterns on the surface of transverse wall and inner longitudinal wall. (note: Cracks generated by the application of thrust are marked with black symbols, whereas those generated by the application of tensile force are marked with red symbols. (a) Cracks on the transverse wall. (b) Cracks on the interior longitudinal wall.

The development of cracks was observed in the transverse walls on both sides of the structural model after the application of loads in the range of  $\pm 3.4$  mm. The observed cracks were all of a tensile nature and horizontal orientation, with the hypothesis being that they were caused by normal stress during the process of pushing and pulling. At the conclusion of the test, the damage to the transverse walls on both sides was most severe at ground floor level, exhibiting dense through cracks, while the damage to the second and third floors was comparatively minor, exhibiting sparser cracks. Due to the impracticality of observing the crack development of the inner longitudinal walls during the test, an inspection of these walls was conducted post-test. A survey of the structure revealed that the majority of cracks were located on the ground and second floors, forming a staircase pattern. It was evident that fissures had already manifested on the ground floor, extending

to the ground beam. This was primarily due to the fact that the walls on these two floors were located on both sides, and the force application points of the horizontal beams were not on the floor slabs but on the walls of the upper and lower floors. The forces from the horizontal beam tie rods were first transmitted to these two longitudinal walls. In the initial phase of load application, the forces exerted on the two walls comprise two components: firstly, a force allocated to the walls based on the stiffness of the ground floor; and secondly, a force from the horizontal beam tie rods. Consequently, cracking occurs at an earlier stage in these areas. The damage sustained by the transverse and interior longitudinal walls is not severe, with the damage to the transverse walls occurring subsequent to that inflicted upon the reinforced concrete walls. The cracking patterns on the surface of the transverse wall and interior longitudinal wall are illustrated in Figure 13.
