# Seismic Performance of a Masonry Structure with Large Openings and Equivalent Concrete Columns: An Experimental Investigation

**Keywords:** masonry structure; large openings at ground-level floor; equivalent reinforced concrete frame columns; pseudo static test; seismic performance

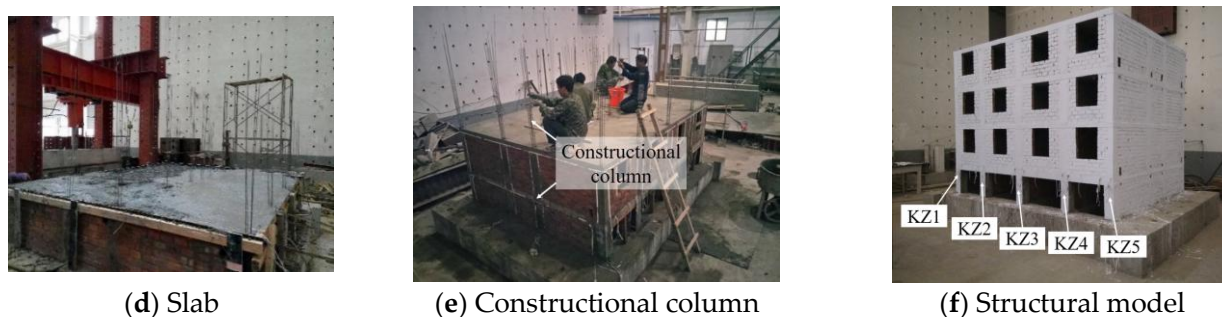
Figure 3. Fabrication procedures of the structural model.

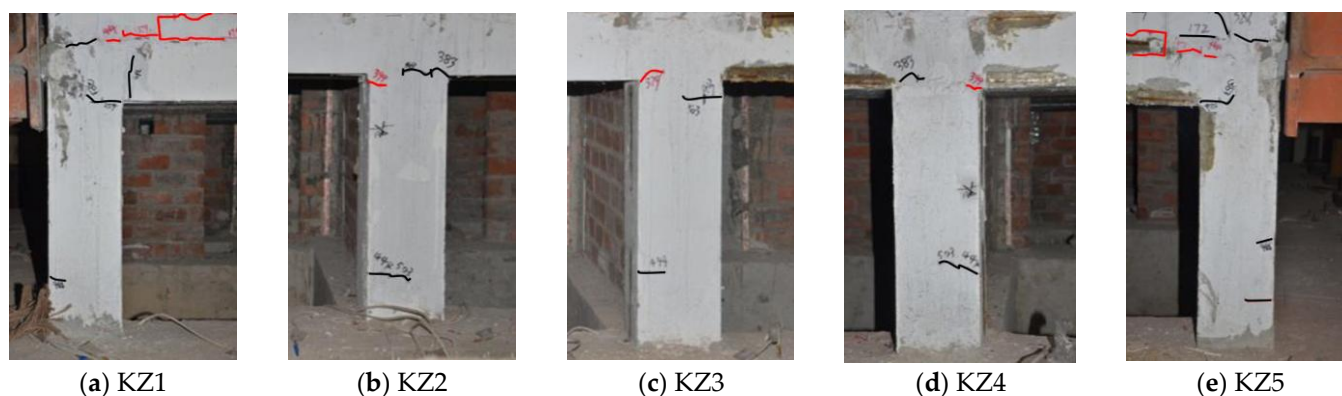
**Figure 13.** Crack pattern of the frame columns at the ground-level floor along A-grid line.

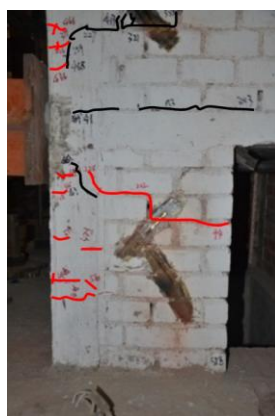
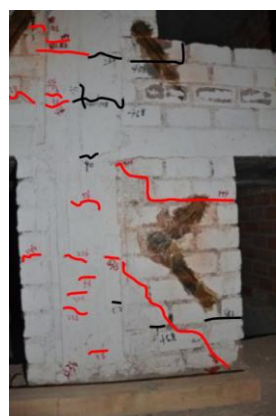
**Figure 15.** Crack pattern of the longitudinal wall and constructional column on the ground-level floor along D-grid line. (a) Wall limb and constructional column at 1-grid line. (b) Wall limb and constructional column at 2-grid line. (c) Wall limb and constructional column at 9-grid line.

The longitudinal walls along the D-grid line at each floor of the model were found to be free of cracking when loaded to  $\pm 0.2$  mm. However, as the displacement increased, horizontal cracks began to appear in the upper mortar joints of the wall limbs at the 1-grid line of the first-floor longitudinal wall of model D-grid line, with a width of 0.05 mm. Concurrently, horizontal cracks emerged on the constructional column at the 2-grid line of the second-floor longitudinal wall of the model D-grid line. The crack pattern of the longitudinal wall and constructional column on the ground-level floor along the D-grid line is shown in Figure 15. As illustrated in Figure 15, 6 mm stepped diagonal cracks were observed to develop along the mortar joints in each wall limb of the ground-level floor longitudinal wall of the D-grid line, at the location of the corner of the door opening. The load was determined to be within the range of  $\pm 6$ . The location of the window corners on the second-floor longitudinal wall of the second-floor D-grid line exhibited 8 mm stepped diagonal cracks, which penetrated the constructional columns. The original cracks on the D-grid line longitudinal wall and constructional column were further developed when loaded to  $\pm 9.6$  mm. The test concluded when the load reached  $\pm 12.0$  mm. Following the conclusion of the test, it was observed that a number of the stepped diagonal cracks present in the first and second floors had penetrated the frame and constructional columns. The diagonal cracks on the second floor exhibited a V-shaped pattern, as illustrated in Figure 16. The crack distribution on the longitudinal wall and constructional column along the D-grid line is illustrated in Figure 17.

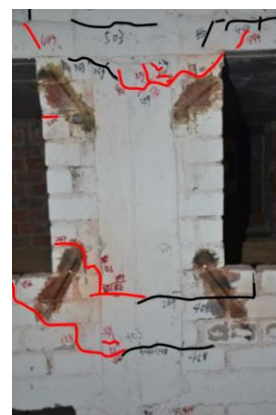
(a) Wall limb and constructional column on 2-grid line

(b) Wall limb and constructional column at 8-grid line

**Figure 16.** V-shaped cracks on the longitudinal walls at the second floor along D-grid line.

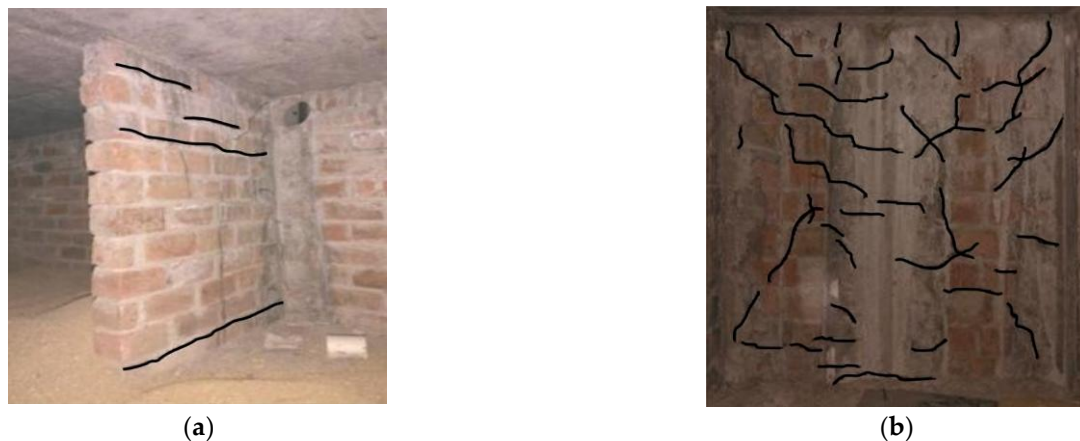
**Figure 18.** Crack pattern of the longitudinal walls and constructional columns along B-grid line. (a) Wall limb and constructional column on the ground-level floor of 9-grid line. (b) Wall limb and constructional column on the third floor of 5-grid line.

The crack pattern of the longitudinal walls and constructional columns along the B-grid line and C-grid line is shown in Figure 18 and Figure 19, respectively. The longitudinal walls of the B-grid line and C-grid line were arranged in an asymmetrical configuration, and the crack patterns exhibited by these axes were significantly divergent. The longitudinal wall of the B-grid line exhibited an incremental increase in the number of cracks, commencing from the base and culminating at the third floor. The longitudinal wall of the ground-level floor exhibited predominantly horizontal cracks, while the longitudinal walls of the second and third floors demonstrated stepped diagonal cracks. These diagonal cracks intersected with constructional columns in an X-shaped pattern, as illustrated in Figure 18. The development of stepped diagonal cracks was observed along the mortar joints and in the wall limbs at the location of the 1-grid line and 9-grid line on the bottom longitudinal wall of C-grid line. Furthermore, the horizontal cracks presented at the base

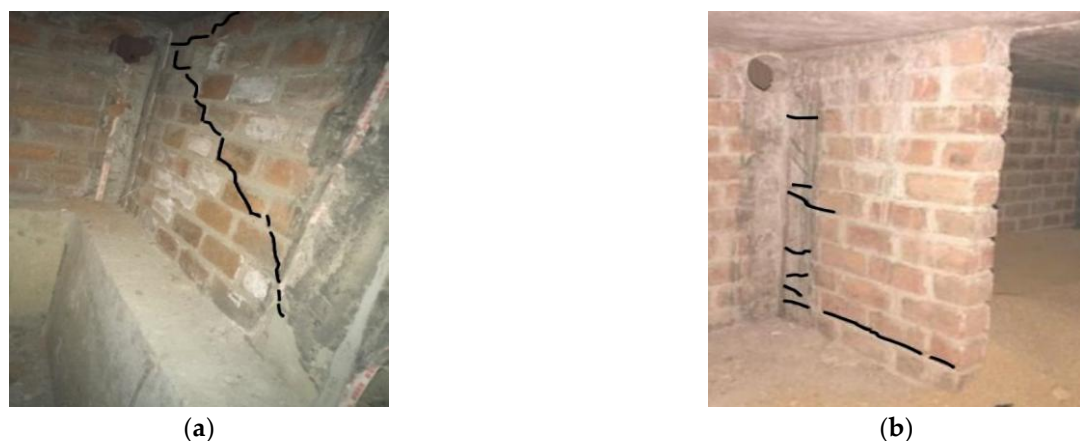
**Figure 19.** Crack pattern of the longitudinal walls and constructional columns along C-grid line. (a) Wall limb and constructional column on the ground-level floor of 1-grid line. (b) Wall limb and constructional column on the second floor of 1-grid line.

of the wall limbs at the 1-grid line and 9-grid line of the longitudinal wall on the second and third floors extended to the constructional columns, as illustrated in Figure 19.
