# A Deep Learning-Based Decision-Support Framework for Assessing the Conservation Condition and Protection Priority of Huizhou Historic Buildings

**Keywords:** Huizhou historic buildings; deep learning; YOLOv11; YOLOv11-seg; instance segmentation; architectural pathology; decorative elements; conservation priority; decision support

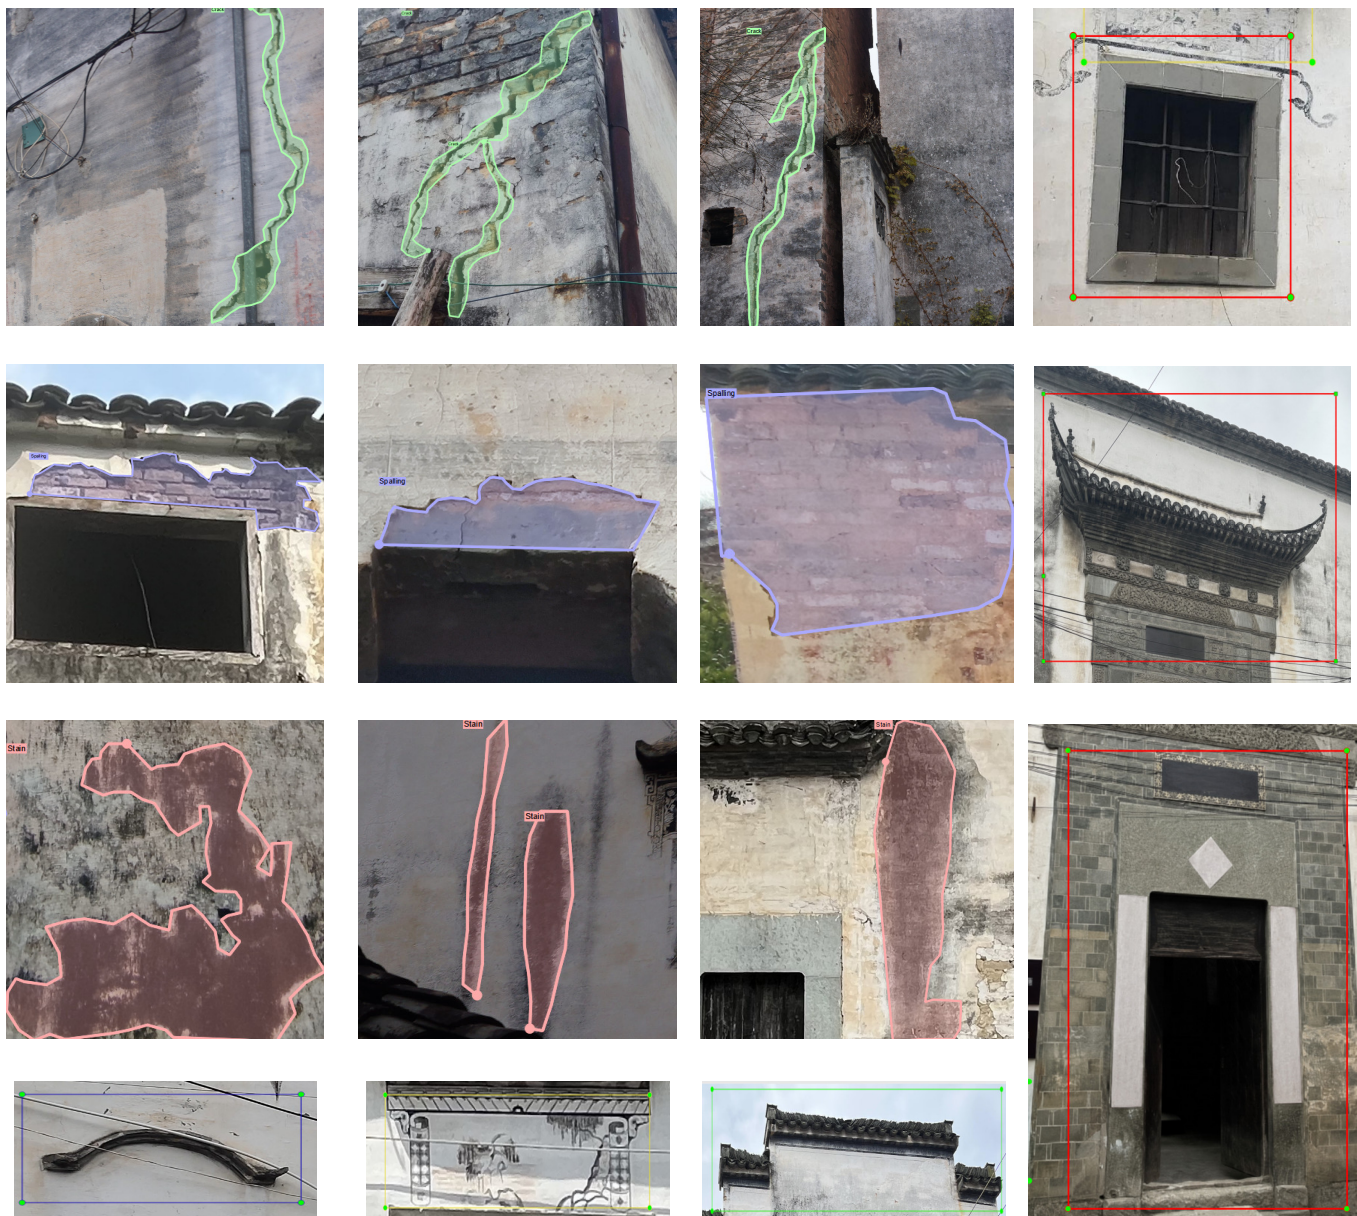
**Figure 2.** Annotation examples of pathologies and decorative or typological elements.

A consistent annotation protocol was established to reduce class ambiguity and inter-annotator variation. Decorative and typological elements were delineated according to their visible physical boundaries. Door annotations included the entrance opening and its visible frame, while window annotations included the opening and visible frame. Door canopies and window heads encompassed the decorative or structural elements above the corresponding openings, and horse-head gables were annotated along their visible stepped outlines.

For pathology segmentation, cracks were represented by narrow polygons following their visible widths rather than by center lines. Spalling annotations followed the boundaries of detached material, plaster loss, or exposed substrate. Stains were delineated according to visible discoloration, textural differences, water traces, or surface deposits. Ambiguous cases were reviewed collectively to improve annotation consistency.

and test subsets at a ratio of 8:1:1. Table 1 summarizes the classification scheme, and Figure 2 presents representative annotation examples used to verify the consistent application of these conventions.

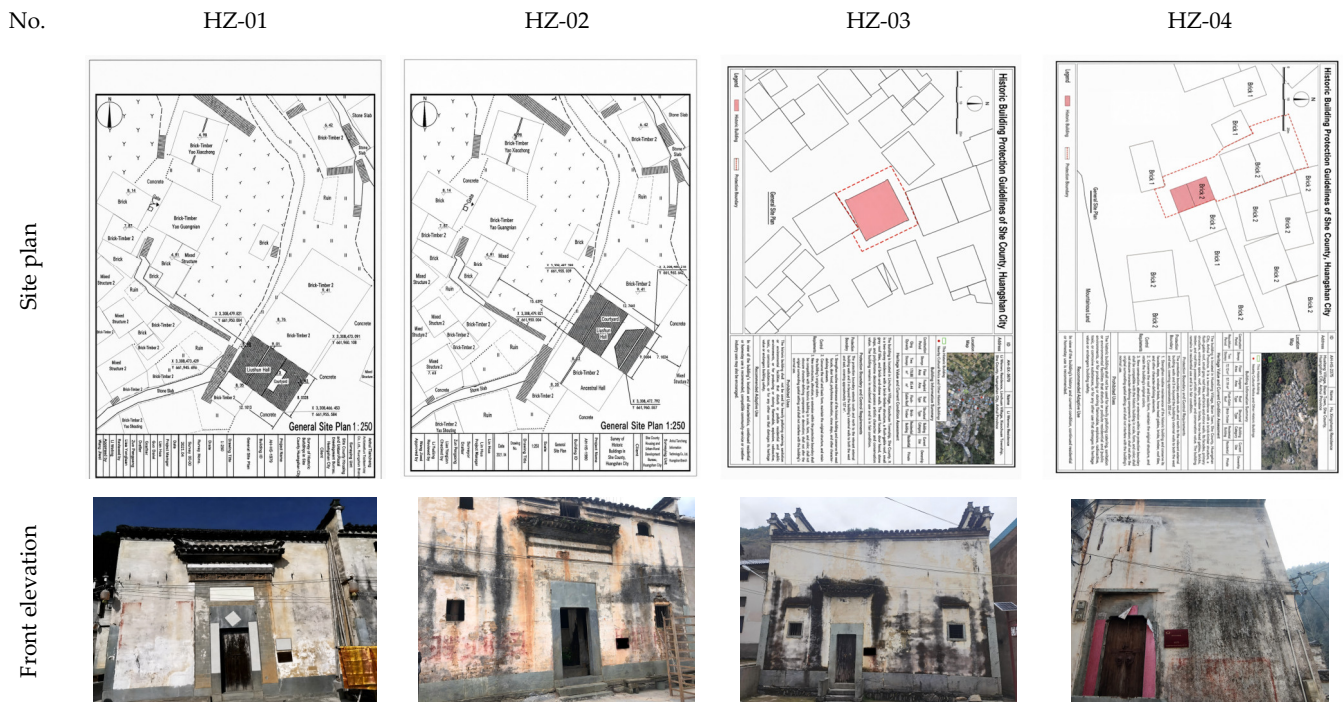
Figure 3. Basic information for the four pilot buildings: site plans and front elevations.

The trained models were applied to four Huizhou historic buildings, each represented by four facade images, resulting in 16 images in total. None of these images were used for model training. The pathology masks were converted into class-specific pixel-area ratios, while decorative-element detections were converted into weighted frequency scores. Given the limited number of buildings and images, this analysis is presented as a pilot application rather than a general validation of large-scale survey performance. The site information and model outputs for the pilot buildings are presented in Figures 3 and 4, respectively.

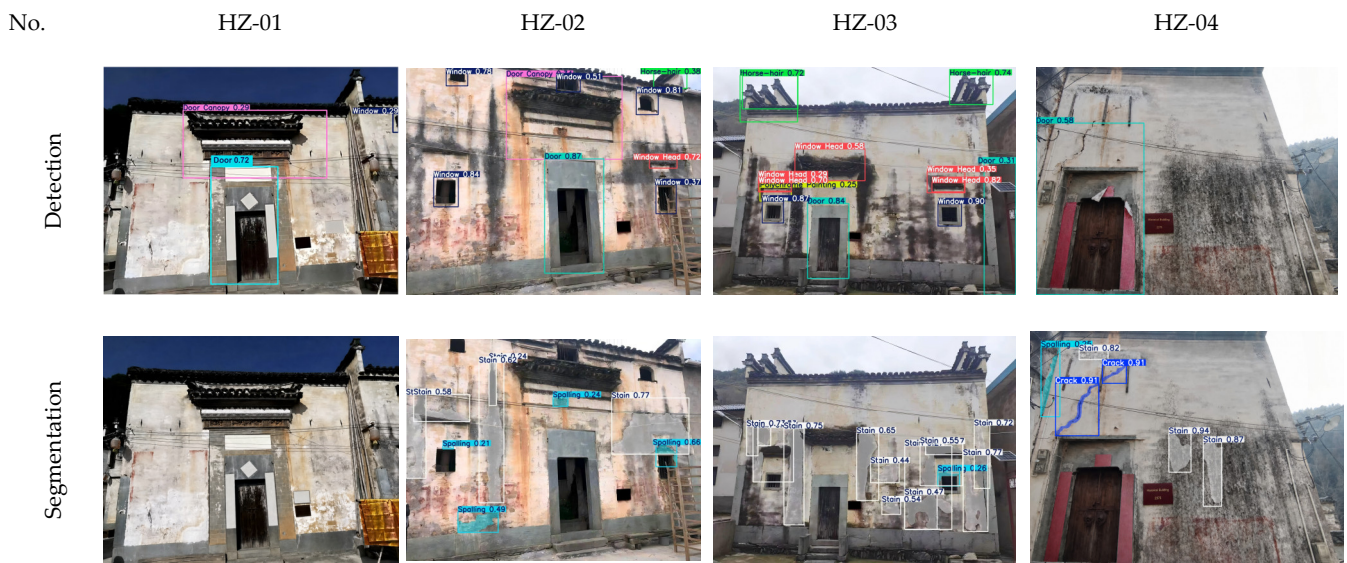
Figure 4. Detection and segmentation outputs for the four pilot buildings.

Under the reference normalization defined in Section 2.6, HZ-03 achieved the highest baseline *CPI* (0.981), combining a high *PSI* (0.969) with the maximum *DVI* (1.000). HZ-02 ranked second and was classified as High priority (*CPI* = 0.760), with a *PSI* of 0.809 and a *DVI* of 0.687. HZ-04 was classified as Medium priority at the baseline weighting (*CPI* = 0.631). Its raw pathology score, derived from crack, spalling, and stain area ratios of 1.73%, 5.77%, and 1.78%, respectively, defined the pilot-specific *PSI* upper reference and therefore produced a *PSI* of 1.000. However, only one door was detected, resulting in a comparatively low *DVI* of 0.078. Because its sensitivity range (0.539–0.723) crossed the Medium–High threshold, the priority of HZ-04 should be regarded as weight-sensitive rather than as a robust categorical assignment. HZ-01 remained low priority (*CPI* = 0.097) because no pathology masks were predicted, although its *DVI* of 0.242 reflected the presence of detected decorative elements. The resulting ranking (HZ-03 > HZ-02 > HZ-04 > HZ-01) therefore reflected the combined influence of predicted deterioration and detected value-bearing elements rather than pathology extent alone.
