# Effect of High Temperature on Micro-Structure and Mechanical Properties of Fiber-Reinforced Cement-Based Composites

**Citation:** Ge, C.; Chen, X.; Gong, Y.; Kong, X.; Chen, F. Effect of High Temperature on Micro-Structure and Mechanical Properties of Fiber-Reinforced Cement-Based Composites. *Crystals* **2024**, *14*, 778. <https://doi.org/10.3390/cryst14090778>

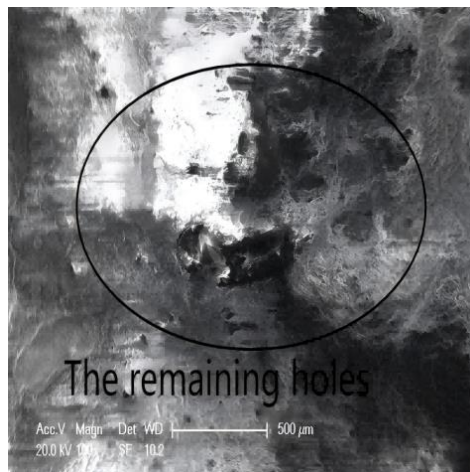
**Figure 12.** SEM diagram of uniaxial tensile process of PVA fiber specimens at 500 °C.

At 500 °C, the real-time microstructural evolution and mechanical curves for the PVA and the PP fiber-reinforced mortar specimens are shown in Figures 12 and 13.

As temperatures rise, moisture gradually evaporates, and the fibers inside the fiber-reinforced mortar specimens progressively dissolve, increasing the number of capillary pores and microcracks [26]. At 500 °C, the real-time microstructural photographs of both fiber-reinforced mortar specimens show complete melting of fibers and the presence of

voids (as shown in Figures 2, 3, 4, 5 and 6c). The surfaces of phases I, II, and III exhibit clear signs of thermal damage. The tensile test process is shorter compared to other temperature ranges, but the tensile strength of the fiber-reinforced specimens is higher than that of the JZ group. This is because the JZ group has a higher density than the fiber group, and the fibers melt and form capillary channels in the fiber group, providing space for the release of steam pressure and reducing damage caused by steam stress inside the concrete [27]. The fibers in both the PVA and the PP fiber-reinforced mortar specimens melt due to high temperatures, causing the interior of the concrete specimens to lose the “bridging” action of PVA and PP fibers. Additionally, when temperatures reach 300 °C, the interlayer water of calcium silicate hydrate (C-S-H) and some of the chemically bound water of hydrated calcium aluminate in the concrete begin to be lost. Further dehydration occurs as  $\text{Ca}(\text{OH})_2$  decomposes, causing the previously dense structure of the concrete specimens to gradually become loose, reducing strength. The mechanical curve from the tensile stage shows that the tensile strength of the PVA fiber-reinforced mortar specimen decreased by 36.47%, while that of the PP fiber-reinforced mortar specimen decreased by 24.14%. The trend of the load–displacement curve resembles that of the JZ group, displaying the characteristics of brittle material failure.

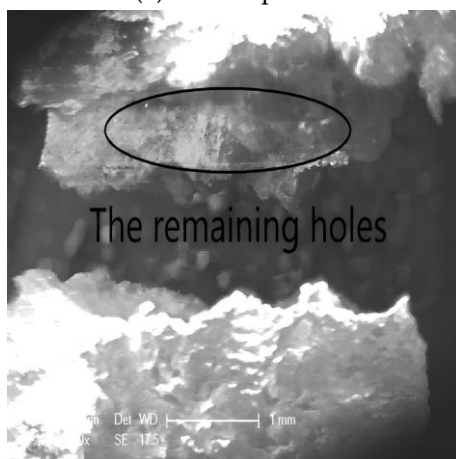
**Figure 13.** SEM diagram of uniaxial tensile process of PP fiber specimens at 500 °C.
