# Deep Learning-Based Technique for Building Damage Extraction and Mapping from Ground-Level Images Using Visible Remote Sensing Indices and Edge Angle Dispersion as Input Features <sup>†</sup>

<sup>†</sup> Presented at 8th International Conference on Knowledge Innovation and Invention 2025 (ICKII 2025), Fukuoka, Japan, 22–24 August 2025.

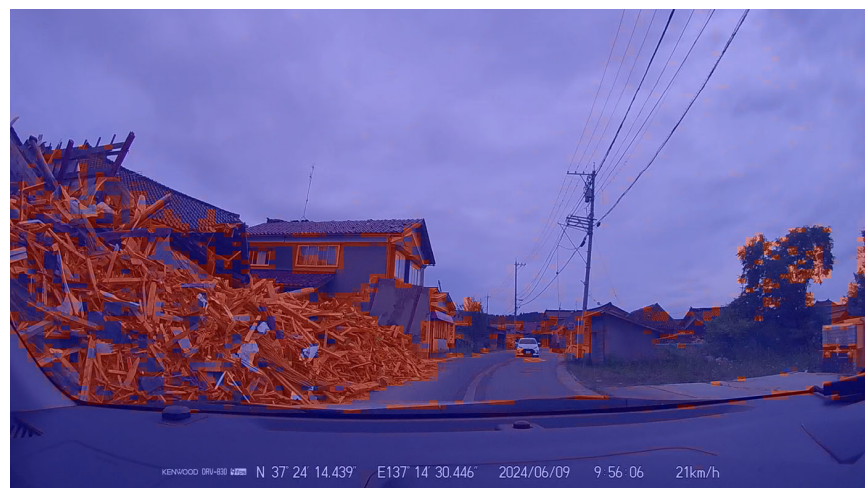
We analyzed the provided images as concrete examples of earthquake damage detection using a deep learning model. These images are crucial for intuitively understanding the data processing, model inference results, and the nature of the training data in this research. First, the first image shows the model's inference results visually overlaid onto the original image (Figure 8). In this image, regions identified by the model as "Damage" are indicated by a red, semi-transparent overlay. This allows for immediate visual confirmation of which buildings or structures the model estimated to be damaged. The varying intensity of the red color likely reflects the confidence level (probability) of the model's damage estimation. For instance, a darker red might suggest a higher certainty of damage. Such a heatmap-like visualization is extremely useful for rapidly identifying damaged areas and providing concrete information to disaster response teams. This is an example of the damage mapping, which is a primary objective of this research, demonstrating the potential for automated systems to provide practical information.

**Figure 8.** Visualization of inference results: image with damaged areas highlighted in red.

Figures 8 and 9 illustrate the training process and inference results of the deep learning model in this study. The first visualization image demonstrates the potential for the model to function as a practical damage mapping tool, while the second and third training images provide specific examples of the visual features the model learns to differentiate between normal and abnormal (damaged) conditions. These images serve as valuable case studies for understanding how the model detects complex earthquake damage and visually represents its findings.

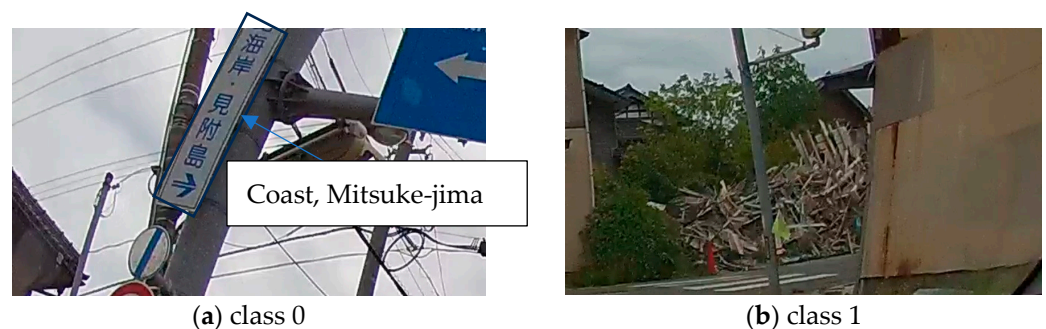
Figure 9a shows a typical example of a training image patch classified as "No Damage" (Class 0) used for model training. This image patch captures buildings and their surroundings that show no obvious signs of damage, such as structural deformation, abnormal changes, or scattered debris. This serves as the foundational data for the model to learn "normal" conditions, i.e., states requiring "No Correction." By learning features like intact building shapes, uniform surfaces, and orderly surrounding environments, the model can then distinguish patches with different characteristics as "Damage."

**Figure 9.** Training images.

Figure 9b is a typical example of a training image patch classified as “Damage” (Class 1) used for model training. This image patch clearly shows explicit signs of earthquake damage, such as structural breakage of buildings, wall collapses, roof damage, and debris scattered in the surroundings. Such data is essential for the model to learn diverse damage patterns, including cracks, structural distortions, debris piles, or exposed internal structures. Importantly, providing a balanced representation of images with different damage types and degrees of severity is crucial for the model to achieve a high recall rate for the “Damage” class. Techniques like SMOTE oversampling likely contribute to enabling the model to learn the varied characteristics within this minority class.
