# Experimental Investigation of the Fatigue Strength and Leakage Failure Mode of Corroded Cast Iron Water Pipes<sup>†</sup>

**Abstract:** Controlled laboratory-based physical evidence is presented, showing how the type of fatigue loading impacts the remaining life and the failure mode of corroded GCI water pipes. Leak-before-burst behavior is shown for pipes experiencing internal water pressure fatigue loading but not for four-point bending fatigue. Sharp pits are shown to reduce fatigue strength by up to 5.4 times, with the degree of reduction dependent on alignment. Condition assessments of corroded GCI water pipes must consider both the three-dimensional shape of the corrosion pitting and the loading experienced by the pipe to give a true assessment of the damage caused by a corrosion pit.

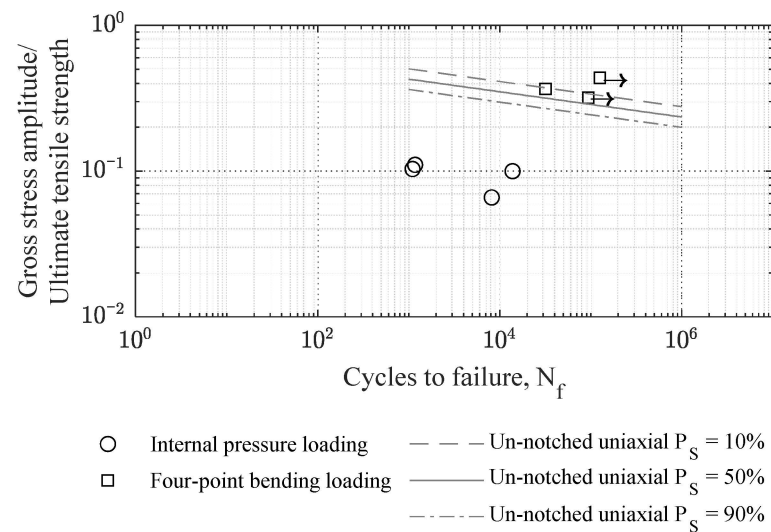
**Figure 3.** Plot showing the sharp axial notch specimen fatigue test data. The un-notched uniaxial fatigue curve from John et al. [5] is included for reference.

The fatigue results are plotted in Figure 3 with the un-notched uniaxial  $R = 0.1$  fatigue curves from John et al. [5] for comparison. An internal pressure scoping test at a lower stress amplitude is included in Figure 3. Only one of the bending fatigue tests failed before  $10^5$  load cycles. A higher stress amplitude was not possible due to equipment limitations.

Figure 3 shows that, when subject to internal water pressure loading, the presence of the sharp axial notch reduced the fatigue strength of the specimens by 3.4–5.4 times relative to un-notched uniaxial loading. When four-point bending loading was applied to the same specimen design, the fatigue strength was slightly greater than the un-notched uniaxial case. These results show that the direction of the applied fatigue stress relative to an irregular corrosion pit significantly affects the detrimental effect of the corrosion pit, meaning the damage caused by a pit is a function of the pit's geometry and the loading applied to the pipe. Condition assessments of corroded GCI water pipes must consider both the three-dimensional shape of the corrosion pitting and the loading experienced by the pipe to give a true assessment of the damage caused by a given corrosion pit.

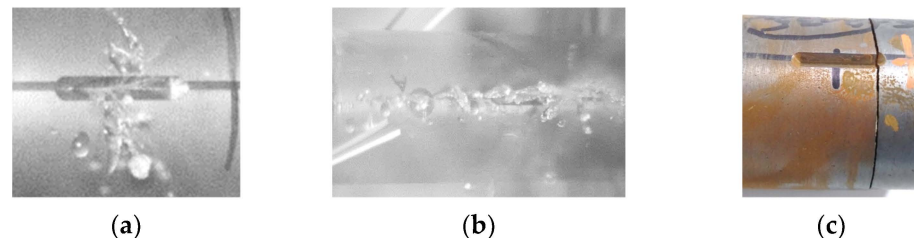
**Figure 4.** Images showing specimen failure modes: (a) A leaking axial crack contained within the pit; (b) a leaking axial crack extending beyond the pit; (c) a circumferential crack post-test.

All specimens subject to internal pressure fatigue loading developed an axially aligned crack at the root of the pit that allowed water loss (Figure 4a). For the two specimens that failed after  $\sim 10^3$  load cycles, the crack leaked for  $\sim 100$  load cycles and then grew beyond the notch in a single load cycle, resulting in a leaking crack  $>100$  mm long (Figure 4b). One pipe that failed after  $\sim 10^4$  load cycles leaked for  $\sim 200$  load cycles without the crack growing beyond the pit, while the other leaked for  $\sim 2000$  load cycles without the crack growing. These two tests were stopped automatically because of pressure load drop.

The only four-point bending fatigue specimen that failed developed a circumferential crack during a single load cycle located at one end of the pit (Figure 4c). This failure did not trigger the high-speed camera due to a lighting issue. Gradual pressure drops were detected for the internal pressure loading specimens that coincided with leakage. No pressure drop was detected for the failed four-point bending fatigue specimen, indicating that no leakage occurred before the full-circumferential crack formed.
