Seismic Performance Enhancement of RC Columns Using Thin High-Strength RC Jackets and CFRP Jackets

George Kalogeropoulos * and Alexander-Dimitrios Tsonos

Department of Civil Engineering, Aristotle University of Thessaloniki, GR-54-124 Thessaloniki, Greece; tsonosa@civil.with.gr

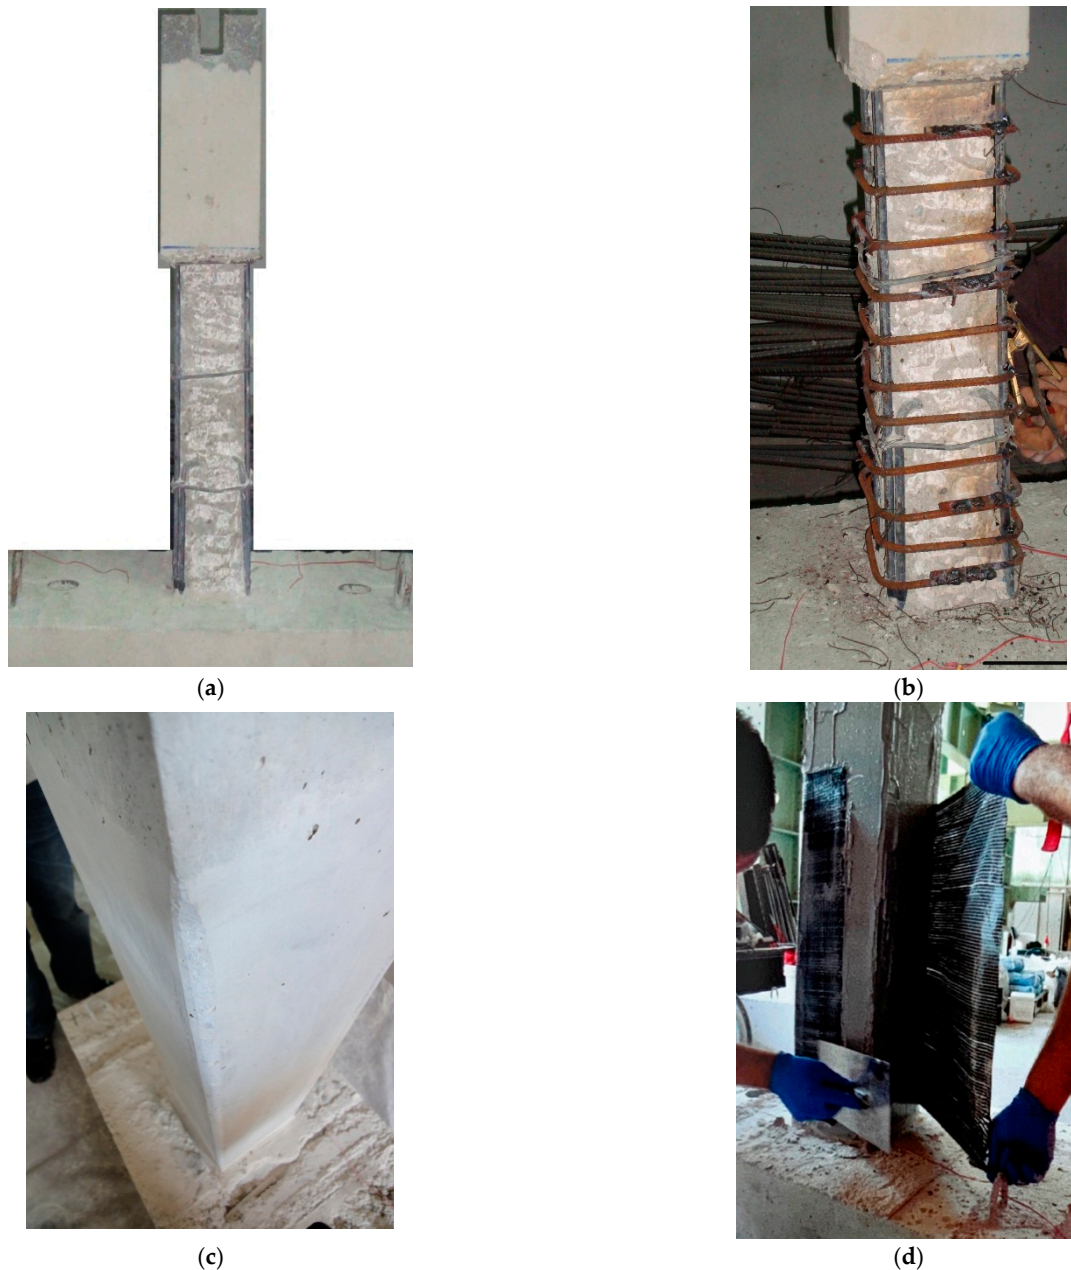
Figure 2. Strengthening interventions (a) specimens RG₁ and RG₂: the concrete cover is chipped-away; (b) specimens RG₁ and RG₂: the ties of the thin high-strength RC jacket are placed in touch with the initial column; (c) specimen FS₂: smoothing of the column surface and curving of the column edges; (d) specimen FS₂: wrapping of the CFRP textile and full integration to the resin matrix.

The strengthening of specimen FS₂ required careful smoothing of the column surface. In particular, a spinning wheel was used to rub the surface in the circumference of the column along the critical height (600 mm) (see Figure 2c,d) and improve the contact with the CFRP textile, while also preventing potential damage to the textile from surface imperfections and protrusions. Furthermore, the column edges were curved with a radius of two and a half times the width of the concrete cover [30] to prevent tearing of the CFRP textile (see Figure 2c). Thereafter, the surface of the column was cleaned with air pressure and covered with epoxy resin. The textile was subsequently applied in the transverse direction with the fibers perpendicular to the column axis, to secure the effective

confinement of the column's critical region (see Figure 2d). A trowel was used to press the CFRP textile to the surface of the column and removing the captured air. Thus, full integration of the textile to the resin matrix was achieved. The length of the CFRP jacket equaled 1700 mm, while the jacket started 20 mm above the foundation block of the specimen, to avoid potential damage to the CFRP textile layers during cycling [30,31]. The properties of the CFRP textile and of the epoxy resin are illustrated in Table 3. The required width, t_j , of the CFRP jacket for providing the necessary confining stress to the critical region of the column, was calculated using Equation (1), which is introduced by the Greek Code for Interventions (GCI 2017) [31]. It was found that two layers of the CFRP textile should be wrapped around the column. In Equation (1), t_j is the width of the CFRP jacket; A_j is the cross-section area of the jacket; s_w is the distance between stirrups or FRP strips; f_{yk} is the yield stress of the plain lap-spliced bars; l_s is the lap splice length; γ_{Rd} , λ_s , β and μ are coefficients equal to 1.5, 0, 1.0 and 1.0, respectively; $\sigma_{jd} = E\varepsilon_{jd}$ is the design stress, which is equal to the yield stress $\sigma_{jd,max}$ for the CFRP textile used to improve the load transfer mechanism between the lap-spliced bars; A_b is the diameter of one lap-spliced bar.

In the case of specimens RG₁ and RG₂, the necessary external confinement for ensuring yielding of the columns' inadequately lap-spliced reinforcement was provided by a thin RC jacket of high strength. Using a jack hammer, the concrete cover along the column critical height was chipped-away prior to the construction of the jacket. Subsequently, B500C steel bars of 8 mm diameter were placed in touch with the initial column, while they were formed as closed ties spaced at equal distances of 50 mm (see Figure 2a,b). Eventually, eleven ties were used to confine the critical column height (600 mm). Moreover, electrical resistant strain gages were attached to the ties of the jacket to allow for the measuring of the of steel strain value variations during cycling and ascertain if yielding of reinforcement was achieved. Then, the premixed, rheoplastic, non-shrink and non-segregating concrete of high strength was poured into the wooden formwork, which was constructed around the column of each specimen. The material characteristics of the thin RC jacket of high strength are illustrated in Tables 1 and 2.

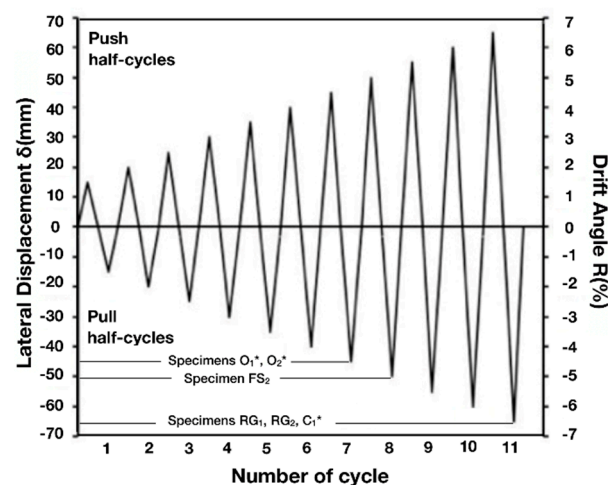
Figure 4. Displacement-controlled schedule. * Specimens O_1 , O_2 and C_1 were tested in a previous work [3].

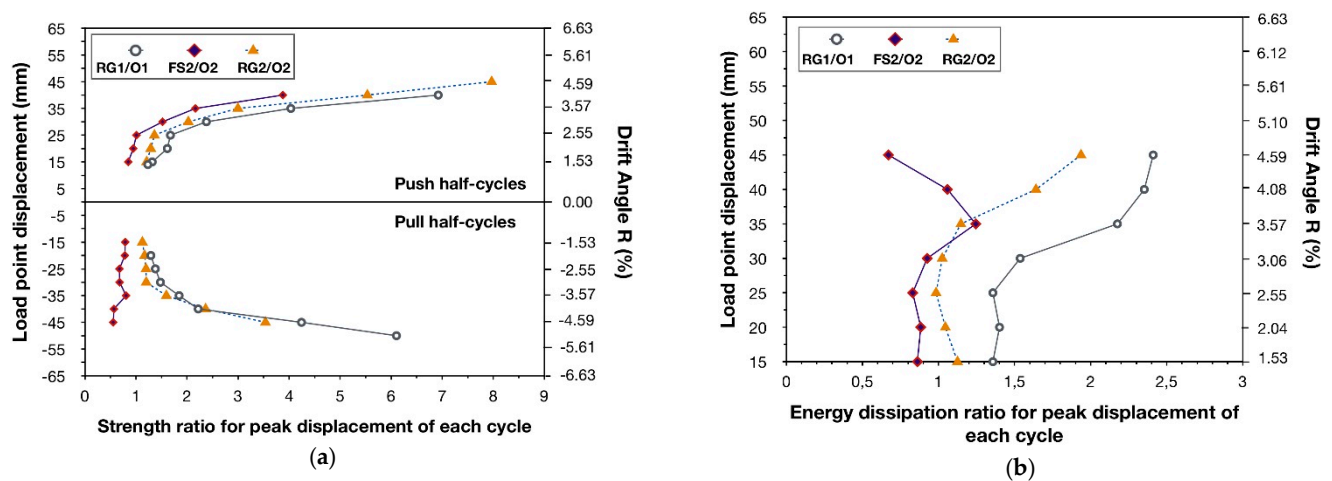
Figure 7. Plots of (a) load point displacement-versus-strength ratio for peak displacement of each cycle and (b) load point displacement-versus-energy dissipation ratio for peak displacement of each cycle of the strengthened specimens RG₁, RG₂ and FS₂ with respect to specimens O₁ and O₂ [3].

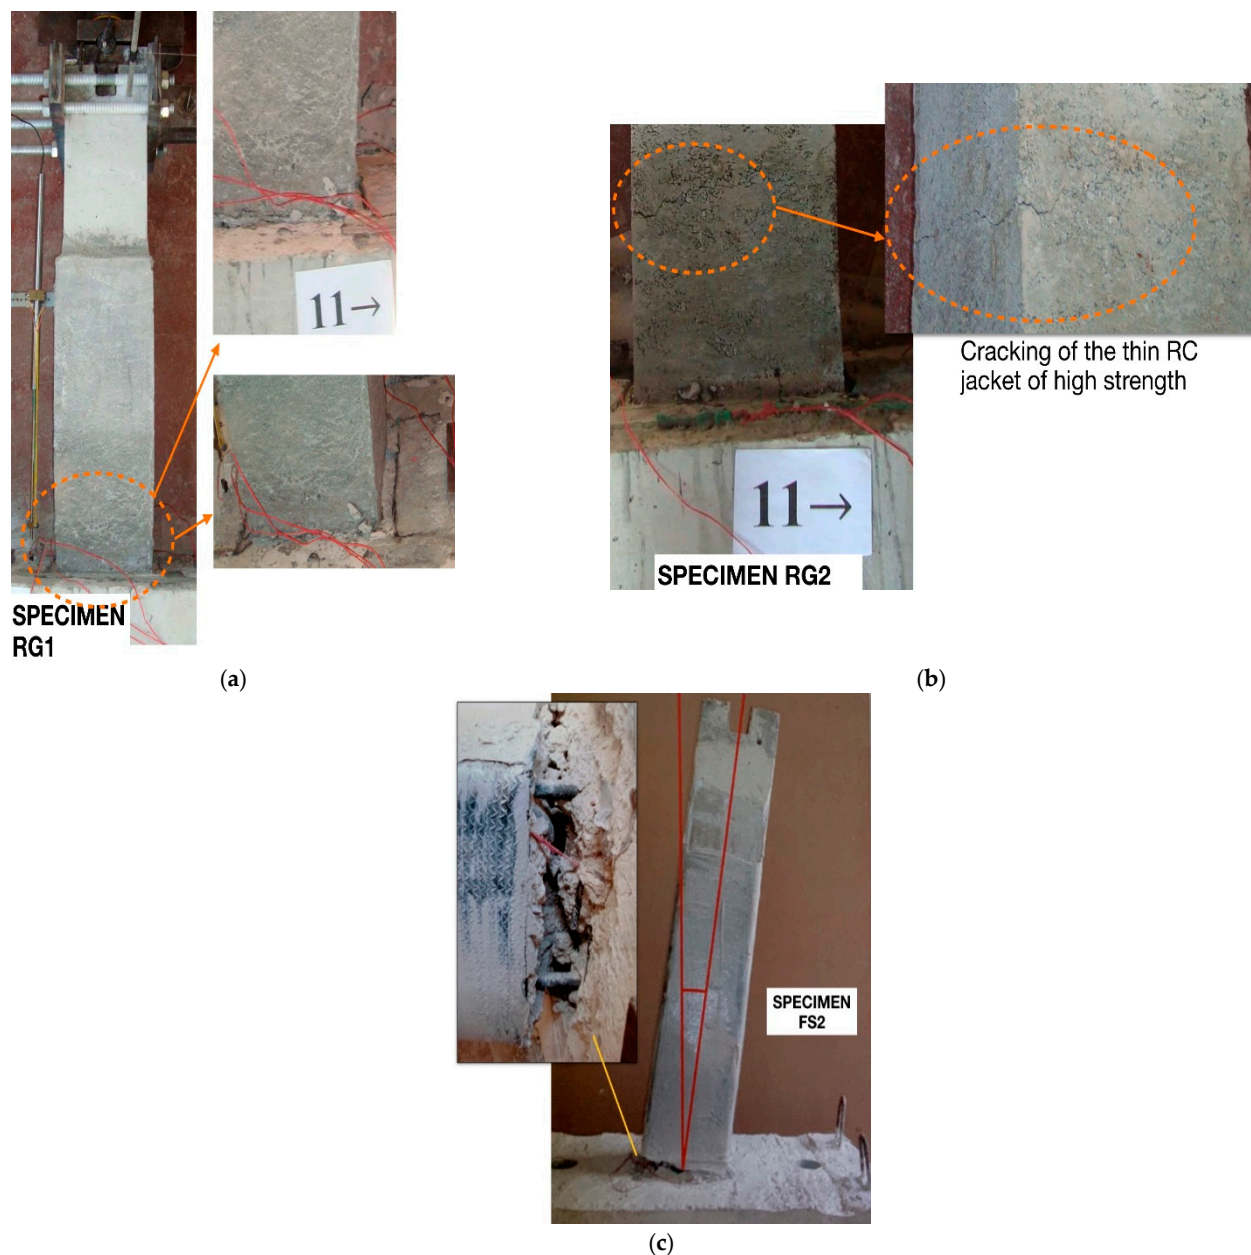
Figure 8. Failure modes of column specimens (a) RG₁ and (b) RG₂ strengthened with thin high-strength RC jacket and (c) of specimen FS₂ strengthened with CFRP jacket of two layers of textile.

Specimen FS₂ was strengthened pre-earthquake by wrapping two layers of CFRP textile around the critical column region. The number of the required layers was determined using Equation (1). The column eventually exhibited brittle failure due to excessive slipping of the lap-spliced bars. In particular, during the first cycle of the earthquake-type loading, the main flexural crack was formed at the column base. The damage gradually evolved with the increase in lateral displacement values during the subsequent cycles, while progressive slipping of the lap-spliced reinforcement also occurred. As a result, the cracking at the column base sequentially dilated, and disconnection of the column from the

strong foundation block of the specimen eventuated for drift angle values, R , was greater than 4.08 % (see Figure 8c). At the end of testing of FS₂ (after eight cycles of reversed inelastic lateral displacements), the pullout of the column's longitudinal reinforcing bars was apparent. The excessive slipping of the bars was also ascertained from the data acquired from strain gages, which were attached to the bars, showing almost stable steel strain values during the consecutive loading cycles (see Figure 11e) [23]. In Figure 8c, the failure mode of specimen FS₂ is depicted, characterized by excessive residual deformation and rotation of the column. From the plots of energy dissipation capacity-versus-load point displacement (see Figure 6b), it can be observed that the strengthened column, FS₂, performed similarly to specimens C₁ and RG₂ during the first five cycles of the reversed inelastic lateral displacements (drift angle, R , equal to 3.57%), while subsequently showing a degrading hysteresis behavior similar to that of the corresponding original column specimen, O₂. The latter is also clearly demonstrated on the hysteresis loops of FS₂ (see Figure 5c). For instance, rapid deterioration of lateral bearing strength and peak-to-peak stiffness, intensive pinching of the hysteresis loops around the axes, horizontal branches showing excessive bar slipping and poor energy dissipation capacity dominated the hysteresis behavior of the column after the sixth push half-cycle and the fifth pull half-cycle of the seismic loading. The peak-to-peak stiffness of specimen FS₂ deteriorated more sharply during the first three cycles, while it subsequently deteriorated with a slower rate. For a lateral drift angle, R , equal to 5.10%, the peak-to-peak stiffness of FS₂ equaled only 1% of its initial value during the first cycle of loading (see Figure 6a). The hysteretic energy dissipation capacity of specimen FS₂ was similar to the capacities of C₁ and RG₂ for up to a drift angle value, R , equal to 3.57%, while afterwards it was rapidly reduced due to the excessive slipping of reinforcement (see Figure 6b). Nevertheless, the confinement provided by wrapping the two layers of the CFRP textile around the column of specimen FS₂ improved the failure mode of the specimen with respect to that of the corresponding original specimen, O₂ [3]. In particular, the evolution of damage was delayed, since excessive disintegration of the core concrete and loss of the concrete cover were effectively restricted. The strengthened column FS₂ initially showed a dissipating hysteresis behavior until the fifth cycle of the seismic loading. Thereupon, excessive slipping of the lap-spliced reinforcement dominated the cyclic response of the specimen, causing a degrading overall hysteresis response.

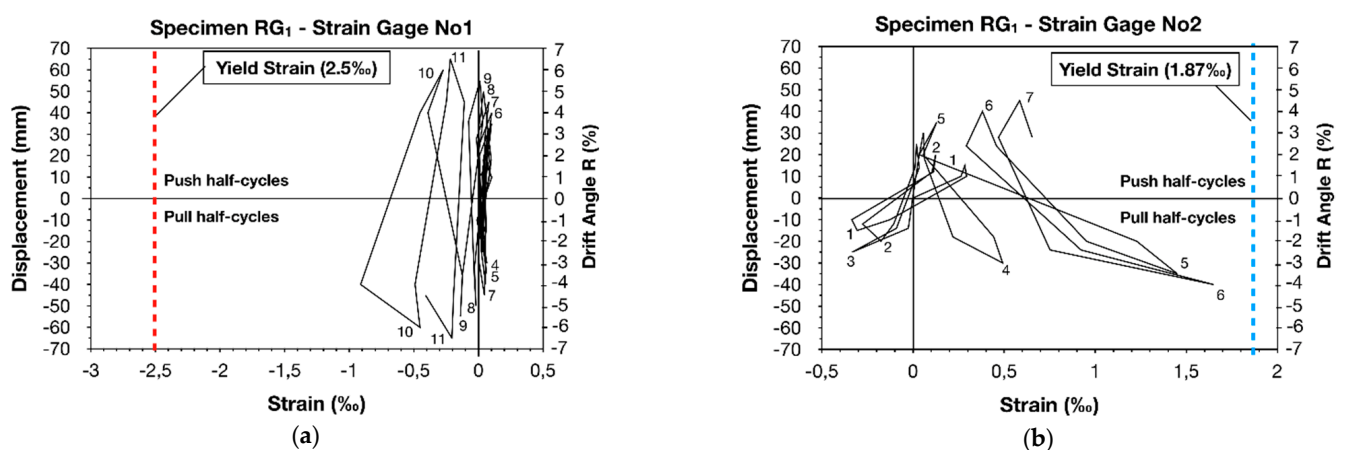
Figure 11. Plots of displacement-versus-strain-versus drift angle measured by strain gages which were attached on the steel bars of specimens RG₁ (a–d); FS₂ (e).

the lap-spliced reinforcement during the consecutive cycles of loading. This continuous increase in steel strain values up to the fifth cycle of loading indicates an absence of bar slipping for a drift angle ratio of up to 3.57% [36]. However, the strain values remained lower than steel yielding strain $\epsilon_y = 1.87\%$ (see Figure 11e). Thus, from the measurements of the strain gages, it was demonstrated that the confinement provided by the CFRP jacket was insufficient to allow yielding of the lap-spliced bars. The latter is attributed to the unexpected failure of the jacket, which, in turn, caused loss of the confinement provided to the lap splice region, while triggering brittle bond-slip failure and slipping of the bars.

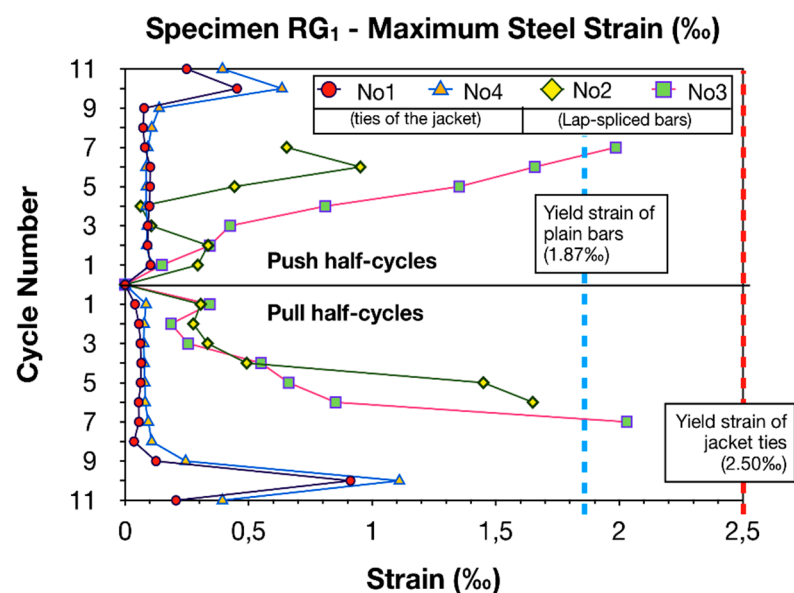
Figure 12. Maximum values of steel strain—specimen RG₁.

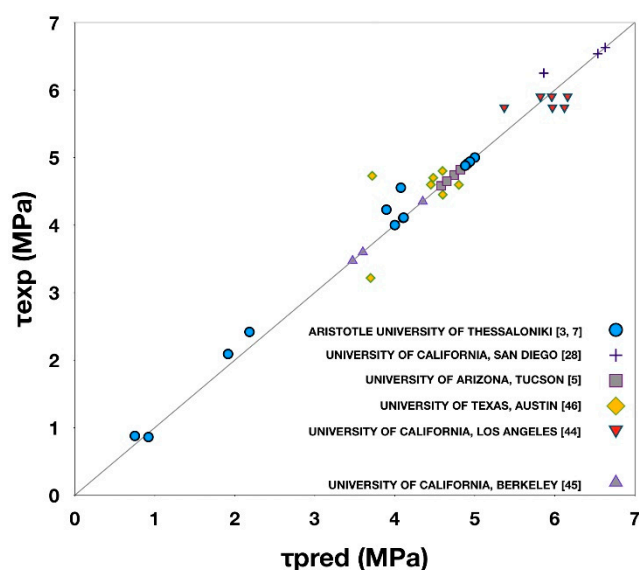
Figure 15. Experimental-versus-predicted values of shear stress in the lap splice region according to the proposed formulation.

The validity of the proposed analytical model was checked using experimental data from 13 column specimens tested in the Laboratory of Reinforced Concrete Structures and Masonry Buildings of the Aristotle University of Thessaloniki [3,7], as well as data from 23 similar experiments found in the literature [5,30,46–48] (see Figure 15). In Table 4, the shear capacities and the predicted actual values of the lap splice shear stress are shown. In partic-

ular, the value of actual shear stress in the potential failure plane between the lap-spliced bars when yielding of the bars occurs is $\tau_{cal} = \gamma_{cal} \sqrt{f'_c}$. Thus, γ_{cal} is calculated when the tension force acting in the bar, $V_u = A_s f_y$, equals the bond force developed between the bar and the concrete along the lap splice, $V_n = \gamma_{cal} \sqrt{f'_c} A$, where $A = 3 \cdot d_b \cdot l_s$ is the area of the potential failure plane. The coefficient γ_{ult} is calculated from Equations (3)–(7), and the ultimate shear stress is subsequently given by the expression $\tau_{ult} = \gamma_{ult} \sqrt{f'_c}$. The value of γ_{exp} is calculated from the expression $A_s \sigma_s = \gamma_{exp} \sqrt{f'_c} A$, where σ_s is the stress value calculated according to the Hook's law ($\sigma_s = E \varepsilon_{exp}$) using the maximum measured steel strain value, $\varepsilon_{s,max}$. The latter is measured experimentally by strain gages attached to the steel bar ($\varepsilon_{exp} = \varepsilon_{s,max}$). If the measured maximum strain, $\varepsilon_{s,max}$, exceeds the yielding strain, ε_y , then ε_y is used to calculate the developed stress ($\varepsilon_{exp} = \varepsilon_y$) since the Hook's law is not applied in the post-yielding range. According to the analytical formulation when the calculated shear stress is lower than the ultimate strength, $\tau_{cal} = \gamma_{cal} \sqrt{f'_c} < \tau_{ult}$, then the predicted actual value of the lap splice shear stress will be near τ_{cal} , because the lap splice permits the yielding of reinforcement $\tau_{pred} = \tau_{cal}$. Contrarily, when $\tau_{cal} > \tau_{ult}$ lap splice failure occurs prior to the yielding of reinforcement and $\tau_{pred} = \tau_{ult}$. In the case of specimens RG₁ and RG₂, it was demonstrated that the implementation of the analytical model ensured the satisfactory design of the thin RC jackets, which provided adequate confinement to the lap splice region and allowed for the yielding of the inadequately lap-spliced bars.
