Article

Experimental Investigation of the Structural Performance of Existing and RC or CFRP Jacket-Strengthened Prestressed Cylindrical Concrete Pipes (PCCP)—Part A

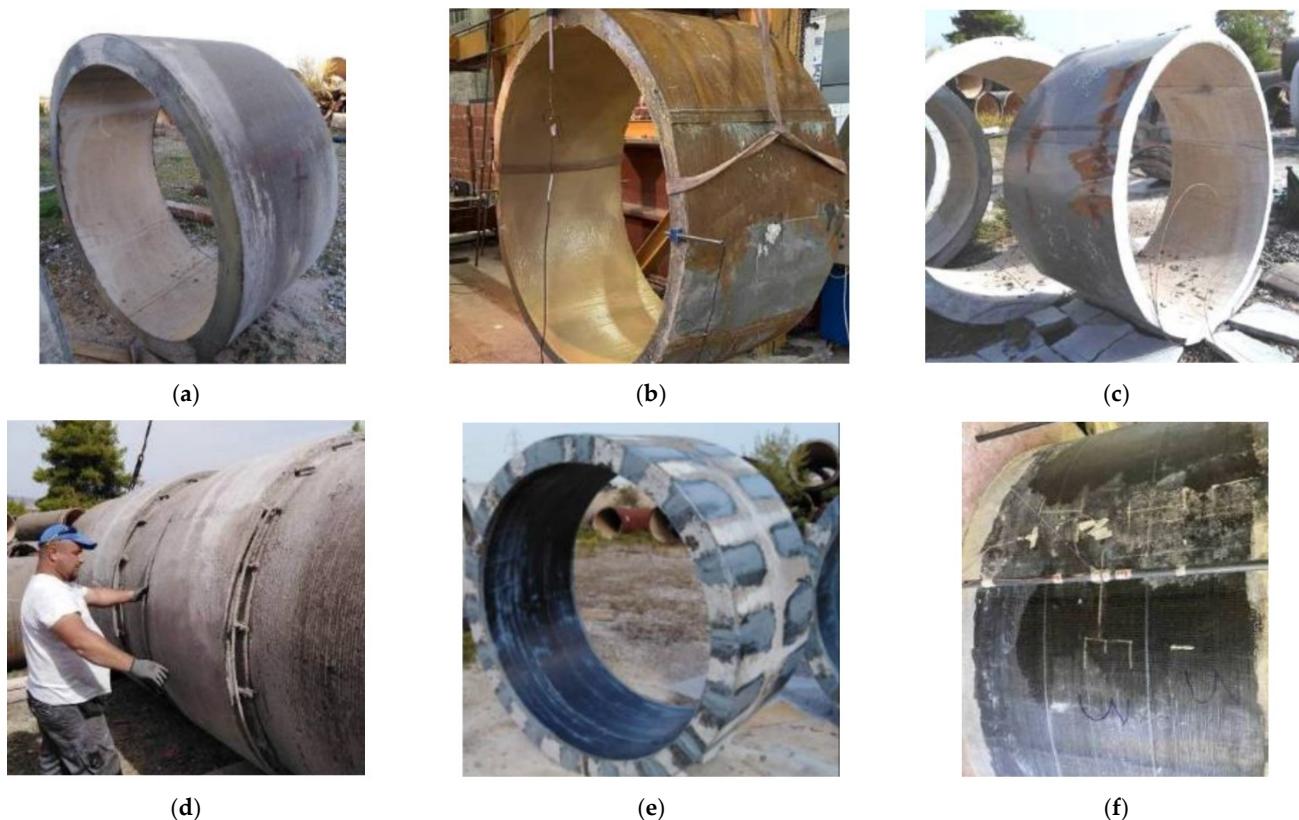
Figure 1. The various types of tested pipe specimens. (a) Original pipe with fully active prestressing wires, (b) Original pipe. Prestressing wires re-moved, (c) Original pipe. Prestressing wires removed, (d) External RC Jacket, (e) Internal CFRP jacket and (f) External CFRP jacket.

These two loading types combined with the previously mentioned five types of specimens resulted in the ten specimens listed in Table 1. These specimens were prepared in situ (Figure 1) according to specified technical details and were transported to the Laboratory of Strength of Materials and Structures of Aristotle University for testing.

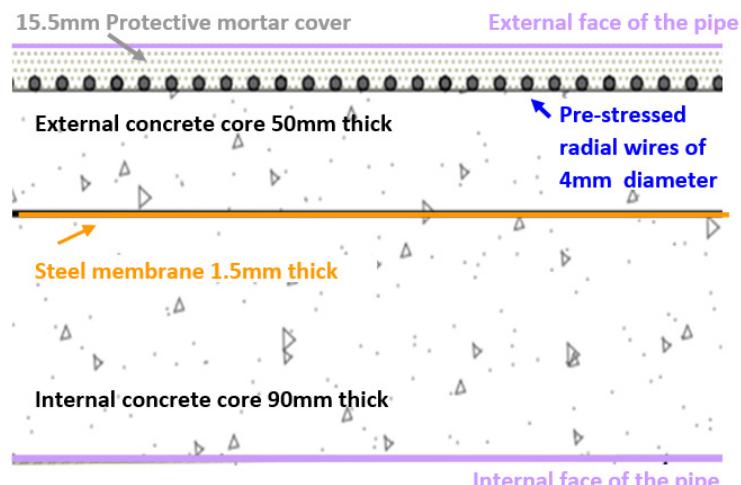
Figure 2. Cross-section of the original PCCP with fully active prestressing wires.

Figure 2 depicts a typical cross-section of the original pipe with a fully active prestressed wall with a total thickness equal to 156 mm. From the internal face to the outside layer of the concrete core, where the prestressing wires are placed, the concrete thickness is equal to 141.5 mm (including the steel membrane). Within this concrete thickness, a thin steel cylindrical membrane is placed at a distance equal to 90 mm from the internal face of the pipe. The thickness of this membrane is equal to 1.5 mm, as measured in the laboratory. Steel coupons of this membrane were tested in axial tension. They were taken either from the pipe before any loading (virgin) or from four different locations of the specimen after it had been subjected to internal pressure in the laboratory. The obtained axial tensile stress-strain response is depicted in Figure 3. From the virgin coupon, the ultimate tensile stress was equal to 385.3 MPa, and the yield stress was equal to 296.7 MPa. The coupons taken from the membrane of the pipe specimen that was loaded by internal pressure demonstrated a lower capacity to deform than the virgin specimen. This indicates that the steel membrane at these locations exceeded the yield during testing. Moreover, the

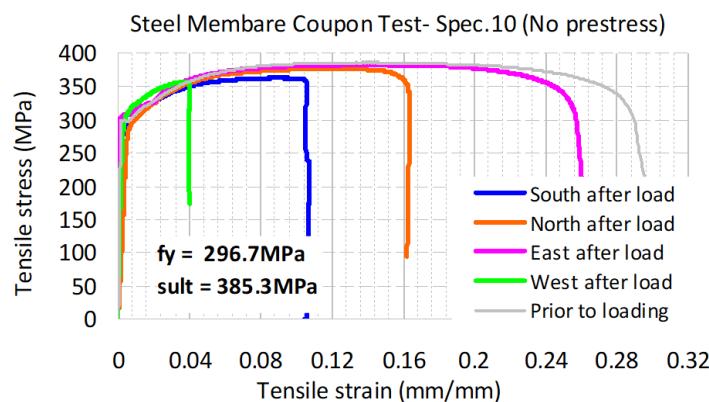
Figure 3. Tensile behaviour of steel membrane coupons taken from tested pipe specimens.

tensile behaviours exhibited by these four strained coupons were different from each other, which also indicates that despite the axisymmetric nature of the loading, the plastification of the steel membrane is not axisymmetric. At the outer face of the concrete core, 4 mm diameter wires were wrapped radially and stressed. Nine (9) coupons were sampled from these prestressing wires, which resulted in an average ultimate tensile stress equal to 1756 MPa and an assumed yield stress equal to 1400 MPa. These test results are shown in Figure 4 together with the assumed constitutive law for the prestressing steel, which was utilized in subsequent numerical simulations.

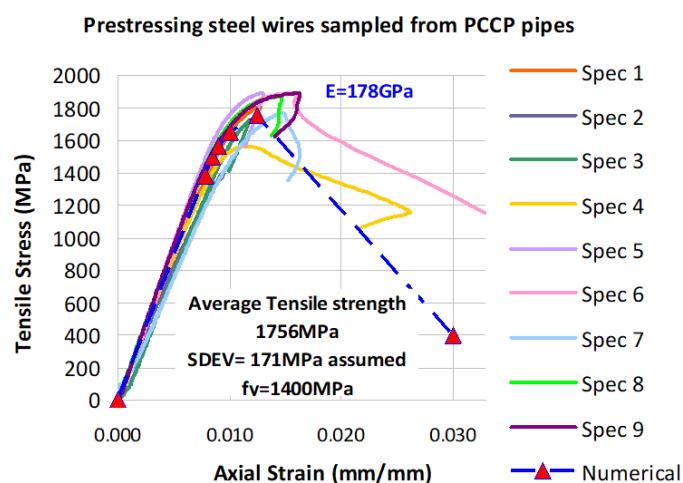
Figure 4. Tensile behaviour of prestressing wire specimens.

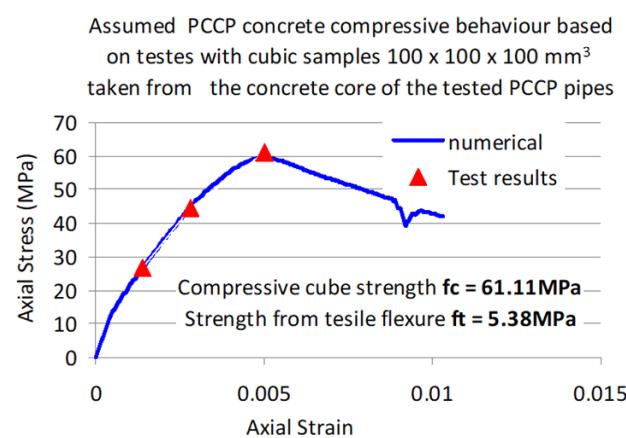
Figure 5. Compressive behaviour of concrete core specimens taken from the tested PCCP pipes.

Samples were also taken from the concrete core of the tested PCCP pipes. They formed either cubic specimens ($100 \text{ mm} \times 100 \text{ mm} \times 100 \text{ mm}$) for compression tests or prismatic specimens for three-point flexure of 50 mm nominal thickness, 60 mm nominal width and 130 mm nominal length. The obtained results are shown in Figure 5 together with the assumed compression stress-strain concrete constitutive law that was utilized in subsequent numerical simulations. The average compressive cubic stress found from these tests was equal to 61.11 MPa , whereas the tensile strength from flexure was found to be 5.38 MPa .

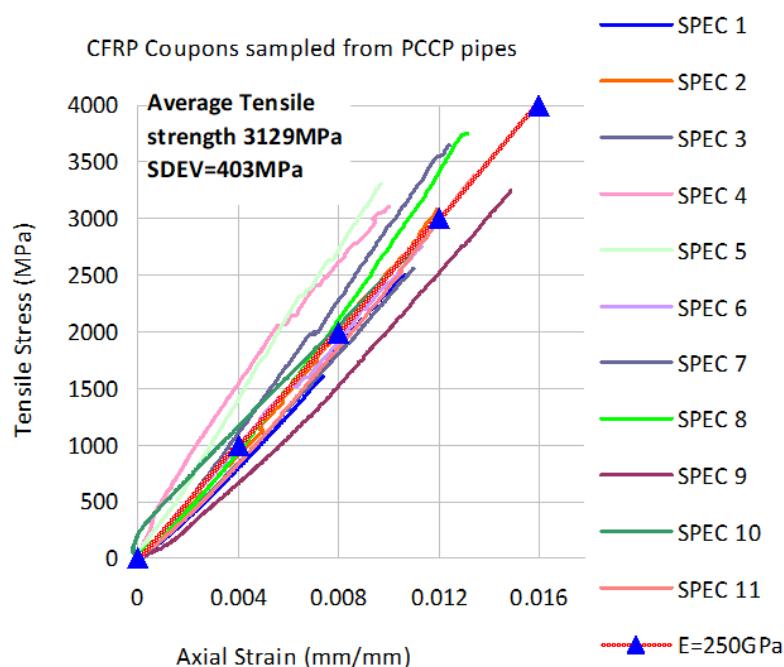
Figure 6. Tensile behaviour of CFRP specimens taken from the tested PCCP pipes.

The CFRP strips used in the schemes were cut from sheets of 600 mm width. Therefore, one such strip was wrapped circumferentially around the pipe (either at the internal or external face) with an overlap of 400 mm at its ends. Each CFRP reinforcing jacket was formed by three layers of CFRP strips sequentially attached on top of each other. The actual thickness of each layer was equal to 0.167 mm (SikaWrap300C), thus forming a total CFRP thickness, together with the resin layers, equal to approximately 2.54 mm. Certain additional CFRP layers were placed along the longitudinal axis at the two edges of the tested pipe extensions in the form of brackets bridging the internal and external faces of the pipe in order to prohibit the debonding of the CFRP sheets at these locations. Coupons were cut from the CFRP sheets placed at the exterior of the PCCP of the tested pipes after being tested and were subjected to axial tension. The obtained stress-strain response from eleven (11) CFRP coupons is shown in Figure 6. The average tensile strength was found to be 3129 MPa, and Young's modulus was equal to 250 GPa, corresponding to a maximum average tensile strain equal to 1.252%.

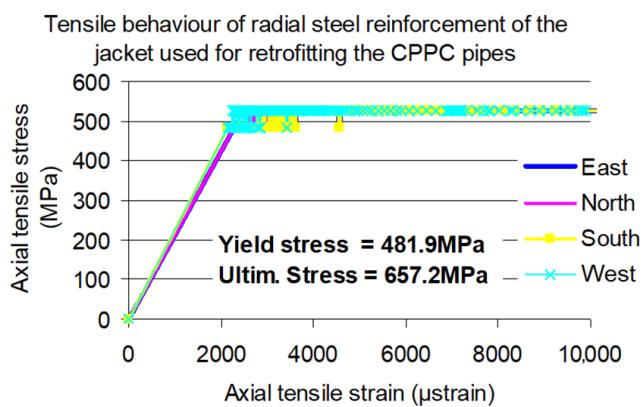
Figure 7. Tensile behaviour of radial reinforcing bar specimens taken from the tested PCCP pipes with the RC jacket.

The sprayed RC jacket was constructed by first placing 18 mm diameter longitudinal reinforcing bars, spaced every 300 mm, just above the prestressing wires. Radial closed-ring reinforcing bars of 14 mm diameter, spaced at 95 mm intervals, were next placed in contact with the longitudinal reinforcement. Both the longitudinal and radial reinforcing bars were secured in place by 250 mm diameter spacers resting on the surface of the prestressing wraps. The special concrete mix was sprayed uniformly all around the periphery of the specimen, providing a new concrete layer with a thickness approximately equal to 50 mm. The quality of this layer of sprayed concrete is C40 with a compressive strength equal to 40 MPa. The reinforcing bars of this external sprayed concrete jacket were of B500C quality, with nominal yield stress equal to 500 MPa. The tensile behaviour of the radial 14 mm diameter reinforcing bars of this RC external jacket (shown in Figure 7) was found by testing coupons taken from these jackets following the internal pressure test of the relevant pipes. Table 2 lists all of the geometric details, together with the most important mechanical properties of all materials involved. Figures 8–10 depict the cross-section details of the used alternative repair-strengthening schemes that were investigated in the framework of this study.

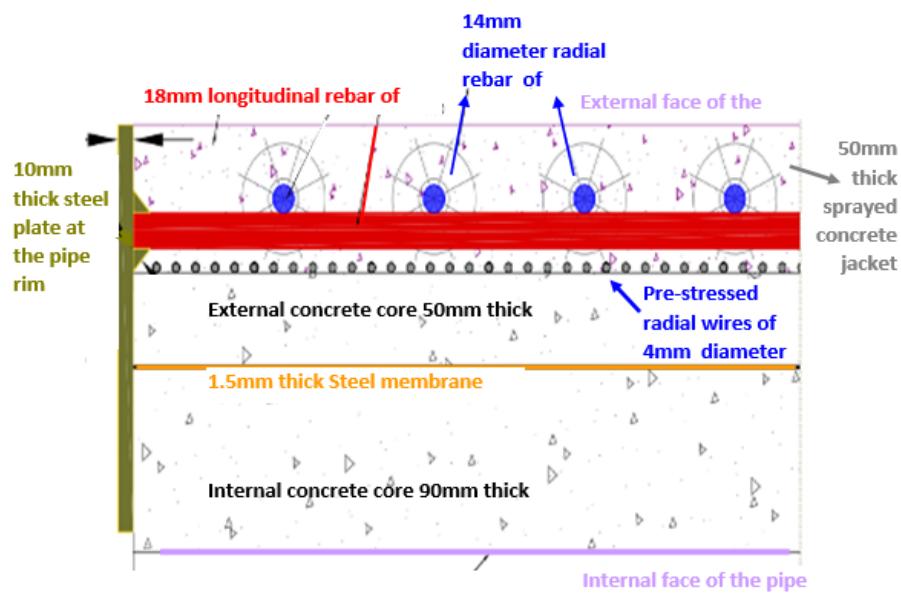
Figure 8. Cross-section of the PCCP pipe with active prestressing wires and external RC jacket.

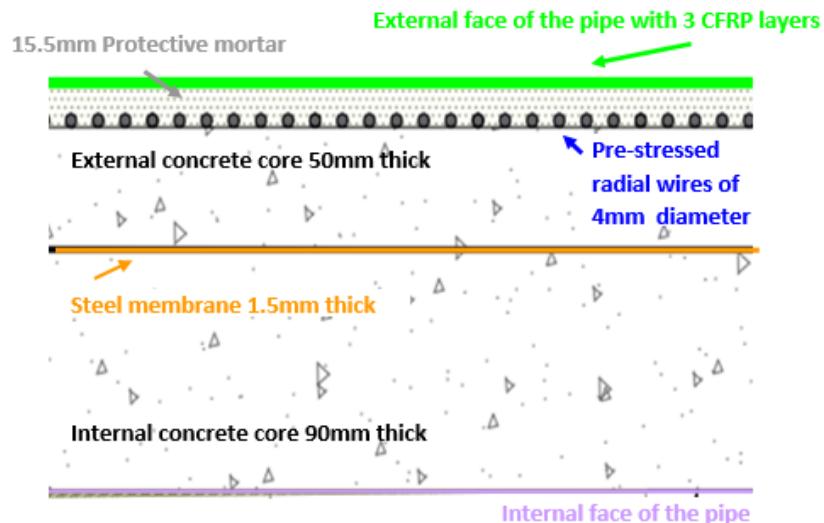
Figure 9. Cross-section of the PCCP pipe with active prestressing wires and external CFRP layers.

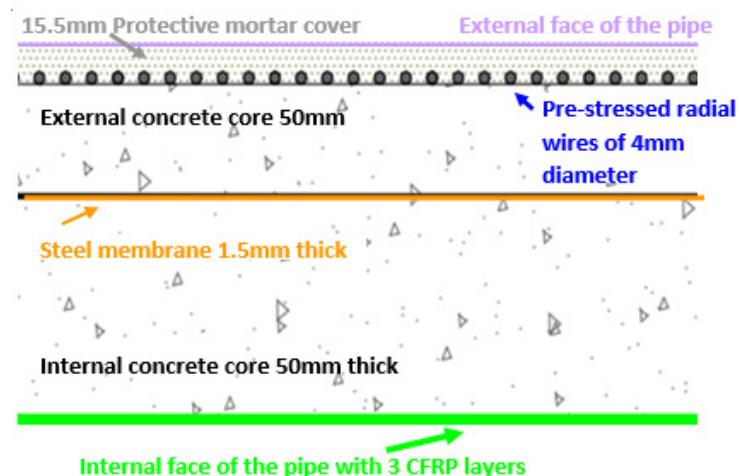
Figure 10. Cross-section of the PCCP pipe with active prestressing wires and internal CFRP layers.

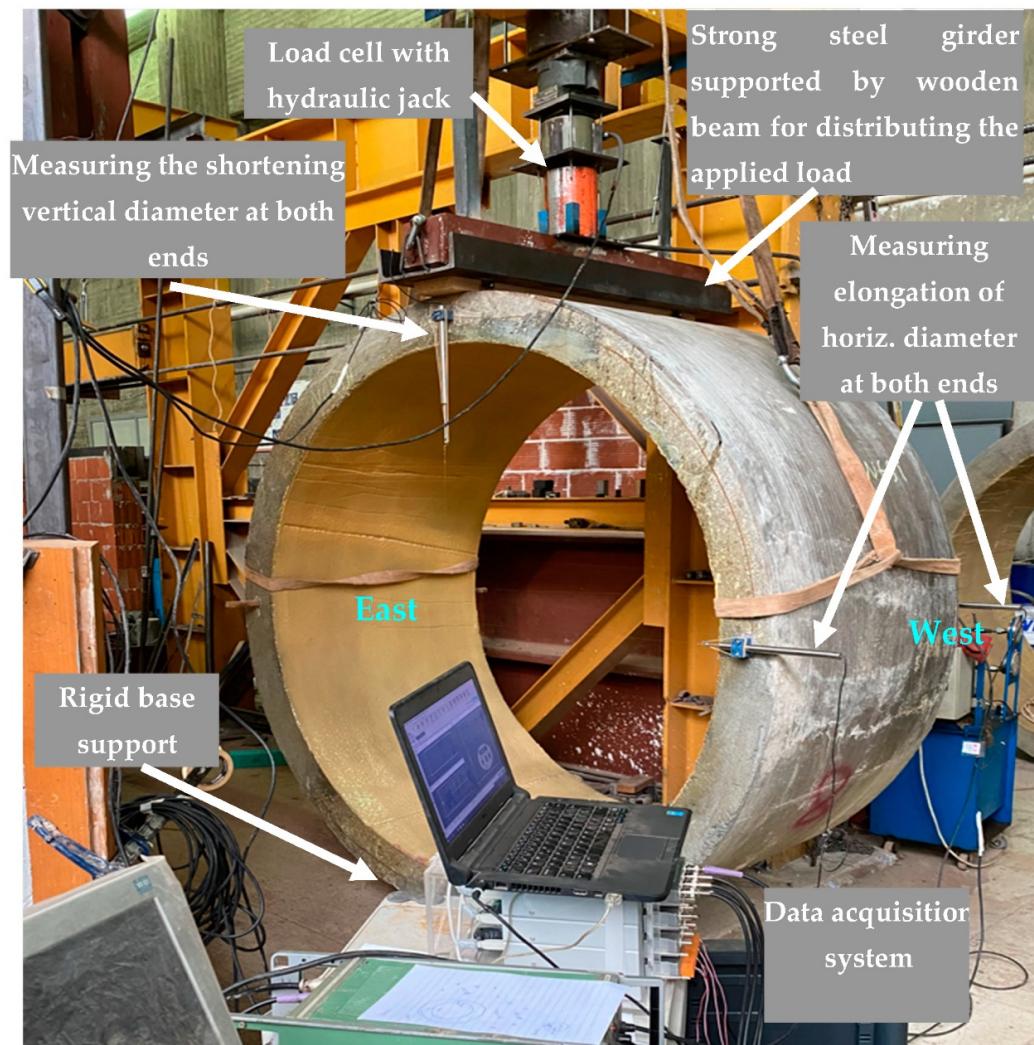
Figure 11. Experimental set-up for testing the PCCP pipe specimens under a three-edge bearing loading arrangement.

The five (5) specimens listed in Table 1 were subjected to 3EB loading (Figure 11) according to the provisions of ASTM C497M-17 [28]. In Figure 12, the applied vertical load against the measured deformations of the pipe during the 3EB tests is summarized. The plotted deformations in this figure were the shortening of the vertical diameter (in line with the applied load) and the elongation of the horizontal diameter of the pipe. Table 3 lists the values of the vertical and horizontal deformations corresponding to the maximum recorded load for each specimen, together with the values of the vertical load that produced a 0.3 mm crack. The following are the main observations: (a) The removal of the prestressing wires resulted in a significant reduction in the bearing capacity of the pipe for this type of loading. (b) The internal FRP jacket did not result in any noticeable increase in the bearing capacity of the pipe for this 3EB loading. (c) On the contrary, the external jacket, either with CFRP or with RC layers, resulted in a significant increase in its bearing capacity for this 3EB loading. (d) The bearing capacity under 3EB loading of the tested specimen either with an external CFRP jacket or with an external RC jacket, when compared to the corresponding bearing capacity of the specimen with all the prestressing wires fully active, showed an increase of either 50% or 65%, respectively.

Initially, this simulated prestress defect process was performed by loading a pipe specimen during the 3EB testing presented in Section 3 (Figures 11 and 12). For this purpose, Specimen 8 was selected, which had been previously subjected to 3EB loading with the prestress fully active. Despite this previous test, this specimen retained approximately 60% of its maximum load at the end of this 3EB test. The wires located at a length of 300 mm at the Eastern cross-section (16 wires) were cut as shown in Figure 21, placed evenly with respect to the axis of symmetry, indicated with the red dotted line. This cross-section was selected arbitrarily, representing a typical cross-section of the pipe specimen. The wire located at the axis of symmetry was left intact. Figure 22 depicts the obtained 3EB load–deformation response of Specimen 8 with 16 wires neutralized by cutting, as shown in Figure 21. In Figure 22, the corresponding responses of Specimen 8 before cutting the wires and that of Specimen 9 without any prestress are also shown. As can be seen, the

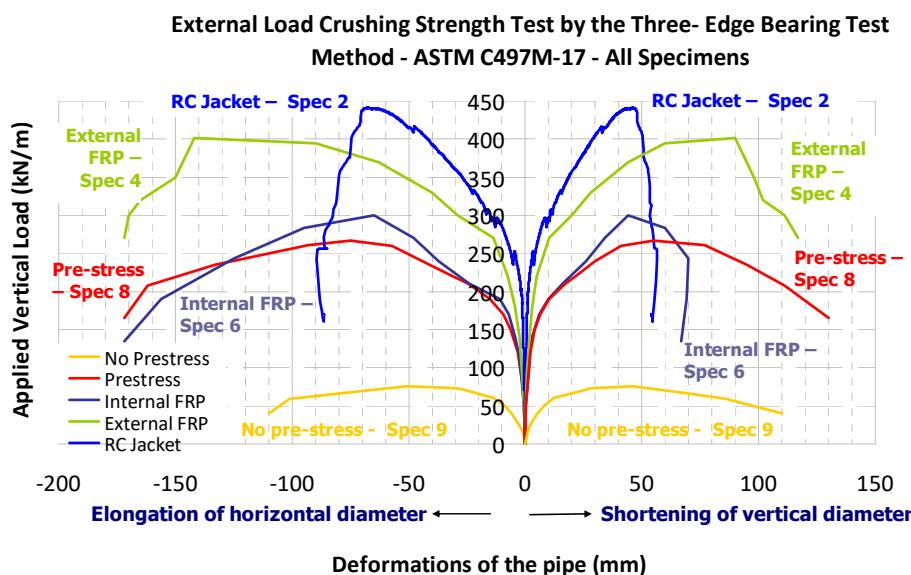
Figure 12. Summary of the measured load–displacement response obtained during 3EB-ASTM:C497 M-17 testing.

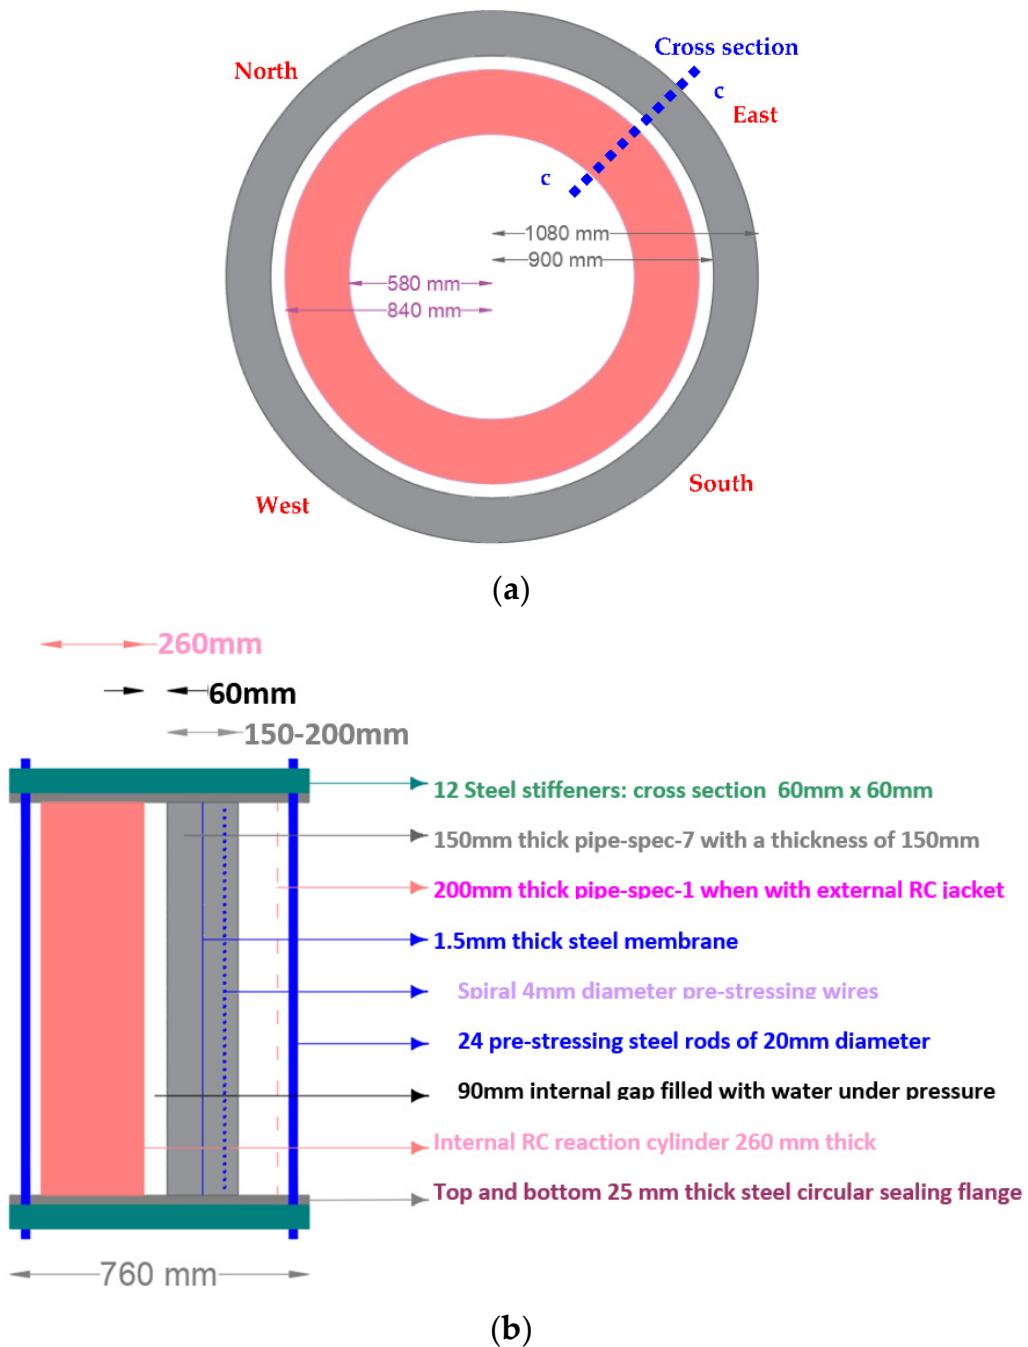
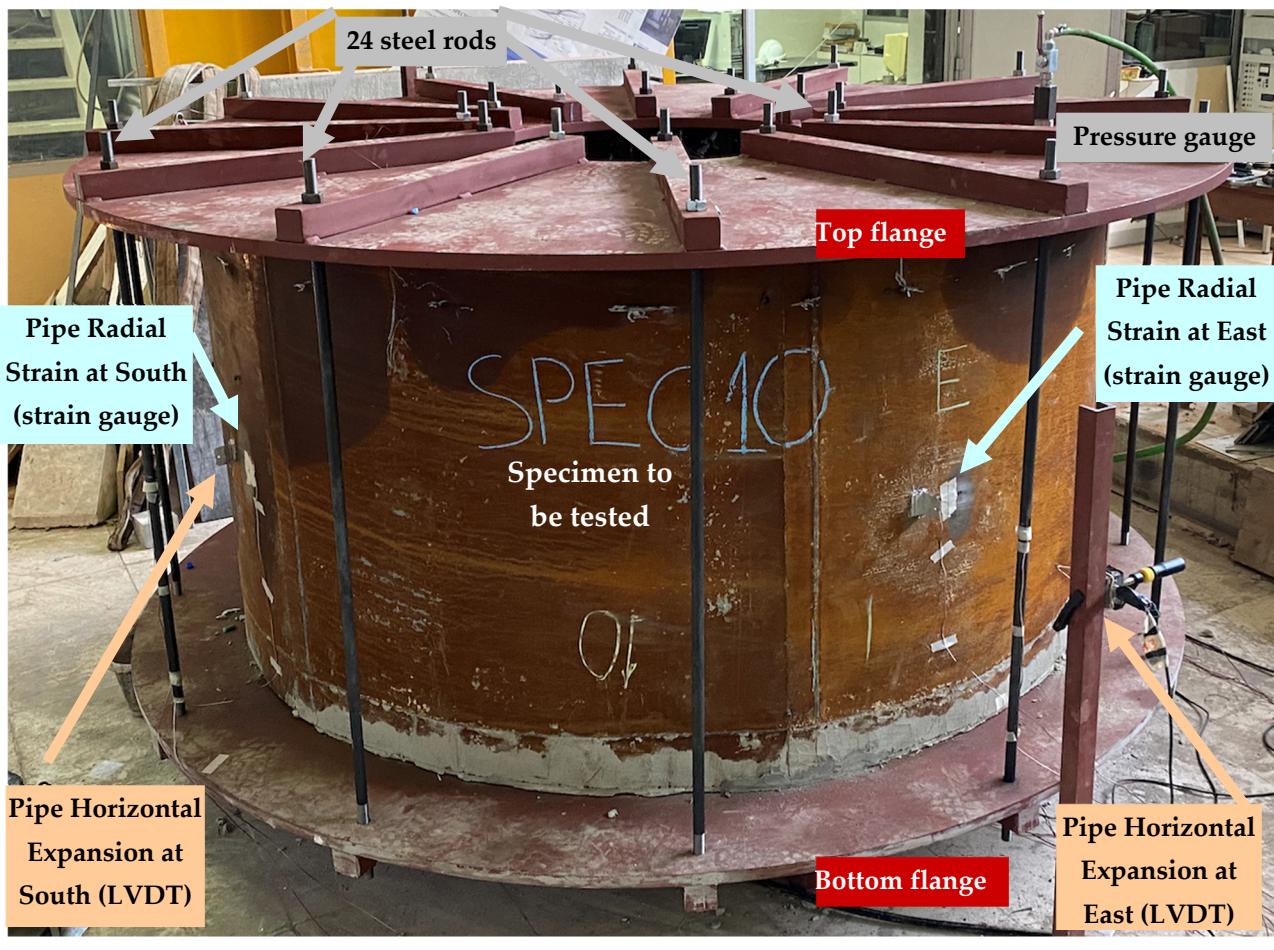
Figure 13. (a) A cross-section of the loading arrangement perpendicular to the longitudinal axis of the pipe showing: (1) the 260 mm thick reaction cylinder in the interior (red colour) with internal and external radii of 580 mm and 840 mm, respectively. (2) The pipe specimens at the exterior (grey colour) with a thickness ranging from 100 mm to 200 mm. The gap in between (white colour) is filled with water under pressure. The indicated external diameter of 1080 mm represents the maximum possible value of the pipe diameter when reinforced with the external RC jacket. (b) A cross-section c-c of the loading arrangement of (a). (c) Experimental set-up for testing the PCCP pipe specimens under an internal hydraulic pressure loading arrangement.

The external diameter of this cylinder was approximately 1680 mm, its height was the same as that of the specimens (1000 mm), and its average thickness was equal to 260 mm; it was designed to act as a loading reaction cylinder (Figure 13). Each pipe specimen was placed with its longitudinal axis vertical, placing this reaction cylinder inside its internal

diameter, thus forming a system of twin tubular concentric vertical cylinders with a gap of 60 mm (Figure 13a–c). Two identical thick steel circular plates (25 mm thick flanges) formed the top and bottom sealing covers of the whole system (Figure 13a–c). These plates were stiffened with twelve (12) radial stiffeners, which were provided with the appropriate anchoring seats so that each could host two steel rods of 20 mm diameter (24 rods in total). Prior to applying the internal hydraulic pressure, all of these steel rods were lightly prestressed consecutively in a step-by-step controlled manner so that these covers would provide the necessary sealing of this loading system.

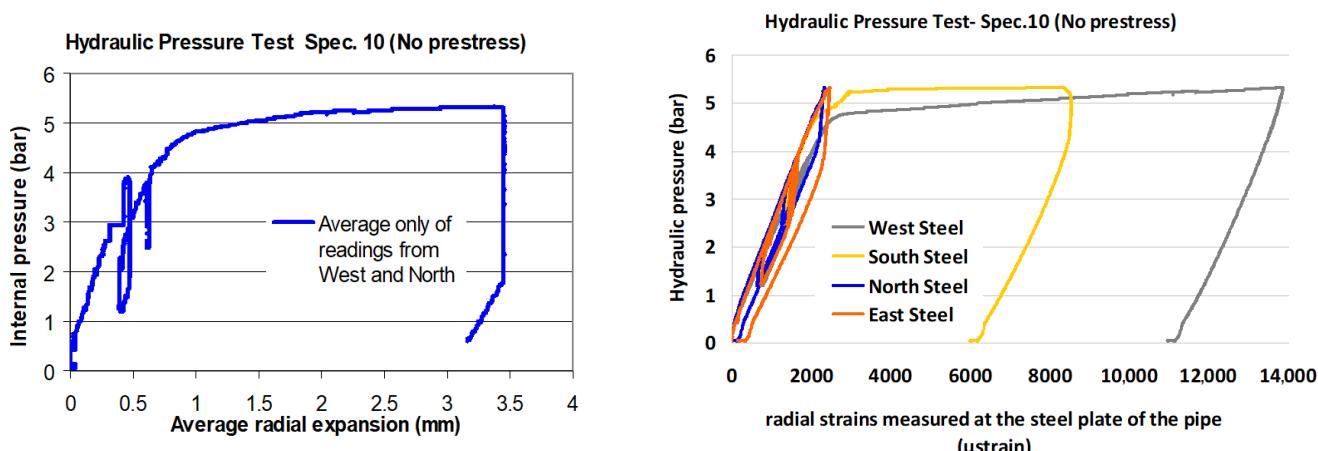
Figure 14. Measured response for Specimen 10 without prestressing: (Left) average radial expansion of the pipe radius; (Right) radial strains of the steel membrane ($1 \text{ bar} = 0.1 \text{ N/mm}^2$). Because the amplitude of the radial expansion for internal pressure above 2.8 bar recorded at two locations (East and South) for this specimen (Spec. 10) was found to contain erroneous readings, the plotted average radial expansion was based on readings taken at the other two locations (West and North).

previously described strain gauges is also plotted against the variation in the internal hydraulic pressure amplitude, at the same time denoting the location where these strain gauges were attached. In Figure 14, the measured response of Spec. 10 (without prestress) is shown. Figure 14 (left) depicts the radial expansion versus internal pressure, whereas Figure 14 (right) depicts the radial strains recorded at the steel membrane. As already mentioned, the expansion of the radius of the pipe was measured at four diametrically opposite locations (namely, East, West, North and South). Because the prestressing wires and the layer of concrete between these prestressing wires and the internal steel membrane were removed, it was possible to attach strain gauges directly to the steel membrane at the same locations as the displacement transducers. As can be seen in Figure 14 (left), the slope of the curve corresponding to the variation in the radius expansion against the internal pressure changes when the internal pressure reaches 2.8 bar. When the internal pressure increases further, the expansion of the radius increases at a higher rate than before. This must be attributed to the cracking of the concrete, which means that for internal pressure values higher than 2.8 bar, the internal pressure is resisted solely by the steel membrane. When the internal pressure reaches approximately 4.0 bar, two unloading cycles are performed.

Permanent radial expansion was retained after unloading, which is attributed to the permanent cracking of the concrete. On the contrary, the strains measured at the steel membrane (Figure 14, right) during unloading reached their initial values, demonstrating that for this amplitude of internal pressure (4.0 bar), the steel membrane deformed in its elastic range, not yet reaching the yield point. However, when the internal pressure was increased beyond 4.0 bar, reaching an amplitude of approximately 5.0 bar, the steel membrane radial strains at two locations (West and South) increased in a non-linear manner, indicating that the steel membrane was yielding at least at these two locations. For internal pressure values higher than 5.0 bar and up to 5.2 bar, the radial expansion continued to increase at an even higher rate than before. Considerable permanent deformation and strain levels remain at unloading.

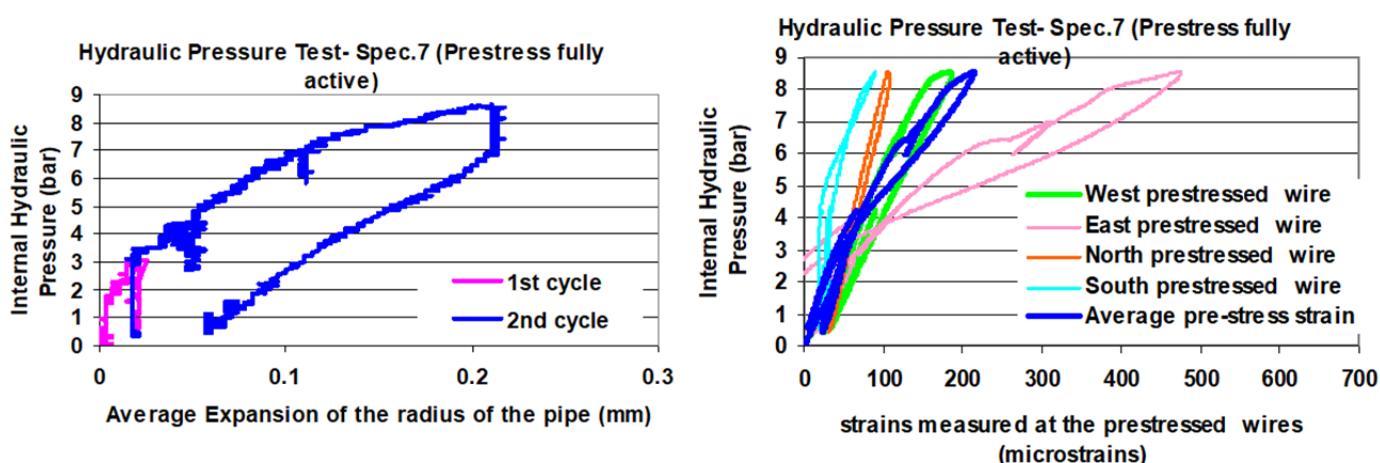
Figure 15. Measured response for Specimen 7 with fully active prestressing: (Left) average radial expansion of the pipe radius; (Right) radial strains of the prestressing wires ($1 \text{ bar} = 0.1 \text{ N/mm}^2$).

In Figure 15, the measured response of Spec. 7 is shown. For this specimen, all of the prestressing wires are fully active. Figure 15 (left) depicts the variation in the applied internal hydraulic pressure against the average expansion of the pipe radius. The variation in the prestressing wires' radial strains measured at four locations (East, West, North and South), together with their averages, is plotted against the variation in the applied internal hydraulic pressure in Figure 15 (right). This variation is almost linear with no remaining strains at unloading, confirming that the prestressing wires perform within their elastic range up to the applied internal maximum pressure of approximately 8.5 bar. Due to safety precautions, no attempt was made to increase the internal pressure beyond this set limit value, because this specimen did not have any retrofitted line of defence like specimens Spec. 5, Spec. 3 and Spec. 1, which were tested next.

As can be seen in Figure 15 (left), at the end of the second loading–unloading cycle, having reached an internal pressure of approximately 8.5 bar, there is remaining expansion of the pipe radius, indicating a certain type of non-linear response. This must again be attributed to the micro-cracking of the internal concrete volume. The forming of these micro-cracks cannot be identified from this figure, except from the change in the slope of the variation in the internal pressure against the radial expansion on the loading path of the first loading cycle at approximately 3.5 bar. When prestressing is fully active, it introduces a compressive stress field on the concrete volume that, up to a certain pressure level, less than 8.5 bar, counteracts the tensile stresses resulting from the internal pressure, thus prohibiting the development of concrete cracking. On the contrary, when the prestressing wires become inactive, regardless of the cause, as in the case of Specimen 10, this limit is approximately 2.0 bar.

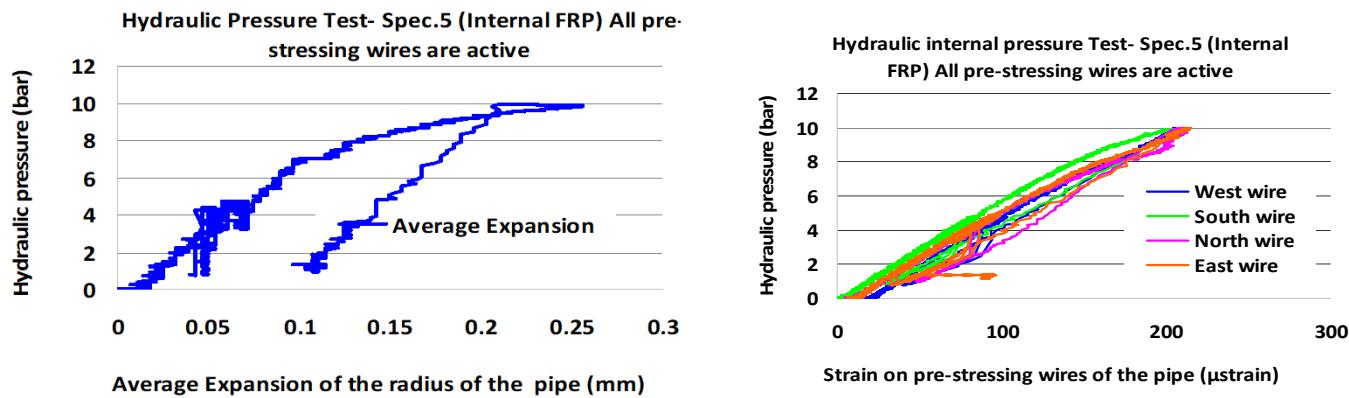
Figure 16. Measured response for Specimen 5 with fully active prestressing and an internal FRP jacket: (Left) average radial expansion; (Right) radial strains of the prestressing wires ($1 \text{ bar} = 0.1 \text{ N/mm}^2$).

Figure 16 depicts the measured response during the internal hydraulic pressure testing of Specimen 5, which is a specimen with fully active prestress and is retrofitted with a radial three-layer CFRP jacket attached to its internal pipe surface. The applied internal pressure variation is plotted against the average radial expansion (Figure 16 left) or the radial strains developing on the prestressing wires (Figure 16 right). This measured response again confirms that at the maximum internal pressure, approximately 10.0 bar, the prestressing wires deform within their elastic range. At the end of the first loading–unloading cycle, having reached a maximum internal pressure of approximately 10.0 bar, there is a remaining permanent expansion of the radius of the pipe, which again is attributed to the micro-cracking of the internal concrete volume (Figure 16 left). The active prestress with the internal CFRP jacket controls this concrete micro-cracking for internal pressure values up to 8.0 bar.

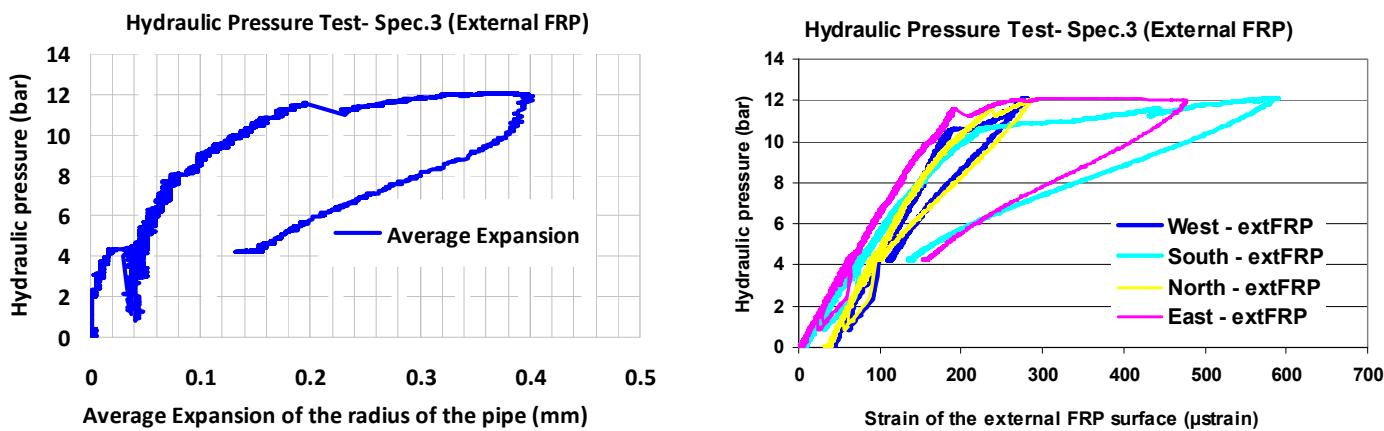
Figure 17. Measured response for Specimen 3 with fully active prestressing and an external FRP jacket: (Left) average radial expansion; (Right) radial strains of the external FRP jacket ($1 \text{ bar} = 0.1 \text{ N/mm}^2$).

Figure 17 shows the measured response recorded during the internal hydraulic pressure testing of Specimen 3, which is retrofitted with a three-layer CFRP jacket attached to its external pipe surface and with all prestressing wires fully active. The applied internal pressure variation is plotted against the average radial expansion (Figure 17 left) or radial strains measured at four locations of the external CFRP jacket (Figure 17 right). The variation in these CFRP strains against the internal pressure is almost linear up to an amplitude of 10.0 bar. Beyond this internal pressure amplitude, the CFRP at South and East locations becomes noticeably larger than before. Moreover, at the end of this loading–unloading cycle, having reached a maximum internal pressure amplitude of approximately 12.0 bar, there is remaining permanent expansion of the radius of the pipe, which is again attributed to the micro-cracking of the internal concrete volume.

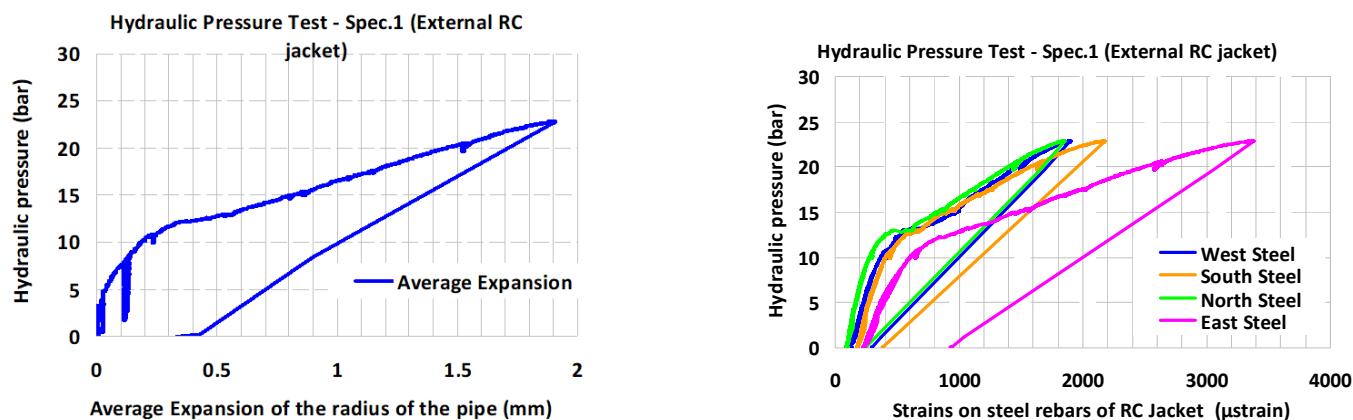
Figure 18. Measured response for Specimen 1 with fully active prestressing and an external RC jacket: (Left) average radial expansion of the pipe radius; (Right) radial strains of the radial reinforcing bars of the external RC jacket ($1 \text{ bar} = 0.1 \text{ N/mm}^2$).

Finally, Figure 18 shows the measured response recorded during the internal hydraulic pressure testing of Specimen 1, which is retrofitted with an external RC jacket and has, at the same time, all prestressing wires fully active. An initial change in slope can be seen in Figure 18 (left) for an internal pressure amplitude above approximately 6.0 bar. Moreover, permanent remaining radial expansion can also be seen for the unloading path, having reached an internal pressure amplitude of 8.0 bar. The radial expansion versus the internal pressure variation (Figure 18 left) changes its slope even further for an internal pressure amplitude higher than 11.0 bar. For pressure values larger than 11.0 bar up to almost 23 bar, the slope of the curve representing the variation in the radial expansion versus internal pressure remains almost constant. After unloading, there is considerable remaining permanent radial expansion. The same observations can be made for the variation in the

radial strain versus the internal pressure response depicted in Figure 18 (right). These are the radial strains of the radial reinforcement of the RC jacket. As can be seen in Figure 18 (right), at the maximum applied internal pressure of 23.0 bar, the East radial reinforcing bar within the RC jacket is stressed beyond its yield point at the maximum applied internal pressure.

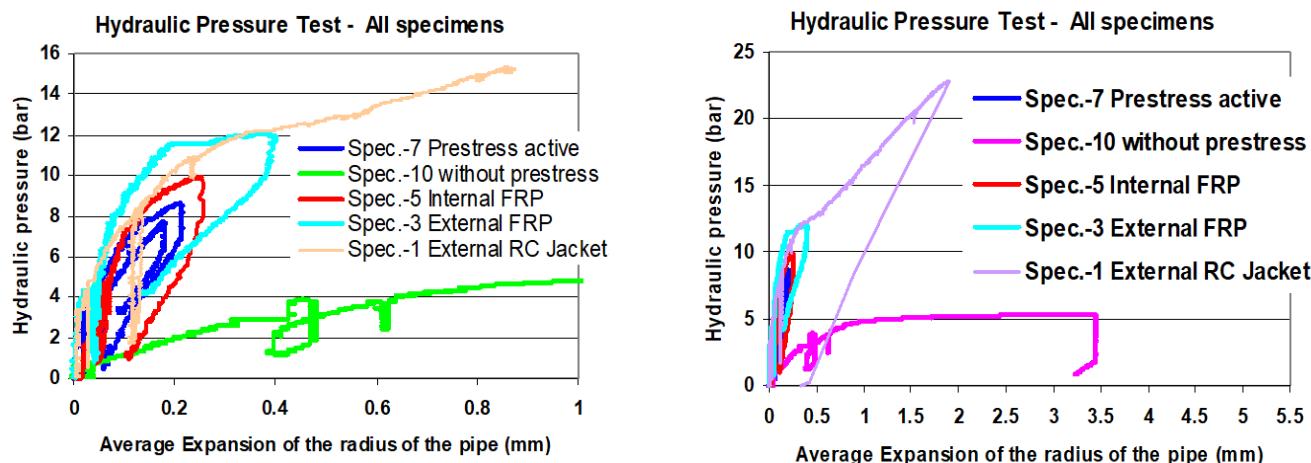
**Figure 19.** Radial expansion versus internal hydraulic pressure response for all tested specimens.

Table 4 lists the most significant parameters during the internal hydraulic pressure tests for all examined specimens, whereas Figure 19 compares the variation in the internal hydraulic pressure versus the expansion of the pipe radius for these five (5) specimens. Figure 19 (right) plots the same variation as that in Figure 19 (left) with a different scale for the abscissa axis in order to show details of the measured response of Specimens 1, 3, 5 and 7. As can be seen in both plots, the radial expansion response of Specimen 10 (having inactive prestressing wires) is much larger than that of Specimens 1, 3, 5 and 7 (all of which have active prestressing wires). Therefore, it can be concluded that fully active prestress is critical for the performance of the pipeline. As can be seen in Figure 19 (right), all specimens with fully active prestressing wires have a loading path whereby the radial expansion versus the internal pressure response is almost identical for internal pressure amplitudes up to approximately 8.0 bar. An internal pressure increase beyond this pressure amplitude unveils the effect of retrofitting the pipe with the three different jacketing schemes described. From the recorded response, it can be concluded that the prestressing wires reach their yield when the internal pressure increases beyond an amplitude of 12.0 bar. For all of these retrofitting schemes, cracking of the internal concrete volume is initiated at an internal pressure higher than 8.0 bar. These observations are also confirmed by the relevant values listed in Table 4.

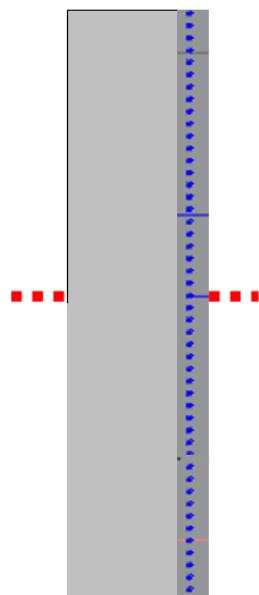
Figure 20. Typical cross-section of the pipe with prestressing wires.

A typical cross-section of the pipe specimen is depicted in Figure 20. The red dotted line indicates the axis of symmetry at mid-length, whereas blue dots show the 4 mm diameter prestressing wires. The following procedure was adopted in order to perform a laboratory simulation of the defective condition of the prestressing wires (see also Figure 13a–c). As discussed in Section 4, the neutralization of the prestress resulted in a significant reduction in the ability of the pipe to withstand the internal hydraulic pressure. To simulate defective prestress, the following process was adopted after completing the loading–unloading cycles of the 3EB and internal hydraulic pressure tests described in Sections 3 and 4, with all prestressing wires being fully effective for eight (8) specimens (see Table 1).

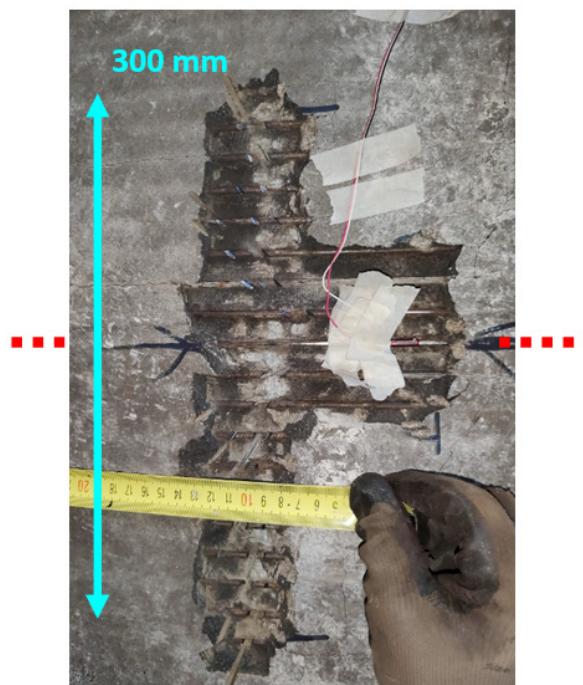
Figure 21. External façade of the pipe at the East cross-section before the 3EB test.

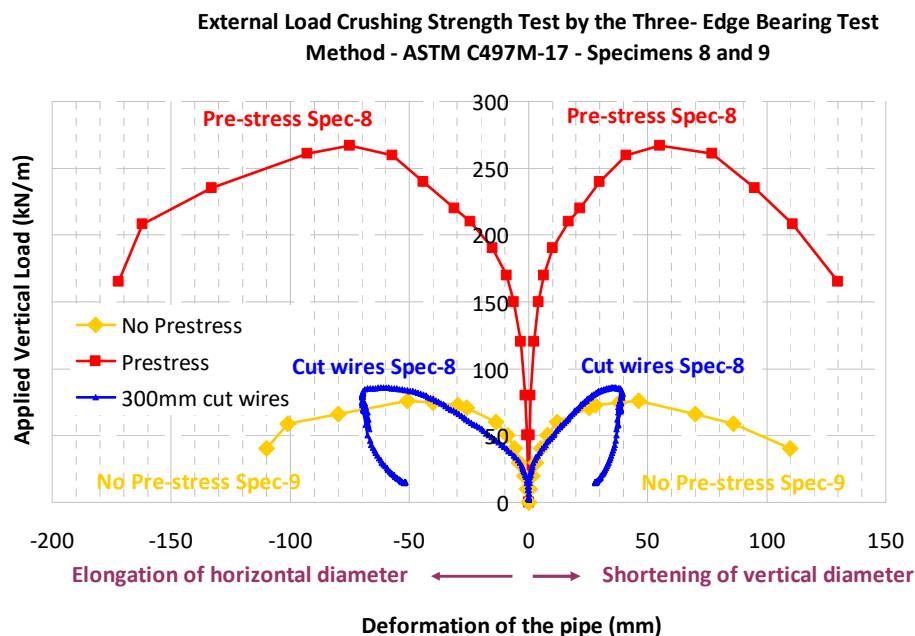
Figure 22. Measured response of Specimen 8 with 16 prestressing wires neutralized by cutting.

cutting of these wires resulted in a reduction in the bearing capacity of the specimen with the described simulated prestress defect to the level that was obtained for the specimen without any prestress.

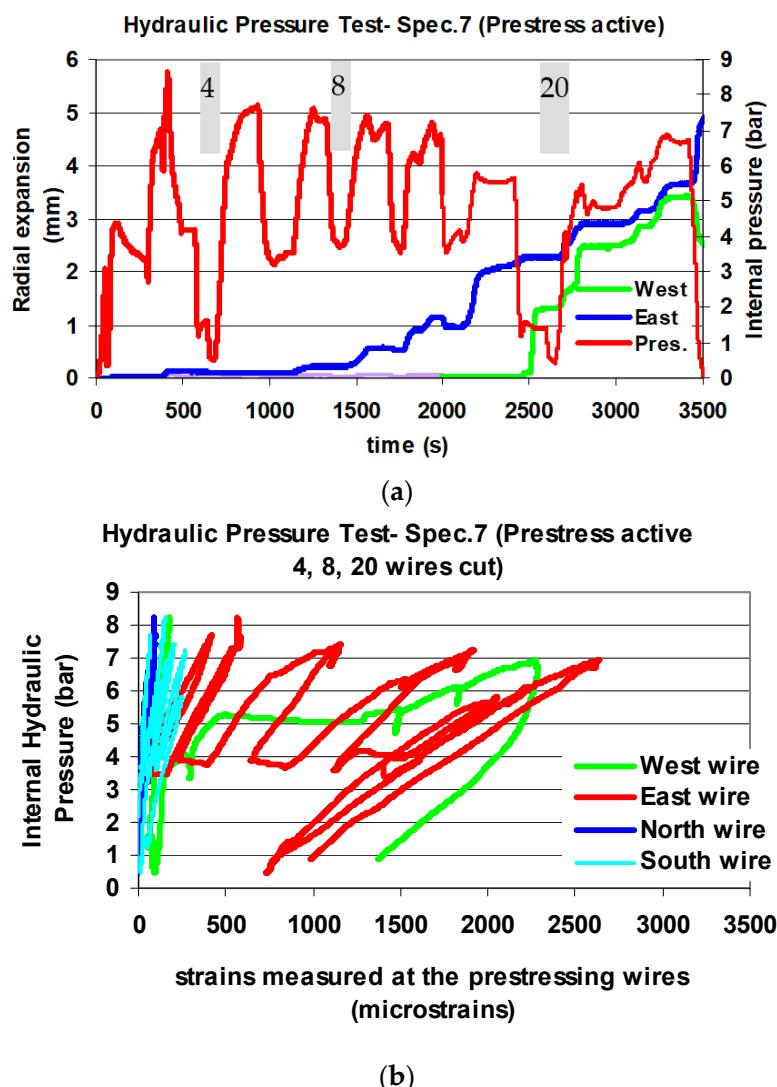
Figure 23. (a) Variation in radial expansion at East and West sections with the variation in internal pressure for the whole duration of the test. The time and the number of cut wires are also indicated with grey stripes. (b) Variation in wire radial strain versus internal pressure for the specimen with cut wires (4, 8 and 20).

Specimen 7 and Specimen 5 were used to simulate defective prestress in the way described. The prestressing wires of these two specimens were easily accessible by locally removing the protective mortar cover. Care was taken not to disturb the instrumentation that was placed at this location during the wire-cutting process. The presence of the CFRP jacket (Specimen 3) or RC jacket (Specimen 1) did not allow such a wire-cutting process. The obtained measured response for Specimen 7 (original pipe) and Specimen 5 (pipe with internal CFRP jacket) is next presented and discussed. Figure 23a,b depict the measured response when subjecting Specimen 7 to internal pressure, first with all prestressing wires fully active and then during the process of cutting the specified wires sequentially, as previously described. Figure 23a shows the applied internal pressure loading–unloading cycles over time, where the described wire-cutting process is indicated. In the same figure, the measured radial expansion at the East and West cross-sections is also shown. Figure 23b again shows the applied cycles of internal pressure together with the radial strains measured at the East, West, North and South cross-sections.

The progressive cutting of the prestressing wires resulted in the enlargement of the radial expansion at the East and West cross-sections and the straining of the Eastern wire left at the axis of symmetry. The increase in the number of cut wires resulted, as expected, in larger values of the radial expansion and the straining of the wire for relatively small internal pressure amplitudes. This in turn can lead to a reduction in the internal pressure capacity of the pipe as a result of the prestress defect. Due to time and safety restrictions, this part of the test sequence was extended to a duration of 3500 s, not including the time required for cutting the wires.
