Article

Experimental Investigation of the Structural Performance of Existing and RC or CFRP Jacket-Strengthened Prestressed Cylindrical Concrete Pipes (PCCP)—Part A

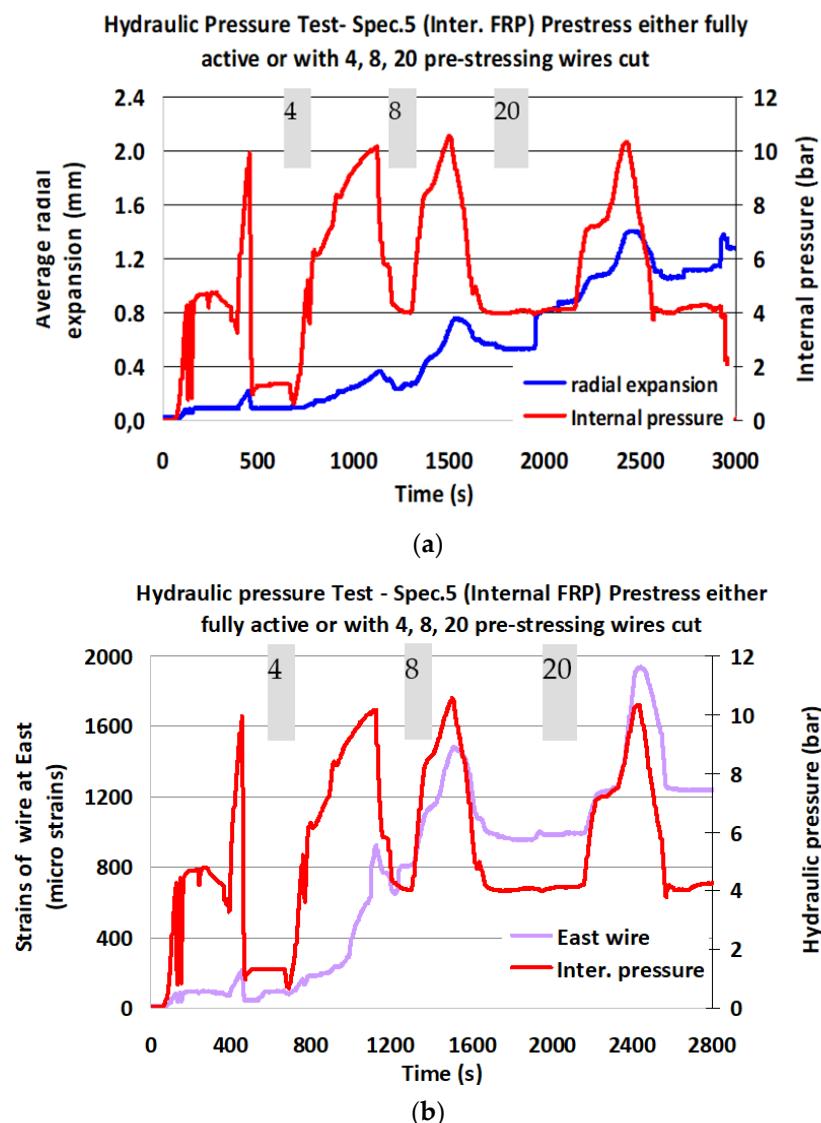
Figure 24. (a) Variation in the average radial expansion versus internal pressure for the whole duration of the test. The time and the number of cut wires are also indicated with the grey stripes. (b) Variation in wire radial strain versus internal pressure for the specimen with cut wires (4, 8 and 20). The time and the number of cut wires are also indicated with the grey stripes.

Figure 24a,b depict the measured response when subjecting Specimen 5, with an internal CFRP jacket, to internal pressure when having all prestressing wires fully active and then applying the process of cutting the specified wires sequentially, as described before. The progressive cutting of the prestressing wires resulted in an enlargement of the average radial expansion and the straining of the wire left at the axis of symmetry. The increase in the number of cut wires resulted in larger radial expansion values and a considerable strain increase of the Eastern wire for relatively small internal pressure amplitudes. However, this time, the internal CFRP jacket kept the enlargement of the pipe deformation under control despite the progress of the simulated prestress defect. Consequently, the internal CFRP jacket can control the detrimental effect that a prestress defect can have on the internal pressure bearing capacity. Again, due to time and safety restrictions, the test sequence was extended to a duration of 3500 s, not including the time required for wire cutting. Therefore, the previously stated conclusion should be considered under these limited-time test conditions.

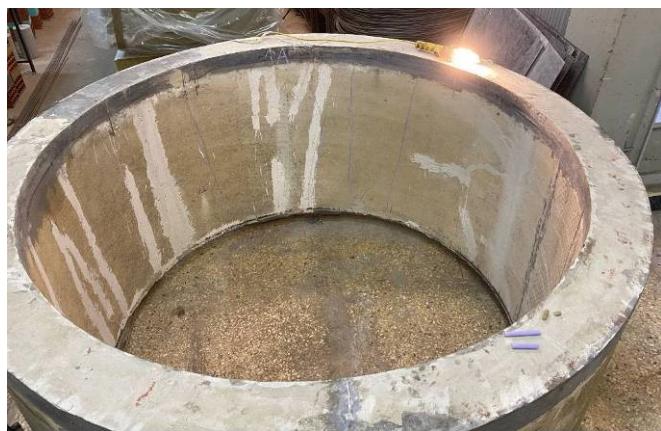
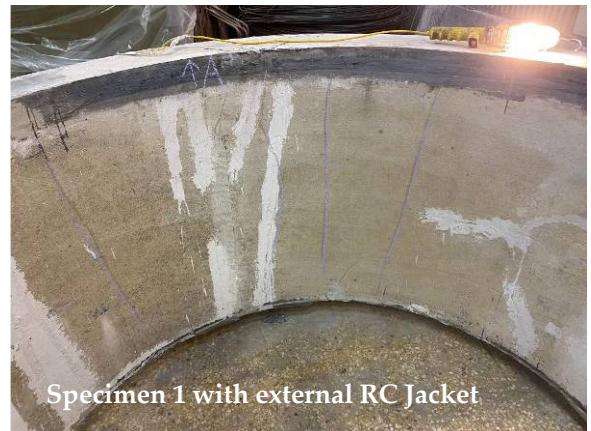
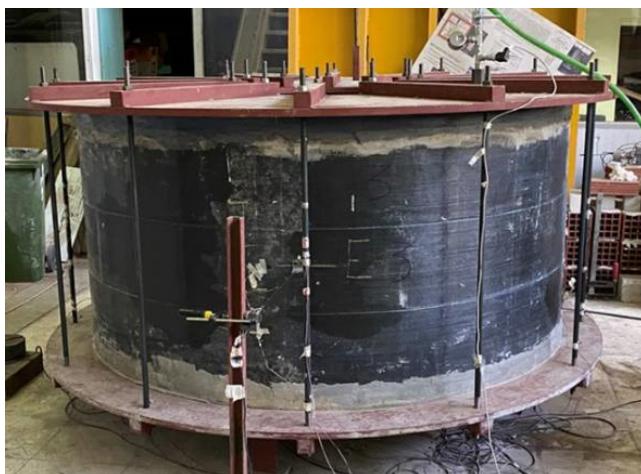
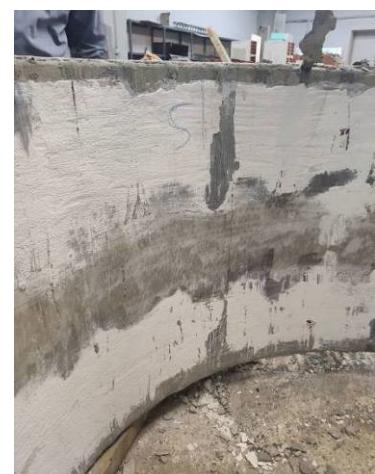
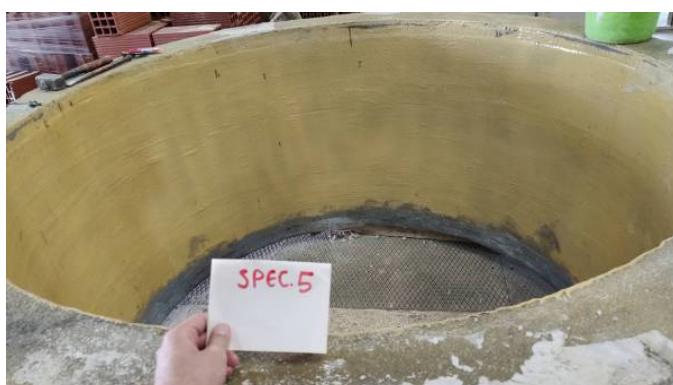
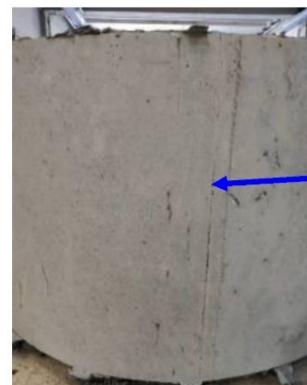
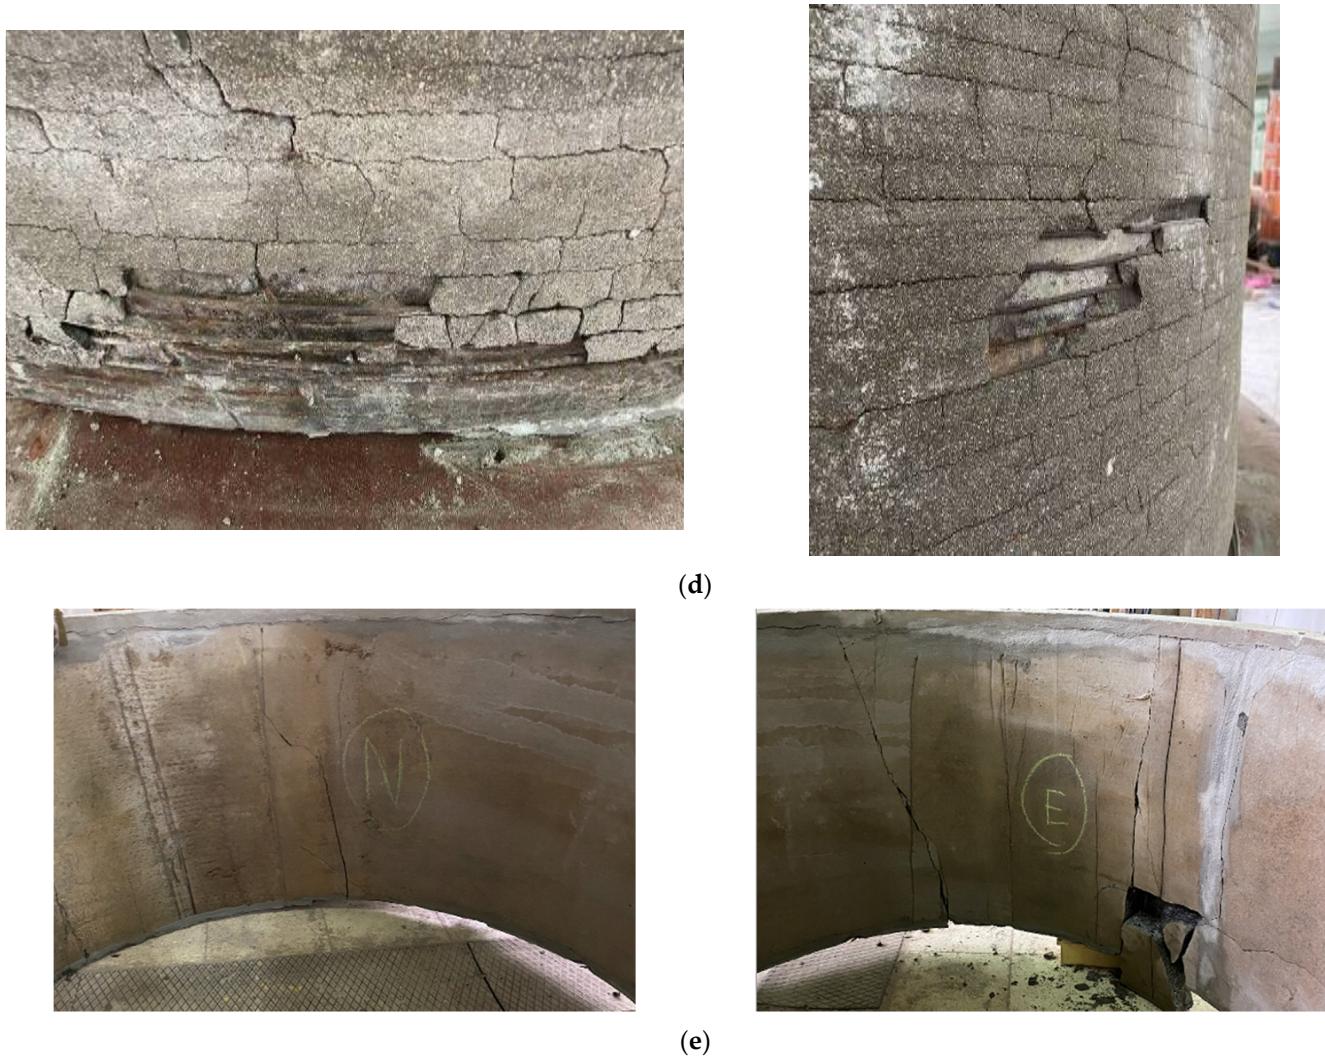
Figure 25. (a) Specimen 1 with an external RC jacket and fully active prestressing wires after the internal hydraulic pressure test. Concrete micro-cracking visible at the internal concrete surface. (b) Specimen 3 with an external FRP jacket and fully active prestressing wires after the internal hydraulic pressure test. (c) Specimen 5 with internal FRP jacket and fully active prestressing wires after the internal hydraulic pressure test. Identified micro-cracking at the external concrete surface. (d) View from different sides of the external surface of Specimen 7 with fully active prestressing wires after the internal hydraulic pressure test. (e) Internal surface and concrete cracking of Specimen 10 with inactive prestressing wires.

3. This simulated prestress defect was attempted for both the original pipe (Specimen 7) without any strengthening and for Specimen 5 strengthened with an internal FRP jacket. The simulated prestress defect was accomplished by sequentially cutting specific numbers (4, 8 and 20 prestressing wires) of specific prestressing wires, all at the same location (Eastern cross-section). For Specimen 7 (original pipe without strengthening), the radial expansion amplitude increased rapidly after eight prestressing wires were cut. When the number of cut wires reached 20, the measured radial expansion was equal to over 5 mm for an internal pressure amplitude equal to 6.7 bar, a pressure level considerably smaller than the set limit pressure of 8.5 bar. On the contrary, for Specimen 5 (with an internal CFRP jacket) with 20 prestressing wires cut, the radial expansion reached only 1.4 mm for an internal pressure amplitude equal to 10.0 bar, a pressure that is larger than the set pressure limit. The radial expansion remained smaller than 1.0 mm when the number of cut wires was equal to eight (8) or less, although the internal pressure amplitude was kept above 10 bar. Therefore, it can be concluded that the internal CFRP jacket can withstand the set pressure limit for a prestress defect corresponding to the one simulated in the laboratory. Damage patterns at the end of the test sequence are shown in Figure 25a–e.
