Article

# The Zagreb (Croatia) M5.5 Earthquake on 22 March 2020

**Abstract:** On 22 March 2020, Zagreb was struck by an M5.5 earthquake that had been expected for more than 100 years and revealed all the failures in the construction of residential buildings in the Croatian capital, especially those built in the first half of the 20th century. Because of that, extensive seismological, geological, geodetic and structural engineering surveys were conducted immediately after the main shock. This study provides descriptions of damage, specifying the building performances and their correlation with the local soil characteristics, i.e., seismic motion amplification. Co-seismic vertical ground displacement was estimated, and the most affected area is identified according to Sentinel-1 interferometric wide-swath data. Finally, preliminary 3D structural modeling of the earthquake sequence was performed, and two major faults were modeled using inverse distance weight (IDW) interpolation of the grouped hypocenters. The first-order assessment of seismic amplification (due to site conditions) in the Zagreb area for the M5.5 earthquake shows that ground motions of approximately 0.16–0.19 g were

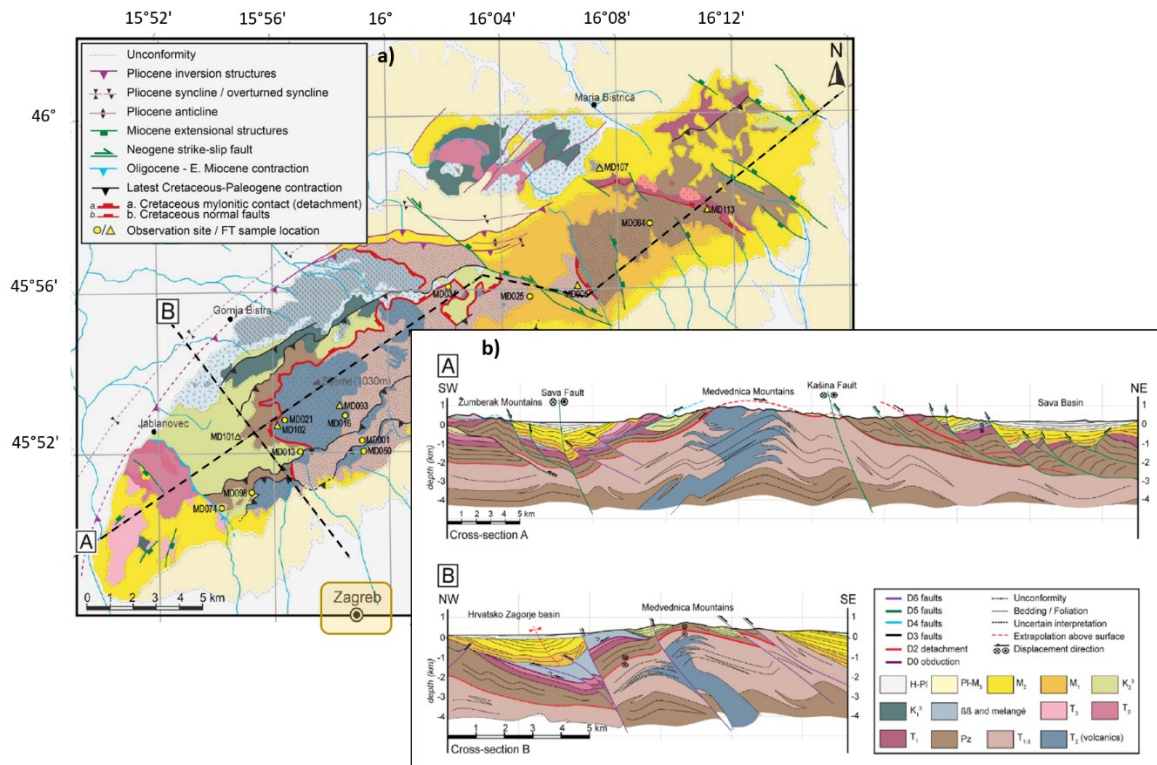
**Figure 1.** (a) Geological map of the Medvednica Mountains. The map shows the location of the cross-sections A and B; (b) Cross-sections across the Medvednica Mountains: (A) longitudinal (SW–NE) and (B) transversal (NW–SE) (after [11]).

The Medvednica Mountains are composed of a Paleozoic to Mesozoic metamorphic core overlain by non-metamorphic Mesozoic and Cenozoic rocks ([13–15]; Figure 1a). All units are truncated by normal and reverse faults and are surrounded by the Miocene–Quaternary deposits of the Pannonian Basin.

A system of south-dipping longitudinal reverse faults has been mapped on the surface along the Medvednica Mountains [15] and interpreted in one of the latest tectonic models as the youngest (Pliocene to Quaternary) system of reverse faults ([11]; Figure 1) that are probably still active [7]. The reverse slip of the primary ruptured fault (Fault 1) of the Zagreb 2020 earthquake sequence (Figure 13; Supplement 1) generally corresponds to the frontal reverse fault striking along the northern foothills of the mountain (Figure 1b). However, the interpreted steep frontal reverse fault does not match the modeled gently inclined primary fault that is here interpreted as a thrust fault (Figure 13). Thus, a fault that could accommodate such a movement is probably a southeast-dipping thrust fault that completely dissects the basement of the central part of the Medvednica Mountains. This master thrust could represent a basal detachment (*décollement*) of the system of steeper reverse faults striking along the Medvednica Mountains. It could be steeper in the frontal part and thus could match the North Medvednica reverse fault, or it could be buried below the Neogene Hrvatsko Zagorje basin (Figure 1b; Figures 12 and 13).

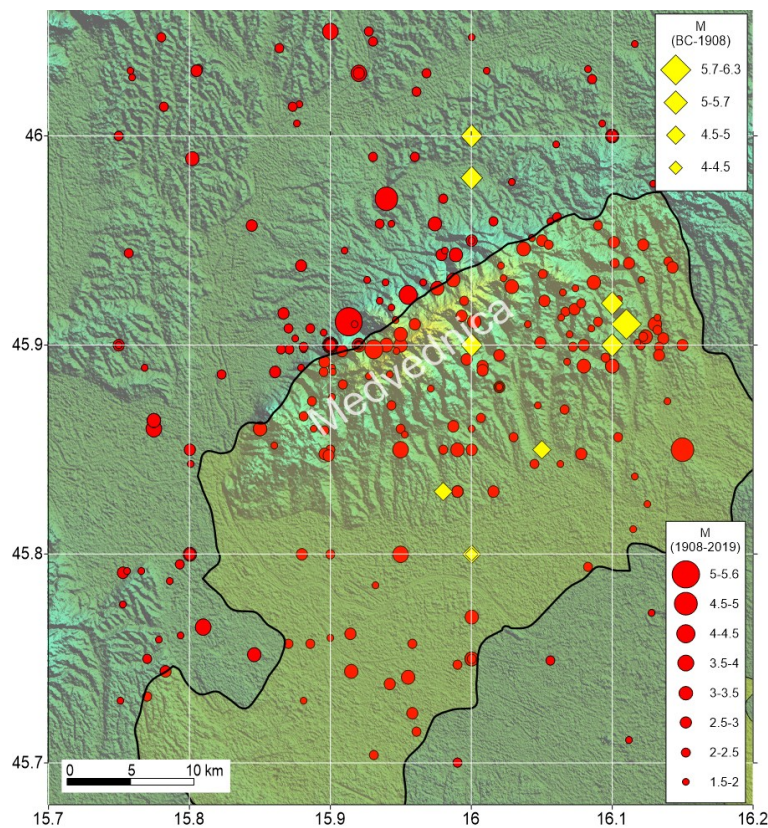
**Figure 2.** Spatial distribution of earthquakes with locations in the wider Zagreb area from BC to 2019 (according to the updated version of the Croatian Earthquake Catalogue, first described in [18]). The urbanized Zagreb city area is displayed with yellow shadowing.

Figure 2 displays the locations of the epicenters of all earthquakes that have occurred in the wider Zagreb area (BC to 2019).

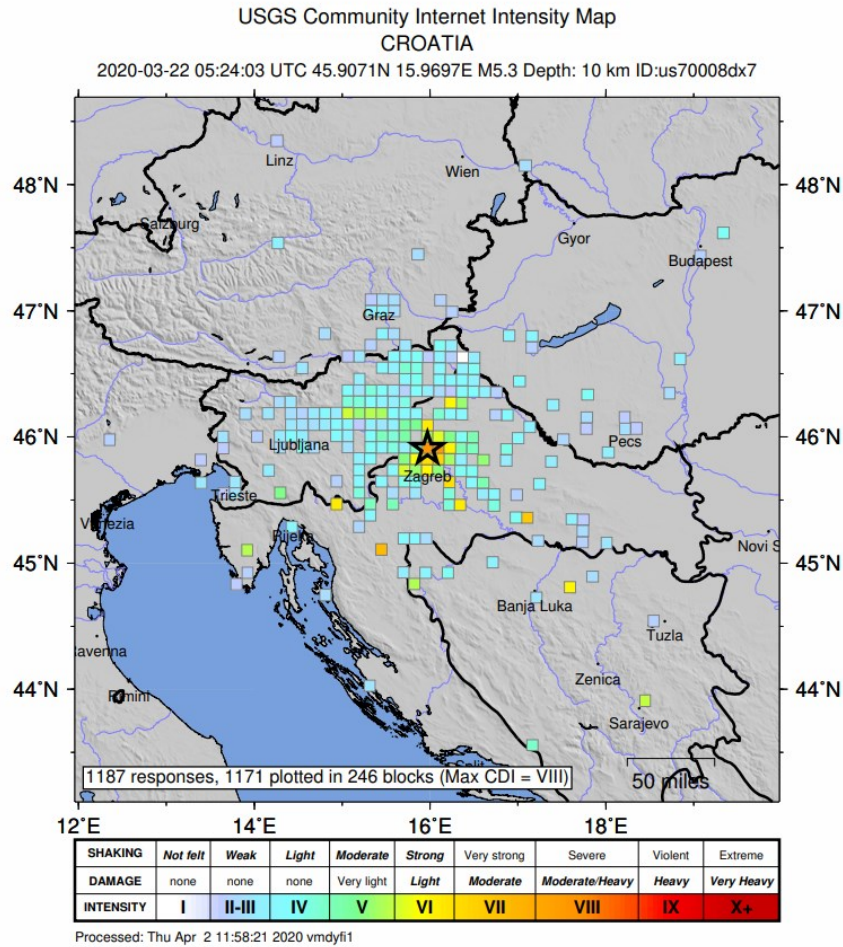
**Figure 3.** Intensity map according to data collected by USGS [19].

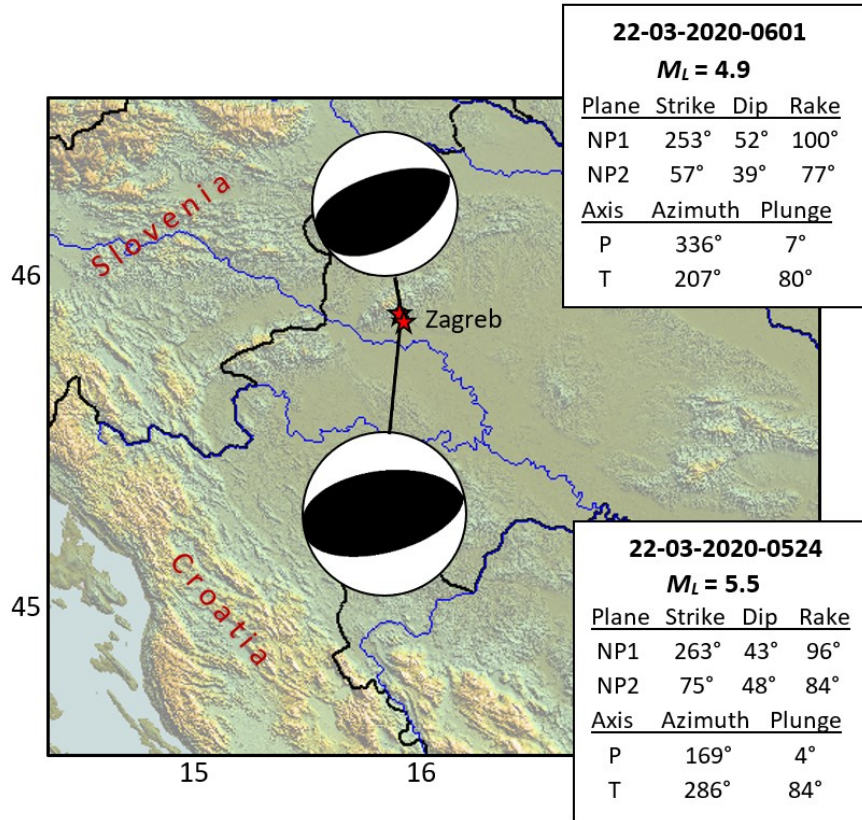
**Figure 4.** Fault-plane solutions of 22 March 2020 earthquakes at 05:24 UTC and 06:01 UTC. The focal sphere is shown in stereographic projection.

Based on the analysis of data recorded in Croatia and around the world (waveform data taken from the USGS National Earthquake Information Center [20]), the focal mechanisms of the main earthquake and the strongest aftershock were calculated (Figure 4).

The fault-plane solution of the main shock indicates that the earthquake occurred on a reverse fault whose fault plane dips at an angle of 43° to the south-southeast or at an angle of 48° to the north-northwest. The axis of maximum tectonic pressure (P) was horizontal and in the SSE-NNW direction, while the axis of maximum tension (T) was almost vertical. The calculated fault mechanisms will be described in greater detail in Section 4.5 and linked to the geological features of the study area.

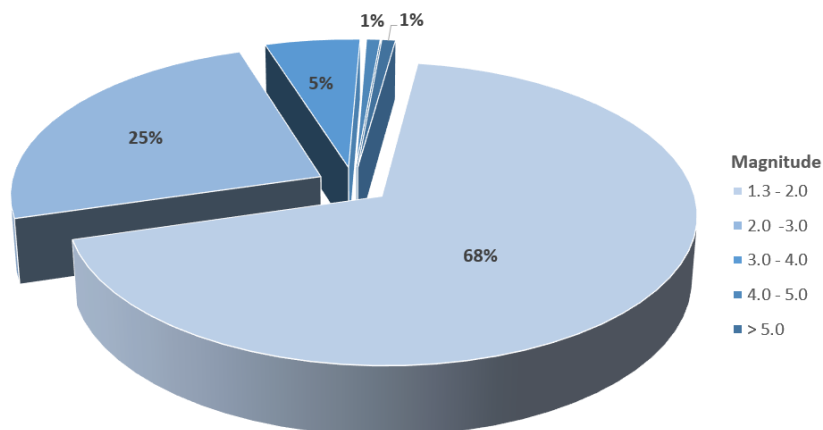
**Figure 5.** Percentage of earthquakes of each magnitude interval that occurred in the epicentral area of the Zagreb earthquake in the period from 22 March to 1 April 2020.

Since no one knows how much accumulated energy is released through a main earthquake, the aftershock activity is normal and not uncommon. Figure 5 presents the number of earthquakes of a certain magnitude (greater than 1.3) that occurred after the main earthquake of 22 March 2020 at 05:24 UTC.

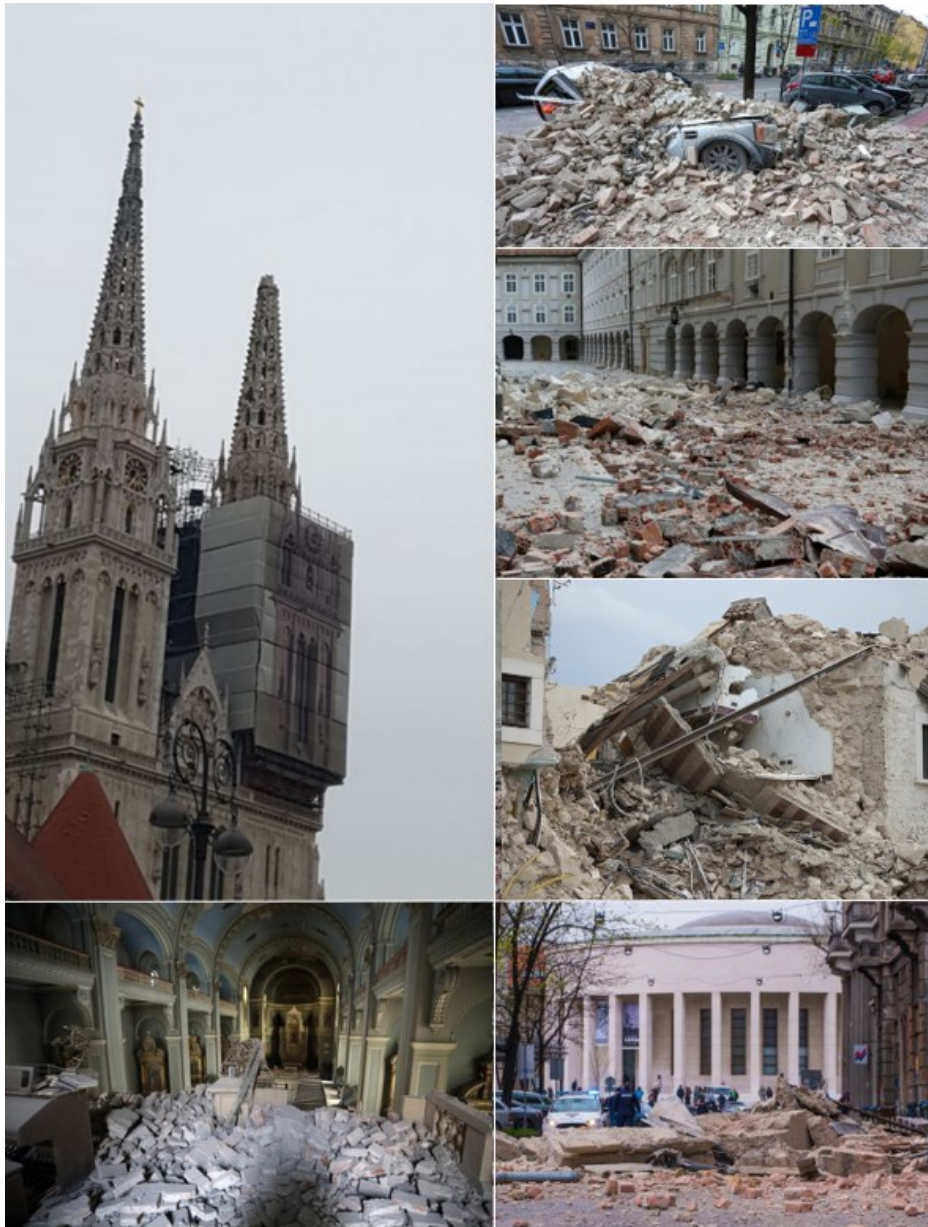
**Figure 6.** Photos of damage in Zagreb caused by the 22 March 2020 earthquake.

The earthquake hit the city center hardest, and the initial information indicated that the damage was great. Much damage to the cultural and historical architectural heritage of the city of Zagreb was reported, with severe damage to the south tower of Zagreb Cathedral. About 16,555 residential, public and monumental buildings were damaged (Figure 6) as declared by [21,22].

Figure 6 illustrates that in the old city center, three- to five-story masonry buildings, constructed from the time period of the Austro-Hungarian monarchy to 1920, sustained very heavy damage or were destroyed due to the M5.5 Zagreb earthquake on 22 March 2020. There were 26,197 damaged buildings in total (approximately 1900 uninhabitable), among which 9642 were family houses (as declared by [21,22]). As stated in the Disaster Risk Assessment for the Republic of Croatia [24], before 1920, masonry buildings used wooden slab construction, while reinforced concrete (RC) slabs were introduced in the period from 1920 to 1945. Before 1945, buildings possessed only initial earthquake resistance, and earthquake load was not considered in design (up to 5% of relevant peak ground acceleration - PGA was considered in design due to wind load). In compliance with Earthquake Hazard Map of Republic of Croatia [25], the relevant PGA based on 10% exceedance in 50 years, i.e., a return period of 475 years in the Zagreb area goes up to 0.28 g. The consideration of earthquake action in the design of buildings dates from 1946; however, the designs provided inadequate solutions. From 1945 to 1964, earthquake load was considered in the design of buildings by using simplified methodologies (the horizontal force at the top of the building); however, only up to 10% of the relevant PGA was considered in design. In 1964, as a result of the M6.9 Skopje (North Macedonia) earthquake in 1963, the Ordinance on Temporary Technical Regulations for Construction in Seismic Areas (Federal Republic of Yugoslavia (FRY) Official Journal, [26]) was issued. The ordinance required the construction of vertical or horizontal confining elements in masonry buildings, but it provided low earthquake resistance in general. In 1981, it was replaced by the Ordinance on Technical Standards for the Construction of High-Rise Buildings in Seismic Areas (FRY Official Journal, [27]), which provided moderate resistance. Between the years 1964 and 1998, 30–50%

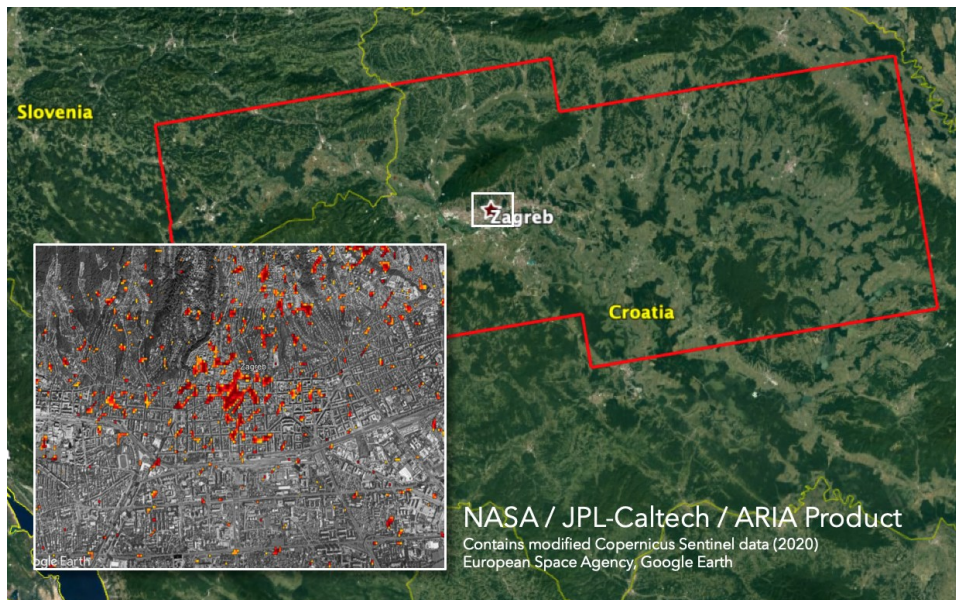
**Figure 7.** Damage proxy map created by the Advanced Rapid Imaging and Analysis (ARIA) team at NASA's Jet Propulsion Laboratory (JPL) and the California Institute of Technology. This map contains modified Copernicus Sentinel data, processed by the ESA and analyzed by the NASA JPL/Caltech ARIA team. This task was carried out at the JPL, funded by NASA. [23].

The extent of the damage is also visible on the damage proxy map (DPM) (Figure 7), which was created by the Advanced Rapid Imaging and Analysis (ARIA) team at NASA's Jet Propulsion Laboratory and the California Institute of Technology, both in Pasadena, California. The map depicts areas that were likely damaged. The map was derived from synthetic aperture radar (SAR) images

from the Copernicus Sentinel-1 satellites, operated by the European Space Agency (ESA). The team compared a post-event image acquired on 23 March 2020 with pre-event images taken since January 2020. The image covers an area of 166 by 56 km (103 by 35 miles), shown by the large red polygon. Each pixel measures approximately 30 m across. The color variations from yellow to red indicate increasingly significant surface changes. Preliminary validation was performed by using photographs from various sources, including news media. This damage proxy map should be used as a guide to identify damaged areas. The full map is available online at [23].

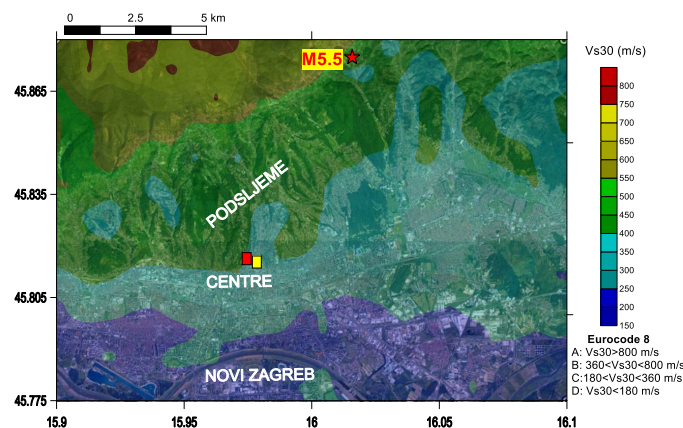
**Figure 8.**  $V_{s30}$  map of the Zagreb area obtained based on approximation via correlation to topographic slope ([46]; source: [47]). Locations of Zagreb Cathedral (yellow square) and Croatian Parliament (red square) are shown. The M5.5 epicenter location is marked with a red star.

Interestingly, the first scientifically explained observation of the local soil amplification effects and variable earthquake damage due to different local geological units during shaking was presented by Stur [44], who analyzed the Klana (Croatia) earthquake sequence with the main shock on 1 March 1870 ( $I_{max} = VIII$  °MSK), presenting a detailed report on building construction and observations of the unequal distribution of earthquake damage related to soil conditions with geological sketches, damage locations of objects and a map of the shaken area. Herak et al. [45] presented their macroseismic study of this earthquake sequence and measured the horizontal-to-vertical spectral ratios (HVSRS) of ambient noise at six locations to compare estimates of soil response in the epicentral area with observations of site effects [44] during the Klana earthquake. Presented findings and observations from [45] are similar to the observations of [44] about local site effects in Klana and Studena. Similarly, we attempted to assess the seismic site amplification distribution that occurred during the Zagreb M5.5 earthquake to possibly correlate it with observed damage in the city area and local site effects. For the first-order assessment of seismic site conditions, we used maps of the average shear velocity down to 30 m ( $V_{s30}$ ), which is correlated with topographic slope [46], as displayed in Figure 8.

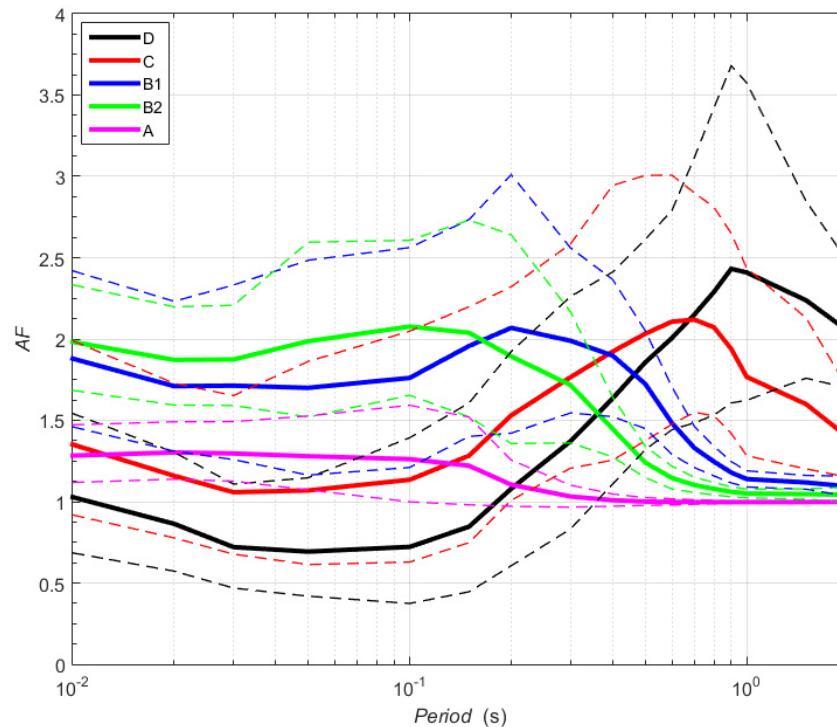
**Figure 9.** Median site amplification factors [41] for  $V_{530}$  site classes based on Eurocode 8 with ( $\pm 1$  standard deviation (dashed lines) for the  $PGA_{ROCK}$  in the range of 0.159–0.185 g.

We used a nonlinear site amplification model developed by [48] based on the site parameter ( $V_{S30}$ ) and the intensity of input rock motion ( $PGA_{ROCK}$ ), similar to models developed by [49–51]. Based on the well-known properties of random vibration theory (RVT) and seismological source theory [52],  $PGA_{ROCK}$  values for the M5.5 Zagreb earthquake were estimated (from the Fourier amplitude spectrum (FAS)). The input motion in the RVT-based method is typically defined by Brune's [53] omega-squared point-source stochastic model. The stress drop was set to the prescribed constant value of 100 bar (e.g., see [54]), the focal depth was taken as  $h = 10$  km, the average value of crustal shear wave velocity was equal to 3.5 km/s and the density was 2800 kg/m<sup>3</sup>. Frequency-dependent attenuation, the  $Q(f)$  value, was adopted from [55] as  $Q_c(f) = 78f^{0.69}$ , and the near-site attenuation parameter  $\kappa_0 = 0.028$  s was adopted from [56]. We chose to select locations near epicentral area and set the epicentral distance to vary from 1 to 5 km. The corresponding target values of  $PGA_{ROCK}$  were calculated in the range of 0.159–0.185  $g$ . Based on these results, we estimated the median site amplification factor ( $\pm 1$  standard deviation) using the Stanko et al. [48] model for  $V_{S30}$  categories defined by Eurocode 8 (Figure 9). Standard deviation of median site amplification describes site response variability as the effect of variations in ground motions and local site parameters. For site class B, we used two bins, 360–600 m/s (B1) and 600–800 m/s (B2), consistent with the findings of [57]. As underlined in [58], profiles with relatively shallow surface layers underlain by hard bedrock surfaces may have high impedance contrasts leading to strong resonance effects, which is the case for the Zagreb Podsljeme zone. The dominant period/frequency of the ground motion and the natural period/frequency of the soil are especially critical for possible resonance effects during earthquakes, which can result in heavy destruction. Therefore, knowing the building resonance frequency is important for structural stability during earthquakes and for limiting the extent of resonance damage. If the period of ground motion matches the natural resonance of a building, it undergoes the largest oscillations possible and suffers the greatest damage [30]. In general, the Zagreb residential area in terms of  $V_{S30}$  categories is in categories B1 (Podsljeme) and C (city center and Novi Zagreb), which show site amplifications most prominent between 0.1–0.5 s (2–10 Hz) and 0.4–0.9 s (1.1–2.5 Hz). Compared to the period–building relationship of  $T = 0.016H$  presented in [59], these periods correspond to family houses and 3- to 4-story (B1) and 4- to 15-story buildings (C1).

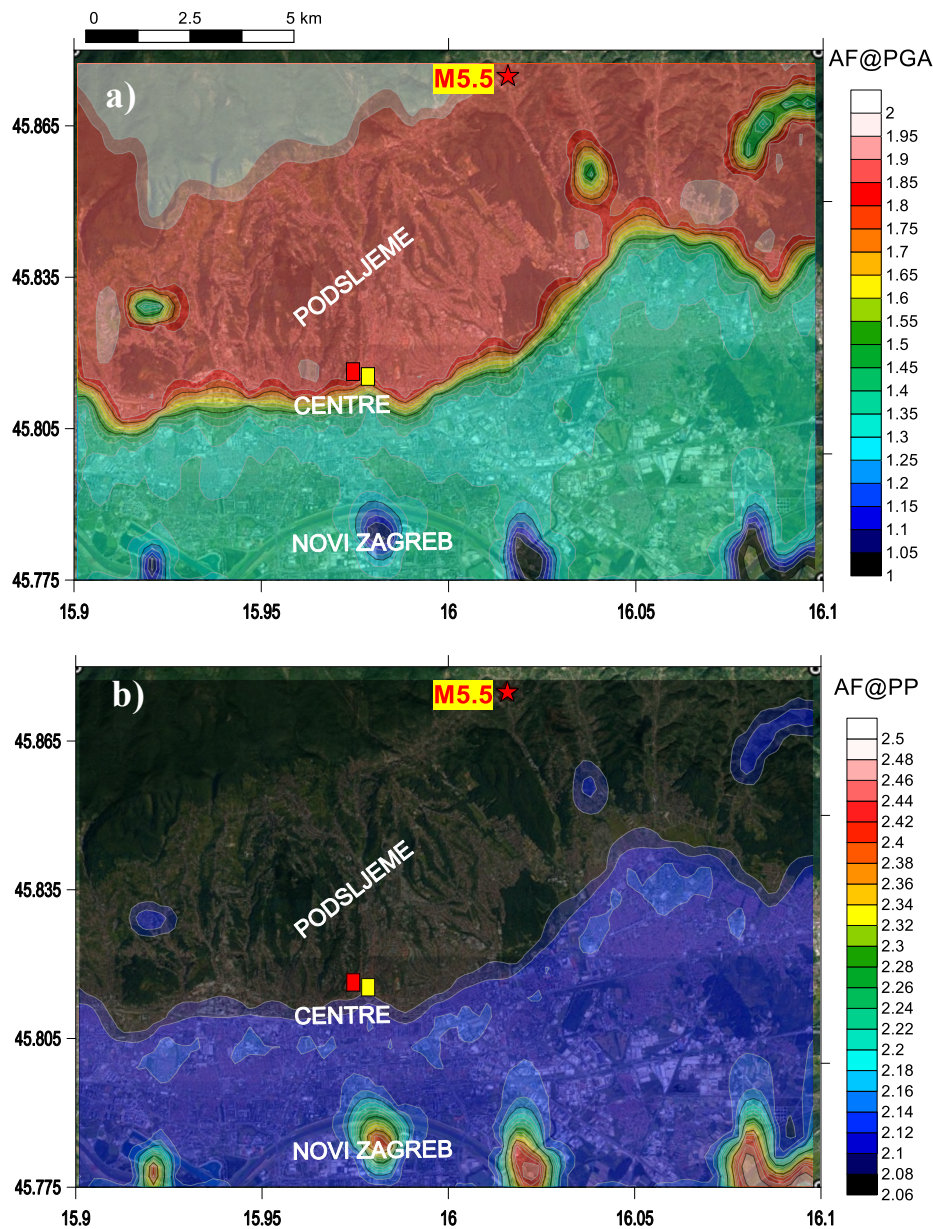
**Figure 10.** (a) Site amplification map for the PGA at surface (AF@PGA) and (b) the predominant amplification peak period (AF@PP) for estimated  $PGA_{ROCK}$ .

Figure 10 shows two site amplification maps for the  $PGA$  at the surface ( $AF@PGA$ ) and for the predominant amplification peak period ( $AF@PP$ ) for estimated  $PGA_{ROCK}$ . The amplification factor at the surface ( $AF@PGA$ ) of the input M5.5 event seismic motion (approximately estimated between 0.16–0.19 g) tends to be 1.6–1.8 in the Podsljeme zone, approximately 1.4–1.6 in the city center and approximately 1.3 in the alluvial Sava zone (Novi Zagreb) due to the nonlinear effects of strong shaking [42]. At the resonant period ( $AF@PP$ ), the observed amplification factor varies from 2.1 in the Podsljeme zone to 2.2 in city center and 2.4 in the Sava alluvial zone. Observed amplifications probably can also be correlated with ground motion polarization and directionality at sites with pronounced topography [60].

The first-order assessment of seismic amplification (due to site conditions) in the Zagreb area for the M5.5 earthquake shows that ground motions of approximately 0.16–0.19 g were amplified at least twice (if the standard deviation is taken into account, they can be amplified by a factor of 3.0 at some locations) in the Podsljeme and city center zones where the greatest extent of the damage is reported. Damage is most prominent in older buildings built before 1964, while newer buildings that were built using Eurocode 8 sustained very little or no damage, particularly in the Novi Zagreb area where the amplification factor at the resonant period is up to 2.4 (with standard deviation, it can be up to 3.6). Severe damage to the south tower of the Zagreb Cathedral (yellow square) could likely be the result of old construction and resonance effects; for category C,  $AF@PP = 2.2$  at the period of 0.8–0.9 s (1.1–1.25 Hz), which corresponds closely to the Cathedral period of 0.71–0.92 s (1.08–1.4 Hz) [61]. Similar results are observed for the Croatian Parliament (also an old building that suffered considerable damage), where the soil category is B1 with estimated  $AF@PP = 2.08$  at a period 0.31 s (3.16 Hz).

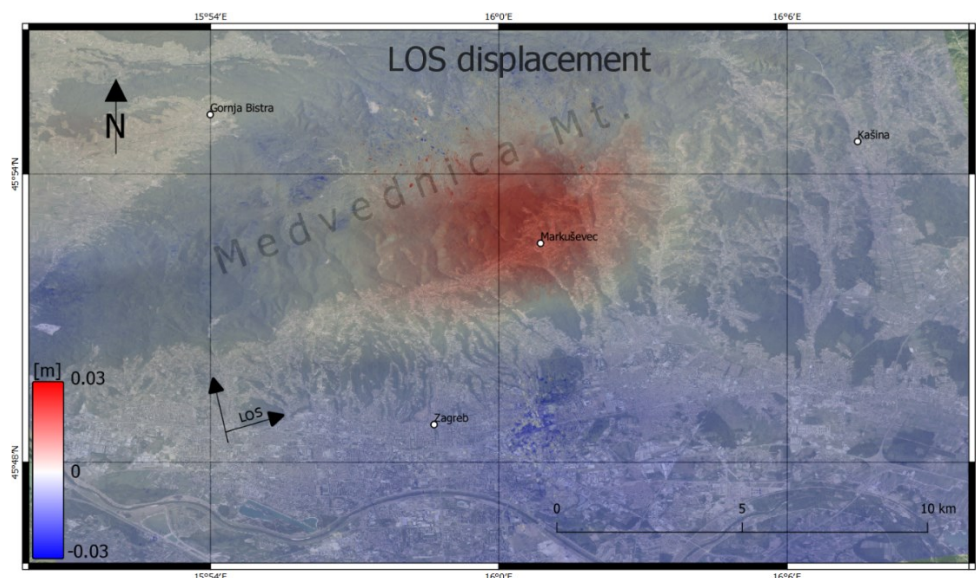
**Figure 11.** Unwrapped interferogram map indicating co-seismic line-of-sight (LOS) deformation of the 22 March 2020 earthquake.

The observed co-seismic deformation implies an approximately 3 cm uplift of the epicentral area that covers approximately 20 km<sup>2</sup>.

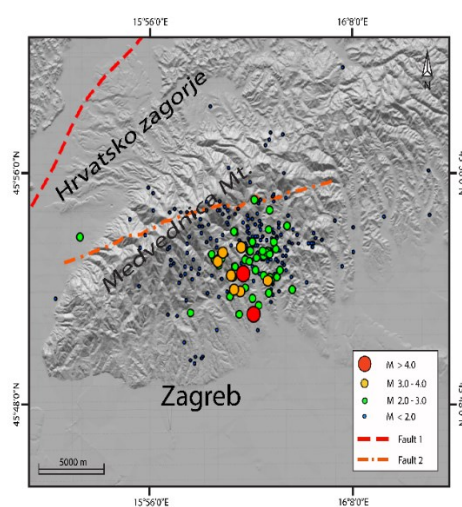
**Figure 12.** Spatial distribution of earthquake epicenter locations in the period from 22 March to 1 April 2020 (the Zagreb 2020 earthquake sequence). Fault lines are simple projections of the two modeled fault plains from the deep subsurface of the Medvednica Mountains to the surface (see Supplement 1 and Figure 13).

A set of 257 measurements was analyzed both spatially and temporally and processed for import into geological 3D modeling software. To achieve better visual insight, the hypocenters were scaled based on magnitude values ( $M_L$ ) into four intervals: <2.0, 2.0–3.0, 3.0–4.0 and >4.0 (Figure 12).

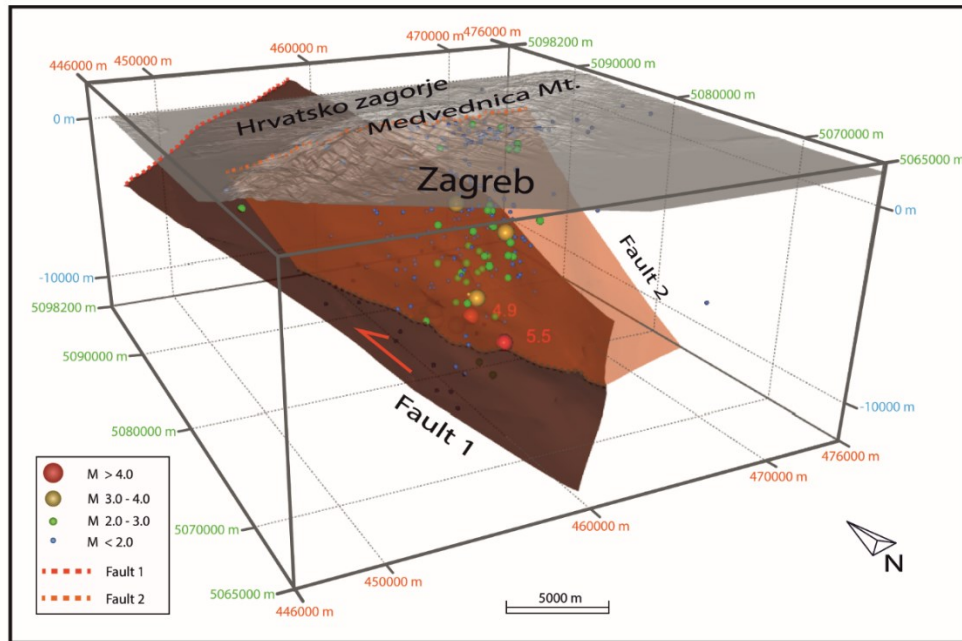
**Figure 13.** Preliminary structural 3D model of the Zagreb 2020 earthquake sequence. Coordinates are shown in HTRS96/TM coordinate system, and the elevation is in meters (no vertical exaggeration). Fault 1 is interpreted as a primary thrust fault, and Fault 2 is interpreted as a secondary (reverse?) fault.

Based on the selected datasets, two major faults were modeled using inverse distance weight (IDW) interpolation of the preselected datasets (hypocenters). The faults represent the preliminary structural model of the Zagreb 2020 earthquake sequence (Figure 13).

Using the previously described methodology, a primary fault plane was modeled (Fault 1) based on the dataset containing 45 hypocenters, including most of the highest magnitude events in the Zagreb 2020 earthquake sequence. The fault is characterized by an orientation similar to the southeast-dipping instrumentally calculated fault-plane solutions of the main shock and the strongest aftershock (Figure 4). The rupture along Fault 1 propagated towards the northwest, apparently along a deep-rooted southeast-dipping thrust fault (125/31, dip direction/dip angle). The thrust fault can be projected to the surface where it virtually appears in the central part of the Hrvatsko Zagorje basin (Figures 1b and 13).

In addition to Fault 1, a generally south-dipping fault (166/57) of unknown character (Fault 2) was modeled based on a dataset with 77 hypocenters situated above the main shock. Fault 2 includes most of the moderate magnitude events of the earthquake sequence.

The secondary fault (Fault 2) is a south-dipping, east–west striking fault of unknown character that dissects the mountain generally across the highest peaks (Figure 13). There are similar faults that are interpreted on the published geological maps as reverse faults [13,14], but further analyses and focused investigations are needed.
