# Reconstructing Impact of the 1867 Ionian Sea (Western Greece) Earthquake by Focusing on New Contemporary and Modern Sources for Building Damage, Environmental and Health Effects

**Citation:** Mavroulis, S.; Mavrouli, M.; Lekkas, E.; Carydis, P. Reconstructing Impact of the 1867 Ionian Sea (Western Greece) Earthquake by Focusing on New Contemporary and Modern Sources for Building Damage, Environmental and Health Effects. *Geosciences* **2024**, *14*, 214. <https://doi.org/10.3390/geosciences14080214>

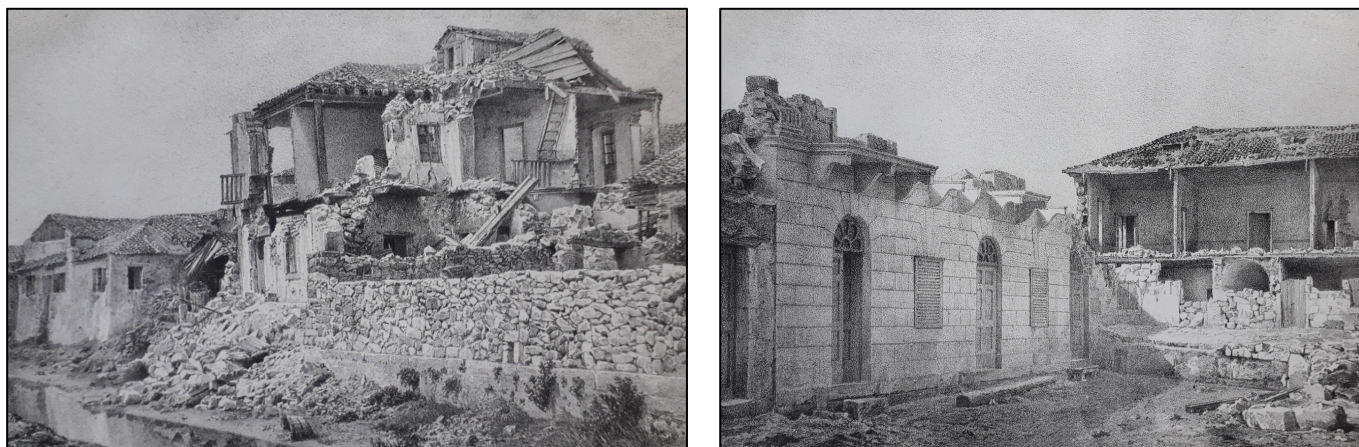
**Figure 10.** Typical views of structural damage caused by the 4 February 1867 earthquake to houses with load-bearing masonry walls in the town of Lixouri, located in the Paliki Peninsula. The photographs were first published by Fouqué [28], in his report on the 1867 earthquake. Partial collapse of the masonry is visible (damage of grades 4 and 5 according to the EMS-98 guidelines).

In terms of damage grades based on the EMS-98, the main structural damage recorded in most of the villages affected by the 4 February 1867 earthquake included: (a) partial or total collapse, corresponding to damage grade 5 and (b) heavy structural damage, including serious failures of walls resulting partial failures of roofs and floors, excluding collapse, corresponding to damage grade 4 (Figure 10).
