# The Susceptibility to Salt Fog Degradation of Stone Cladding Materials: A Laboratory Case Study on Two Limestones from Portugal

**Keywords:** natural stone; building cladding; aging; salt-fog; flexural strength

**Citation:** Pires, V.; Rosa, L.G.; Amaral, P.M.; Simão, J.A.R. The Susceptibility to Salt Fog Degradation of Stone Cladding Materials: A Laboratory Case Study on Two Limestones from Portugal. *Heritage* **2023**, *6*, 492–504. <https://doi.org/10.3390/heritage6010026>

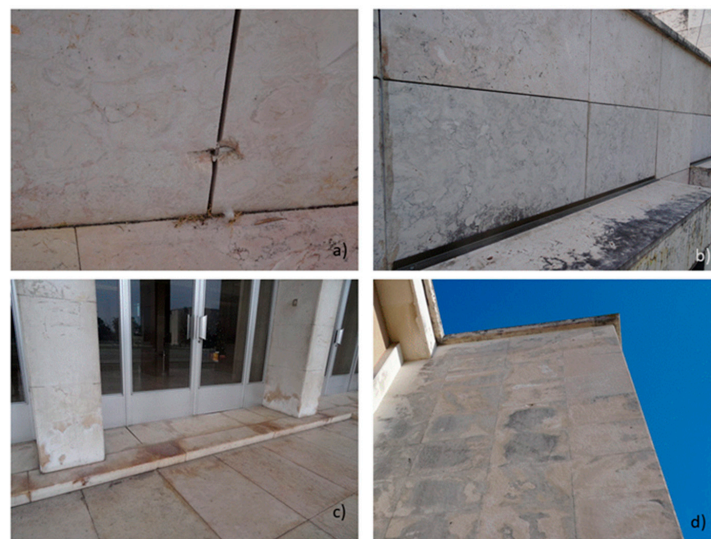
**Figure 1.** Examples of natural stone facade reactions to environmental conditions: (a) anchor rupture leading to strength loss; (b) biocolonization showing a relevant colour change; (c) white stains from saline efflorescence; (d) dark stains from water absorption, which might lead to slab detachment (photo credits: Vera Pires).

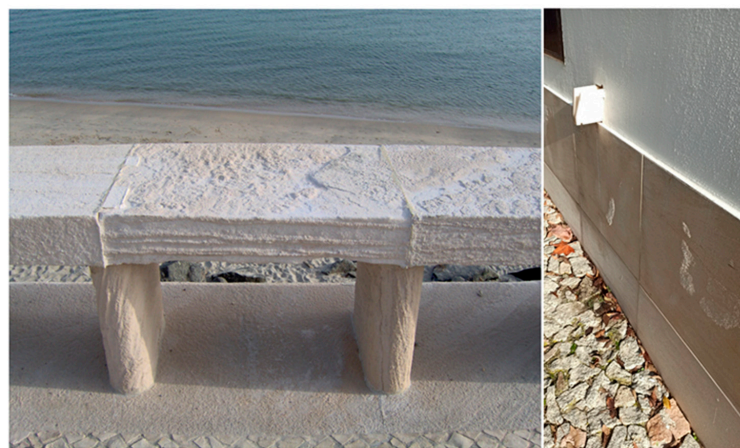
**Figure 2.** Examples of limestone elements subjected to natural salt weathering in a coastal area (photo credits: Joaquim Simão and Carla Lisci).

Salt fog activity involves mechanisms such as salt crystallization and deposition of salt on the stones surface, salt solution penetration in stone pores, and further salt expansion at each repeated imbibition–drying cycles, which cause the increase in voids in the stone framework, followed by removal of soluble salts and minerals that might lead to weight loss, porosity increase, and mechanical decay [16] (Figure 2).

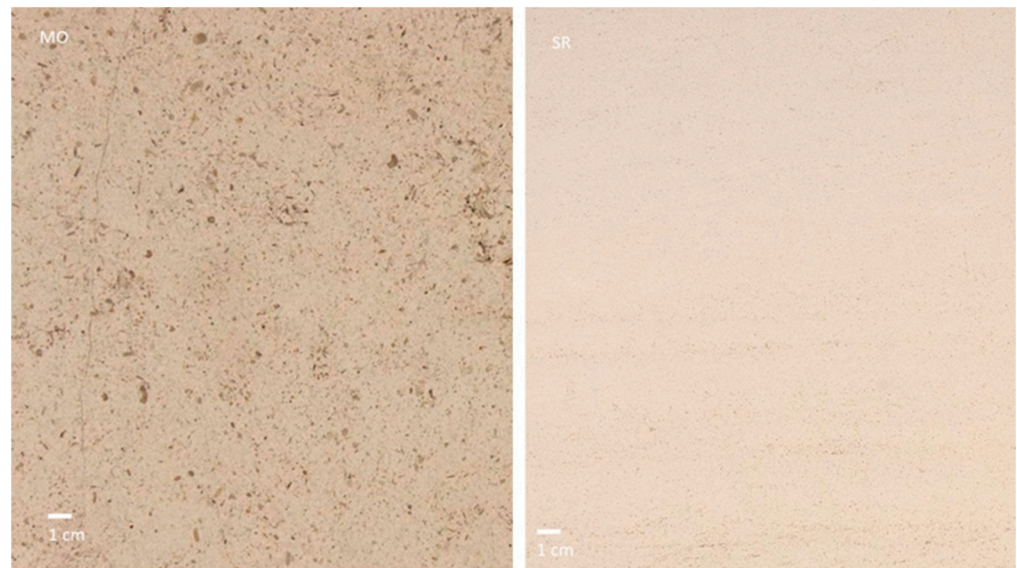
**Figure 3.** Macroscopic aspect example of the selected limestones: MO and SR with a honed finish.

The selected limestones—Soft Moleanos (MO) and Semi-Rijo (SR)—originated from the limestone massif of Estremadura (MCE: “Maciço Central Estremenho”) in Portugal. MO is described as a sparitic limestone, bioclastic, showing the presence of oolites and peloids. MO colour is usually beige/light cream, giving indication of a high purity carbonate level [32]. SR limestone is described as a fine-grained whitish limestone, calciclastic to oolitic, little bioclastic, with micritic cement and rare sparite [32,33] (Figure 3).
