Article

Experimental Investigations of Cement Clay Interlocking Brick Masonry Structures Strengthened with CFRP and Cement-Sand Mortar

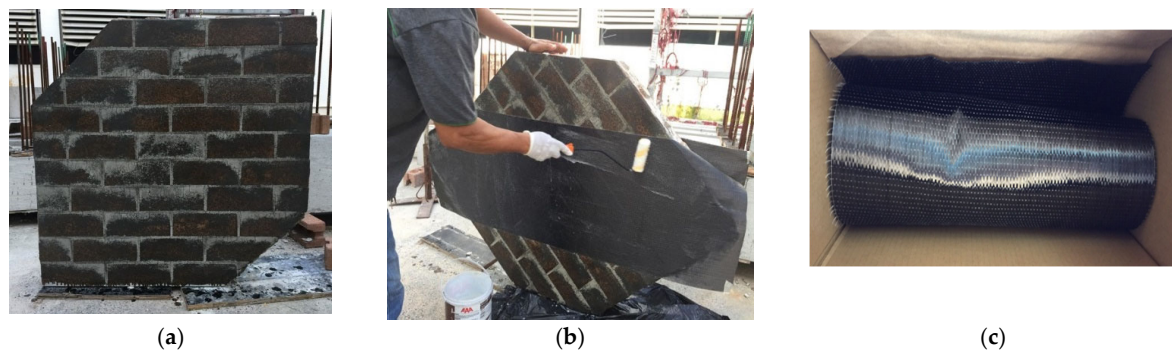
Figure 3. Application of epoxy resin and CFRP: (a) Epoxy resin applied to the wall; (b) Hand layup method of CFRP application; (c) Unidirectional CFRP.

Next, the unidirectional CFRP composites were applied using epoxy resin to the walls of CCI brick masonry, as shown in Figure 3. The CFRP composites were applied using the hand layup method. The CFRP composites were employed in two configurations, in the form of strips and over the full surface, as shown in Figure 1. In addition, similar configurations were also prepared in combination with the CS mortar.

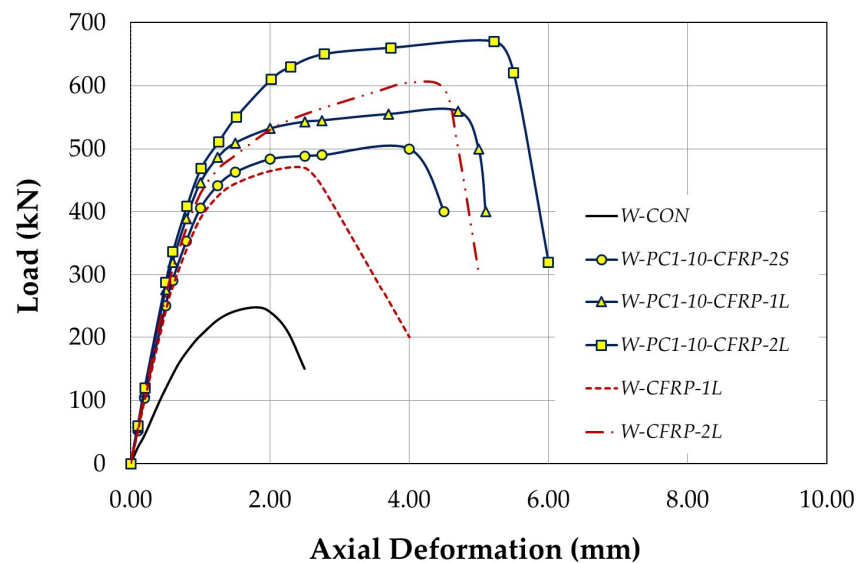
Figure 9. Axial Load versus axial deflection responses of all CCI brick masonry walls.

The axial load versus the deformation response of the walls of CCI brick are shown in Figures 7–9. The axial deformation was plotted by using the average results of LVDTs L1 and L2. It was found that the stiffness, ultimate load-bearing capacity, and ultimate deflection of the CCI brick masonry walls could be very effectively enhanced by exploiting the combination of CS mortar and CFRP composites.

The control wall (W-CON) exhibited approximately linear axial load versus axial deformation response until the ultimate load. The CCI bricks were crushed at the peak load and the load carrying capacity suddenly decreased. On the other hand, the axial load against axial deformation responses of the strengthened walls were comprised of three parts. The first part of the response is described by a linear line similar to the response of the control wall. The second portion of the curve is a transitional part, where both the load and the deformation of the confined masonry were softened and exhibited a nonlinear behavior accompanied by a large increase in deformation. In the third phase, the load versus deformation responses of the wall again increased linearly until the sudden failure. However, a much lower elastic modulus was exhibited compared to the initial first segment of the curve of strengthened specimens.

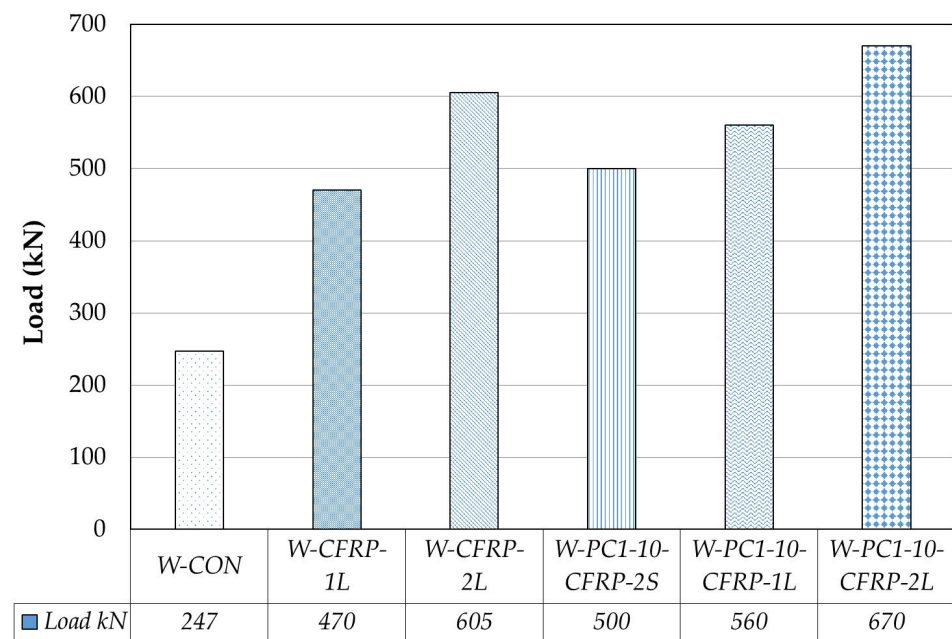
Figure 10. Comparison of ultimate load carrying capacities of CCI brick masonry walls.

The ultimate load-bearing capacity of CCI brick masonry walls was greatly influenced by different strengthening methods such as CFRP and its combination with CS sand mortar. The experimental results of ultimate load-carrying capacity are graphically compared in Figure 10. It can be viewed from the figure that, the CFRP composites alone or in combination with the CS mortar are very effective to improve the ultimate load-bearing capacity of the walls of CCI brick masonry.

The ultimate load bearing capacity of the CFRP composite-strengthened walls (W-CFRP-1L and W-CFRP-2L) was observed 90% and 145% larger than the control wall, respectively. Moreover, the combined use of CS mortar with the CFRP composite further enhanced the maximum load-bearing capacity of the walls of CCI brick. In comparison to the control wall, the ultimate load-bearing capacities of W-PC1-10-CFRP-1L and W-PC1-10-CFRP-2L were raised by 127% and 171%, respectively. Moreover, the performance of strengthening configuration B (CFRP composite strips) was also investigated with the purpose of reducing the cost of the strengthening material. The test results reveal that the use of CFRP composites in strips is also useful to enhance the maximum load-bearing capacity of the CCI brick walls. The maximum load-carrying capacity of the W-PC1-10-CFRP-2S wall was increased by 102% as compared to the control wall.

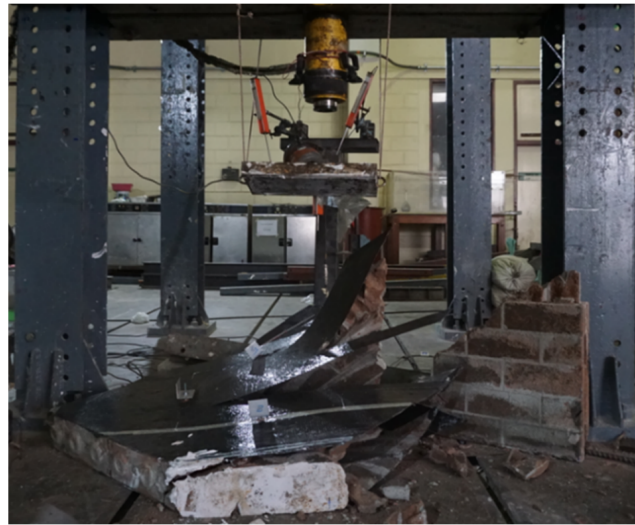
Figure 13. Failure of W-CFRP-1L and W-CFRP-2L walls at loads 470 and 605 kN, respectively.

The modes of failure of the walls of CCI brick at the ultimate stage are displayed in Figures 12–15. As shown in Figure 12, the CCI brick splitting in the middle of the masonry wall was the primary cause of the control or unstrengthened masonry wall ultimate failure. At the base of the reference wall of CCI brick masonry, severe compression crushing of the CCI bricks was recorded before the ultimate failure, while minor splitting and cracking were also seen there. As illustrated in Figure 13, the final failure of CCI brick masonry walls strengthened with CFRP composites (without CS mortar) was mostly caused by the explosive splitting and crushing of the CCI bricks, together with a quick fall. As illustrated in Figure 14, the eventual failure in the case of walls of CCI brick masonry strengthened with a combination of CS mortar and CFRP composite was caused by the crushing of the CCI bricks and a slight debonding of the CFRP composite from the CS mortar. The CCI brick masonry wall (W-PC1-10-CFRP-2S) that had been reinforced with CFRP composite strips and CS mortar ultimately failed due to severe crushing and splitting of the CCI bricks in the area that was being loaded, as well as the complete debonding of the CFRP strips from the surface of the CS mortar, as shown in Figure 15.

Debonding of the CFRP composites from the wall and compression crushing and splitting of the CCI bricks are two basic categories of the failure process of walls of CCI brick masonry. A splitting and compression crushing failure mode would be inherited by brick masonry. On the other hand, the application of CFRP and CS mortar would offer confinement to the brick masonry and the ultimate failure would be a combination of debonding of the CFRP composite and the crushing and splitting failure of the walls of CCI brick masonry. The failure modes of the walls of CCI brick masonry are summarized in Table 4.

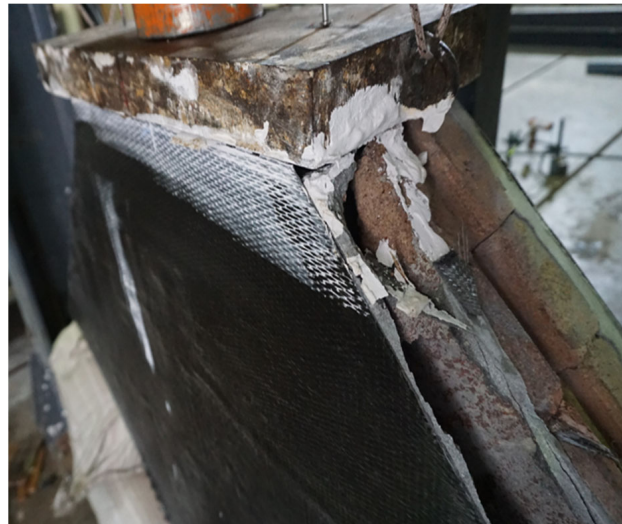
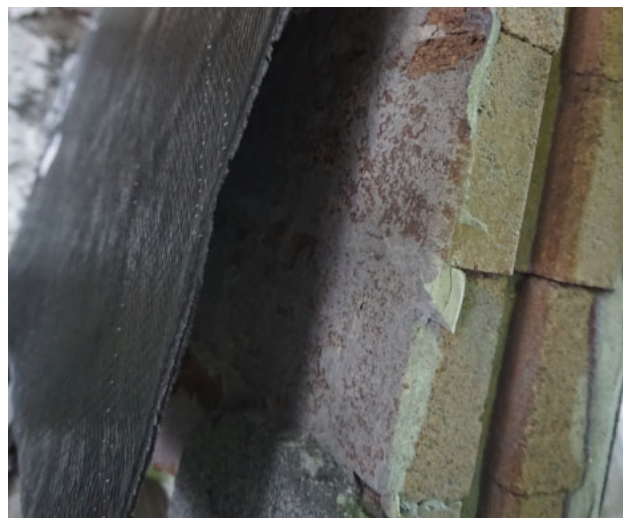
Figure 14. Debonding of CFRP composites from CS mortar at load 450 kN.
