Article

Sand Beach Nourishment: Experience from the Mediterranean Coast of Israel

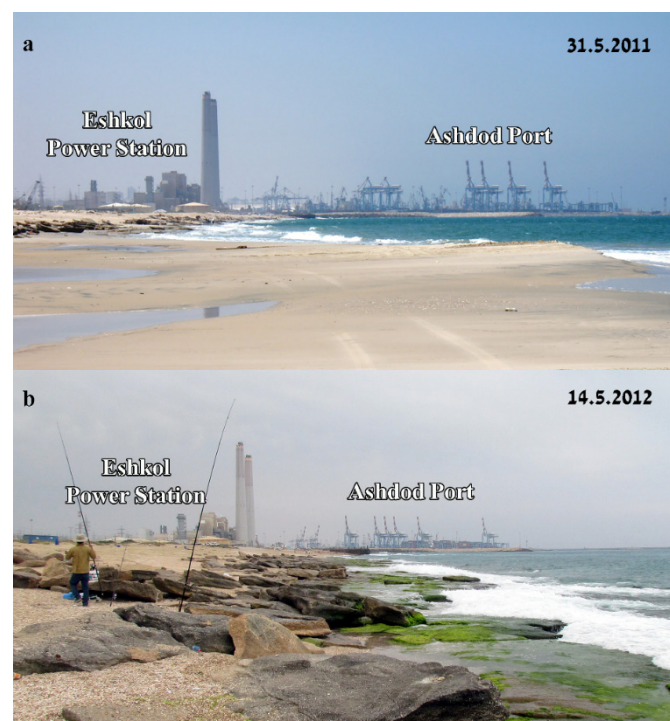
Figure 3. The rocky (beachrock) coast north of Ashdod Port: (a) during the nourishment operation (May–August 2011); (b) about a year later (May 2012).

In spring 2012, a few months after the nourishment was completed, a site visit found no evidence of the massive sand nourishment, while the beach had reverted to its previous rocky state (Figure 3b).

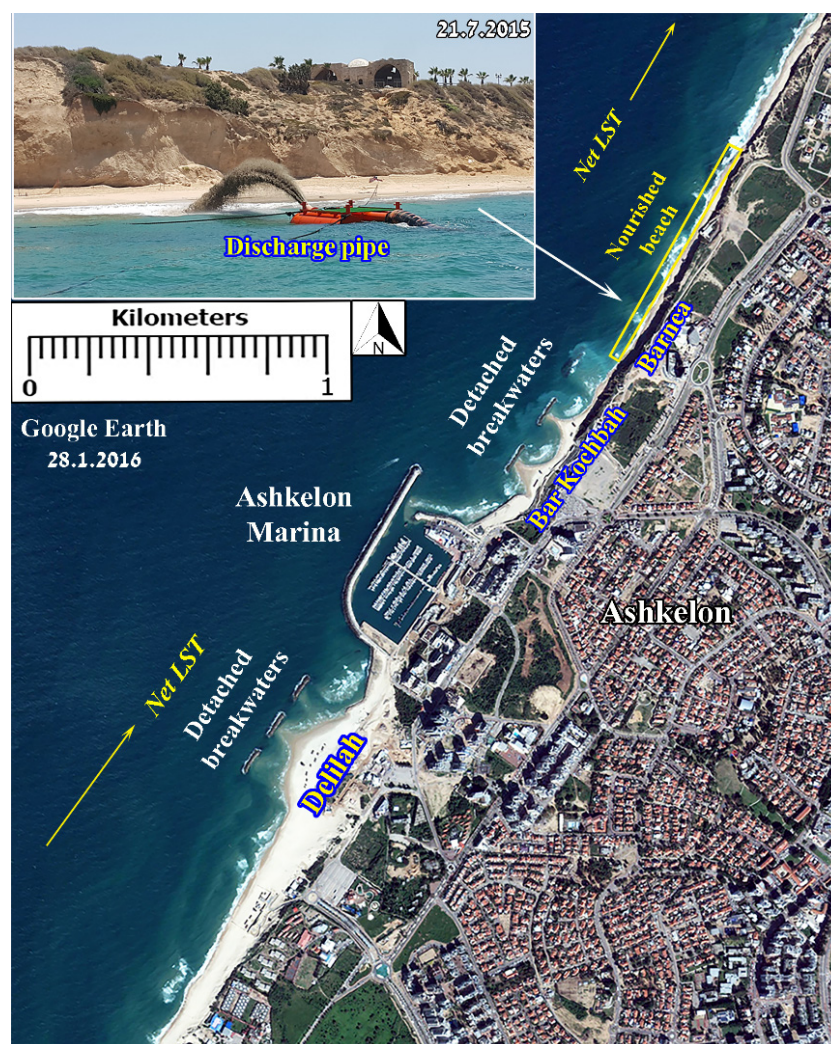
Figure 4. North Ashkelon sand beach nourishment project (July–October 2015). Nourishment rainbowing operation via discharge pipe (top inset). Background: Google Earth image, 28 January 2016.

Ashkelon is the southernmost city on the Mediterranean coast of Israel. The city has a 12 km stretch of beautiful sandy beaches which attract tourists from Israel and abroad. Ashkelon Marina is situated on the central coast of Ashkelon (Figure 4), about 50 km south of Tel Aviv, and about 11 km north of the border of the Gaza Strip (Figure 1). The Marina was built between 1992 and 1994 on a straight sandy beach backed by an 18 m-high kurkar cliff, and about 200 m north of the central bathing beach of Ashkelon (Delilah Beach). This beach was significantly widened after the construction of three detached breakwaters in 1984. The length of the Marina's main breakwater is 720 m, and that of the lee breakwater is 285 m. The head of the main breakwater is located at a water depth of about 6 m, and projects about 350 m into the sea (Figure 4).

northward to Barnea Beach and further north (Figure 4). A comparative analysis of aerial photographs shows that the shoreline up to 1 km north of the detached breakwaters had retreated by 32–56 m between 1986 and 2014 [45]. This resulted in the collapse of the unstable coastal cliff, which retreated about 30 m mainly after the marine construction, leaving the front of the Harlington Hotel (former Holiday Inn Hotel) about 30 m from the cliff edge [41].

The sand was deposited between the shoreline and water depth of 2 m by the method used in Ashdod in 2011, and was bulldozed ashore (Figures 4 and 5).

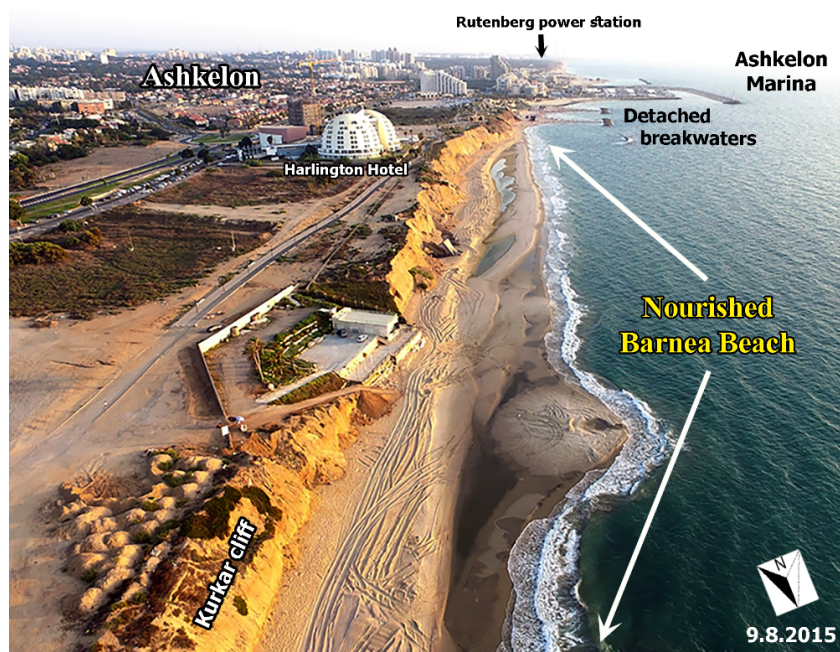
Figure 5. Aerial photograph of the coast north of Marina Ashkelon at the completion of sand nourishment (9 August 2015).

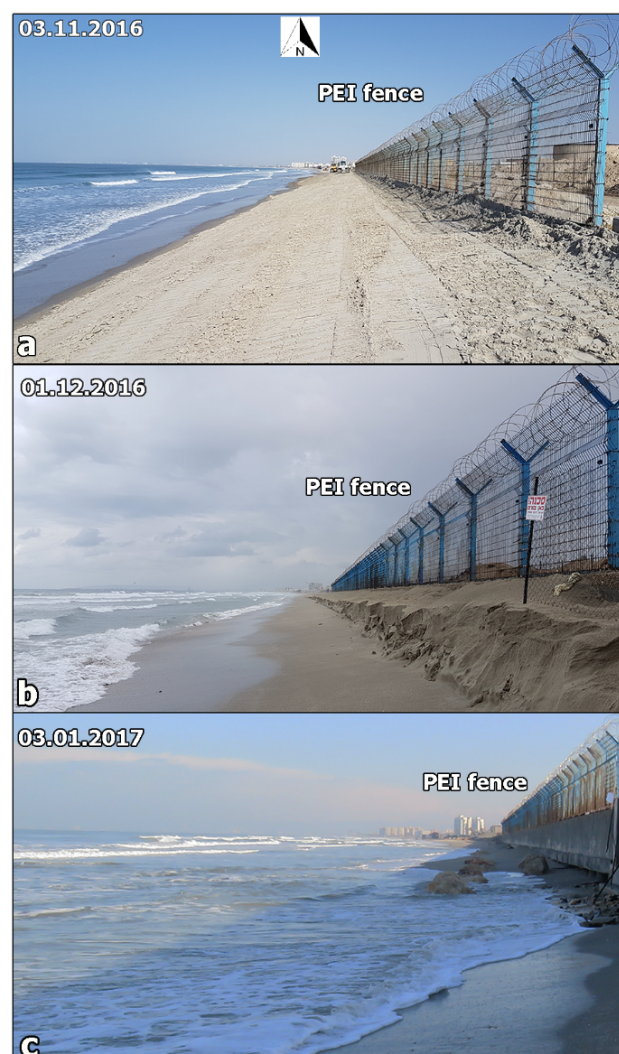
Figure 7. The sandy beach along the southern part of PEI fence: (a) after nourishment; (b) one month later; (c) two months after nourishment.

The second nourishment was carried out in October 2016, when a sand volume of 100,000 m³ was dredged north of the main breakwater of the new naval harbor (Figure 6: Imported Site 2), and nourished a coastal section of 500 m along the southern and central parts of the PEI fence. The nourished sand was bulldozed to decrease sand porosity. A pre-nourishment grain size analysis of six samples in the imported site showed that the mean grain size was in the range of 140–170 µm, which was compatible with the sand in the nourished coast. When the nourishment ended the 3 m high PEI fence was protected by a triangular sandbar that widened the beach by more than 20 m (Figure 7a). However, a few days after the nourishment, the sandbar began to erode due to a typical seasonal storm, and in less than three weeks most of the sandbar had almost disappeared (Figure 7b). At the beginning of December 2016 an extreme storm with a significant wave height (H_s) of 5.2 m and a maximum wave height (H_{max}) of 10 m destroyed all evidence of the nourishment (Figure 7c).

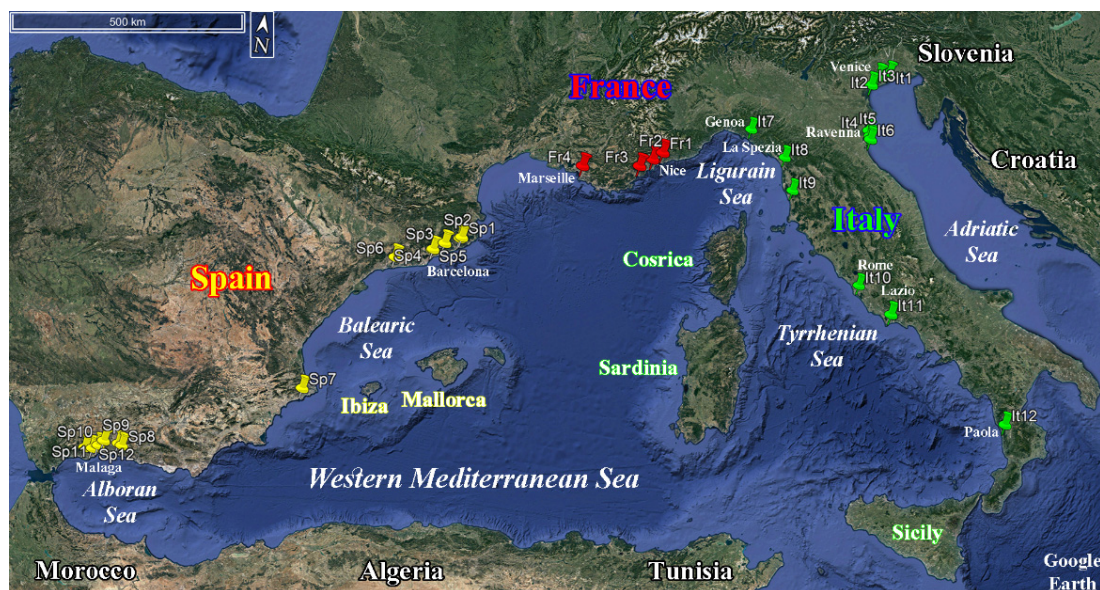
Figure 8. Selected beach nourishment sites along the Mediterranean coast of Spain (Sp1–Sp12), Italy (It1–It12) and France (Fr1–Fr4) (see Appendix A: Table A1).
