# Recording the SS *Thistlegorm*: Rapid Multi-Image Underwater Photogrammetric Survey of a Large Second World War Wreck

**Abstract:** This paper describes the workflow followed to survey and monitor the interior and exterior of a large and complex metal wreck, the SS *Thistlegorm* in the Red Sea, using digital photogrammetry. Utilizing a simple single-camera rig and off-the-shelf software, this study presents a cost-effective and easily replicable method for monitoring change in metal wrecks that meets professional standards and can involve non-specialists in data collection. This paper details the background of the SS *Thistlegorm*, the equipment used, and the photogrammetric surveys conducted in 2017 and 2022. It outlines the importance of having a clearly thought-out data-management system when working on a large target recorded over a limited series of dives. In particular, this paper considers testing the accuracy of the data obtained and describes the post-processing workflow in detail. The conclusion underscores the feasibility of achieving an accurate geo-referenced baseline 3D survey with readily available equipment and how these data can contribute to historical research

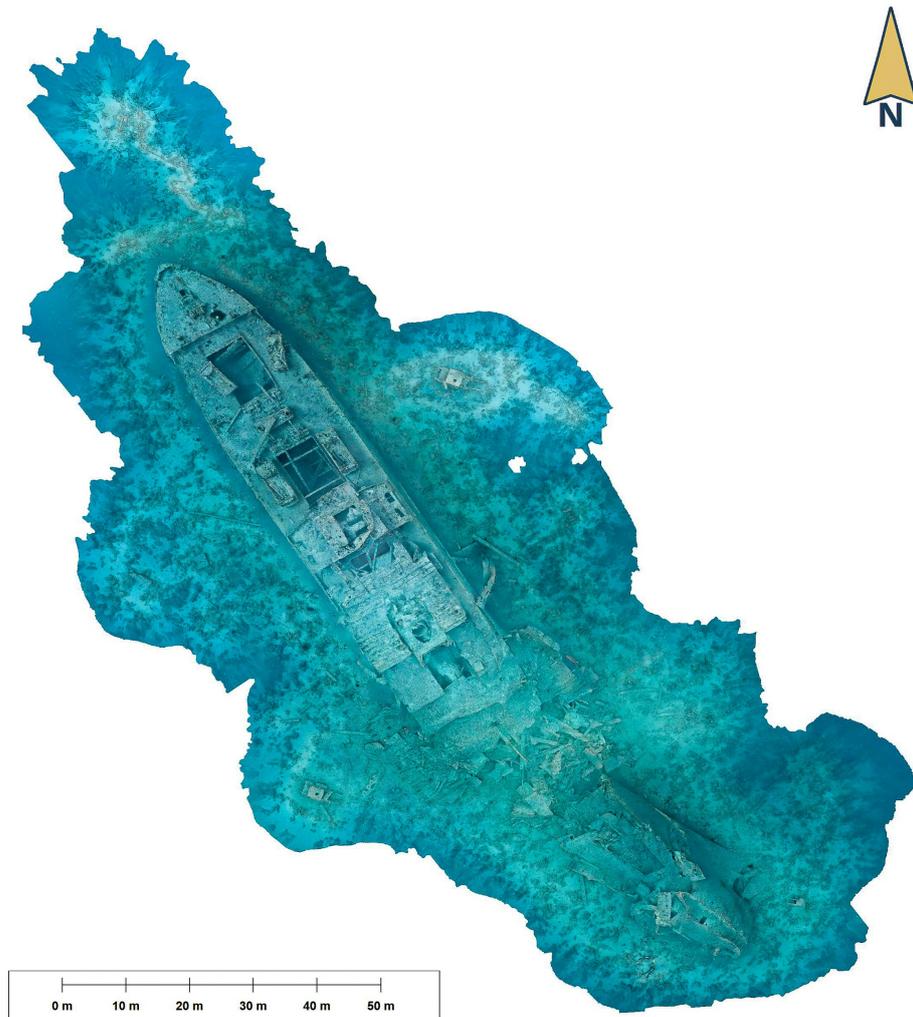
**Figure 2.** Orthophoto derived from the 3D model of the SS *Thistlegorm*. Here, the wreck and surrounding seabed are viewed from the surface. The main deck from bow to just aft of the engine room have been well preserved. The explosion centered at Hold No. 4 has completely destroyed the ship in this section. The stern, now lying on its port side, remains preserved.

At the time of construction, the *Thistlegorm* was recorded as being 131 m long with a gross tonnage of 4898.13 grt and a total cargo space of 7782 cubic meters. The wreck now rests on a seabed featuring low-lying rocky outcrops interspersed with patches of fine sand at a depth of 32 msw. Physically large, the wreck of the SS *Thistlegorm* is subject to strong currents and variable underwater visibility ranging from 10–15 m to 25–30 m. The bow and midship sections of the wreck remain upright and largely intact, while the stern section has collapsed to the port side. Between both sections lie the shattered remains of Holds No. 4 and 5, where a spread-out and structurally complex debris field testifies to the massive explosion that took the vessel to the bottom (Figures 2 and 3).

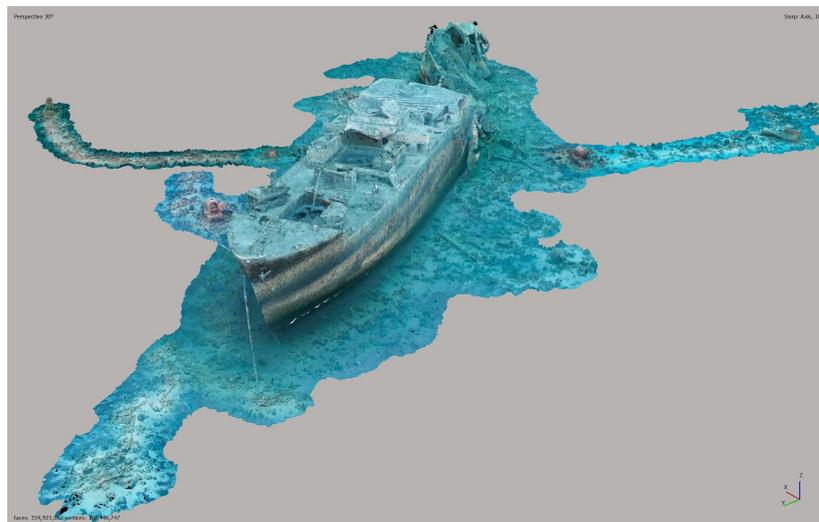
**Figure 3.** Viewed from the port side, the 2017 survey covered the main wreck site. The port and starboard locomotive boilers were located and added during the 2022 fieldwork.

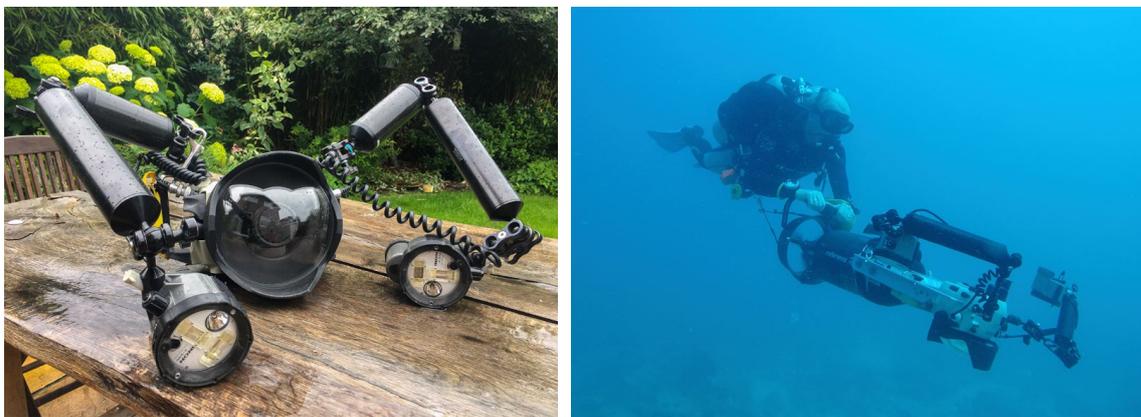
**Figure 4.** Left: Nikon D700 DSLR camera with 16 mm fisheye lens in a Subal housing. Artificial lighting is supplied by two Inon Z240 strobes. Close-range handheld photogrammetry techniques were used extensively during the fieldwork. Right: the large exterior sections of the wreck were surveyed by mounting the camera on a dive scooter.

All of the images in 2017 and the majority in 2022 were captured using a Nikon D700 SLR body (Nikon Corp., Tokyo, Japan) with a Nikon 16 mm fisheye lens encased in a Subal underwater camera housing (Subal GmbH, Vienna, Austria). All shots were illuminated with artificial light using—in this case, two Inon z240 strobes (Inon Inc. Tokyo, Japan) (Figure 4).

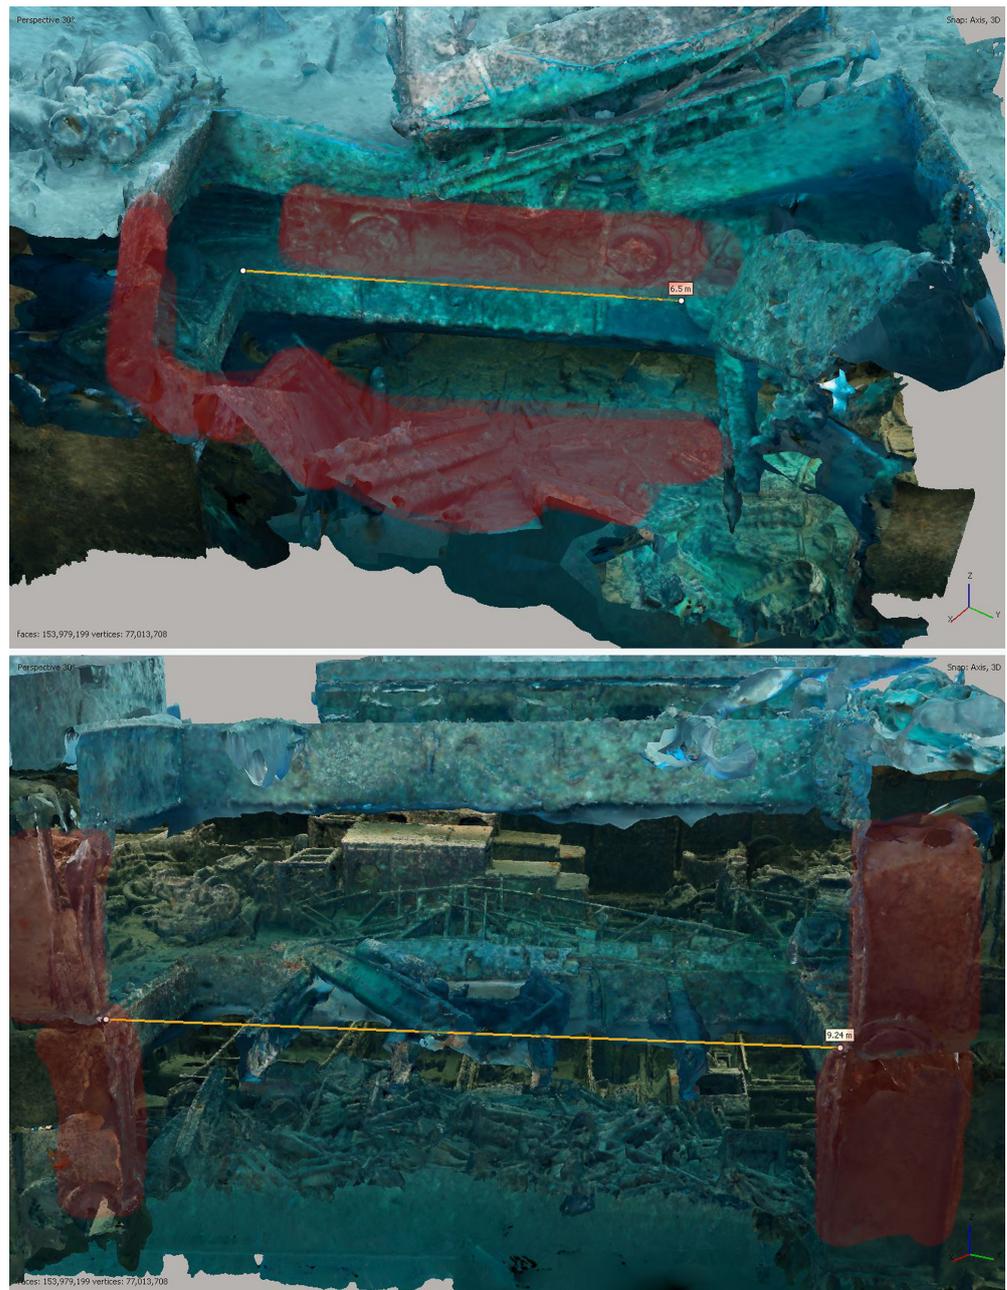
**Figure 5.** (Top): Section through Hold No. 1 viewed from starboard side with red highlight showing areas requiring care to ensure overlap between the main, upper, and lower cargo decks. The partial collapse of the main deck on the port side has provided plenty of material. (Bottom): Section through Hold No. 2 viewed from the starboard side. The red areas highlight vertical supports between decks.

With the outside covered and a draft model built, surveying the holds and their cargo commenced. Particular attention was paid to the joining points between the decks to ensure the separate scans would align later. As a complex 3D structure, the original ship's structure of vertical supports between decks and the now-collapsed hold covers of Hold No. 1 were used to tie the main, upper, and lower decks into a single set of aligning images (Figure 5).

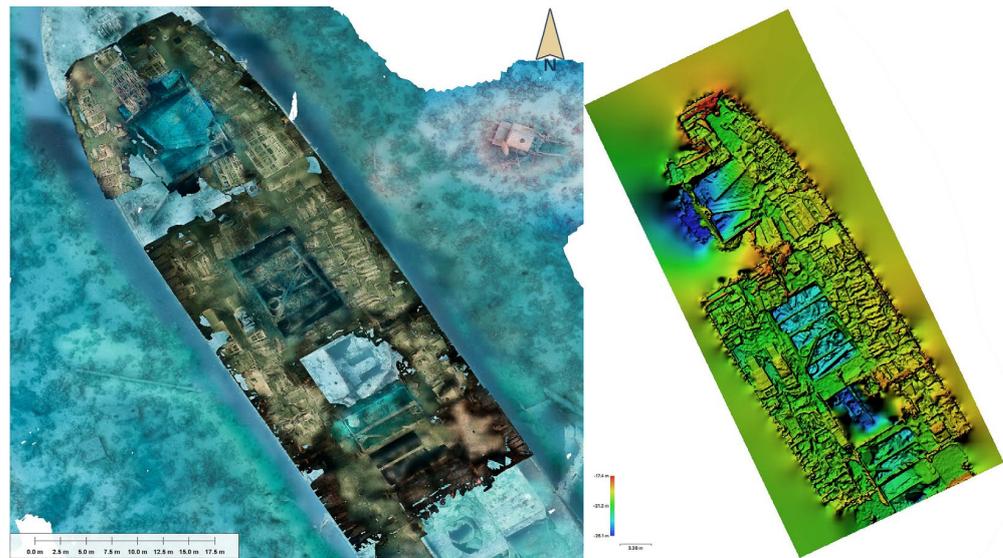
**Figure 6.** On the **left**: Orthomosaic of the upper cargo deck as surveyed in 2017, shown as a layer in Global Mapper and in context of the main wreck site orthomosaic. The forward area port side was surveyed in 2022 and is included as a separate layer. On the **right**: 2017 Digital Elevation Model of upper cargo deck showing relative depth of the seabed.

The remains of the lorries, motorbikes, and aircraft parts, all packed into the cramped space of the holds, presented their own unique set of issues, especially in keeping the camera aligned parallel with the surface being captured in tight spaces. A frequent problem was other divers and their bubbles appearing in the images—the wreck is very popular—and having moving objects in the images can cause alignment issues. Scanning the cargo hold decks took a total of 5 dives to complete (Figures 6 and 7).

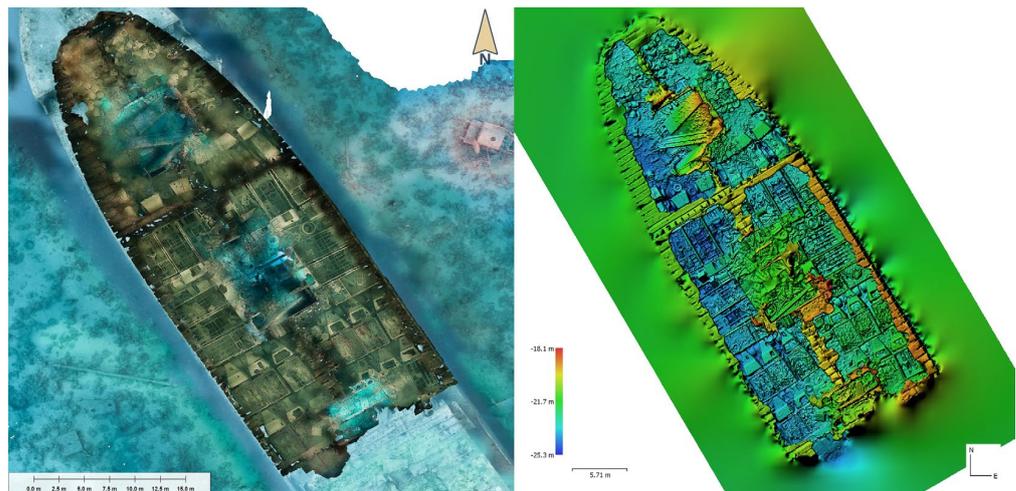
**Figure 7.** On the **left**: Orthomosaic of the lower cargo deck as surveyed in 2017, shown as a layer in Global Mapper and in context of the main wreck site orthomosaic. Reprocessed in 2022. On the **right**: Digital Elevation Model of lower cargo deck.

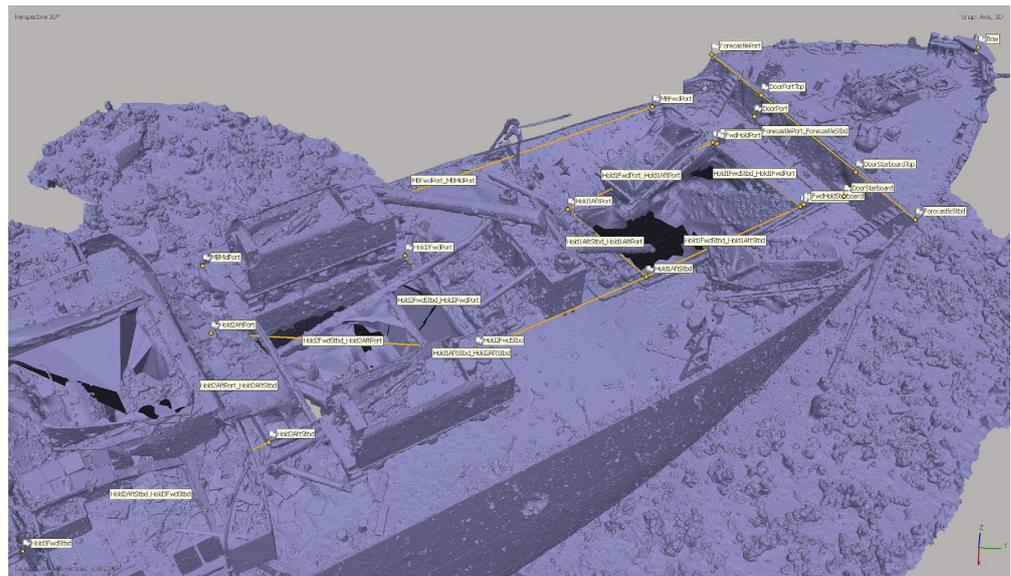
**Figure 8.** A 3D rendering of the bow area showing control points and scale bars applied. Constraints were taken from direct measurement in the field and from the original builder’s plans.

Subsequent to the 2017 fieldwork, the *Thistlegorm* builder's plans were located in the Tyne and Wear Archives. Physical measurements taken from the as-constructed plans were used to validate field measurements and were later used to add additional constraints to the 3D model reprocessed in 2022 (Figures 8 and 9).

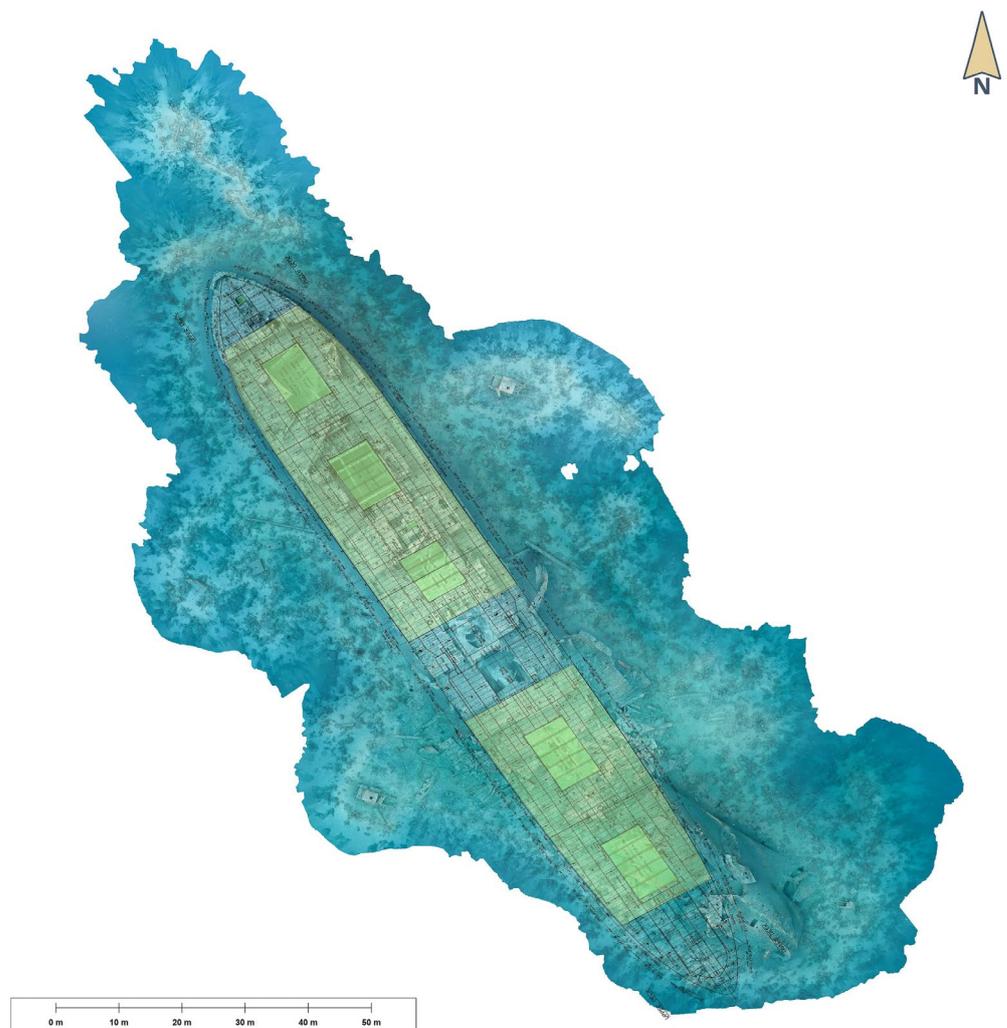
**Figure 9.** Main site orthomosaic overlaid in Global Mapper with manually rectified contemporary builders plans. Vector area data have been added to highlight location of the holds (yellow) and hold entrances (green). Source: Tyne & Wear Museum DS.JLT.4.PL.599.9.2.

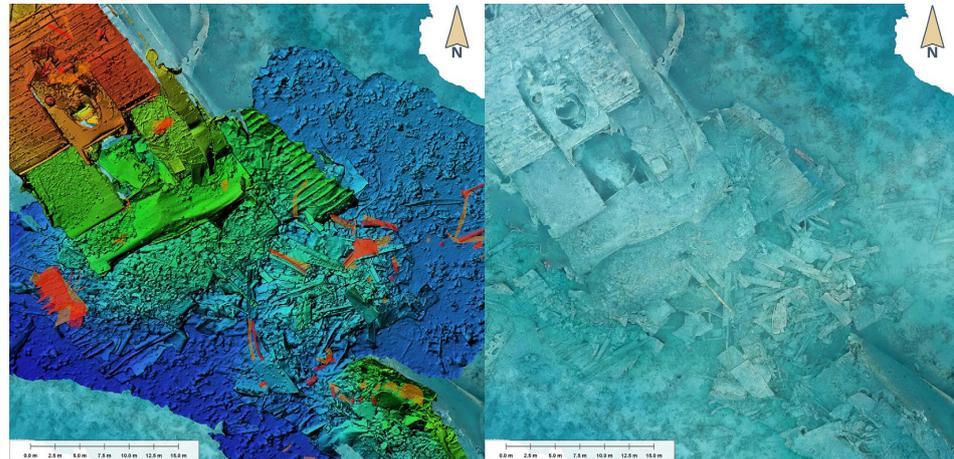
**Figure 10.** On the left: Composite view of 2017 orthomosaic with 2022 survey area Digital Elevation Model (DEM) as a separate layer in Global Mapper. Objects identified, along with changes and differences between 2017 and 2022, have been highlighted. On the right: 2017 orthomosaic of the same area. It is worth noting several air-dropped depth charges, containing approx. 340kgs of explosives, have been moved between surveys.

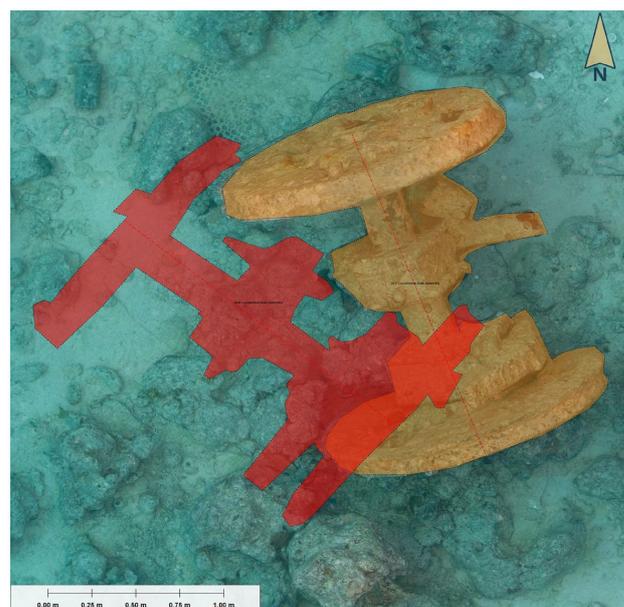
**Figure 11.** Orthomosaic view of the locomotive wheel assembly showing its original location in 2017 (in orange) and its new position in 2022 (outlined in red).

One issue arose during post-processing when using a substantial and believed-to-be static object. In order to align it with the main wreck, we selected a locomotive wheel assembly with an estimated mass of 2 tons, which was present in the 2017 survey. Given the minimal expected movement of the object between the surveys, it was considered a low-risk choice. However, during the post-processing alignment of the starboard boiler model, it became evident that the wheel assembly had rotated by 30 degrees at some point between the 2017 and 2022 surveys (Figure 11). The reasons for this movement are unknown, but it was most likely caused by a vessel mooring line. This unexpected movement of the wheel assembly resulted in excessive error when attempting to align the features of the assembly. Five alternative and common points from less-obvious features were chosen for alignment to correct the issue.

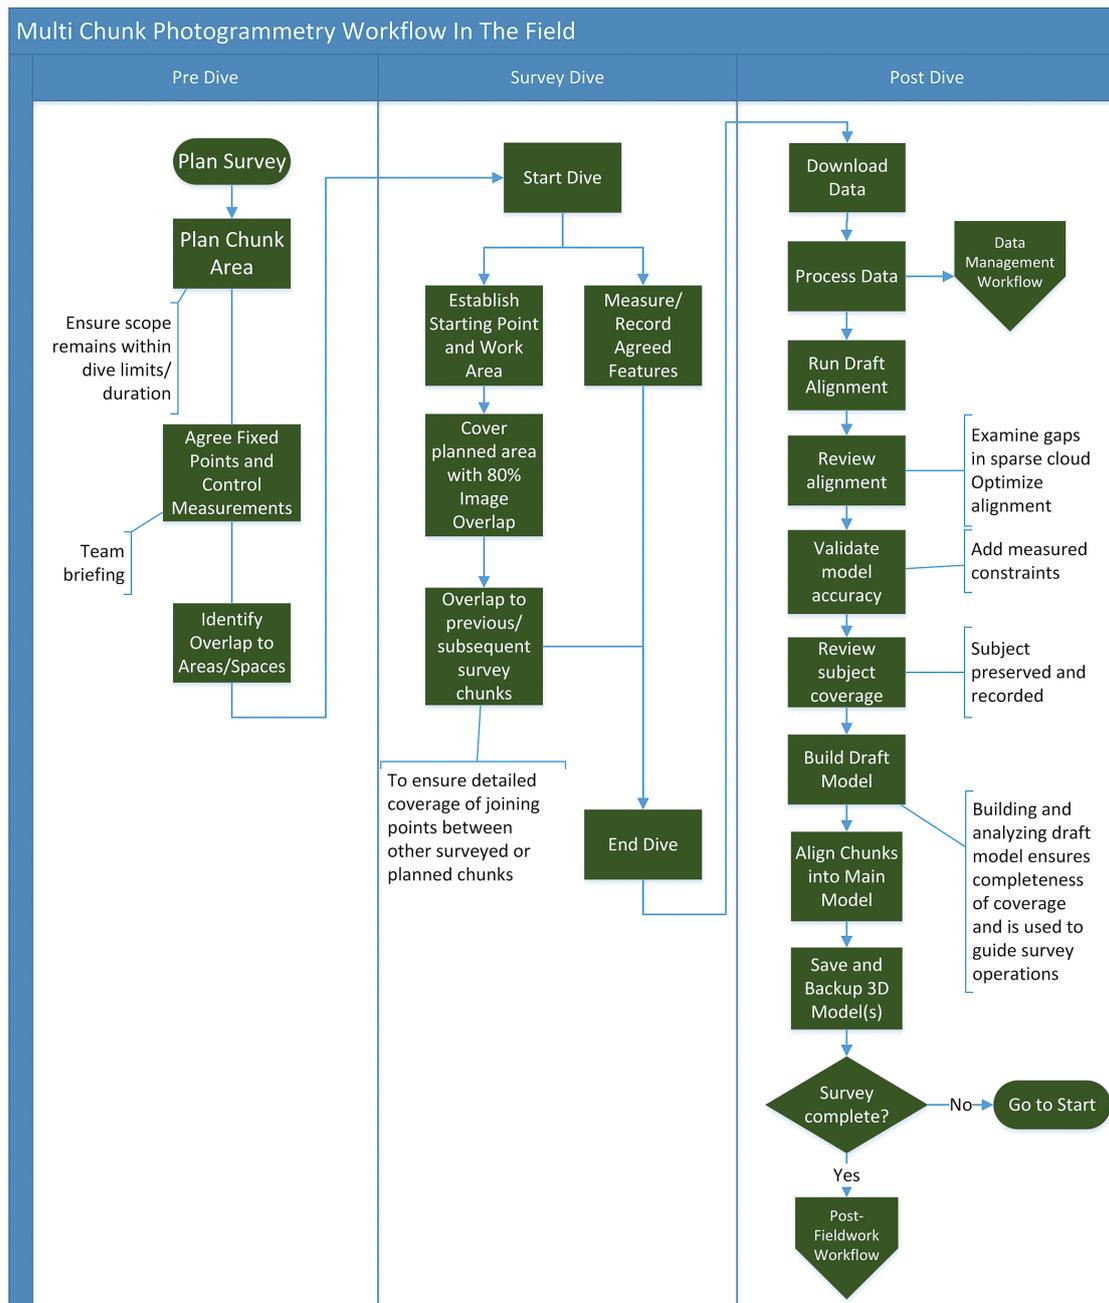
Figure 12. Workflow applied during fieldwork, including in-field processing and model building.

Setting a clear data-management strategy in the field is one of the most important and often overlooked factors in executing an underwater photogrammetry project, especially when dealing with a large subject captured over multiple dives. Photogrammetry can quickly generate masses of unstructured, unordered data. Issues of image traceability and retrieval are compounded when more than one photographer is contributing to a project. As a result, a method for managing images is critical (Figure 12).

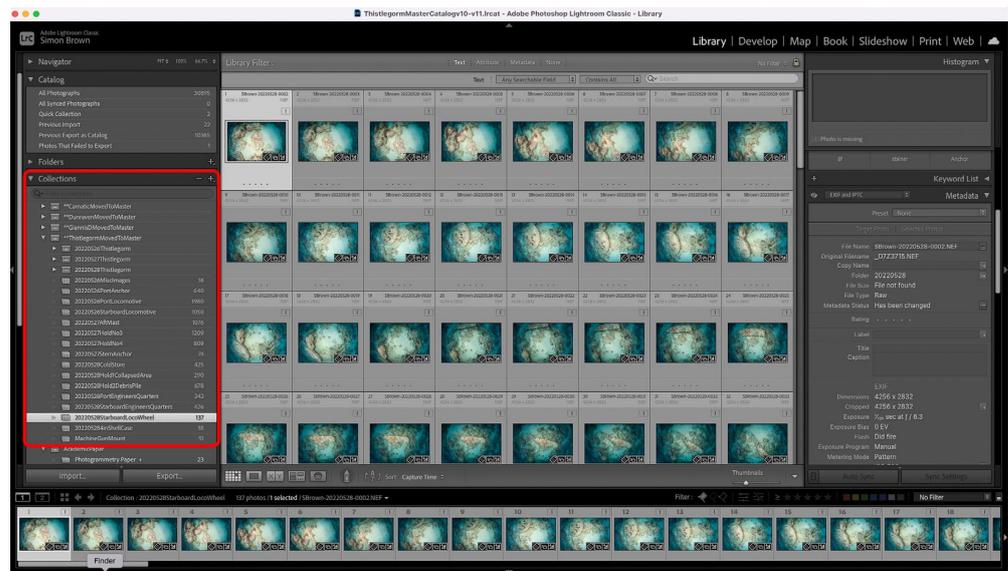
**Figure 13.** View of Adobe Lightroom and SS *Thistlegorm* catalog managing 30,000 images. A subset of 137 images detailing a railway locomotive wheel has been selected using a Collection to hold relevant images for quick access.

For ease of use and quick access, relevant images are grouped into Lightroom Collections, enabling very fast retrieval of sets of relevant images (Figure 13). Adobe Lightroom Collections are generally not machine-readable, not transportable, and not inherently embedded in the image file. For these reasons, they are not considered a primary source of project data and value. That said, they are very convenient when working in Lightroom, and every subject covered on the various projects was afforded at least one Collection describing the group of related images.

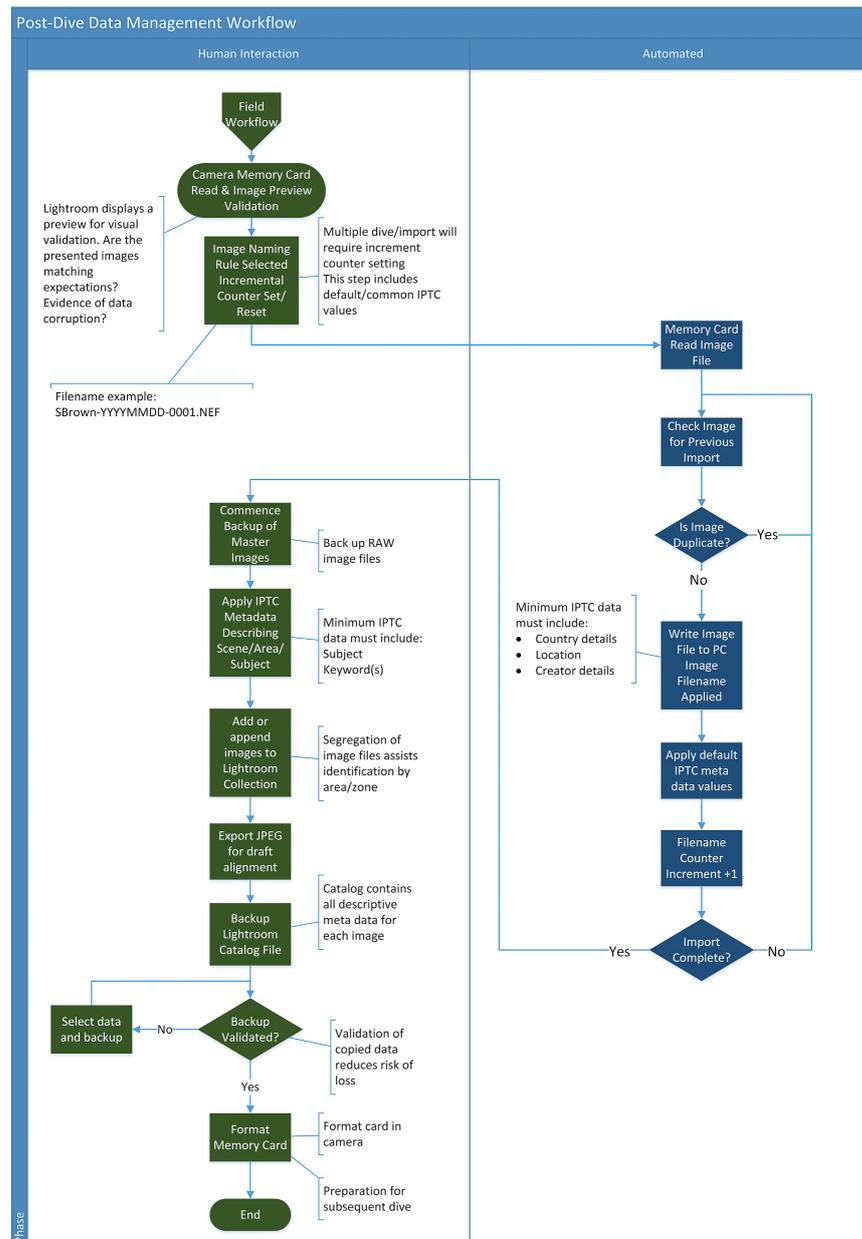
**Figure 14.** Workflow describing the process and method applied to manage each image that will be contributing to the photogrammetric 3D reconstruction.

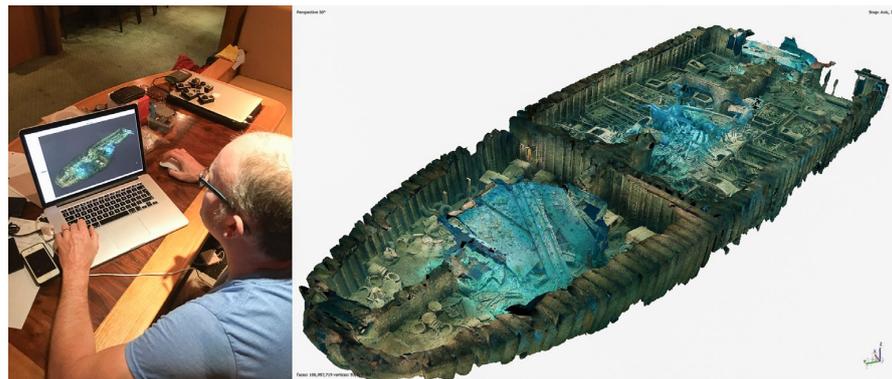
**Figure 15.** Whilst on site, processing began to verify the quality of overlap. In this instance, the lower cargo deck sparse cloud is being reviewed for consistency and coverage (**left**). The final model is shown on the (**right**).

Processing the model began on-site using an Apple Mac Book Pro laptop running Agisoft Photoscan Pro V1.3. A draft model was assembled after each dive was completed (Figure 15). The draft model produced from downsampling from full resolution proved the images were aligning well and allowed direct recording of survey measurements. The draft model provided an invaluable reference for when the final model processing commenced.

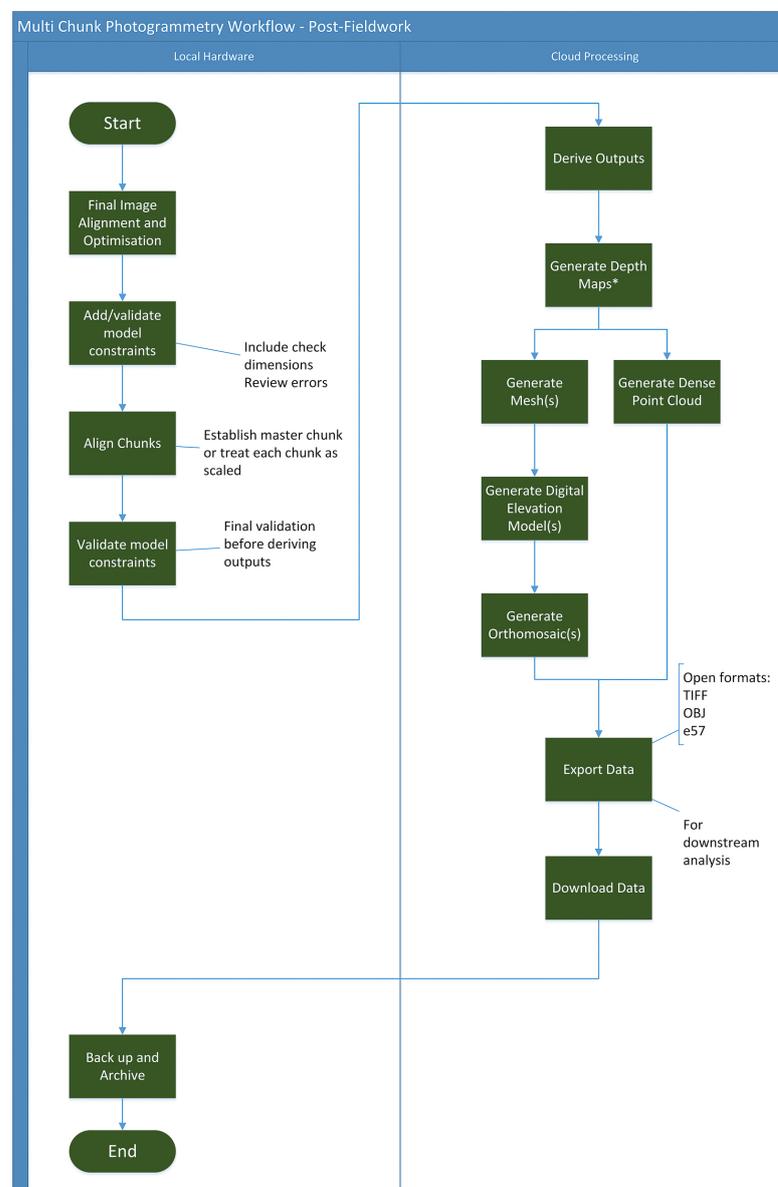
**Figure 16.** Workflow describing the post-fieldwork process applied to the photogrammetry models. Note the use of cloud computing to access additional hardware resources for final output generation. \* Depth Maps not available in 2017 but were used for 2022 processing.

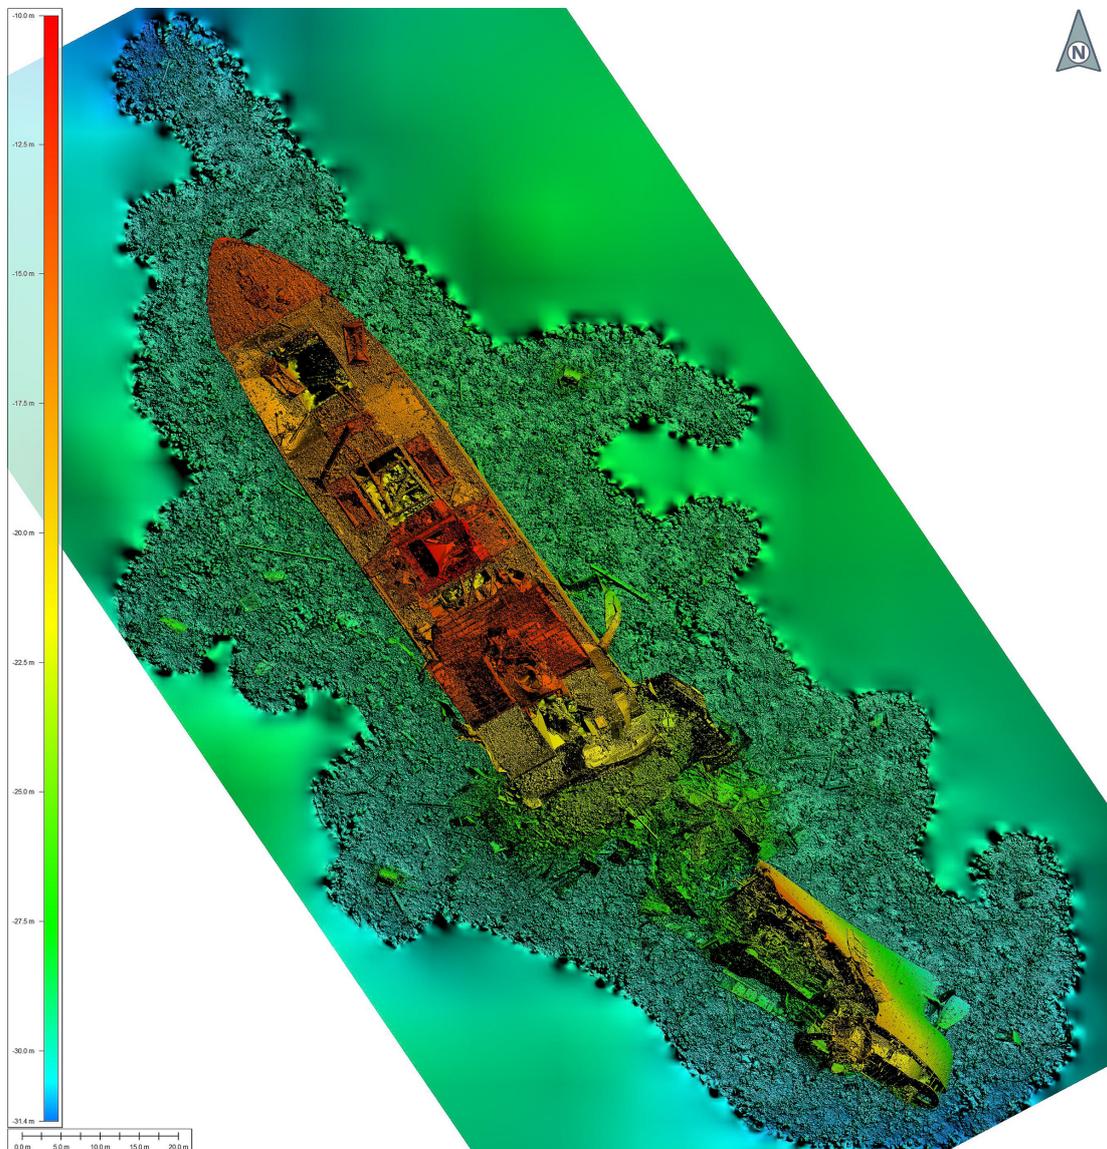
**Figure 17.** Digital Elevation Model (DEM) of the SS *Thistlegorm*, as recorded in 2017 with color shader applied in Global Mapper to highlight depth of seabed.

Two-dimensional orthophotos and digital elevation models (DEMs) can be extracted from the model to create geometrically accurate plan views (Figure 17). As measured points and GPS data were used during the build, the resulting image can be scaled and measured. With 14,000 high-resolution images, the main site orthophoto was generated at an accuracy of 10 mm per pixel (attempts to obtain higher resolution caused out-of-memory errors and crashed the hardware). With around 5000 or so images, the hold orthophotos were generated to an accuracy of 1 mm per pixel.

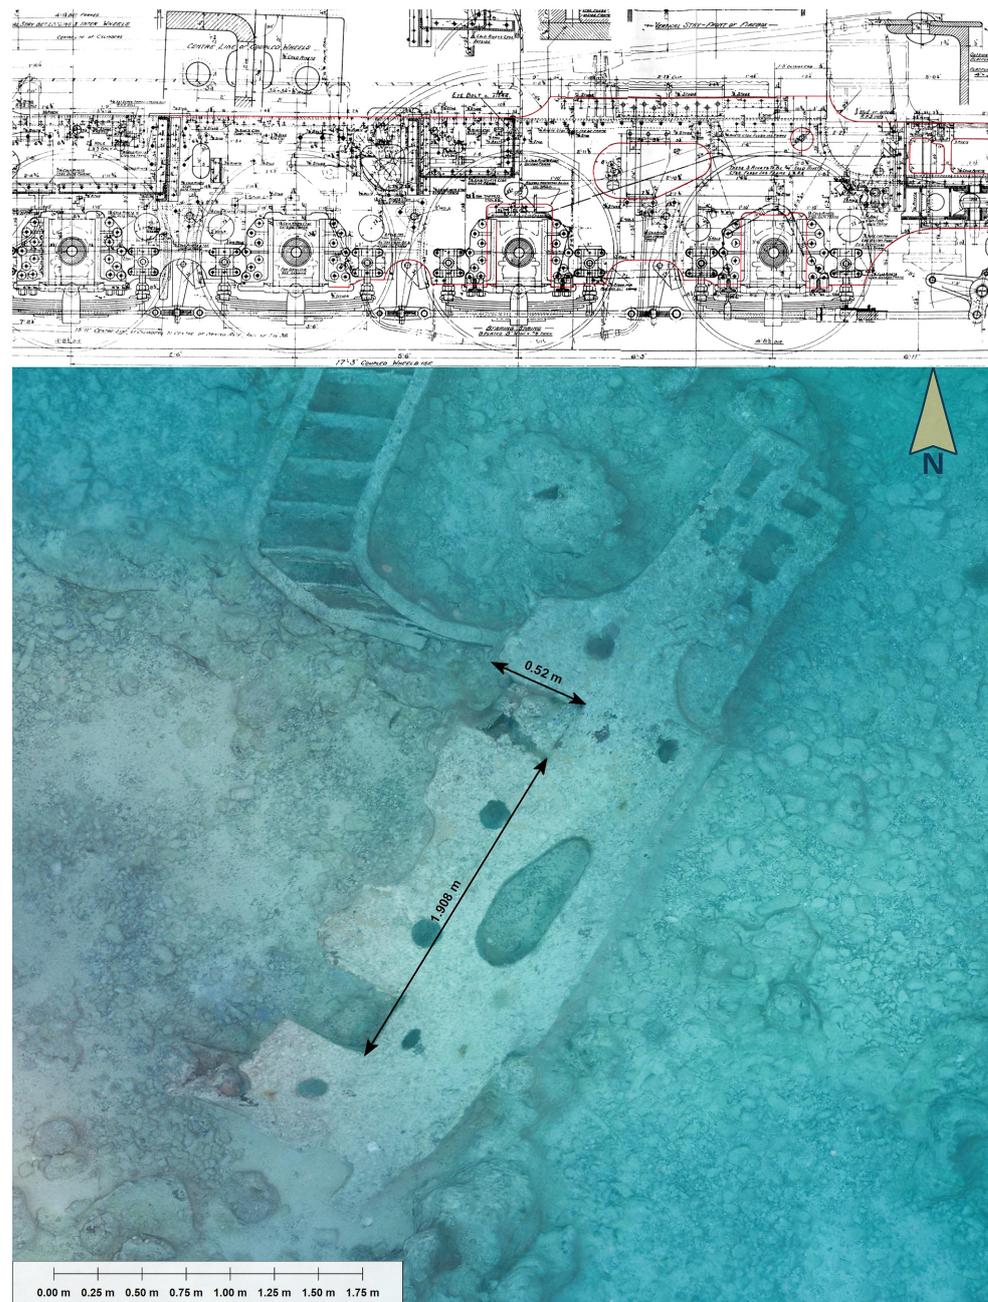
**Figure 18.** Contemporary engineering drawing of locomotive main frame highlighted in red outline (top) with as-designed dimensions compared to the corresponding artifact on the seabed (bottom). Dimensions taken directly from the orthomosaic, derived from the scaled 3D model, are comparable to the “as designed” plans.

**Table 3.** Measurement comparisons from the Stainer 8F steel plate, components, and fuel tenders.

Dimension	Engineering Drawing Value	Model Value	Variance
Stainer F steel plate—distance between axles	6’ 3” (1.9558 m)	1.908 m	0.0478 m
Stainer F steel plate—pitch between cut holes	46” (1.1684 m)	1.14 m	0.028 m
Strainer F plate—height of bearing block recess	20.5” (0.5207 m)	0.52 m	0.0007 m
Distance between buffers of the starboard smoke box section of the Stanier 8F	5’ 8” (1.7272 m)	1.73 m	−0.0028 m
The overall distance between outer frames of the starboard smoke box section of the Stanier 8F	7’ 8” (2.322 m)	2.37 m	−0.048 m
The overall distance between main frames of the port smoke box section of the Stanier 8F	4’ 1.5” (1.2573 m)	1.25 m	0.0073
The distance between buffers of the port smoke box section of the Stanier 8F	5’ 8” (1.7272 m)	1.72 m	0.0072 m
The overall distance between outer frames of the port smoke box section of the Stanier 8F	7’ 8” (2.322 m)	2.35 m	−0.028
The overall distance between leading and first driven wheel of the port smoke box section of the Stanier 8F	8’ 9” (2.667 m)	2.67 m	−0.003

Measurement between rear and center axle centers of the fuel tender	7’ 6” (2.286 m)	2.32 m	−0.034 m
Distance between buffer centers of the fuel tender	5’ 8” (1.727 m)	1.74 m	−0.013 m
Distance between axle centers of the fuel tender	15’ (4.572 m)	4.64 m	−0.068 m

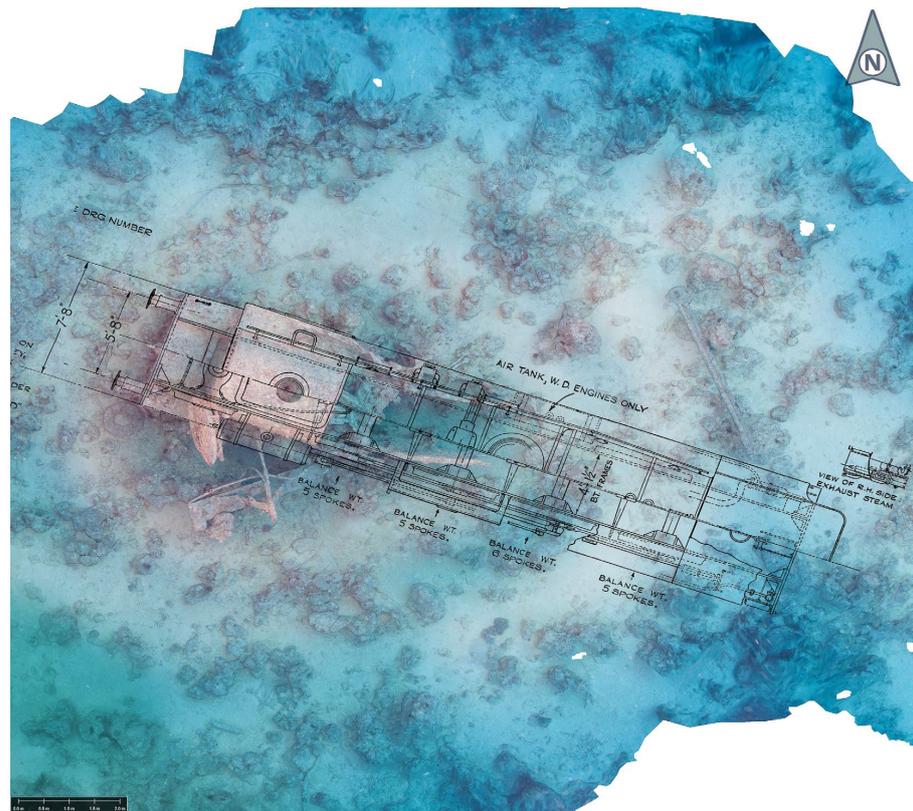
**Figure 21.** Orthomosaic view of the starboard Stanier 8F locomotive overlaid in Global Mapper with contemporary engineering drawing layer of the as-designed locomotive. Such drawings provided a wealth of evidence to support confirmation of model scaling and accuracy.

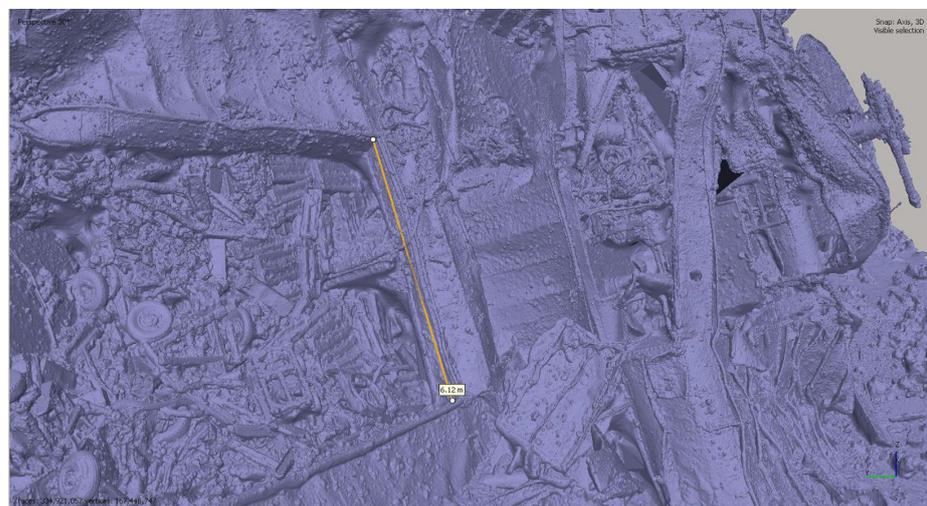
**Figure 22.** Measurement across the lower deck of Hold No. 5 entrance used to confirm model accuracy.

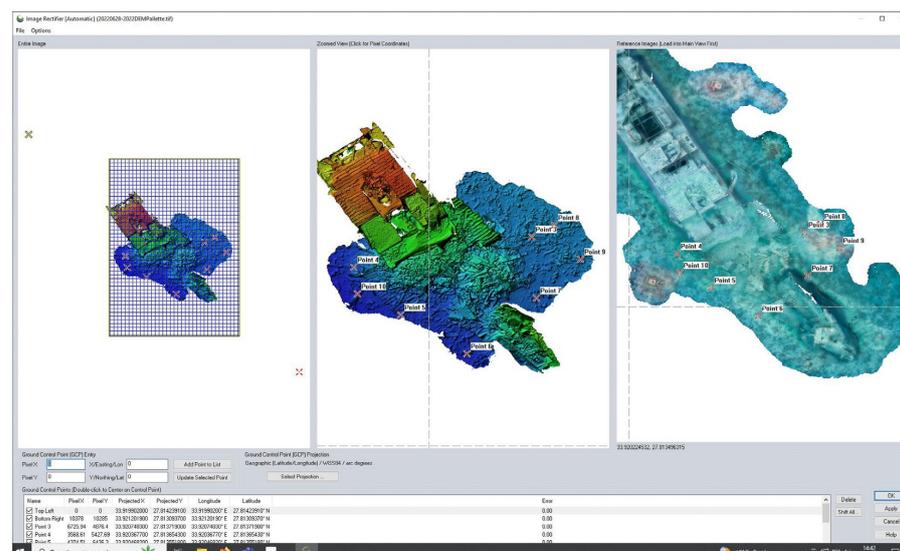
Figure 23. Manual rectification performed in Global Mapper via inputting common feature points to align datasets lacking geo-reference data. Manual rectification adds value to otherwise unreferenced or scaled datasets.

Datasets processed and lacking scale or geo-reference location data can be used for comparative analysis and identification of change. Using the GIS software application Global Mapper Pro v24.1.0 (Blue Marble Geographics, Hallowell, Maine, USA), successive layers of 2022 data were added and manually rectified to align with the 2017 baseline orthomosaics (Figure 23). Care must be taken during manual rectification and requires an absolute minimum of 3 points to achieve a rudimentary orientated alignment. A greater number of points is advised, with 5 being the recommended minimum. Points should be evenly distributed and avoid referencing any feature at risk of movement. This approach has permitted the use of data that may otherwise have to have been set aside. Having a baseline orthomosaic survey also allows the use of photographic images and data taken by recreational divers with differing levels of skill to record changes to the wreck over time.

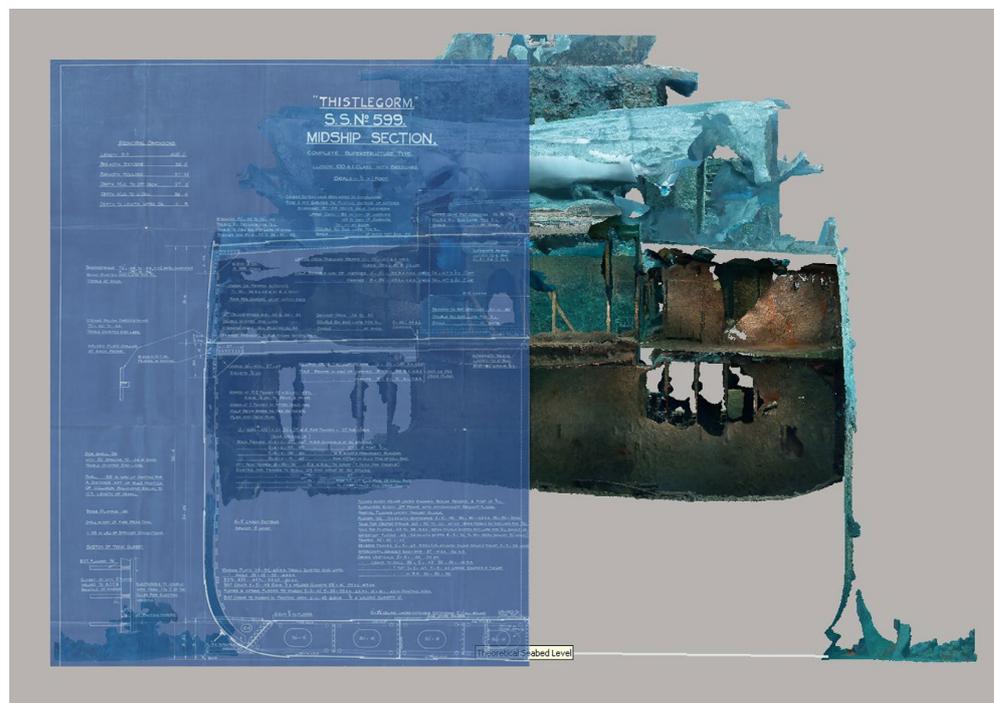
**Figure 24.** Section of the wreck, taken at frame 94 looking forward, compared to contemporary builders' plan section taken midships. Historical information and documentary evidence have provided key evidence and fresh insights into the vessel and its history. Blueprint © Lloyd's Register Foundation.
