# Research on the Mechanical Mechanism and Detection Technology of Abnormal Wear and Contact Wire Disengagement in Rigid Overhead Contact Systems

**Keywords:** rigid overhead contact system; pantograph–catenary dynamic interaction; abnormal wear; contact wire disengagement; engineering inspection

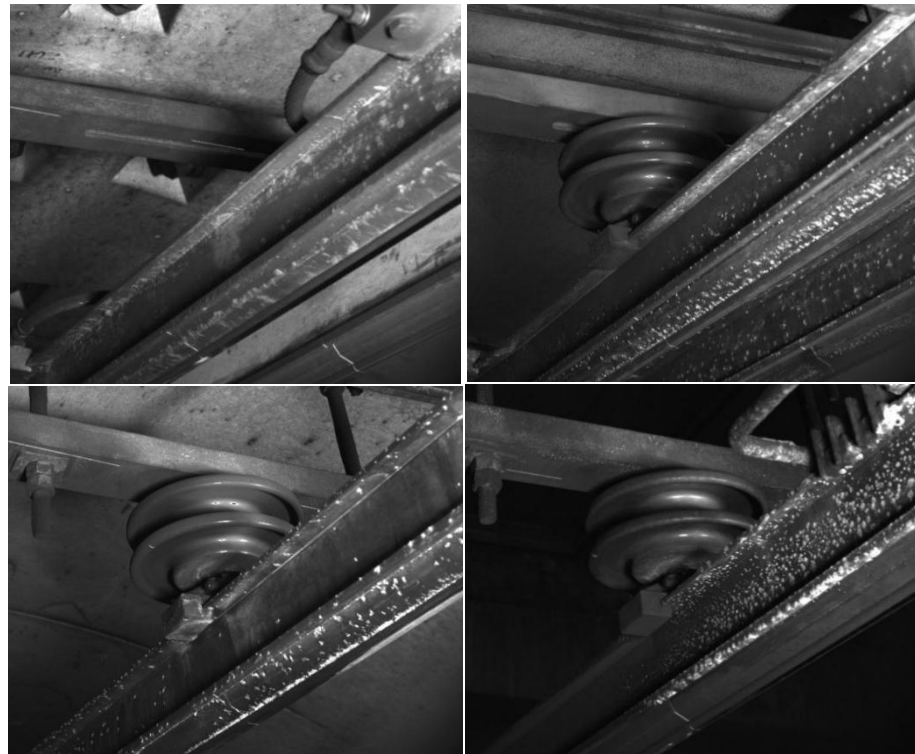
**Figure 7.** Chemical Corrosion of the Conductor Rail.

The tunnel leakage water contains corrosive substances from the geological strata, directly inflicting corrosion damage on the structural components of the overhead contact

system. The typical corrosion of the conductor rail in the Beijing subway network is illustrated in Figure 7.

**Media intrusion and interface degradation:** The high humidity of the tunnel environment acts as an inducer of electrochemical reactions and a catalyst for the degradation of mechanical properties. Humid air within the tunnel or water seepage from the ceiling easily accumulates at the conductor rail slot, forming a thin electrolytic water film. Furthermore, the interior of the conductor rail is typically coated with conductive or anti-corrosion grease; continuous high humidity or water vapor flushing can lead to the emulsification and loss of these grease components, directly exposing the metal interface and causing abnormal variations in the friction coefficient. The combined effect of humidity and the clamping stress of the conductor rail itself accelerates the microcrack propagation in the metallic material, making the conductor rail more susceptible to plastic deformation when subjected to pantograph impacts.

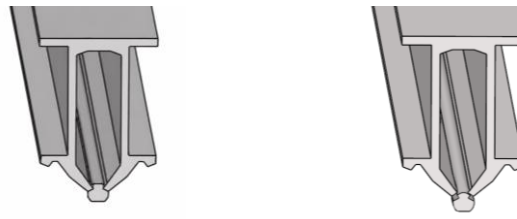
**Figure 9.** Comparison before and after disengagement.

The disengagement scenario was simulated at the overlapping span, and the specific model comparison is illustrated in Figure 9.

In the simulation, the contact wire was divided into two segments: the first anchor section preceding the disengagement location, and the second anchor section originating from the disengagement point. Because no disengagement occurred in the first anchor section, the experimental groups yielded identical pantograph–catenary contact force results to the control group. Conversely, disengagement was initiated at the beginning of the second anchor section, causing the simulation results of the experimental groups to exhibit significant discrepancies depending on the disengagement severity. Figure 10 and Table 7 illustrates the comparative simulation results of the pantograph–catenary contact force when the train passes through the overlapping span under five disengagement conditions: 0, 0.6, 0.8, and 1 cm. At the overlap span, as the contact wire disengagement amplitude gradually increases, the contact loss rate at the disengagement position increases from 0% at 0 mm to 36.03% at 10 mm. When the disengagement amplitude reaches 6 mm, both the maximum contact force and the standard deviation show relatively large values. Overall, the standard deviation of the contact force and the contact loss rate generally increase with the aggravation of contact wire disengagement.

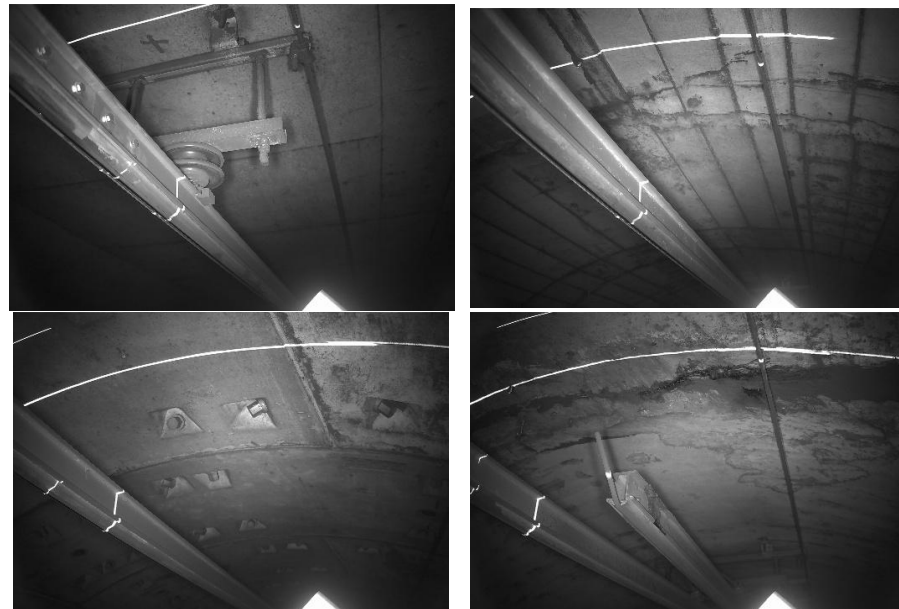
**Figure 15.** Image Captured by the Area-Scan Camera.

The image captured by the area-scan camera is shown in Figure 15. Due to the single-camera configuration, the imaging quality degrades significantly when the conductor rail is either too close or too far, making it difficult to discern conductor rail disengagement.
