# Properties of Old Concrete Built in the Former Leipziger Palace

**Abstract:** This research aims to determine the mechanical, chemical, and physical properties of old concrete used in the former Leipziger Palace in Wrocław, Poland. The cylindrical specimens were taken from the basement concrete walls using a concrete core borehole diamond drill machine. The determination of the durability and strength of old concrete was based on specified chosen properties of the old concrete obtained through the following set of tests: measurements of dry density, tests of water absorption, specification of concrete compressive strength and frost resistance, determination of the modulus of elasticity, measurement of the pH value, determination of water-soluble chloride salts and sulphate ions, and X-ray diffraction analyses. Large dispersions of the compressive strength (10.4 MPa to 34.2 MPa), density (2049 kg/m<sup>3</sup> to 2205 kg/m<sup>3</sup>), water absorption (4.72% to 6.55%), and stabilized secant modulus of elasticity (15.25 GPa to 19.96 GPa) were observed. The paper is intended to provide scientists, civil engineers, and designers with guidelines for examining and assessing the long

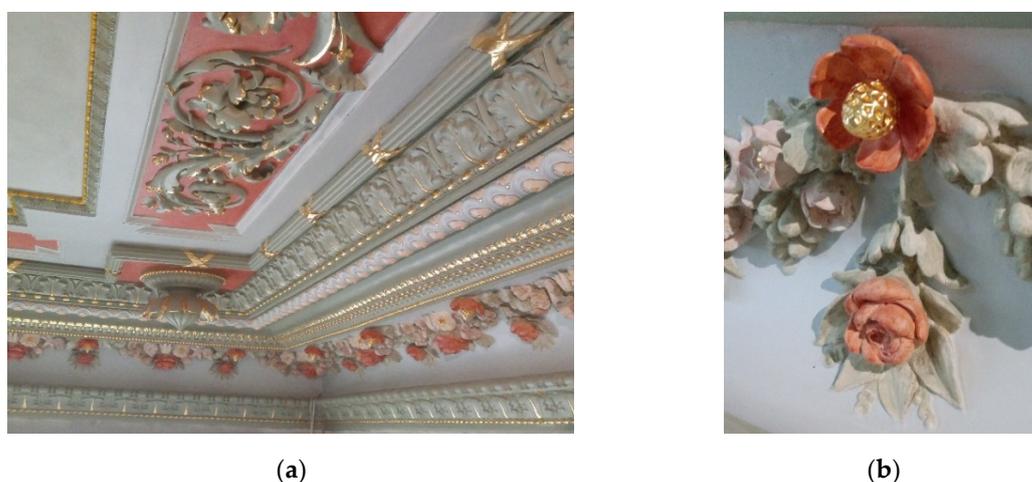
**Figure 2.** Stucco renovation on the ceiling: (a) partial view on the ceiling; (b) view of the gilded floral detail.

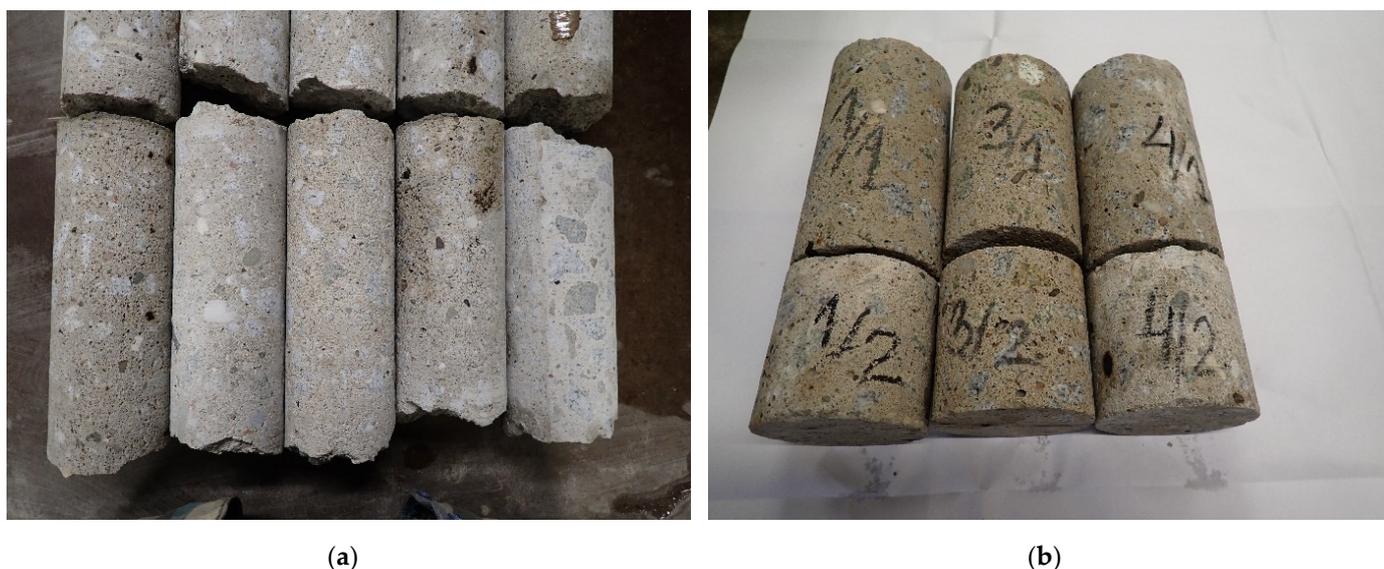
**Figure 3.** Old cylindrical concrete specimens: (a) taken from basement wall using a borehole diamond drill machine; (b) example view on some prepared concrete cores.

The old concrete specimens for the determination of the mechanical, chemical, and physical properties were taken from the structural elements of basement walls by a concrete core borehole diamond drill machine (see Figure 3a). It can be seen that some old concrete cores included visible pores (probably connected with an improper compact procedure of the concrete mix during placement) with a predominance of fine aggregate below 4mm grain-size with a low amount of additional coarse aggregates (granite and boulder) with grains with a diameter of 8 to 16 mm. Two types of concrete cores were prepared for mechanical tests (see Figure 3b). Firstly, 15 concrete cores with a diameter of approximately 100 mm ( $f_{c,cycl 100}$ ) and a length to core diameter ratio of 1 were used for compressive tests. The dimensions of the concrete cores were specified according to the standard EN 12504-1 [53]. The strength results determined for the chosen diameter of concrete cores of  $f_{c,cycl 100}$  can be directly comparable to the cube strength  $f_{c,cube}$  of 15 cm × 15 cm × 15 cm concrete specimens. Secondly, six concrete cores with a length to core diameter ratio equal to 1.5 and 2.0 with a diameter of approximately 100 mm were prepared to determine the modulus of elasticity indicated by two chosen standards. The EN 12390-13 [54] standard guidelines state that for the determination of the modulus of elasticity in compression, the ratio between the specimen length and the dimension will be in the range from 2 to 4, while the ASTM C469M standard [55] requires cores having a length-to-diameter ratio greater than 1.5. It should be noted that in old concrete structures, often it is not possible to drill cores with high length to core diameter ratios (due to, e.g., low old concrete strength, voids, or low-quality interlayers in concrete). In these cases, it is necessary to limit planned mechanical tests or to use non-standards specimen dimensions. The results obtained for cores with low dimensions can be recalculated to standard dimensions of concrete specimens according to proper guidelines with the application of the strength correction factor [56].

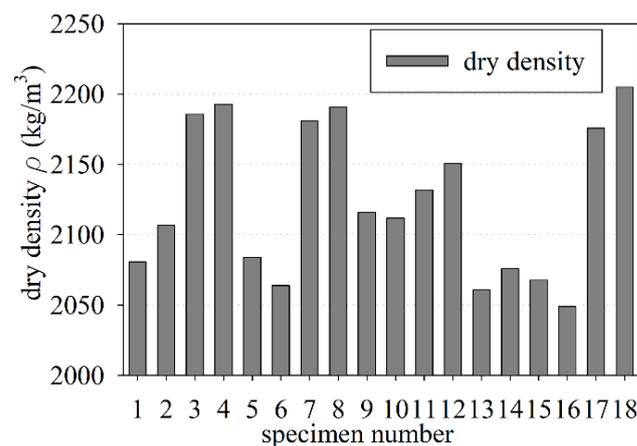
**Figure 4.** Measurement of the old concrete dry density.

The laboratory tests showed that the dry density of the old concrete varied from 2049  $\text{kg}/\text{m}^3$  to 2205  $\text{kg}/\text{m}^3$  (see Figure 4). The mean dry density value of the old concrete was equal to  $2124 \pm 13 \text{ kg}/\text{m}^3$ , while the median was 2114  $\text{kg}/\text{m}^3$ . The mean dry density value fulfilled the conditions for normal-weight concrete, according to EN 206 [65] (the dry density over 2000  $\text{kg}/\text{m}^3$  and below to 2600  $\text{kg}/\text{m}^3$ ). However, the mean dry density of the old concrete specimens are below the 2160  $\text{kg}/\text{m}^3$  limit specified in the ACI 318-19 standard [66] for normal-weight concrete; thus, the investigated old concrete could not be categorized as normal concrete, according to the ACI 318-19 standard [66].

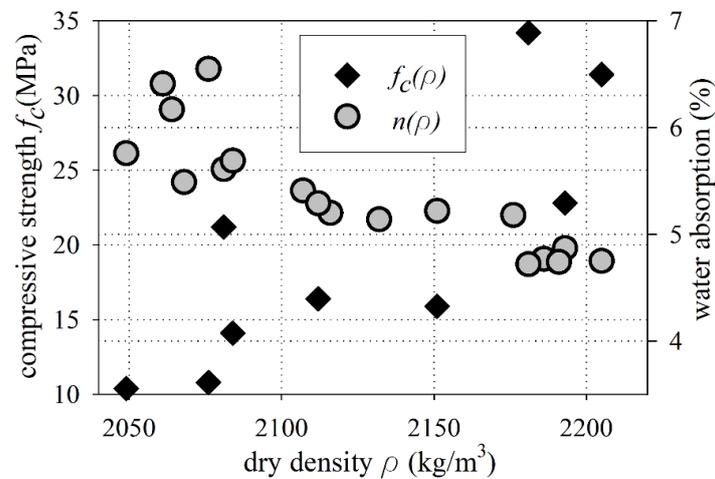
Figure 5. Compressive strength and water absorption vs. dry density.

The specified water uptake capacity of the old concrete samples ranged from 4.72 to 6.55% (see Figure 5). The mean value of the water absorption was  $5.39 \pm 0.13\%$ , while the median was equal to 5.26%. The water absorption for structural concrete should not be greater than 9% for concrete protected from atmospheric conditions, and not greater than 5% for concrete exposed to atmospheric conditions [60]. On the other hand, the structural concrete is qualified as poor quality when the water absorption value is greater than 5%, according to the report of the International Federation for Structural Concrete [67].

The uniaxial test results of the compressive strength for old concrete cores vs. the dry density are shown in Figure 5. Figure 5 exhibits the general characteristic, that an increase in the density of old concrete caused a higher compressive strength and lower water absorption of old concrete. The compressive strength of concrete cores varied from 10.4 MPa to 34.2 MPa. The difference in compressive strength results may result from the production technology, which was probably based on hand mixing with handmade proportions of the concrete components. Additionally, a lack of uniform compaction during the placement of old concrete causes differences in dry density and compressive strengths. The mean in-situ compressive strength value was  $19.7 \pm 2.8$  MPa, while the median was equal to 16.4 MPa. The strength results of the concrete cores were comparable to the cube strength (see EN 12504-1 standard [53]), so  $f_{c,cube} = f_{c,cycl 100} = 19.7 \pm 2.8$  MPa. Figure 6 shows that parts of some concrete specimens after uniaxial compressive tests—views of the form of failure with visible organic inclusions and predominance of fine aggregates.

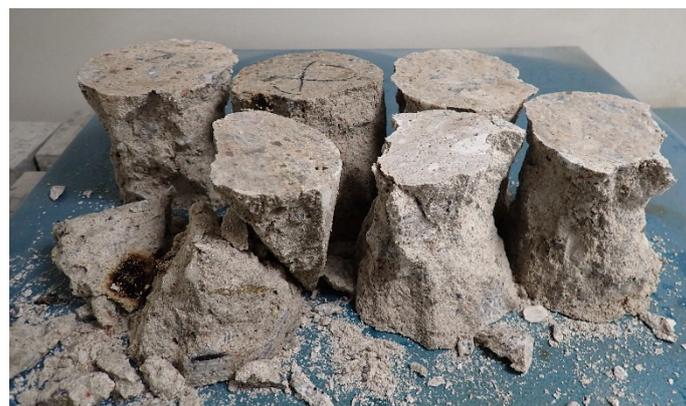
Figure 6. Parts of some concrete specimens after uniaxial compressive tests—views of the form of failure with visible organic inclusions and predominance of fine aggregates.

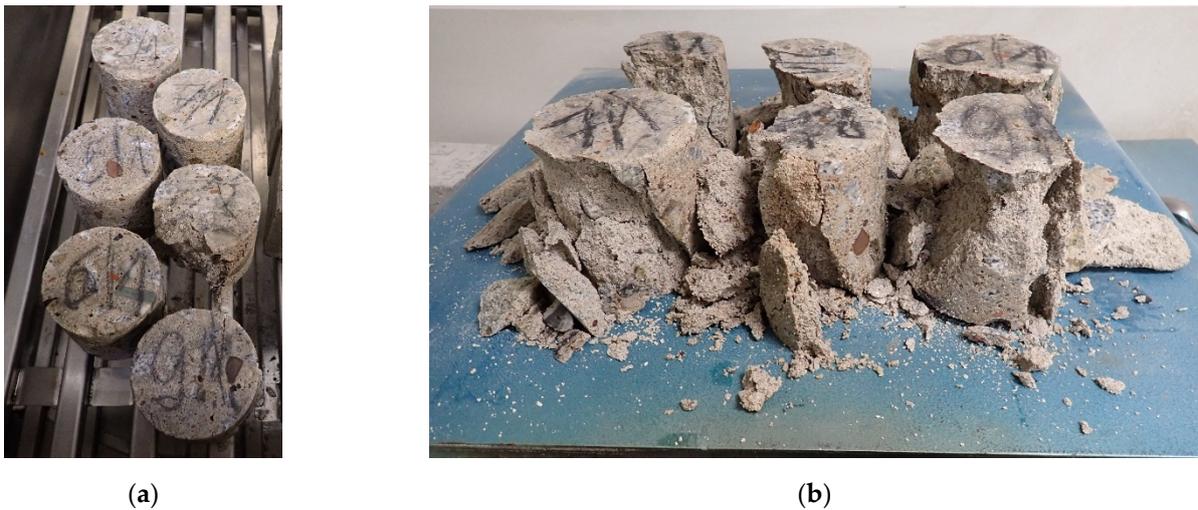
**Figure 7.** Frost resistance tests: (a) view of concrete specimens inside the freezing chamber after tests; (b) view of a form of failure concrete specimens.

Cylindrical samples were subjected to 50 freezer cycles consisting of freezing at  $-18 \pm 2$  °C for 4 h and thawing by total immersion in water at  $18 \pm 2$  °C for 4 h. After 50 freezer cycles (see Figure 7a), the compressive strength tests were performed (see Figure 7b). The compressive strength of the old concrete after 50 freezer cycles varied from 1.7 MPa to 16.1 MPa. The mean value of the compressive strength after 50 freezer cycles was  $10.4 \pm 2.2$  MPa, while the median was 12.1 MPa (see Figure 8). The value of the mean compressive strength after 50 freezer cycles was about 47% lower than the compressive strength of the base samples ( $f_{m, is} = 19.7$  MPa). Additionally, two cores showed cracks and visible loosening parts in the concrete from samples (see Figure 7a). The difference between compressive strength, before and after 50 freezer cycles, was considerably higher than 20%, and cracks appeared on the old concrete cores. Therefore, according to PN-B-06250 [60], the old concrete did not have freezing resistance properties.

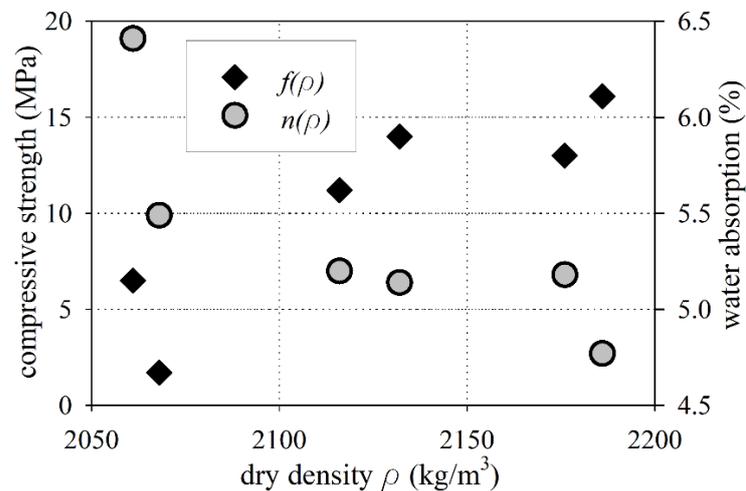
**Figure 8.** Compressive strength after 50 freezer cycles and water absorption vs. dry density.

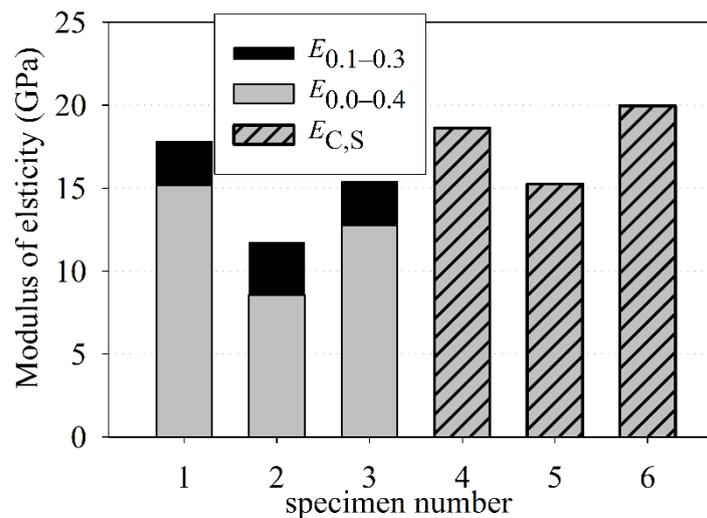
**Figure 9.** Modulus of elasticity in compression vs. dry density.

The stabilized secant modulus of elasticity,  $E_{C,S}$ , specified according to EN 12390-13 [54], ranged from 15.25 to 19.96 GPa (see Figure 9), with a mean value equal to 17.95 GPa. For concrete cores tested according to ASTM C469M [55], the moduli of elasticity was specified as the applicable customary working stress, ranging from 0 to 40% and from 10 to 30%. A difference of about 18% between the mean values of the modulus of elasticity for  $E_{0.0-0.4}$  and  $E_{0.1-0.3}$  was observed. The mean modulus of elasticity for  $E_{0.0-0.4}$  was 12.17 GPa and for  $E_{0.1-0.3}$  was 14.97 GPa.

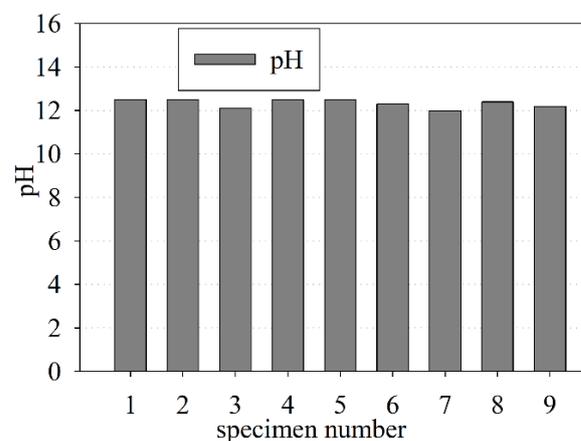
**Figure 10.** The pH value of the old concrete.

The pH value is an important factor that influences the corrosion rate of reinforcement [75,76]. Freshly made concrete has a pH value that varies from 12.5 to 13.5 [77], while the corrosion of reinforcement generally occurs when the pH value is less than 9 [78]. Under the laboratory tests for the old concrete samples, it was determined that the mean value of the pH was  $12.33 \pm 0.06$ , while the median was 12.40. The pH values for the old concrete ranged from 12.00 to 12.50 (see Figure 10). The pH of the old concrete was in the safety range. One of the concrete cores (which was not subjected to strength tests) included a flat bar-shaped reinforcement, which was in a very good condition, which confirms the results obtained for the safe pH value.

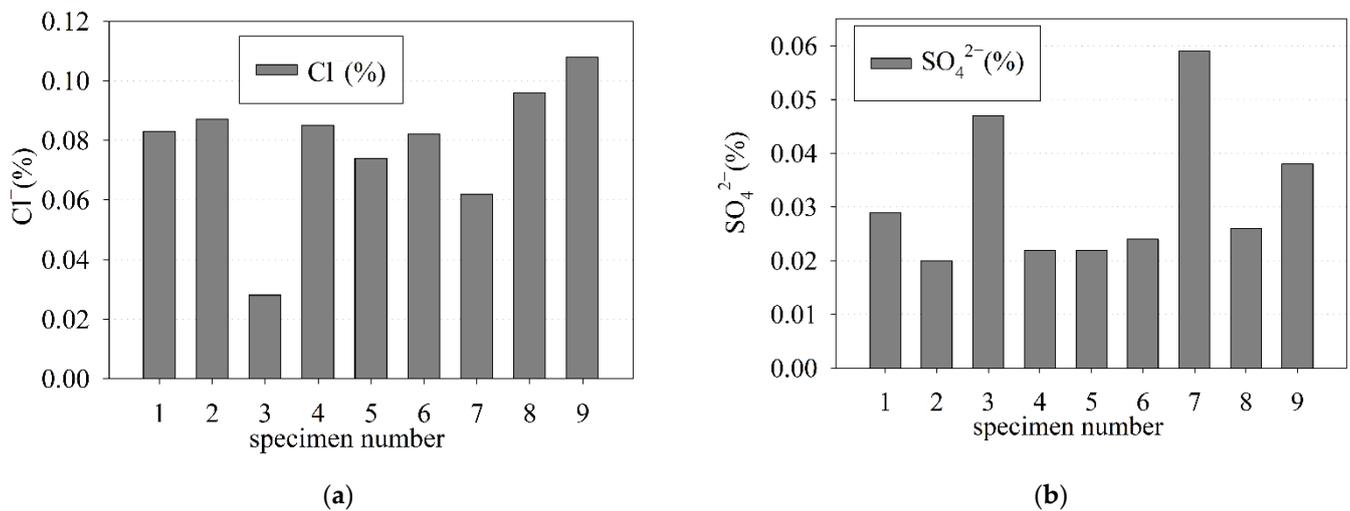
**Figure 11.** Content as the dry weight percentage of water-soluble (a) chloride ions ( $\text{Cl}^-$ ); (b) sulfate ions ( $\text{SO}_4^{2-}$ ).

The content of water-soluble chloride ions ( $\text{Cl}^-$ ) and sulfate ions ( $\text{SO}_4^{2-}$ ) was determined as the percentage of dry weight using the chemical tests. The water-soluble chloride ion values ranged from 0.028 % to 0.108 % (see Figure 11a), with the mean value equal to  $0.078 \pm 0.008\%$  and the median equal to 0.083 %. The sulfate ion values ranged from 0.020 to 0.059% dry weight (see Figure 11b), while the mean value was  $0.032 \pm 0.004\%$  and the median was 0.026% dry weight.

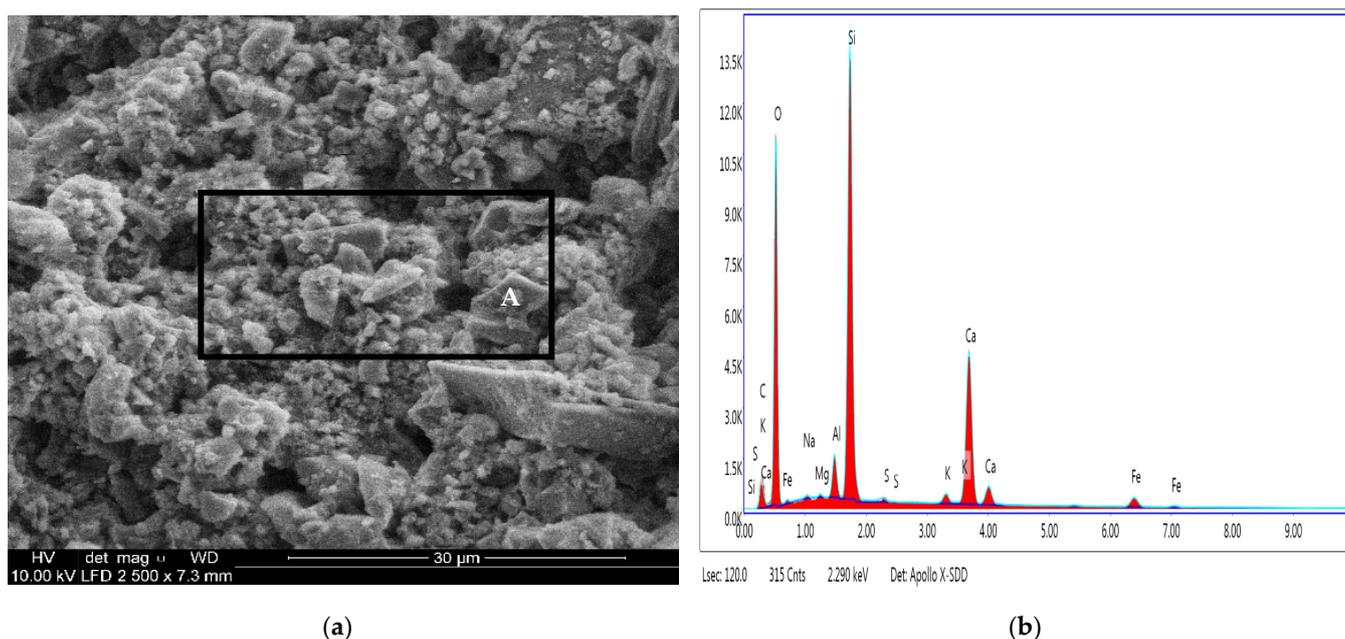
**Figure 12.** SEM/EDS analysis: (a) SEM microscopic images; (b) EDS of the sample on the selected area (A).

The scanning electron microscopy (SEM) image of the chosen sample taken from the old concrete structure is shown in Figure 12a. The results of the analysis of the chemical composition of the sample (in the selected area marked in Figure 12a) based on the presented spectrum (see Figure 12b) determined by the EDAX method are collected in Table 2.

The presented image SEM (see Figure 12a) of the chosen test sample shows that the old concrete element was a layer structure formed from the products of the cement hydration process. The shape and size of the crystalline phases are the result of the formation of chemical compounds in the structure of the tested concrete. According to the data presented in Table 2, the content of elements in the tested sample, taken from the structural old concrete element, is as follows: silica (43.9%), calcium (41.2%), iron (8.3%), aluminium (3.9%), and potassium (1.9%) by weight, respectively. The remaining amount of the identified elements in the structure of the tested sample was below 1% of the mass of the concrete sample.

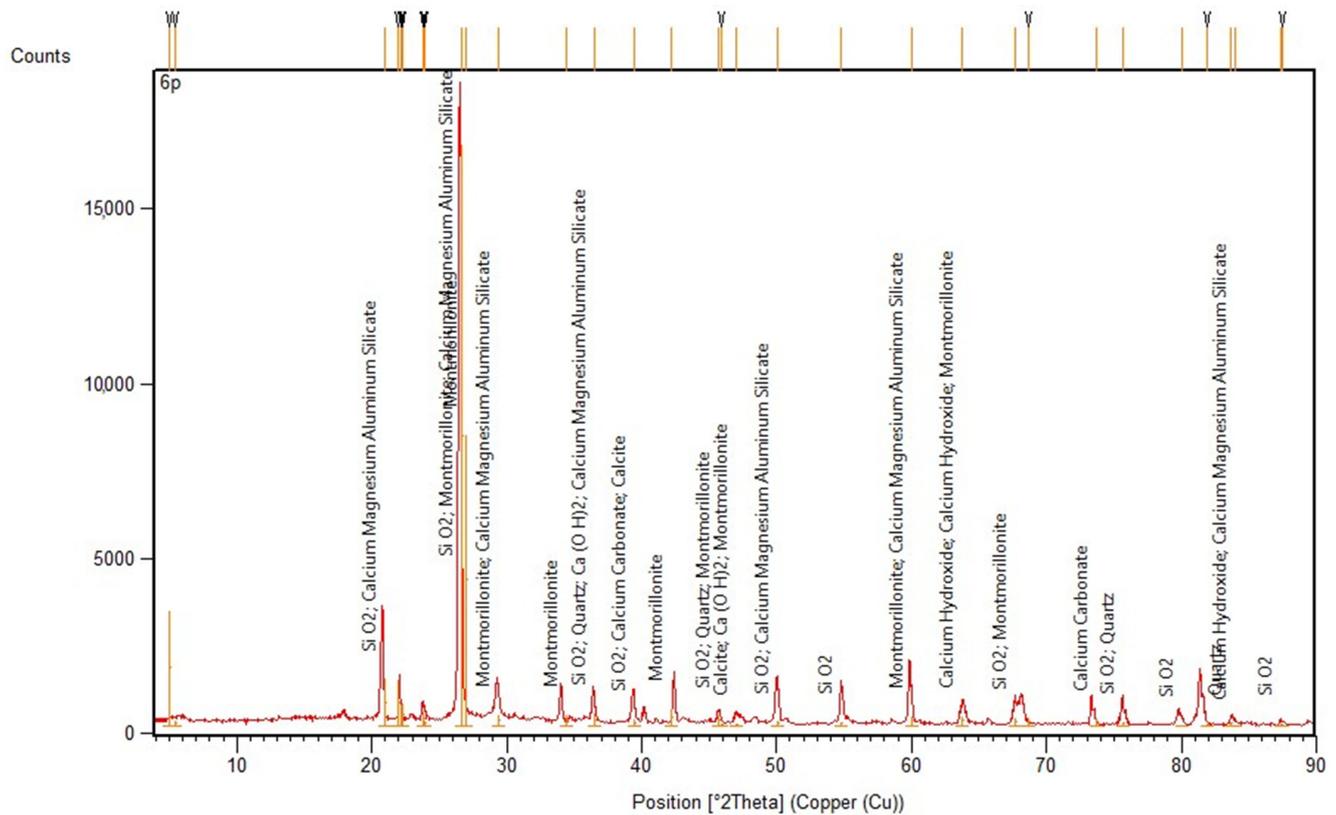
Figure 13. XRD pattern of the old concrete sample.

The XRD method was applied for the identification of the phase composition of the old concrete. The results of the mineralogical composition (in the form of a diffraction pattern) based on a chosen old concrete sample are presented in Figure 13.

The analysis of the evolution of concrete over the years, its phase composition, and its microstructure is critical to determine its durability. The obtained test results (see Figure 13) indicate that the following compounds were mainly dominant in the concrete structure after 120 to 140 years:  $(\text{Na,Ca})_{0,3}(\text{Al,Mg})_2(\text{Si}_4\text{O}_{10})(\text{OH})_2\text{xnH}_2\text{O}$ —montmorillonite, calcium–magnesium–aluminium–silicate hydrate (C–M–A–S–H),  $\text{CaCO}_3$  (calcite) as the carbonate phase,  $\text{Ca}(\text{OH})_2$ —portlandite, and  $\text{SiO}_2$ —quartz. The registered chemical compounds are products of the reacted clinker phases included in the cement used for concrete, including many years of exposure to atmospheric conditions and water.
