# Mitigation Strategies for Long-Term Corrosion in CFST Structures: A Systematic Review

**Keywords:** CFST; external confinement; FRP; FRCM; hybrid systems; corrosion; structural performance; mitigation

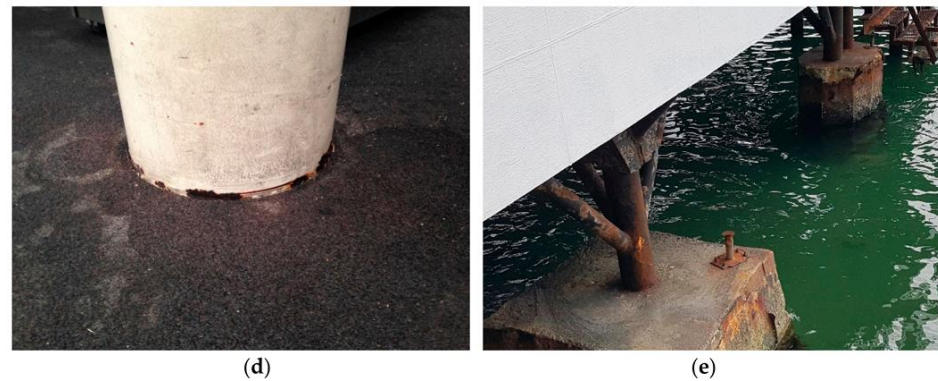
**Figure 3.** Schematic and field observations of corrosion in short tubular steel columns: (a) different offshore exposure environments; (b) localized corrosion at the ends; (c) corrosion along the column length; (d) observed end corrosion; and (e) observed longitudinal corrosion [57].

Circumferential corrosion patterns in CFST structures often develop preferentially at mid-height locations, particularly in vertical members subjected to variable environmental exposure [21,61]. The selective corrosion of the material has a relationship with moisture retention and chloride build-up around the steel pipe, whereby the environment here tends to be more aggressive compared to that of the areas that are continuously submerged, but different from that of areas that are totally exposed to the atmosphere. Such an environment leads to uneven corrosion of the pipe, making it vulnerable to local buckling [62]. Corrosion height significantly influences the compressive strength of steel tubular columns and should be evaluated together with corrosion depth and circumferential extent [57]. Since corrosion damage commonly develops near the mid-height of columns, the effects of damage location under different exposure conditions should also be considered (Figure 3a). In contrast, local corrosion often occurs at column ends due to the accumulation of moisture and debris, which accelerates deterioration (Figure 3b,d). Furthermore, environmental exposure and coating degradation play important roles in corrosion propagation and should be accounted for in durability assessments (Figure 3c,e).

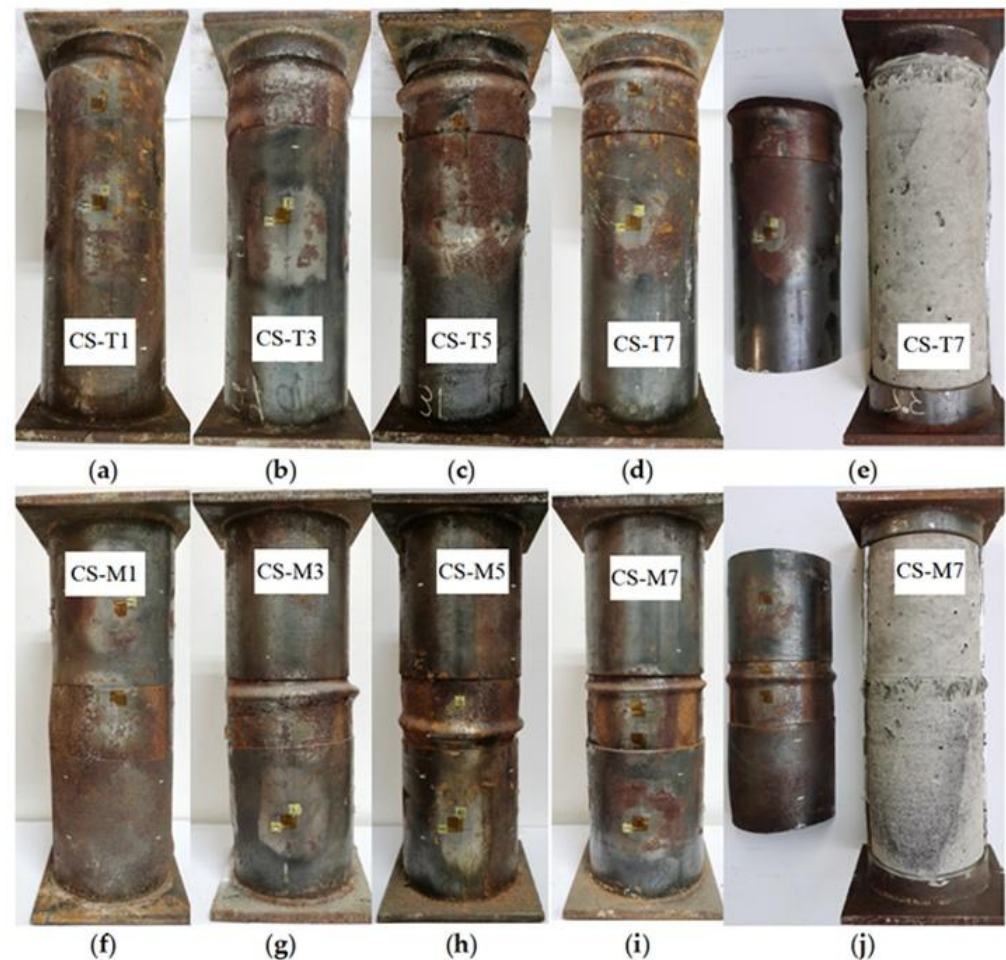
**Figure 7.** Failure patterns of CFST columns [64]: Failure modes of locally corroded CFST columns after axial compression tests: (a) CS-T1 (top corrosion, 10%); (b) CS-T3 (top corrosion, 30%); (c) CS-T5 (top corrosion, 50%); (d) CS-T7 (top corrosion, 70%); (e) separated steel tube and concrete core of CS-T7; (f) CS-M1 (mid-height corrosion, 10%); (g) CS-M3 (mid-height corrosion, 30%); (h) CS-M5 (mid-height corrosion, 50%); (i) CS-M7 (mid-height corrosion, 70%); (j) separated steel tube and concrete core of CS-M7.
