Review

A Review of Corrosion under Insulation: A Critical Issue in the Oil and Gas Industry

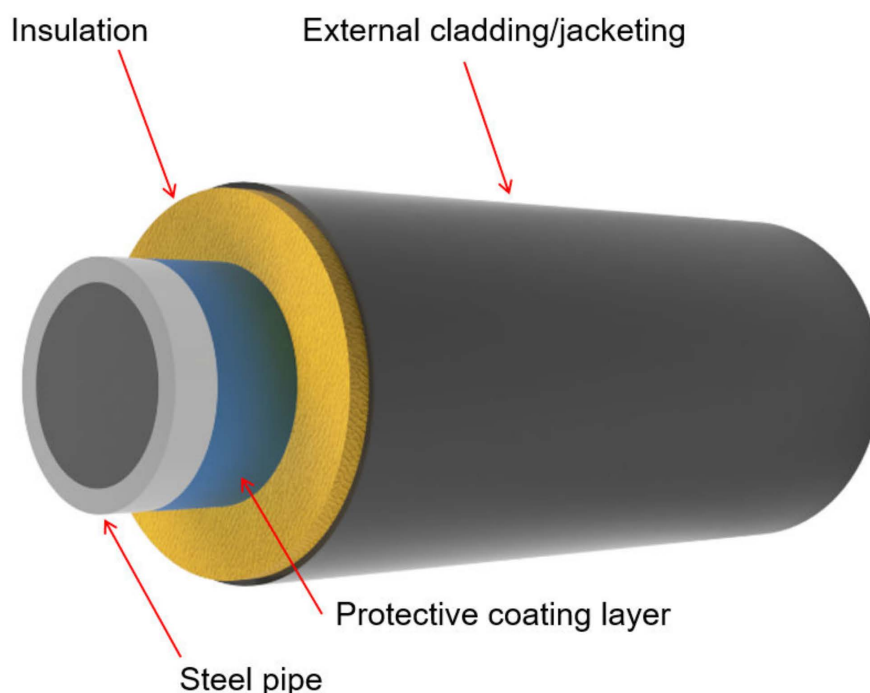
Figure 1. Schematic of a typical insulated pipe, which consists of an external cladding/jacketing, insulation material, a protective coating layer, and a steel pipe itself.

A typical insulated pipe comprises an external jacketing/cladding, an insulation layer, a preventative coating layer, and the steel pipe (Figure 1). All these components are critical to understanding a CUI cycle. As follows, all of the influencing factors will be discussed.

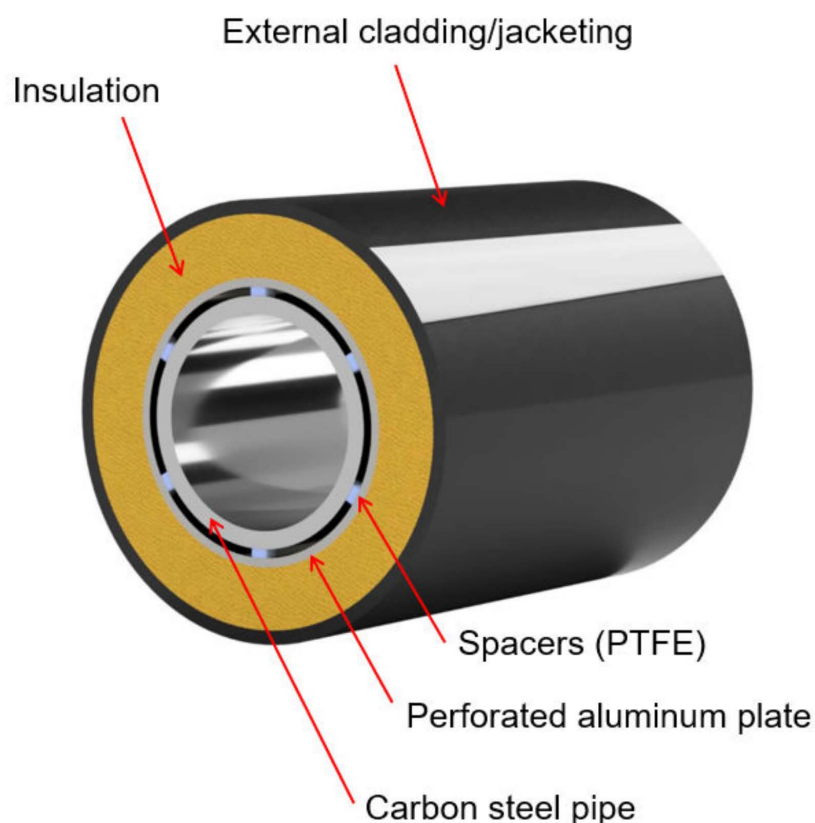
Figure 2. Schematic of “non-contact” or “distance-insulation” system [47].

A “non-contact”, also known as a “distance-insulation” system, was recently proposed to delay the onset of CUI. Non-contact insulation is achieved through the separation of the insulation layer and piping substrate by creating a cavity, which allows moisture/water to evaporate faster, therefore delaying CUI initiation and reducing CUI rates. As illustrated in Figure 2, Haraldsen [47] used polytetrafluoroethylene (PTFE) spacers and perforated aluminium plates simulating the “non-contact” system. Experimental results indicate that the rate of CUI was significantly decreased when insulation was not in direct contact with the underlying substrate.

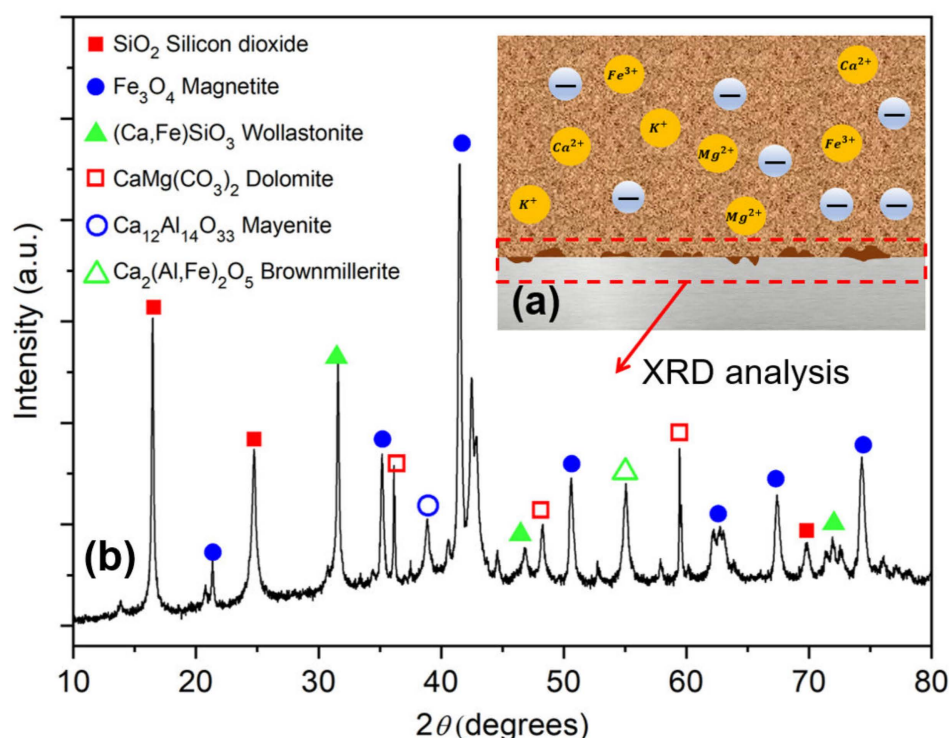
Figure 3. (a) Schematic of metal ions (Fe^{3+} , Ca^{2+} , K^{+} and Mg^{2+}) that leach out from the insulation and (b) X-ray diffraction characterisation of corrosion products formed upon the steel pipe during its interaction with moist insulation, analysed by Cao et al. [49].

It is indicated that certain types of insulation themselves may leach corrosive components, i.e., chlorides and sulfates, subsequently facilitating CUI [1]. The ASTM C795 standard recommends a methodology to quantitatively determine the contents of leachable ions within the insulation. Insulation materials that leach chloride and fluorine exceeding a threshold shall not be used on stainless steel pipework [48]. Recent findings from Cao et al. [49] revealed that the rate of CUI increases due to the release of metal ions (Fe^{3+} , Ca^{2+} , Mg^{2+} , and K^{+}) from the moist insulation (Figure 3), contributing to an increased solution conductivity. Another finding was related to the formation of differential aeration cells during the non-homogenous packing of the insulation. Oxygen diffusion arising from the formation of differential aeration cells could influence the form of corrosion and corrosion rates of metallic piping substrate [49].

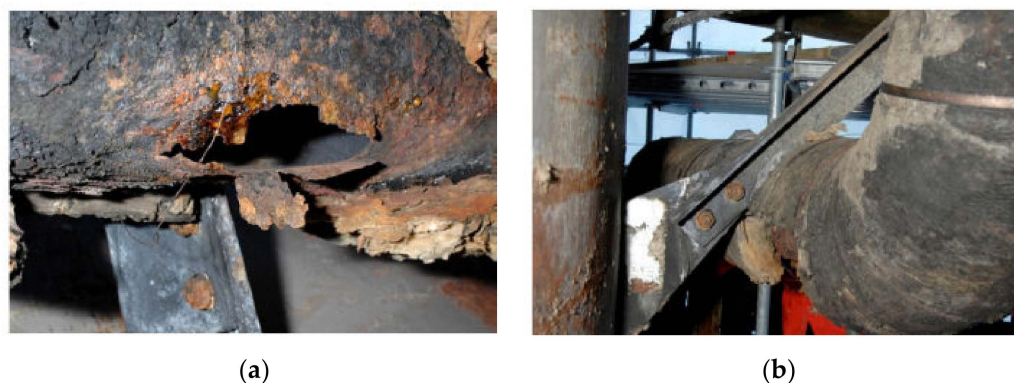
Figure 4. CUI failure in a refinery plant: (a) pipework fracture detail with a huge hole and (b) the installation of walkway bracket touching the pipework. Reprinted with permission from Ref. [23]. Copyright 2013 Elsevier.

Detrimental asset loss caused by CUI was observed and reported from multiple chemical processing plants. In 2013, a pipework failure led to a fire and subsequent explosion at a refinery [23]. The failure was noticed at the bottom dead center of a pipe section, and the pipe wall thickness was reported to have a significant reduction from 8 to 0.5 mm. Further investigation of the incident pointed to the neglect of design standards as the root cause of the failure. In this regard, a walkway bracket was installed at a distance to the insulated pipe far below the distance suggested, as shown in Figure 4. Consequently, water was retained between the jacketing and walkway bracket, leaving water to be easily accumulated within the reservoir and eventually causing corrosion [23].

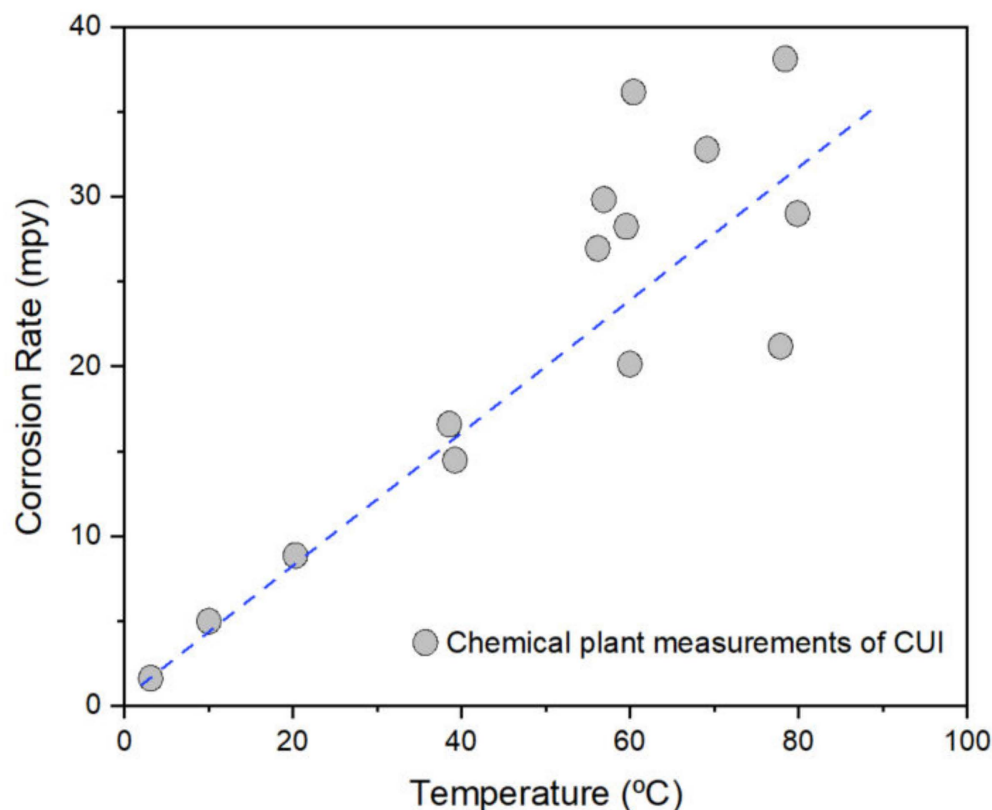
Figure 5. Effect of temperature on steel corrosion in water [6].

where ΔW —mass loss, T —exposure time, A —area, ρ —density, and $K = 8.76 \times 10^4$ [56]. However, corrosion rates obtained from the site are determined through the maximum corrosion depth divided by exposure time [57]. In addition, the uncertainty arising from coating breakdown complicates the in-the-field CUI scenario. In general, corrosion rates increase with increasing operating temperature [6,22,24]. In the context of steel, its corrosion rate under the insulation is reported to increase proportionally with increasing temperature, as shown in Figure 5 [6].

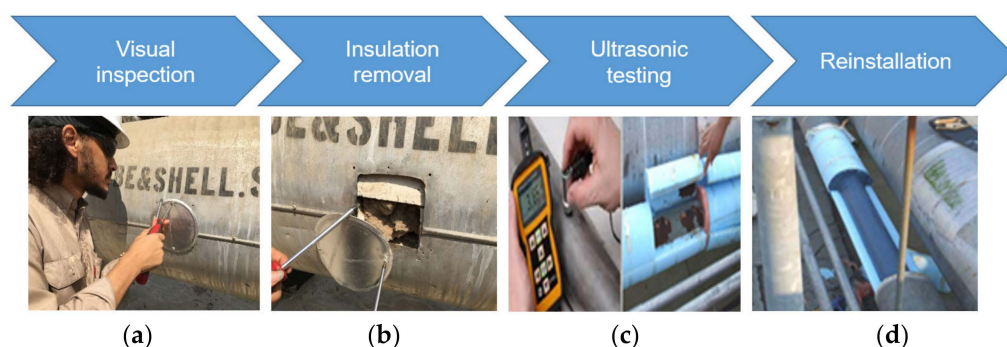
Figure 6. Four major steps involved in a CUI inspection process: (a) visual inspection, (b) partial or complete removal of insulation, (c) ultrasonic testing and (d) reinstallation of insulation material. Reprinted with authors' permission from Ref. [64].

Effective management, especially on the CUI high-risk regions (e.g., 6 o'clock location of insulated pipe, piping joint area, and the insulated facility near the sprinkler system, etc.), is essential to maintain the overall integrity of the insulated equipment. A lack of or insufficient inspection schemes can result in gas leaks and the loss of production. Nowadays, the major methodology used in the oil and gas industry to locate CUI is visual inspection, which requires partial or complete removal of the insulation. A typical process to conduct visual inspection requires inspectors to physically remove the external jacketing/cladding and strip off the insulation, then evaluate and assess the equipment's surface condition, as shown in Figure 6. However, collateral costs associated with scaffold building, insulation removal, and reinstallation can be enormous [9]. Non-destructive testing (NDT) provides an effective and economic approach for end users to conduct corrosion detection without causing a major impact during operation. Some of the NDT methods enable CUI detection without removing external jacketing and insulation material. Commonly considered NDTs include infrared thermography, radiography examination, ultrasonic inspection, and eddy current, which will be detailed in the following sections.

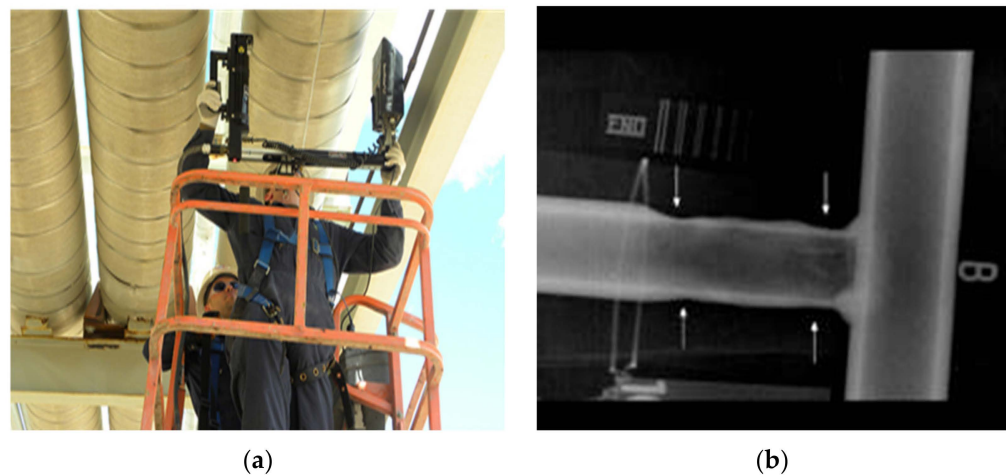
Figure 8. Radiography technique to image the wall thickness loss using C-arm equipment. (a) Operator holds the C-arm machine to check potential piping damage; (b) Radiography images showing pipe wall thickness loss. Reprinted with authors' permission from Ref. [64].

There are four types of commonly known radiography techniques: real-time radiography (X-rays), profile radiography (either X-rays or gamma rays), computed radiography (X-rays), and digital detector array (X-rays). Real-time radiography (RTR) uses X-rays or gamma rays to produce digital images [70]. X-rays can penetrate through the metallic objects and reflect on a receiver panel (e.g., C-arm), which contains microelectronic sensors to produce the image signals, as shown in Figure 8. Areas that experience external corrosion and subsequent wall thinning can be identified from the colour contrast of collected images. Thinner objects allow more radiation to pass through, hence, a larger amount of light can be emitted from the receiver panel, reflecting a lighter colour contrast on the image.

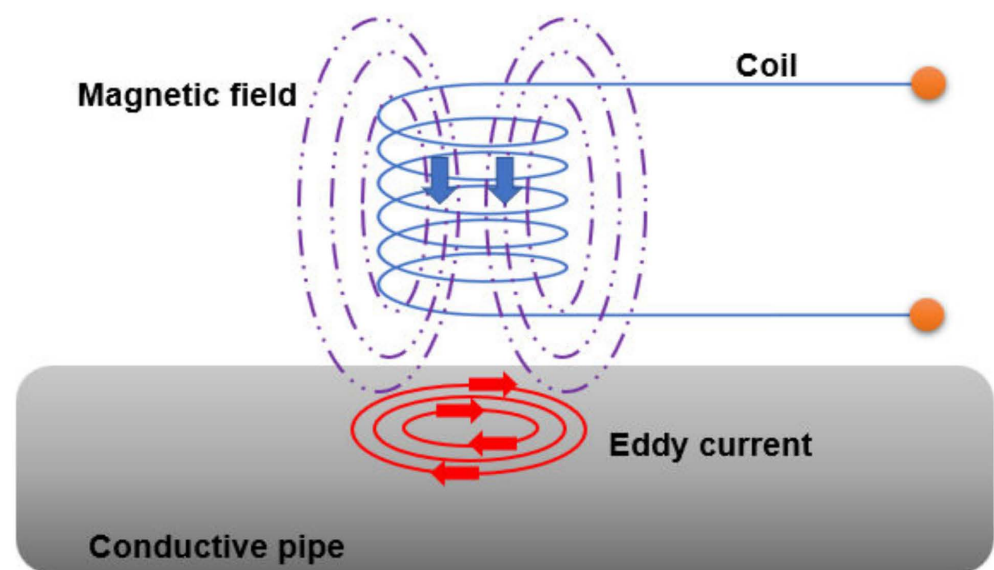
Figure 9. Schematic of eddy current used to inspect the occurrence of corrosion under insulation on a conductive steel pipe.

Pulsed eddy current measures wall thickness loss of piping by distinguishing variations in electromagnetic signals. Pulsed eddy current incorporates coil sensors and magnetic field sensors to locate CUI, as schematically depicted in Figure 9 [83,84]. By emitting an eddy current from an excitation coil towards the as-specified objects, a time-varying magnetic field signal can be reflected and further collected by the receiver coil. The magnetic field will change if defects or flaws exist [84–86]. Cheng et al. [85] reported a correlation

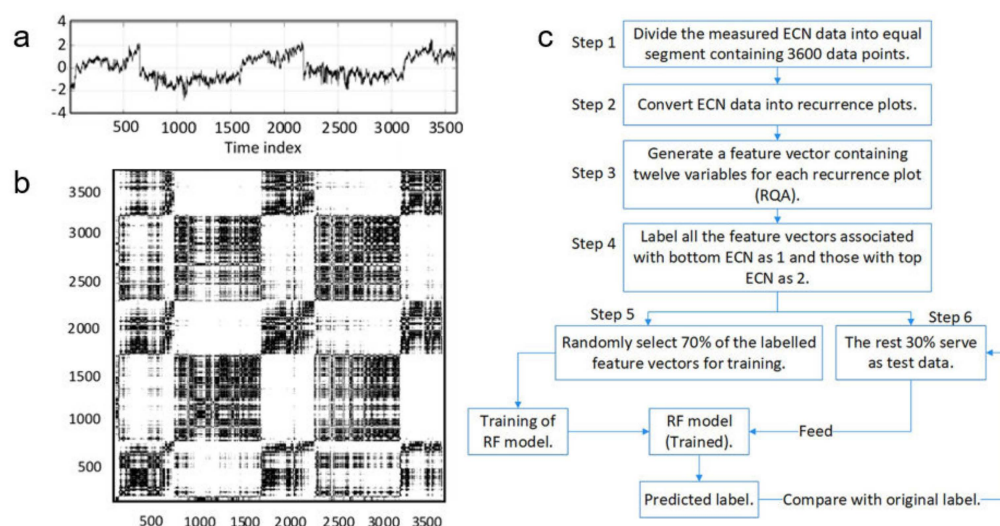
Figure 10. The procedure of employing electrochemical noise data as input to build a random forest model for the identification of CUI types. (a) Electrochemical noise data collected from an experimental CUI rig. (b) Recurrence plot produced from electrochemical noise data input. (c) Steps for training a random forest model to identify the form of CUI. Reprinted with permission from Ref. [94]. Copyright 2020 Springer Nature.

caused by the direct corrosion of wire beams. Electrochemical current noise techniques have demonstrated their popularity in localised corrosion identification [92,93]. Hou et al. used the electrochemical current noise methodology, in combination with recurrence quantification analysis, to develop a random forest model for the identification of the form of corrosion present beneath the mineral wool insulation [94]. The key steps included training a random forest model using noise data as input, converting data into the recurrence plot, extracting feature variables, training the model, and validating the model accuracy. The detailed procedure is listed in Figure 10a–c.

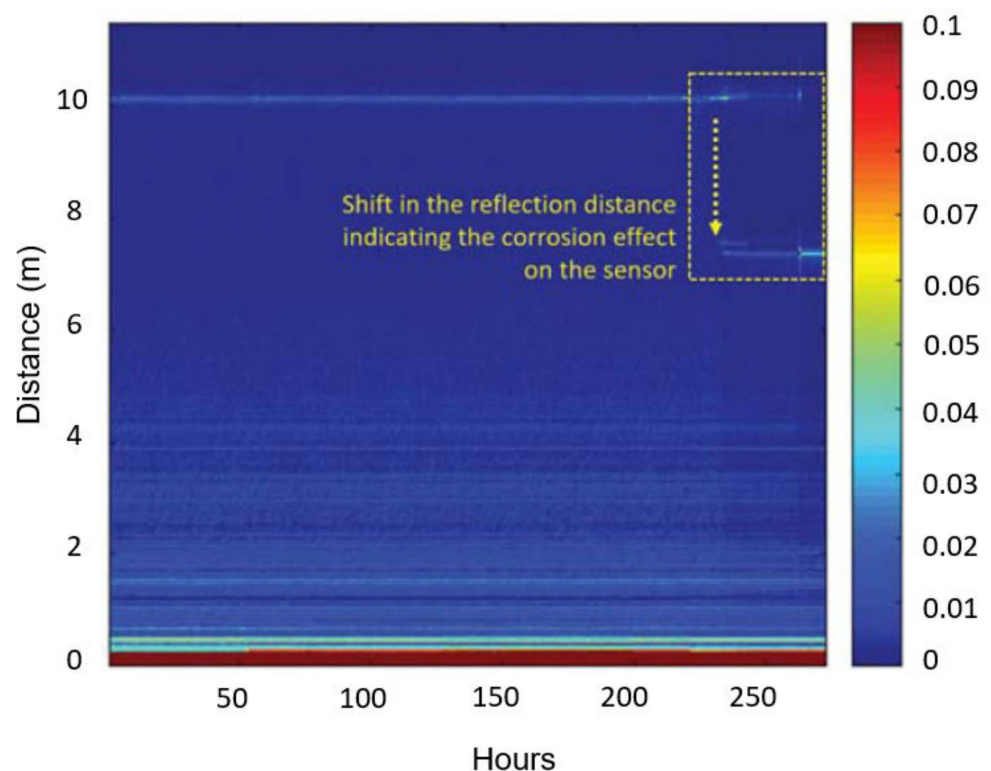
Figure 11. The spectrogram of reflected signals collected from a corrosion sensor, which indicates the location of the corrosion initiation part of a pipe. Reprinted with permission from Ref. [98] CorrosionRadar.

In 2017, CorrosionRadar Ltd. [98] developed a patented sensor to detect the presence of moisture within the insulation and the onset of CUI. The systems combine wave reflection time-of-flight technology and industrial Internet of Things (IIoT) application to locate and monitor corrosion under insulation. The sensor wire is layered with a thin film of sacrificial material that tends to corrode in the presence of water. When sacrificial material corrodes, the electromagnetic wave that travels through the wire is reflected and detected remotely. In one of the case studies, corrosion under insulation was detected on insulated equipment after 230 h at a location 7 m away from the wire's original installation spot. The spectrogram of the reflected signals, as shown in Figure 11, indicates the CUI initiation location.

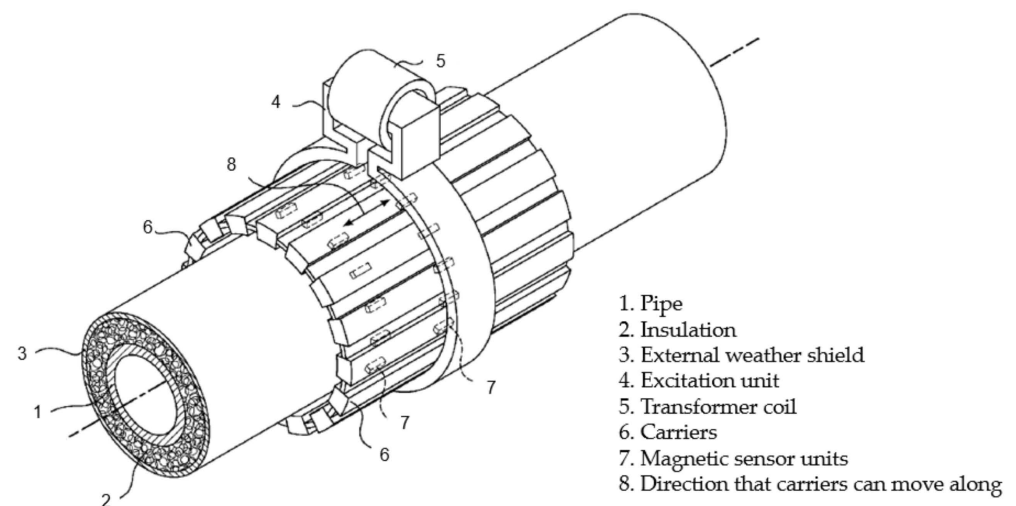
Figure 12. Apparatus sketch for CUI detection equipment that consists of an electrically conductive excitation coil and an electrical power source. Reprinted with authors' permission from Ref. [105].

Bondurant et al. introduced equipment applying an electrically conductive excitation unit to detect CUI. The excitation unit comprises an electrical excitation coil and a power source, as shown in Figure 12. The power source generates an alternating current and CUI can be detected from the changes in magnetic flux that are created by the alternating current [105].

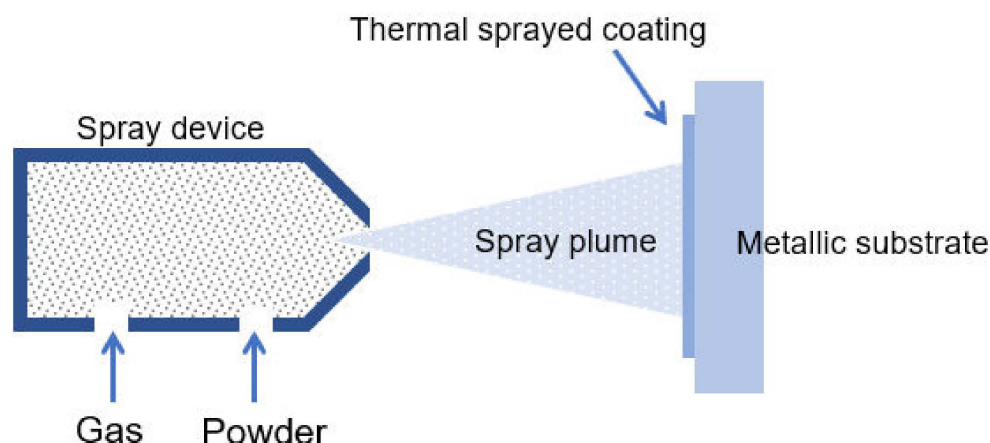
Figure 13. Schematic of thermal sprayed aluminium (TSA) coating process, which involves projecting small molten particles onto a prepared surface and achieving a continuous coating with strong surface adhesion.

The application of protective coating material is considered a highly effective method to mitigate CUI. Coating isolates metallic substrate and acts as the last barrier to prevent the rapid corrosion of the metallic substrate [6]. A protective coating layer can protect steel substrate from the infiltration of oxygen, moisture, and corrosive electrolytes, hence, retarding the electrochemical reactions that occur on the metallic substrates [96–98]. Nevertheless, a poorly applied coating can be detrimental, as coating defects retain contaminants, exacerbating CUI [1]. An example of CUI coating is thermal spray aluminium (TSA), as shown in Figure 13, a type of metallic coating that can be applied on process equipment, storage vessels, and piping. TSA has a long service life of more than 25 years and is able to provide good adhesion and cathodic protection to the exposed steel substrates [50,106]. The integrity of TSA can be affected by multiple factors with recorded premature coating failure (e.g., cracking, blistering, and detachment) reported due to poor surface preparation and coating application [51,106,107]. TSA coating can be applied through a combustion wire-fed system or the twin wire arc method, with both processes involving flame generation. Therefore, partial processing unit shutdown is required when TSA is used for repair, to avoid potential ignition risk.

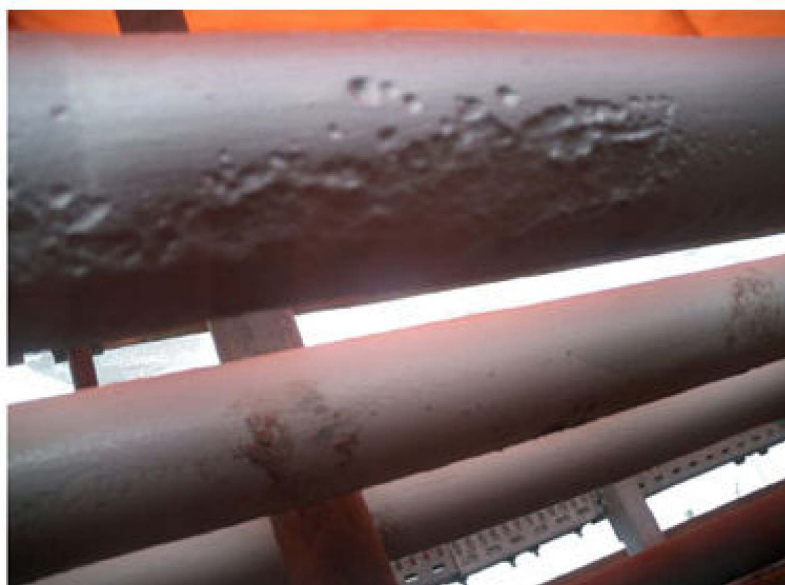
Figure 14. Coating degradation in the form of chained pitting. Reprinted with permission from Ref. [109] Copyright 2013 Springer Nature.

Coating applications should meet the minimum industrial requirement in regard to substrate surface preparation, specified coating wet film thickness, and dry film thickness, which are essential to a coating's final performance. Coating will not provide its intended service life if it is applied over salt/corrosive medium due to contamination (lack of surface preparation). The adhesion strength between coating and substrate will be largely reduced if substrate surface preparation is inappropriate. Coating applied on pipework that is processed under elevated temperatures and intermittent duty can introduce a complex degradation process, as both moisture and thermally induced stress can be another contributing factor. In a hot oil line case study, CUI was found in the form of chained pitting, as shown in Figure 14. The coating used on the inlet line was noticed to have been heavily degraded, with clear flaking and rusting observed. It was inferred that the applied coating had a temperature tolerance below the piping operating temperature at 240 °C [109]. Ingressed saltwater was considered to be another contributing factor, especially when chlorides can concentrate when electrolytes evaporate at high temperatures. A subsequent solution to the problem was to replace the protective coating system with a heat-resistant cold spray aluminium coating.

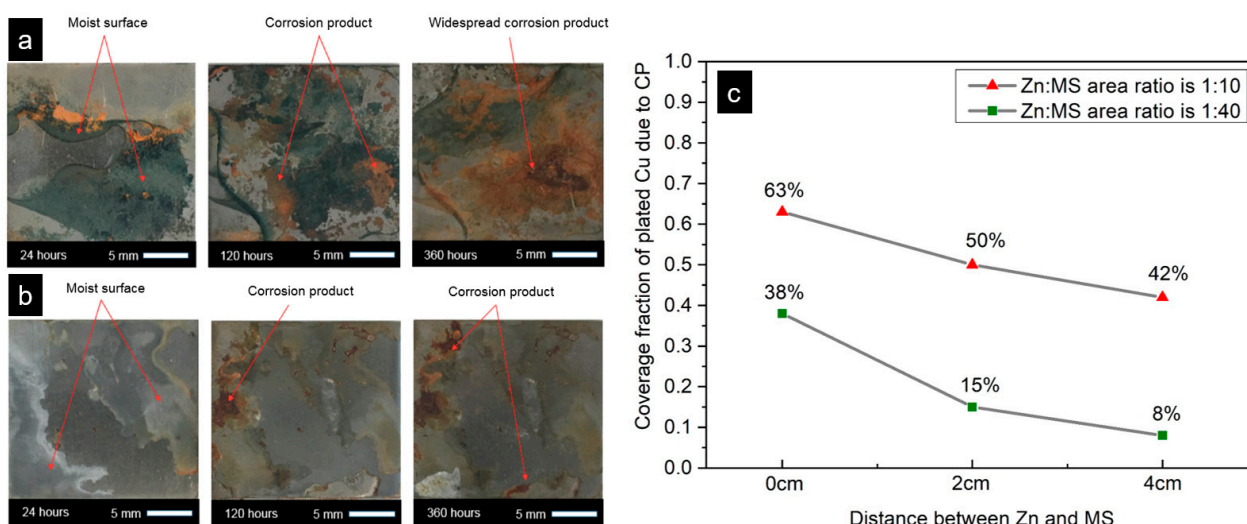
Figure 15. CUI mitigation using cathodic protection, (a,b) a proof-of-concept that cathodic protection using sacrificial Zn can mitigate CUI on mild steel, in which (a) represents mild steel surface morphologies in the absence of Zn protection, (b) represents mild steel surface morphologies with Zn protection and (c) represents the achievable cathodic protection area (represented by the Cu plated region) on steel test plates under different Zn to MS contact modes (0 cm, 2 cm, and 4 cm contact distances) and different Zn to MS area ratios (1:10 and 1:40). Samples and data were analysed by Cao et al. [121].

A strategy implementing a zinc rod as sacrificial cathodic protection (CP) for CUI remediation has been trialled and validated as a proof-of-concept for CUI mitigation [121]. The results reveal that sacrificial zinc can be used to mitigate CUI when moisture content within the insulation is over 25 vol%. An increasing level of ion migration was found when moisture content within the insulation was sufficient. Experimental results reveal a 63% CP efficiency was achieved when zinc was in direct contact with mild steel substrate and insulation was fully saturated (Figure 15). Zinc could therefore be potentially implemented at the six o'clock location of an insulated pipe where moisture is prone to accumulate. However, the suitability of sacrificial protection using zinc for high-temperature applications is not recommended because zinc will reverse its polarity, from anode to cathode, at high temperatures. Consequently, the metallic substrate will corrode more severely.
