# Residual Stresses and the Microstructure of Modeled Laser-Hardened Railway Axle Seats under Fatigue

**Abstract:** Railway wheels are usually attached to axles by press-fitting; therefore, the mechanical processes taking place during operation can result in failure, with fatal consequences for the axle seats. This manuscript describes the effect of laser hardening on the residual stress state, microstructural parameters (lattice defects—dislocations, crystallites, microstrains, etc.), and mechanical properties of laser-hardened EA1N steel railway axles under fatigue life conditions. Differences were found between ground, single-track, and multi-track hardened surfaces. Tensile residual stresses, low dislocation densities and hardnesses, and different microstructures (tempered cubic martensite) were found at the overlapped tracks and at the boundary of the heat-affected zone and bulk surface compared with the hardened zone. As a result, the surface treatment of axle seats by laser hardening improved the fatigue failure resistance compared with untreated seats. Optimal properties of the integrity of the axle seat surface were achieved, including fatigue resistance, which seems to b

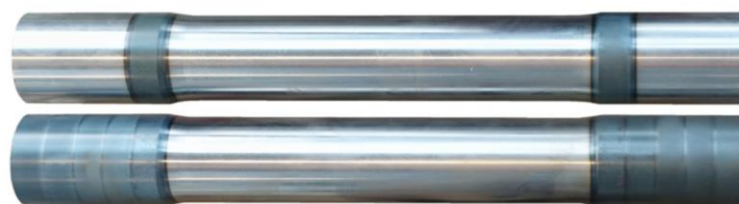
**Figure 2.** Axle models with single-track (up) and multi-track (down) laser hardening.

X-ray diffraction (XRD) analyses were performed in the direction parallel to the axial axis of the axle, i.e., perpendicular to the laser-hardened tracks, as shown in Figure 2. This direction of the axle is more important from a technological point of view (direction of maximum fatigue load).

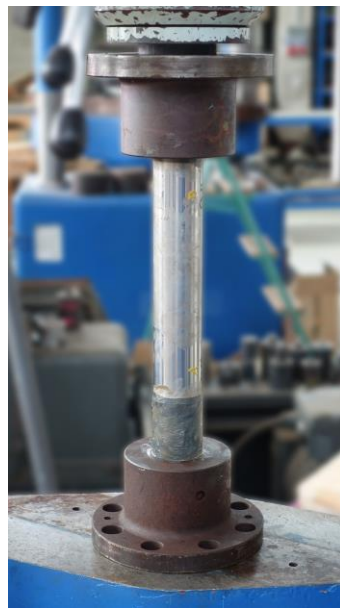
**Figure 4.** Flanges press-fitting of multi-track laser-hardened axle model.

The seat of the model axles was housed by press-fitting in special flanges that were clamped by bolts to the body of the test rig. Pressing of the model axles was carried out on a Schneck ZD 100 servo-hydraulic test rig (SCHENCK RoTec GmbH, Darmstadt, Germany) with a capacity of 1000 kN, as illustrated in Figure 4. Force and displacement were recorded for each model axle since these are critical parameters necessary for the reliable strength of the pressed joint. The relationship between the maximum press-fitting force achieved and the offset of the axle seat and flange diameters is shown in Figure 5. As the radial offset increases, the fitting force also increases, but it is important that even for laser-hardened axles, there is no significant dispersion. The fitting force is determined by the standard in the production of real axles.

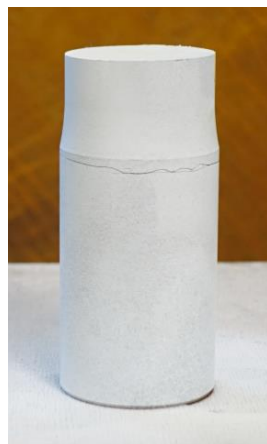
The representative axle seat of the model after the disassembly and application of magnetic powder inspection is shown in Figure 10. In all cases, the crack appeared only on one of the two model axle seats. As mentioned, the cracks initiated at a distance of 4.5 to 7.5 mm from the inner edge of the axle seat, implying an abnormal drop for the multi-track model axles from the main hardness, as depicted in Figure 8. Initiation occurred mostly from a single initiation spot, but there were short cracks around the initiation spot, which caused chips on the fracture surface. These chips were formed by coalescing of the initiation spot and short secondary cracks, as illustrated in Figure 11. The surface of the seats around the initiation spots was covered with corrosion debris and a number of minuscule cracks (Figure 12a), which is typical of fretting fatigue damage. After the initiation stage, the mechanism transforms from fretting fatigue to fatigue controlled by the range of the stress intensity factor. As indicated in Figure 12b, the fracture in the stable fatigue propagation region is formed by ductile striation patterns, i.e., increments of cracks per cycle.

**Figure 10.** Representative axle seat after failure.
