# Study on the Performance Degradation Mechanism of Low-Light-Level Image Intensifiers in Humid and Hot Environments

To analyze the performance stability of image intensifiers under humid and hot environments, this study systematically investigates the device performance degradation mechanism through a combination of natural exposure tests, humidity variation aging tests, disassembly analysis of failed samples, and a vacuum decay model. Experimental and simulated results reveal that moisture ingress in a humid and hot environment serves as the dominant factor governing the luminance gain stability of devices. Microscopic defects such as cracks, voids, and delamination phenomena existing at the sealing interface between ceramic rings and metal gaskets are the direct cause of moisture penetration. The attenuation of luminance gain accelerates significantly with increasing ambient humidity, demonstrating that water vapor is the primary driving factor for the environmental failure of devices. This study clarifies the attenuation mechanism of luminance gain for image intensifiers under humid and hot environments, providing a theoretical basis for the optimization of packaging processes

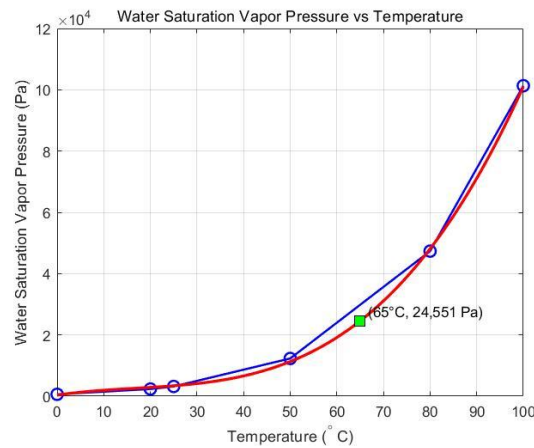
**Figure 1.** Fitted curve of water saturation vapor pressure as a function of temperature.

where  $RH$  is the relative humidity (%),  $E$  is the saturation vapor pressure (Pa) at the given temperature,  $M$  is the molar mass of water (0.018 kg/mol),  $R$  is the gas constant (8.314 J/(mol·K)), and  $T$  is the absolute temperature (K). Absolute humidity,  $a$ , is directly proportional to the partial pressure of water vapor and is a direct physical quantity characterizing the water vapor content. The curve of water saturation vapor pressure as a function of temperature is plotted in Figure 1.

By fitting the data curve in Figure 1, the fitting formula for water saturation vapor pressure as a function of temperature is established as Equation (8), where  $T$  is the temperature in Kelvin and  $E$  is the saturation vapor pressure. Then, according to Equations (7) and (8), the water molecule concentration under different temperature and humidity conditions can be calculated.

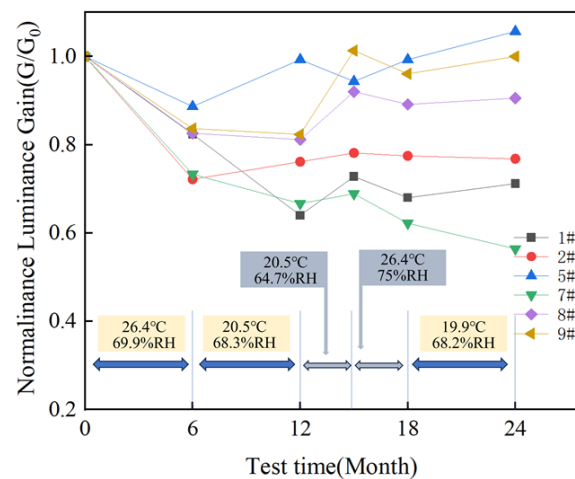
**Figure 2.** Normalized luminance gain of image intensifiers versus exposure time under humid and hot environments, together with the average temperature and humidity values corresponding to each storage stage (monitored every day by hygrothermograph).

The measured data and normalized values of luminance gain of image intensifiers varying with exposure time, humidity, and temperature are presented in Table 1 and Figure 2, respectively. Except for Samples No. 3, No. 4, and No. 6, the luminance gain of the remaining products after 24 months of exposure remains above 70%. However, Samples No. 1 and No. 2 exhibit a clear degradation trend. The initial luminance gain of Sample No. 1 decreases from 12,500 cd·m<sup>-2</sup>·lx<sup>-1</sup> to 8900 cd·m<sup>-2</sup>·lx<sup>-1</sup>, representing a degradation of 28.8%, essentially reaching the lifetime threshold. The initial luminance gain of Sample No. 2 decreased from 15,100 to 11,600 cd·m<sup>-2</sup>·lx<sup>-1</sup>, a degradation of 23.2%. The luminance gain of Sample 5 and Sample 9 fluctuates continuously. Following normalization, the gain oscillates around unity. A reduction in gain is observed under high temperature and humidity during storage, and vice versa.

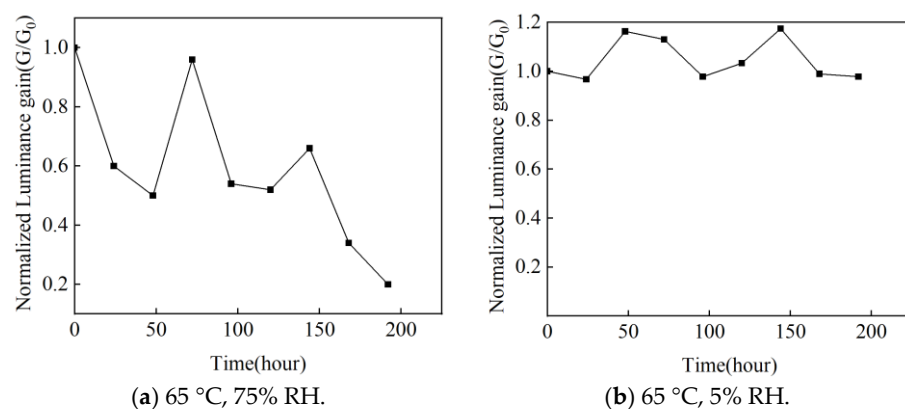
**Figure 3.** Decay curve of normalized luminance gain over time during high-temperature high-humidity/low-humidity aging test (data from a single sample, No. 220406).

The degradation trend of luminance gain during the aging test of image intensifiers under different humidity levels is shown in Figure 3. To eliminate the influence of initial gain variation among devices, all measured gain values are normalized to their respective initial values. When the temperature is 65 °C and the humidity is 75%, the luminance gain exhibits a significant degradation over time. When the humidity is reduced to 5% while keeping the temperature and test duration unchanged, the luminance gain remains approximately constant. The test results indicate that ambient temperature has a relatively small effect on the luminance gain of the image intensifier, whereas ambient humidity causes a pronounced degradation of the luminance gain.

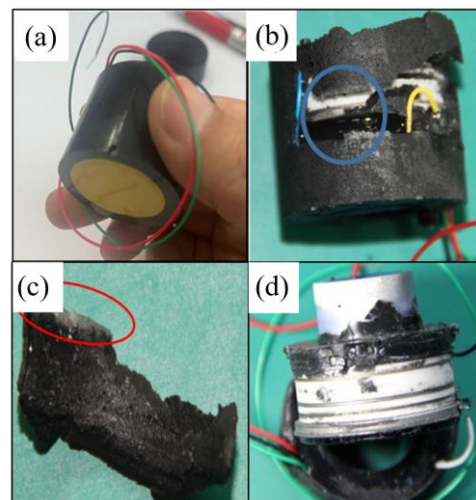
For the devices exhibiting screen flickering and abnormal noise, baking and retesting are performed, followed by disassembly inspection. It is found that the potting of the image intensifier (6#) had insufficient elastomer filling, resulting in voids and brittleness, as shown in Figure 4b,c. Figure 4a–c present photographs of the image intensifier tube shell before and after removal of its rigid outer housing. Figure 4d displays the power supply surface after removal of the sealing compound. These voids are located at the high-voltage solder joint, failing to provide adequate sealing and insulation protection for the bare tube and the solder joint. The severely aged area is highlighted by the red circle in the magnified view of Figure 4c. After prolonged moisture ingress, the surrounding elastomer ages and becomes brittle, and water stains accumulate at the void locations, ultimately leading to discharge at the high-voltage solder joint and causing flickering of the image intensifiers.

**Figure 4.** Photograph of image intensifier sample. (a) Intact sample with rigid outer housing; (b) device after removal of the rigid housing; (c) aging condition (red circle); (d) the power supply surface after removal of the sealing compound.

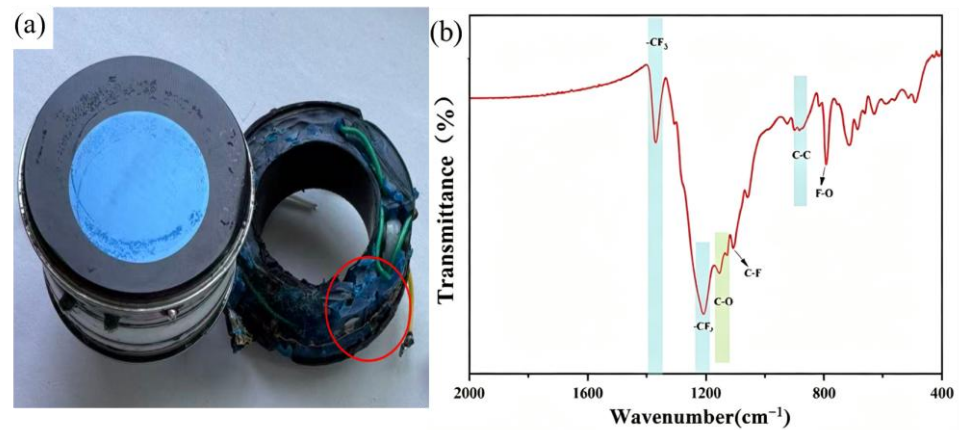
Figure 5 shows the photograph and infrared spectroscopy result of the purple soft elastomer material used in the circuit part protection. Figure 5a presents the photograph of the aged elastomer, where the red circle highlights the region with visible void defects. The spectrum in Figure 5b indicates that the sample is mainly composed of perfluoropolymer, whose gas leak rate is usually below  $1 \times 10^{-10}$  Pa·l/s at room temperature. This material is designed for circuit protection and does not possess the structural function to maintain an ultra-high vacuum [26]. For the devices that completely lost image on the screen (Samples No. 3, No. 4, and No. 6, which failed to undergo performance parameter testing after 6 and 12 months of exposure), baking and retesting are carried out in a high vacuum and temperature chamber. It is found that the devices had completely failed. Subsequently, the devices are disassembled and inspected.

**Figure 5.** Attenuated total reflection (ATR) infrared spectroscopy test results of the circuit part and the green soft elastomer. (a) Morphology of the circuit part; (b) infrared spectroscopy result of the green elastomer.

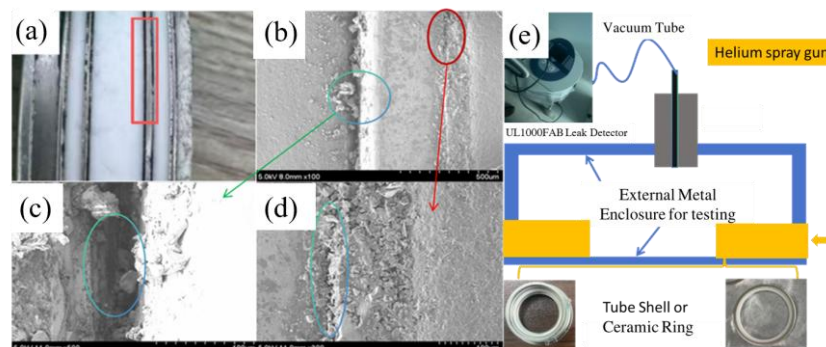
Figure 6a–d show the physical view of the image intensifier tube shell and the microscopic morphology of the tube shell sealing interface. Cracks are observed on the phenolic resin rigid housing on the device surface, and obvious gaps exist between the internal soft elastomer filler and the tube shell. Figure 6b provides a low-magnification overview of the sealing interface, while Figure 6c,d present the magnified view that clearly reveals these interfacial gaps marked by the colored circle. Further helium leak testing is performed on the tube shell and ceramic ring responsible for maintaining the vacuum level of the image intensifier. Figure 6e is the schematic diagram of gas leak rate detection. The hermeticity of the image intensifier tube shells is evaluated using a helium mass spectrometer leak detector with a detection limit of  $1 \times 10^{-13}$  Pa·l/s. The test followed the standard practice described in ASTM E1603 [27]. It is found that the ceramic ring of this device had a clear gas leak problem, with a gas leak rate reaching as high as  $2.4 \times 10^{-11}$  Pa·l/s. Considering the volume of the image intensifier, theoretically, the vacuum level drops to  $1 \times 10^{-4}$  Pa in just three months, meaning that the theoretical lifetime of the device would not exceed three months.

**Figure 6.** Physical and micro-morphology of the tube shell for sample 4# and gas leak rate detection. (a) Photograph of the tube shell; (b) low-magnification overall morphology of the sealing interface (scale bar: 500 μm); (c) local magnification of the interface edge (scale bar: 100 μm); (d) local magnification of the central region of the interface (scale bar: 100 μm); (e) schematic diagram of gas leak rate detection.

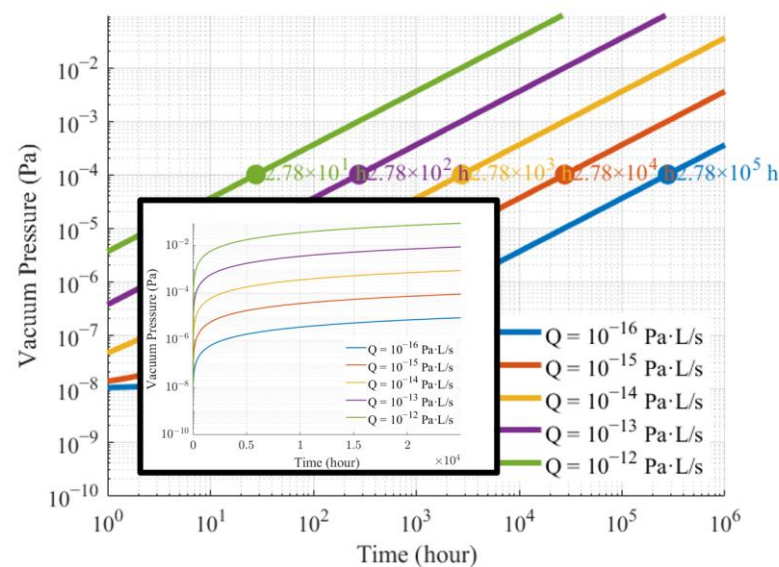
under these five different gas leak rates are plotted, as shown in Figure 7. The gas leak rates are set to  $10^{-16}$  Pa·L/s,  $10^{-15}$  Pa·L/s,  $10^{-14}$  Pa·L/s,  $10^{-13}$  Pa·L/s, and  $10^{-12}$  Pa·L/s, respectively. It is assumed that the volume of the image intensifier is  $1 \text{ cm}^3$ , the initial vacuum level of the image intensifier can reach  $10^{-8}$  Pa [14], and the time range is 100,000 h. According to the vacuum decay kinetic model (Equation (6)), the time required for the internal vacuum level of the image intensifier to drop from the initial value  $P_0 = 1 \times 10^{-8}$  Pa to the failure threshold  $P_t = 1 \times 10^{-4}$  Pa is calculated for five different gas leak rate conditions. The calculation assumed an effective internal volume of the image intensifier  $V = 1 \text{ cm}^3 = 1 \times 10^{-3} \text{ L}$ . The calculated results are converted from seconds to hours ( $1 \text{ h} = 3600 \text{ s}$ ), yielding the durations under different gas leak rates, which are directly presented by the labeled points in Figure 7.

**Figure 7.** Vacuum level decay under different gas leak rates (log–log plot, initial vacuum level is  $1 \times 10^{-8}$  Pa), the insert is a semi-log plot.

The simulation results further reveal that, assuming an initial vacuum level of  $P_0 = 1 \times 10^{-8}$  Pa, the vacuum level decreases rapidly in the initial stage as storage time increases, and then tends to stabilize. Moreover, the higher the gas leak rate, the faster the initial decay rate of the internal vacuum level of the tube shell, and the lower the stabilized vacuum level. Therefore, when manufacturing image intensifier products, the production units should strive to minimize micro-leak holes in the image intensifier, thereby reducing the gas leak rate and ensuring an optimal internal vacuum, which is beneficial for extending the lifetime of the image intensifier.

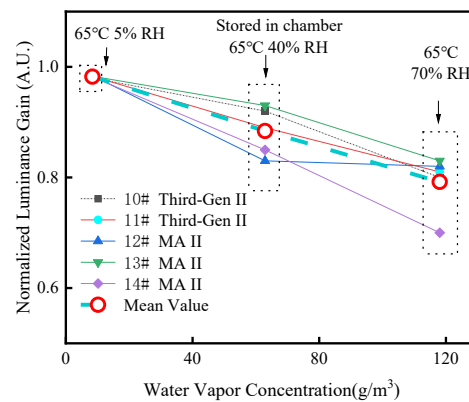
Figure 8 shows the normalized luminance gain degradation values and their mean values of five image intensifiers after 50 h of storage under varying water vapor concentrations. The five image intensifiers used in the experiment include two third-generation image intensifiers (Third-Gen II) and three multi-alkali photocathode image intensifiers (MA II). Relevant storage conditions for each concentration are indicated in the figure. All data group were collected from samples stored in a temperature–humidity chamber, with water vapor concentrations of 8.4, 62.9 and  $118.05 \text{ g/m}^3$ , respectively. The maximum deviations in individual measurements from the corresponding averages are 0.0024, 0.0540 and 0.0920, while the relative standard deviations (RSD) reach 0.1%, 4.4% and 5.9%, respectively. It is evident that the degradation rate of the screen luminance gain of image

**Figure 8.** Relationship between the luminance degradation value of the image intensifiers screen and water vapor concentration.

$$\frac{G_0 - G}{G_0} = k \times a \quad (12)$$

where  $G_0$  is the initial luminance gain;  $G$  is the luminance gain after a certain exposure time;  $a$  is the water vapor concentration (absolute humidity,  $\text{g/m}^3$ ); and  $k$  is the attenuation coefficient ( $1.75 \times 10^{-3} \text{ m}^3/\text{g}$  for 50 h), which depends on factors such as material properties, exposure time, and temperature (unit:  $\text{m}^3/\text{g}$ ). It can be further rearranged as:

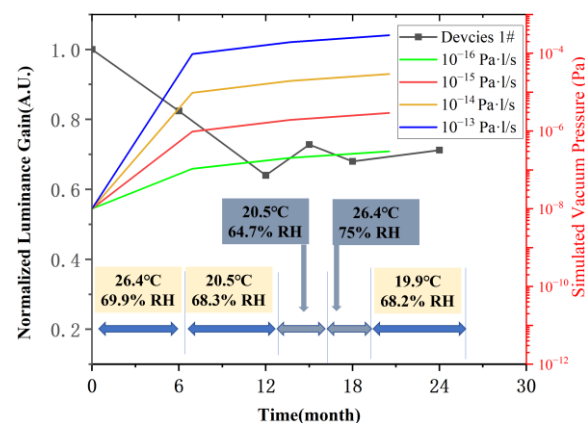
According to the graphical analysis of the luminance gain degradation data of image intensifiers exposed in the field for 24 months, the luminance gain performance degradation shows a linear relationship during the first 12 months, and then becomes essentially stable. This indicates that after the device is moved from a vacuum packaging environment to a high-temperature and high-humidity environment, the luminance gain performance decreases linearly with the ingress of water vapor in the initial stage. After degrading to a certain value and after 12 months, the vacuum level inside the image intensifier begins to stabilize, and the water vapor concentration remains at around  $14 \text{ g/m}^3$  (annual average temperature  $20^\circ\text{C}$ , average relative humidity 69%), as shown in Figure 9. The above phenomenon indicates that the water vapor pressure difference between the inside and outside of the device is no longer sufficient to further degrade the performance of the core internal components, demonstrating that the influence of water vapor concentration on the core components tends to stabilize after it increases to a certain level.

**Figure 9.** Luminance degradation of the image intensifier as a function of exposure time under natural humid and hot environments; the inset illustrates the variation trend of vacuum degree inside the image intensifiers after 12 months under different gas leak rates.
