## Review

# Failure Modes and Influencing Factors of Rubber O-Ring Seals in High-Pressure Hydrogen Environments

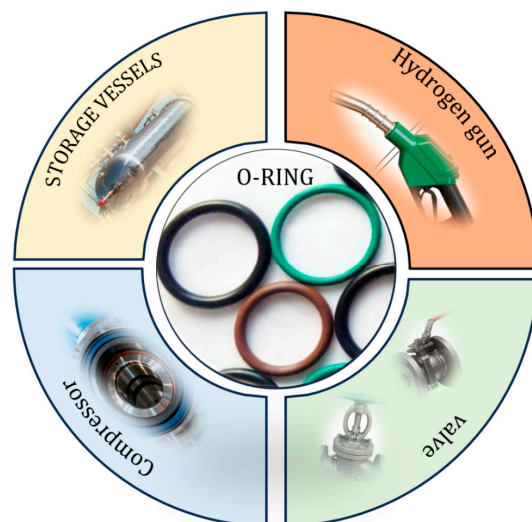
**Figure 1.** Common application scenarios of hydrogen environment O-ring seals.

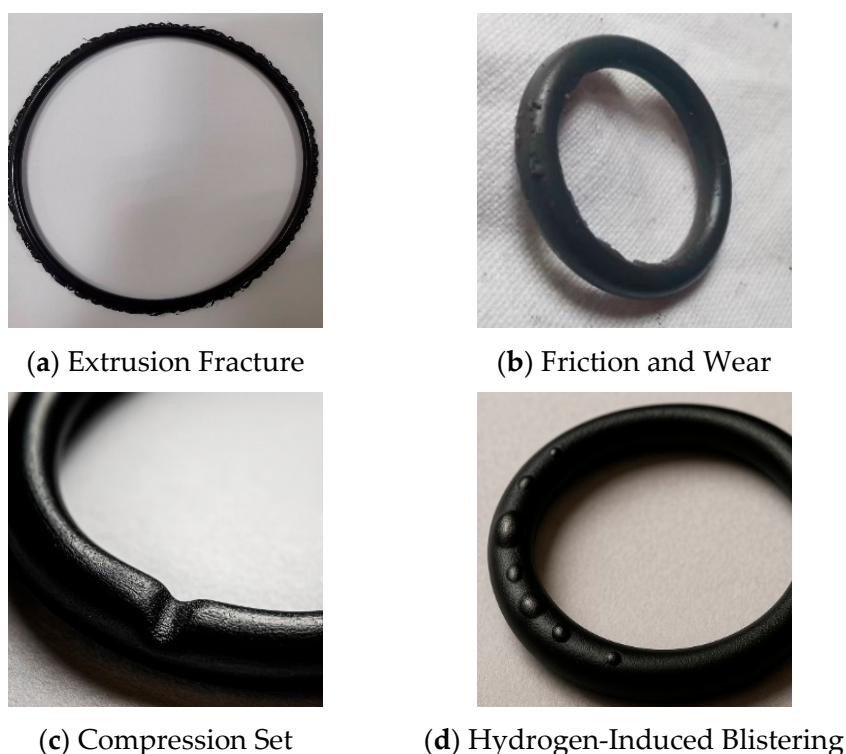
**Figure 2.** Common failure modes of O-rings in high-pressure hydrogen environments.

Under a high-pressure hydrogen environment, the failure behavior of O-rings often exhibits complex multi-mechanism characteristics, which can be mainly categorized into two types: mechanical damage caused by structural and load conditions, and material degradation induced by the hydrogen environment. Some of the hydrogen-induced O-ring failures are shown in Figure 2. Mechanical failure typically stems from structural design flaws, improper control of groove dimensions or compression ratio, with its typical modes including fatigue cracking, extrusion damage, wear, and stress cracking [9]. Fatigue damage is commonly observed in dynamic sealing systems; long-term repeated compression can induce microcracks in stress concentration areas, which gradually propagate and eventually lead to fracture or interface failure [10]. Extrusion damage, on the other hand, frequently occurs under high-pressure conditions when the groove design is unreasonable or the compression ratio is insufficient. In such cases, the rubber material is forced into the gap area, prone to tearing, shearing, or even complete ring detachment [11]. In working conditions where impurity particles, metal burrs, or eccentric movement of mating parts exist, long-term friction and fretting fatigue can cause surface wear and scratches, which further develop into crack sources and accelerate seal failure [11].
