Case Report

Investigation and Analysis of a Hazardous Chemical Accident in the Process Industry: Triggers, Roots, and Lessons Learned

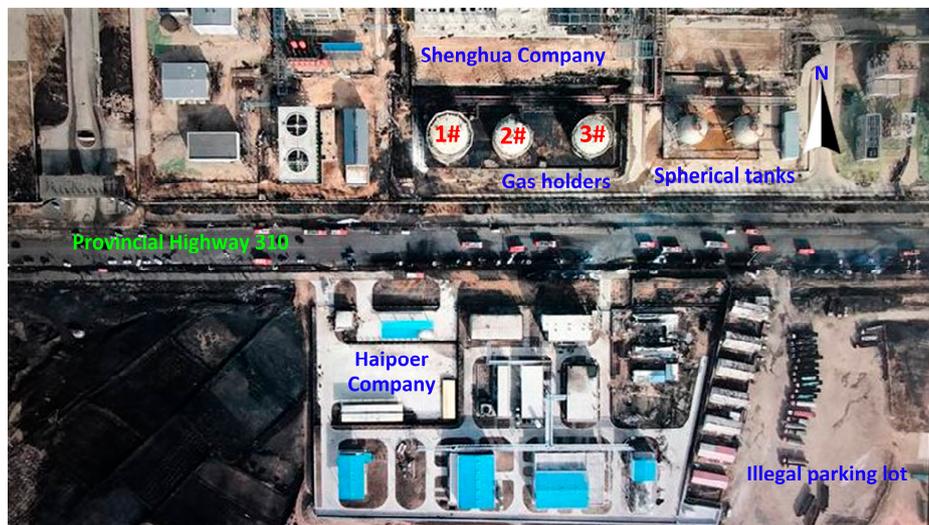
Through on-site investigations, the storage installations of vinyl chloride are located on the south side of Shenghua Company. There are three gas holders distributed from west to east, with volumes of 5300 m³ (1#), 2500 m³ (2#), and 2500 m³ (3#), as well as two similar spherical tanks installed side-by-side, with a volume of 2000 m³. The specific distribution in the plant is shown in Figure 4 below. According to the accident report, the leaks just occurred in the 1# gas holder with the largest amount of vinyl chloride. This installation is designed as a double-layer bell-shaped structure sealed by the water. When the bell housing pulls the middle section up, a U-shaped annular water seal will be formed. The designed height of the water seal is about 0.350 m, which can seal vinyl chloride of 3.43 kPa. The schematic structure of 1# vinyl chloride gas holder is shown in Figure 5.

Figure 4. The map of the accident scene.

As shown in Figure 3, the vinyl chloride gas holder group is located at the southernmost side of Shenghua Company, about 20 m away from the north side of the Provincial Highway 310. Affected by the local terrain condition and the wind direction at the time of the accident, the leaked vinyl chloride spread along the road extensively and diffused to the opposite Haipoer New Energy Technology Company (hereinafter, Haipoer Company, Zhangjiakou, China) who was mainly engaged in the preparation of hydrogen and oxygen by electrolysis of water. Through the on-site surveillance videos, eyewitness interviews and fire spread path analyses, the investigators finally determined that the fire source resulting in the explosion was from a high-temperature muffle furnace near the oxygen preparation and filling area in Haipoer Company. A further investigation and test showed the device had been continuously energized for 4 h and 24 min by the time of the incident, and the temperature at

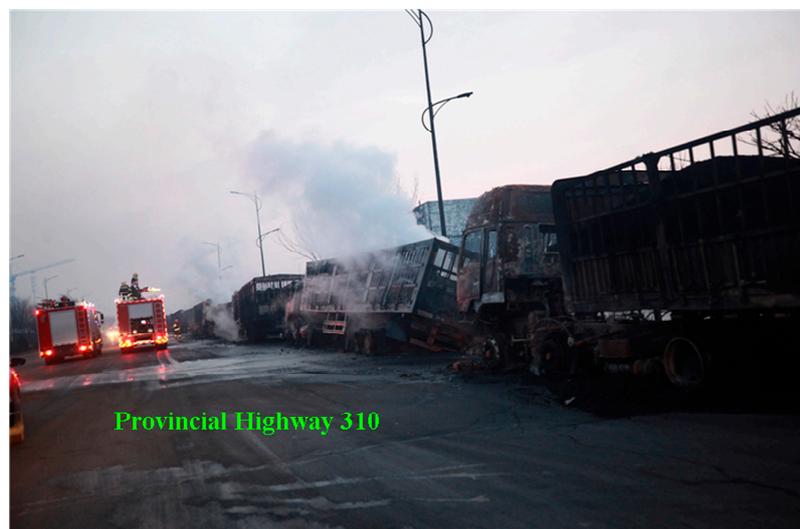
When the explosion occurred, lots of vehicles loaded with raw materials and fuels (coal) hired by Shenghua Company, as well as several small passenger cars were being illegally parked on the Provincial Highway 310 and the opposite illegal parking lot. Many drivers and supercargoes stayed in the trucks overnight because of Shenghua Company's delay of unloading. After the leaked vinyl chloride was ignited, the fire rapidly spread to the vehicles; moreover, the fire further expanded and quickly formed domino effects (see Figure 8) due to the flammable and explosive substances in the vehicles. Therefore, it was not surprising that the accident caused such heavy casualties and property losses.

Figure 8. Damaged vehicles on the Provincial Highway 310.
