Article

Deep Learning-Based Thermal Image Analysis for Pavement Defect Detection and Classification Considering Complex Pavement Conditions

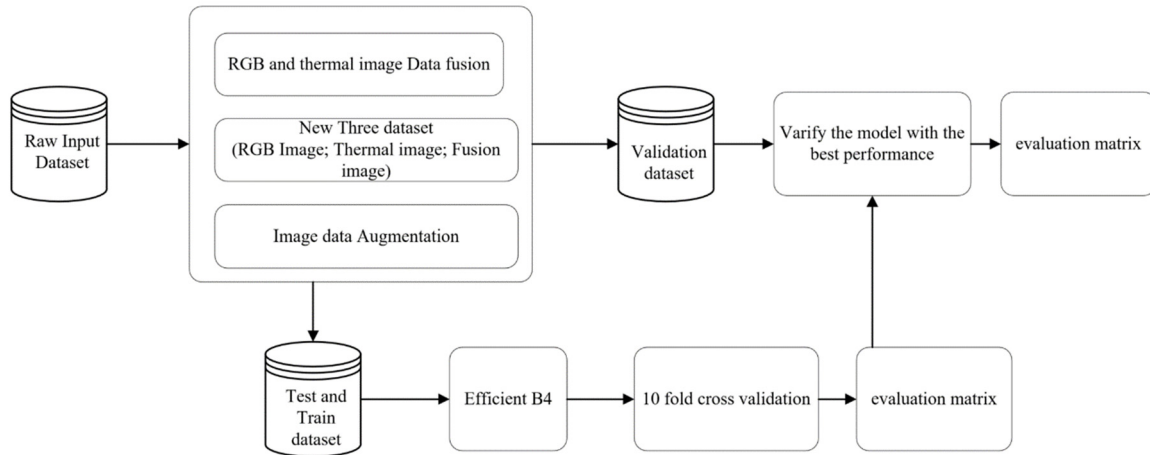
Figure 1 shows the workflow of the proposed work. Each pavement damage was captured as an RGB image and thermal image (registered by the device at the acquisition stage). A 50% transparent thermal image was then superimposed on the RGB image to form a fused image, thus forming three distinct data sets for comparison experiments. Also, nine different categories of pavement damages were considered, and 500 images were captured per category (The diversity of the dataset ensures the robustness of the model in deep learning [35]). The image data was then put through data augmentation to increase the

data sample size. The data set was divided in the ratio of 6:2:2 to form a training set, test set, and validation set. The EfficientNet-based learning mechanism was then used to train the model using a ten-fold cross-validation training method (making the trained model more stable). The optimal model was then selected for model validation.

Figure 1. Work flow of proposed work.

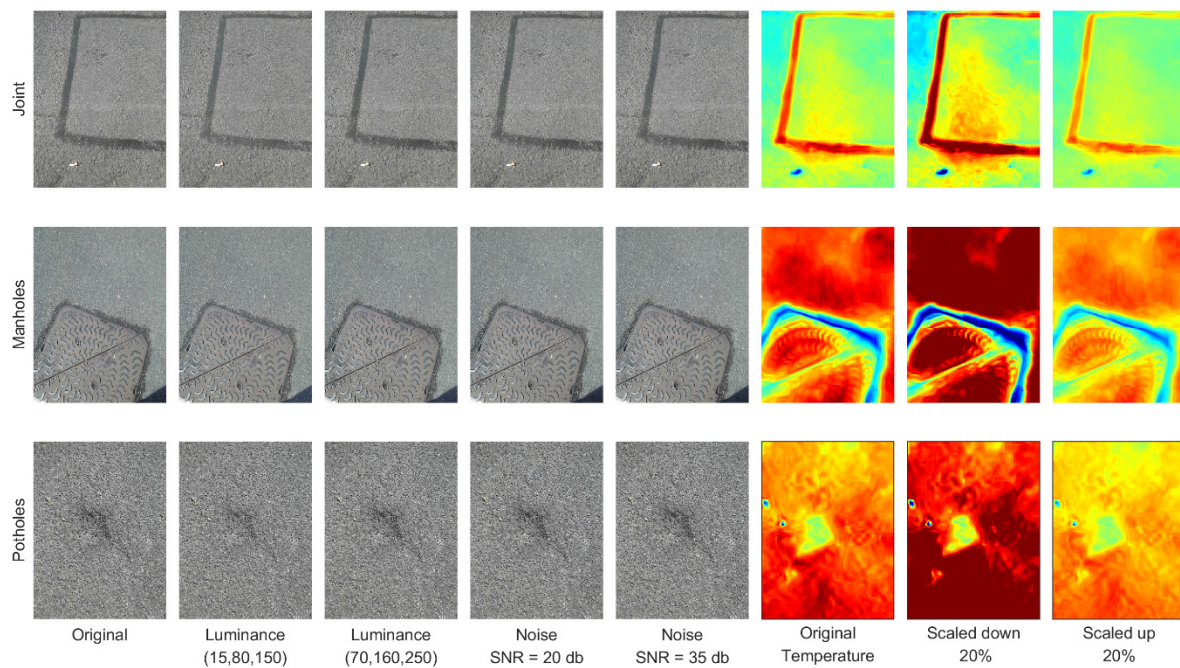
Figure 4. Data augmentation of joint, manholes and potholes.

In this experiment, there were 1500 RGB images and 1500 thermal images in each category after the expansion, totaling 13,500 images. The data classifier was trained using the original images and the expanded data in the dataset collected in 2.2. Only the collected data were used for evaluation to ensure the accuracy of the model and to avoid the existence of similar images in both train and test sets (the dataset was divided first and then the data was augmented. Figures 3–5 shows the results of data augmentation.

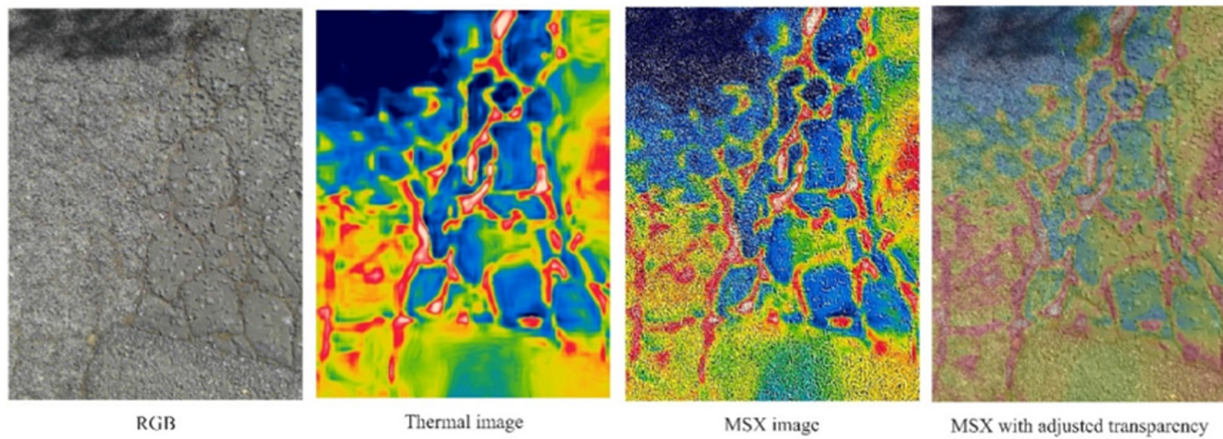
subsequent step of this paper, 50% transparency for the thermal image was used to fuse to form MSX image (performed under MATLAB script), and also augmented MSX images were formed based on the augmented image generated in Section 2.3.

Figure 6. Samples of RGB image, thermal image, MSX image and MSX image with transparency.

Each of the four types of data (indicated in Figure 6) was used as input data. They were then put through the optimal model identified in Section 4.3, and the results are presented in Table 4. Evidently, the RGB input had better prediction results than IR with higher accuracy, precision, recall, and F1-score. Consequently, MSX images enhanced the evaluation results of recognition rate in comparison to RGB images. Finally, the fused image (adjusted the transparency to show both texture and thermal properties) input exhibited significantly higher and better detection results than any other input image types (RGB, IR, and MSX).

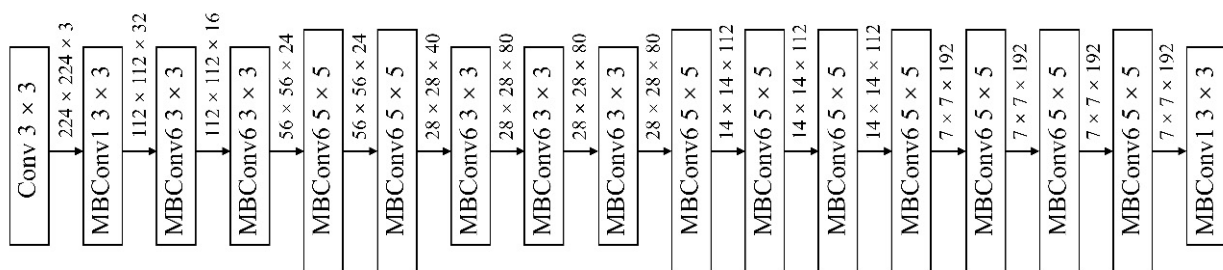
Figure 7. Baseline model EfficientNet B0.

The inverted bottleneck MBConv, the main building block for EfficientNet, consists of a layer that first extends and then compresses the channels, thus direct connections between bottlenecks can be used to connect much fewer channels than the extended layer. Compared to traditional convolutions layers, this architecture has deeply separable convolutions that reduce the computation by a factor of nearly k with conventional layers.

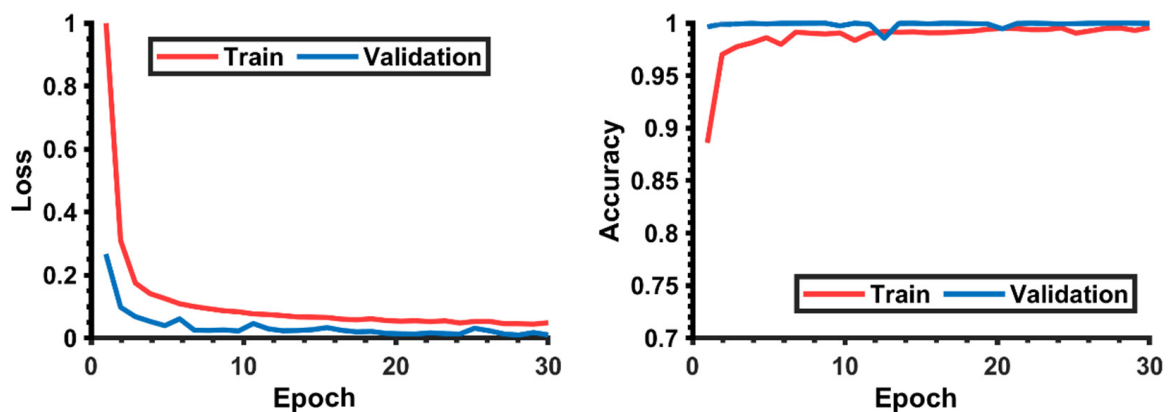
Although different versions of EfficientNet were explored under this research, EfficientNet B4 was chosen as the best encoder option for the main framework in this paper. For the model to converge quickly at the beginning, the dataset was then randomly disrupted before importing for calculation. This ensured that the input contains multiple types of data in a batch. As presented in Figure 10, the model was able to attain good accuracy after 3 epoch training. Furthermore, the algorithm was written to obtain results after 10-fold cross-validation before selecting the optimal one for detection. The results were then presented as an evaluation matrix (see Figure 11). The results showed a high average accuracy measure of 98.34% ranging from 96.91% to 99.52%; however, longitudinal and transverse cracks appear to have certain confusion as 11 images of longitudinal crack were misclassified as transverse crack. The reasons for these misclassifications could be that both longitudinal and transverse cracks exhibit similar texture and thermal characteristics with just the crack orientation seeming different and the angle of crack deflection seemingly difficult to quantify in the dataset. Figure 10 shows the loss and accuracy curves during training and validation.

Figure 10. Training and validation curve of accuracy and loss.

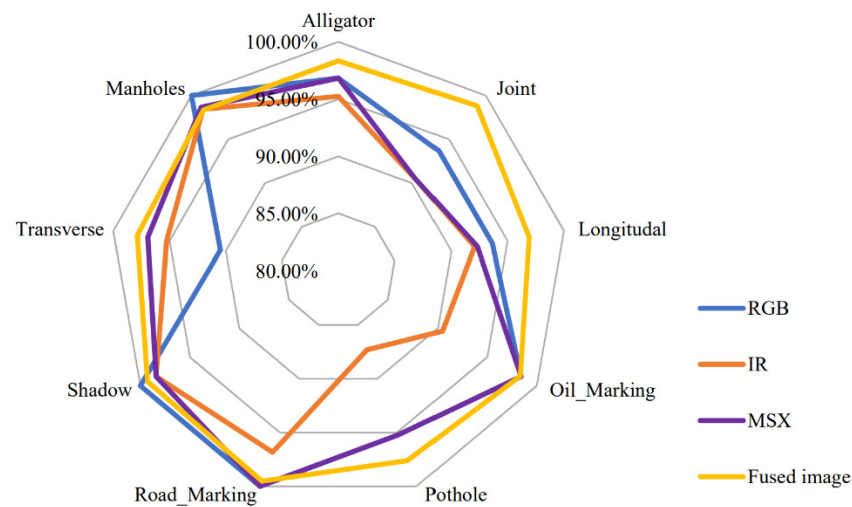
Analysing the same by pavement feature category, Table 5 presents the comparison of the model's prediction performance of the different input types for each class. Also, Figure 12 shows a detailed visual comparison of the model's prediction performance for each input image type. Overall, the results prove that the fused images as input achieve best results than other input image types with reliable predictions for alligator crack, joint, longitudinal crack, pothole, and transverse crack categories. However, the prediction performance for road marking, shadow, and manholes were slightly weaker than RGB images. This also proves that the fused images can indeed provide more information to differentiate pavement features better with more stable recognition performance for complex conditions too.

**Figure 12.** Comparison of performance for each class with different input data.
