Article

A New Methodology for Bridge Inspections in Linear Infrastructures from Optical Images and HD Videos Obtained by UAV

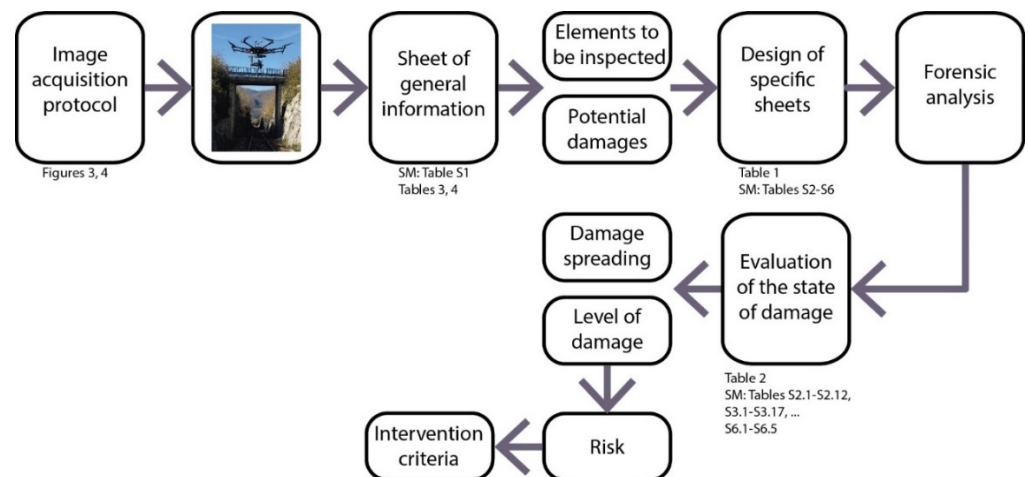
The workflow of the proposed methodology begins with the acquisition of images and videos by an unmanned aerial vehicle (UAV), which allows to safe access to all parts of the structure without traffic disruptions. To avoid erroneous information and/or loss of information, the image acquisition cannot be randomly performed and must follow a standardized protocol, such as the one proposed in this work. Therefore, in this paper, a standardized and systematized proposed image acquisition protocol is applied for data acquisition. The first document to be completed by engineers using the information provided by an UAV is the general information form. After data acquisition, the images and videos are studied by specialized structural engineers for description and damage identification. Also, the structural elements to be reviewed and the list of potential damage must be systematized. Specific standardized forms designed for structural inspection are then filled in using the acquired information. Finally, if necessary, recommendations about the need for new and more detailed inspections, either by specialized engineers or by UAVs should be stated (Figure 2).

Figure 2. Workflow of the proposed methodology.

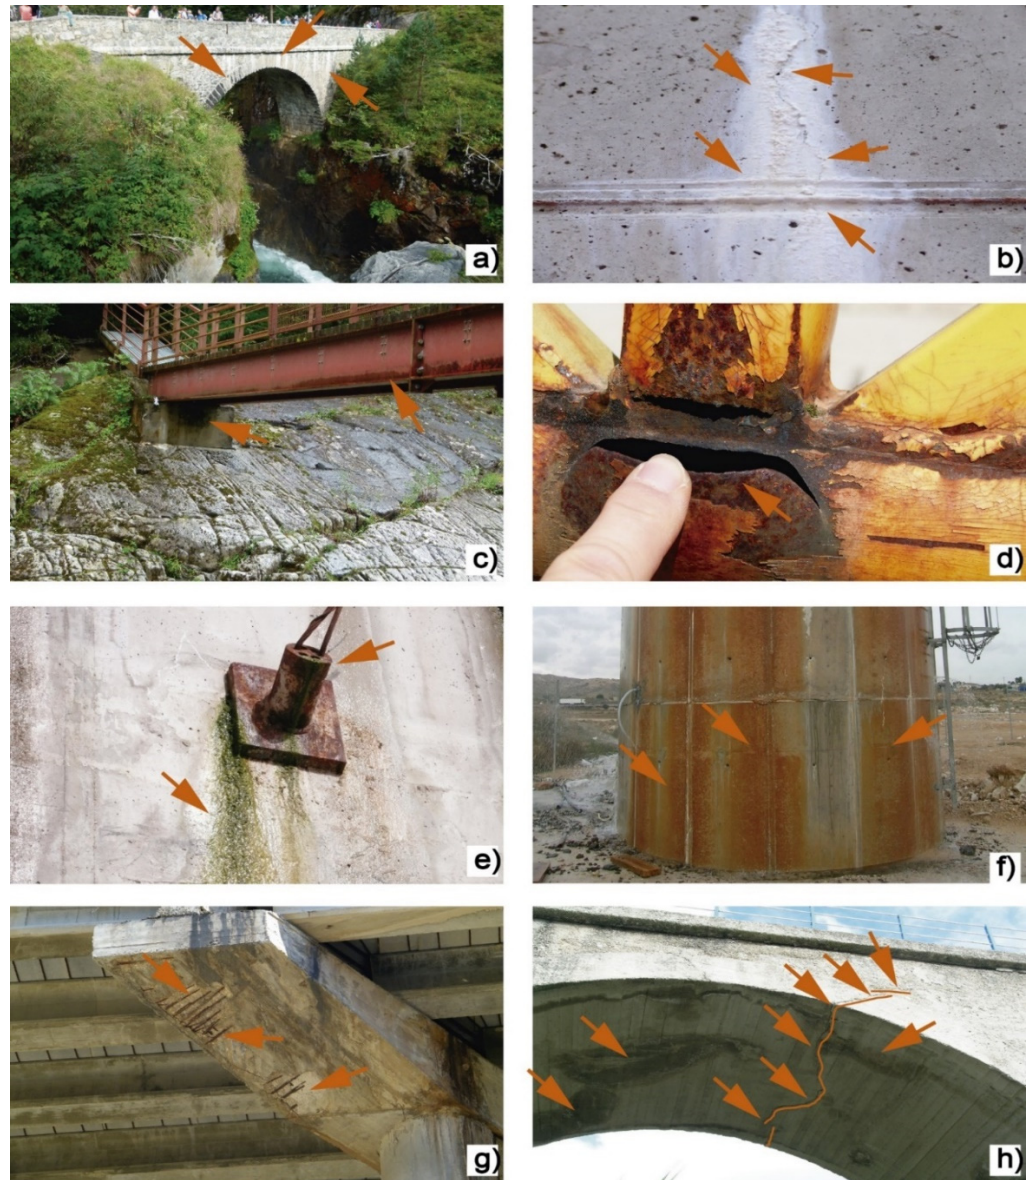
- Lichen growth occurs when a stone-like material (masonry, concrete, bricks, etc.) support exhibits an excessive humidity (Figure 3c,e).
- Rust stains are due to lack of covering in structural reinforcement or to lack of covering in the formwork connectors (Figure 3f).

- Cracking is likely to occur when a structure cannot accommodate a movement (Figure 3b,d,h). Alternatively, cracks can appear because of other nonstructural issues (e.g., thermal effects). They can affect columns, beams, shear-keys, etc. and can present different configurations and distribution patterns. The location, length, orientation, and the opening of cracks are of paramount interest.

- Spalling is a term used to describe areas of concrete that have cracked and delaminated from the substrate. Steel reinforcement corrosion comprises the gradual destruction of the steel reinforcement of reinforced concrete structures by chemical and/or electrochemical reaction with their environment. It can affect any part of the reinforced concrete structure (Figure 3g).

- Structural steel corrosion comprises the gradual destruction of steel structural elements by chemical and/or electrochemical reaction with their environment (Figure 3c–e). It can affect any part of the steel structure. Special attention must be paid in suspension and cable-stayed bridges to the cables and anchorages. This Figure shows some examples of steel structures corrosion.

Figure 3. Some common damages that can affect bridges: (a) efflorescences on a masonry bridge in Cauterets, France; (b) efflorescences and crack in a reinforced concrete wall; (c) lichen growth in abutment and corrosion of a steel bridge beam in Lanuza, Spain; (d) crack and corrosion in steel truss handrail in Alcoy, Spain; (e) lichen growth caused by excessive humidity and corrosion in cable anchor plate in abutment in Benidorm, Spain; (f) rust stains in a surge chamber; (g) concrete spalling due to corrosion of steel reinforcement in a bridge in Petrer, Spain; (h) transverse cracks on reinforced concrete arch of bridge in Alcoy, Spain.

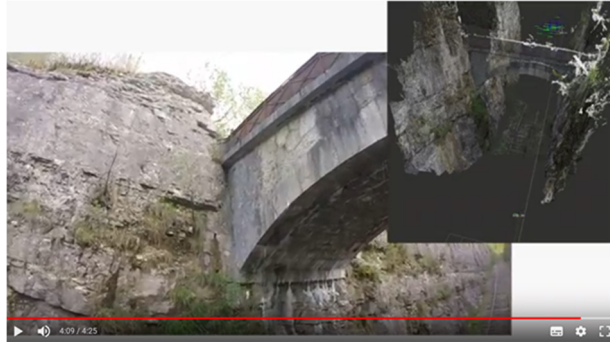
The studied bridge has construction elements made of masonry and of metal. Damage catalogued as M6 (mineral precipitation in joints) and M7 (lichen growth) were identified in the masonry elements, both detected in the abutments and the arch.

Damage M6, corresponding to mineral precipitation in joints (speleothems), showed a moderate damage spreading (some areas about 10–50%) and the level of damage was moderate (light to medium mineral precipitation). Based on this, risk A2/B2 was assigned, which shows that the recommendation regarding the intervention criterion corresponds to new regular inspections whose frequency will be based on the age of the bridge: IC1 (Figure 7).

Damage M7 (Lichen growth) detected on the abutments and the arch of bridge 1 was catalogued as a moderate damage spreading (some areas about 10–50%) and the level of damage as moderate (medium-density colonization). Based on this, a risk A2/B2 was assigned, which shows that the recommendation regarding the intervention criterion corresponds to new regular inspections whose frequency will be assessed according to the age of the bridge: IC1.

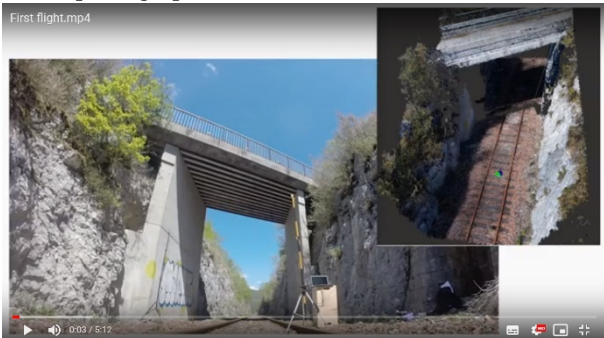
MOMIT MULTI-SCALE OBSERVATION AND MONITORING OF RAILWAY INFRASTRUCTURE THREATS
Reference: Demonstrator bridge 2: Concrete bridge	
Bridge abutment 1 location (UTM coordinates)	X: 46.34248069440977 Y: 5.692425433712043
Slide 1 photograph

On bridge 2, construction elements of concrete, composite elements (metal plus concrete) and construction elements of metal were identified. The damage was catalogued as C2 (Concrete spalling because of reinforcement corrosion) in the concrete elements (abutment A1 and column P1, Figure 8). C3 damage (failures caused by impacts) affected only the column P1 (Figure 8a). Rust stains due to the lack of covering in structural reinforcement, named C4, involved the deck (Figure 9). Finally, damage C7 (Lichens growth) was identified on the abutments, piers, and deck (Figure 9b).
