# UAV and Deep Learning for Automated Detection and Visualization of Façade Defects in Existing Residential Buildings

**Keywords:** unmanned aerial vehicle (UAV); deep learning; coordinate transformation; building façade defect segmentation; mapping; high-density cities

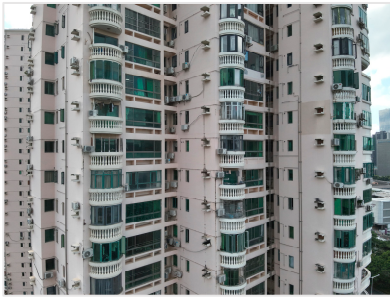
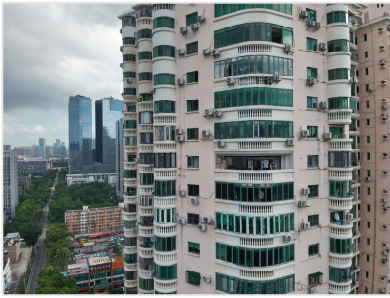
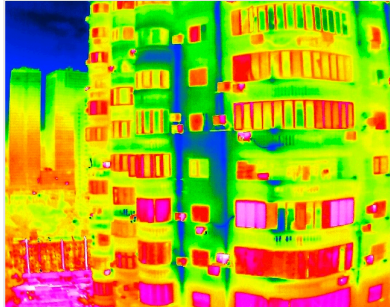
Table 7. Leakage Mapping Results.

| Shennan Garden | DJI0001 | DJI0002 |
|---|---|---|
| Visible light im-<br>age | | |
| Infrared image | | |
| Infrared distort-<br>ion correction | | |
