Quantifying Crack Self-Healing in Concrete with Superabsorbent Polymers under Varying Temperature and Relative Humidity

Ahmed R. Suleiman ¹, Lei V. Zhang ²

Citation: Suleiman, A.R.; Zhang, L.V.; Nehdi, M.L. Quantifying Crack Self-Healing in Concrete with Superabsorbent Polymers under Varying Temperature and Relative Humidity. *Sustainability* **2021**, *13*, 13999. <https://doi.org/10.3390/su132413999>

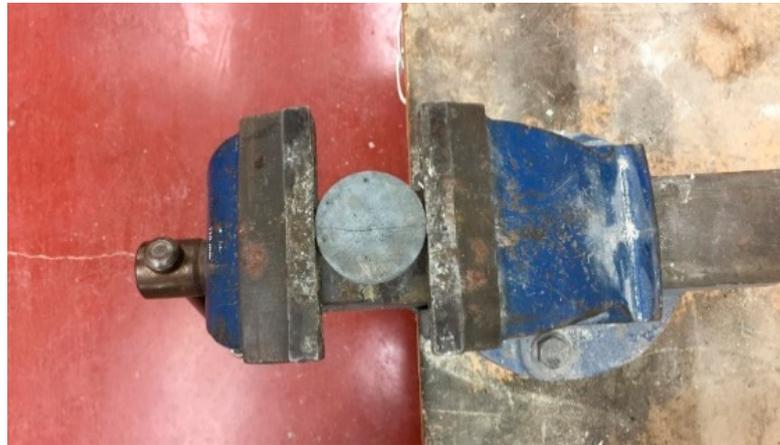
For the computed tomography scan samples, the crack was created using a screw jack (Figure 1). The crack width was controlled via a calibration ruler as per the method described by Roig-Flores et al. [14]. In addition, an optical microscope was used to measure the width of the surface part of cracks. Based on the crack width range, specimens were

Figure 1. Cracking of specimens using screw jack.

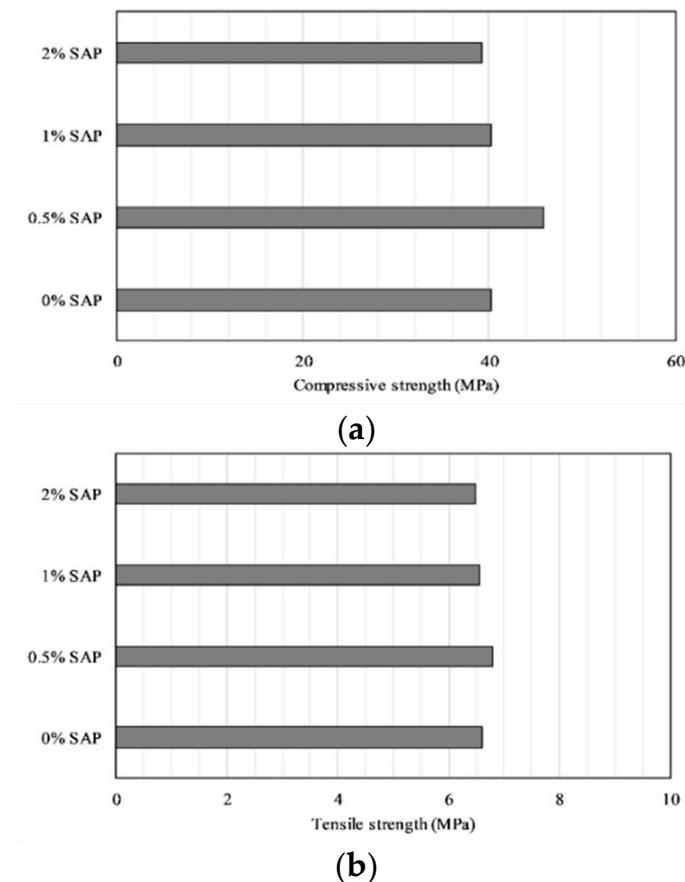
Figure 2 depicts the compressive and tensile strength results of mortar specimens after 28 days. It can be observed that 0.5% SAP specimens achieved an increase in compressive and tensile strength. This can be ascribed to SAP particles which absorb some mixing water, leading to lower water-to-cement (w/c) ratio, and thus resulting in densification of the cementitious matrix. However, by increasing the amount of SAP particles in the cementitious matrix beyond that threshold level, both compressive and tensile strengths decreased, which may be attributed to the formation of macro-pores when SAP particles release the absorbed water at a later stage and shrink and delaying the hydration process due to water absorption during mixing.

Figure 2. (a) Compressive, and (b) tensile strength of specimens (with/without SAP) after 28-d.

4. 0.5% SAP specimens attained an increase in compressive and tensile strength. However, by increasing the amount of SAP particles in the cementitious matrix beyond that threshold level, both compressive and tensile strengths decreased.

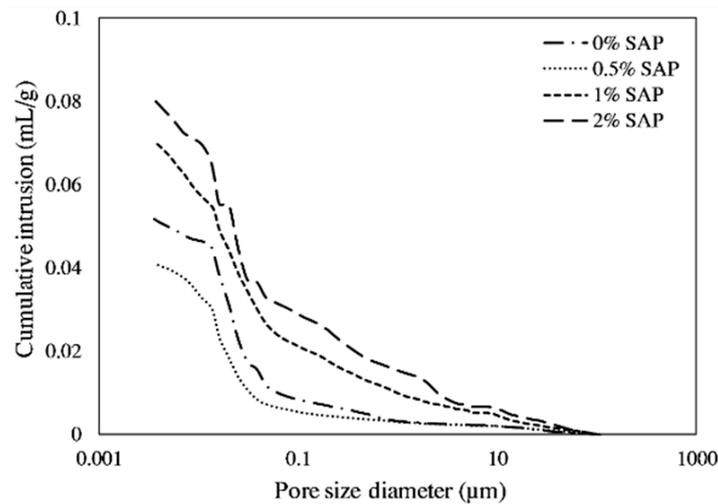
Figure 3a shows the MIP test results for cracked mortar specimens at 28 d (before self-healing). Results indicate that 0.5% SAP specimens had decreased porosity compared

with that of the control 0% SAP specimens since SAP particles absorb some mixing water, which reduces the w/c ratio and results in lower porosity. Similar findings were reported by Mönning [32], who found that the total measured pore volume in specimens made with SAPs was smaller than that in specimens without SAPs. Snoeck et al. [33] also reported that cement pastes with SAPs and without additional water had a decrease in porosity compared to reference specimens with the same w/c ratio.

Figure 3. MIP results for cracked samples (a) at 28 d, and (b) samples with 1% SAP after five months of exposure to different environments.

On the other hand, MIP results show that the total porosity of cement mortars incorporating SAP increased as the SAP content increased beyond 0.5%. During hardening, SAP particles release their absorbed water and shrink, leaving behind voids in the cementitious matrix that have hundreds of microns in size [26,33]. For example, a previous study by Snoeck et al. [34] investigated the effect of high amounts of SAPs on the properties of cementitious materials. They posited that increasing the amount of SAP particles in cement mortars resulted in increasing the total amount of pores. This effect was more prominent with smaller SAP particles due to their higher surface area accessible for combining mixing water.

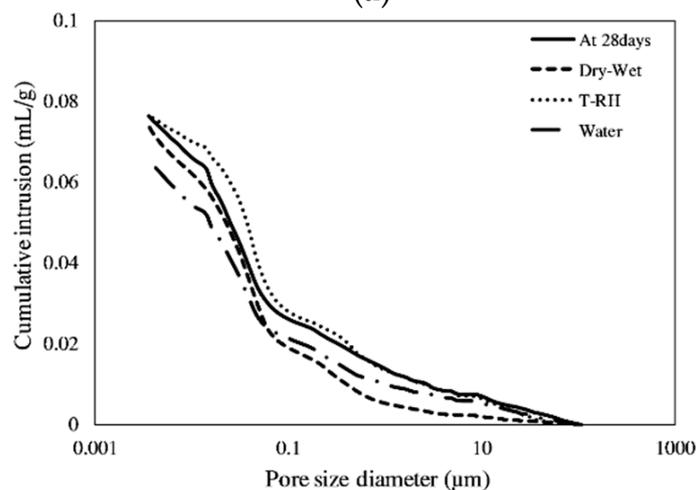
(b)

Figure 3b depicts the MIP test results for cracked mortar samples made with 1% SAPs and exposed to different environments. Results show that submerged samples and samples

subjected to cyclic wetting and drying achieved a reduction in porosity in comparison to that of samples exposed to an environment with a combined change in temperature and relative humidity. The presence of liquid water led to a decrease in porosity, which prompted microstructural densification. On the other hand, samples subjected to an environment with a combined change in temperature and relative humidity had a slight increase in porosity, which may be associated with the development of microcracks resulting from the cyclic exposure to different T and RH.

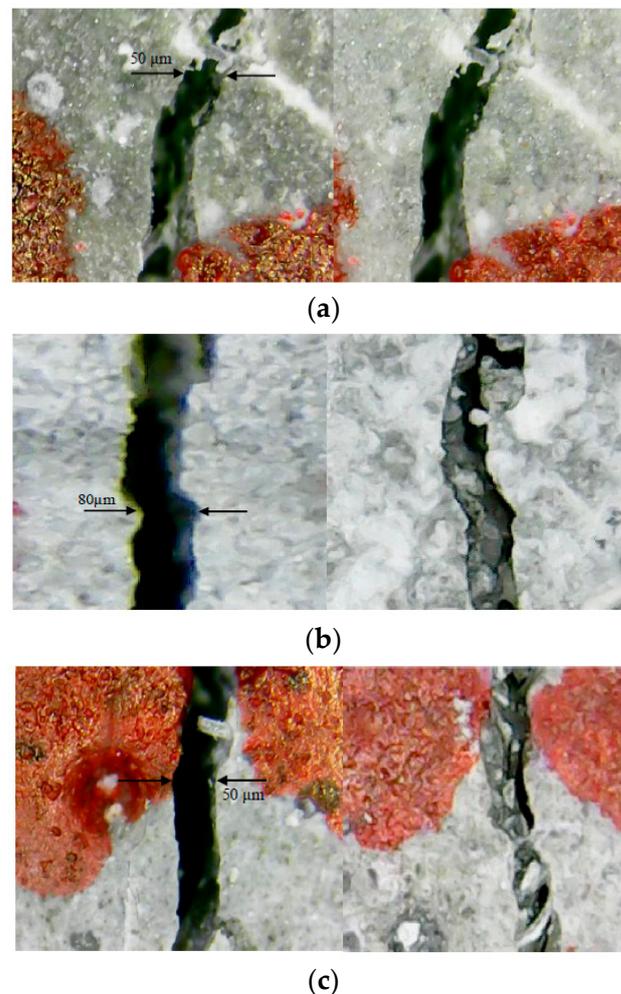
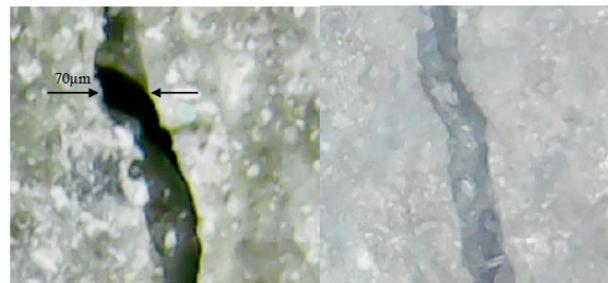
Figure 4 depicts the surface crack healing of mortar samples after five months of exposure to an environment with a combined change in temperature and relative humidity. It can be observed that only specimens with SAPs achieved partial healing. For example, specimens with 2% SAPs had crack closing of up to around $65 \pm 10 \mu\text{m}$. In comparison, 0% of SAP samples featured no crack closing via self-healing. For 1% and 0.5% SAP samples, the widest healed crack was $50 \pm 10 \mu\text{m}$ and $20 \pm 10 \mu\text{m}$, respectively. Therefore, the capacity of crack healing in decreasing order was 2% SAP, 1% SAP, 0.5% SAP, and 0% SAP.

Figure 4. Surface cracks before and after five months of exposure to an environment with a combined change in T and RH of samples (a) 0% SAP; (b) 0.5% SAP; (c) 1% SAP; and (d) 2% SAP.

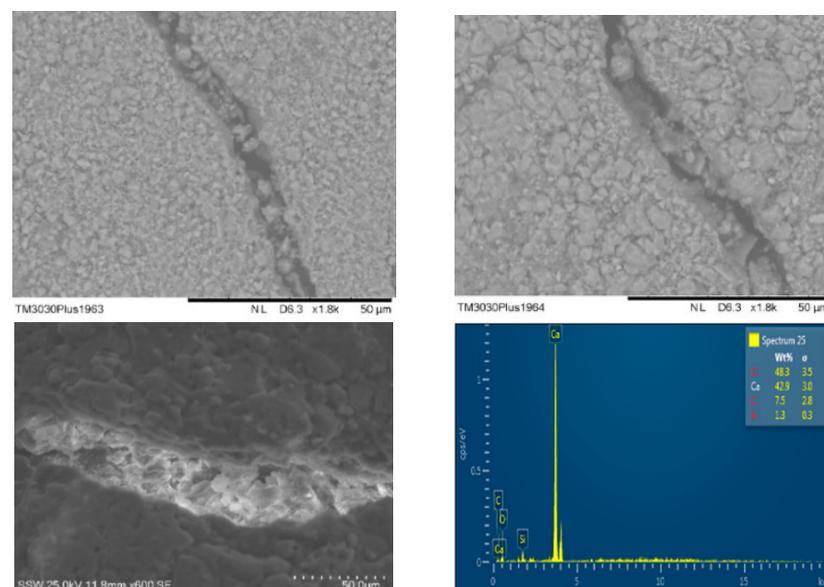
Results of EDX analyses (Figure 5) revealed that healing compounds formed in surface cracks were dominated by CaCO_3 . Apparently, SAP particles were able to absorb moisture and stimulate autogenous healing, even without direct contact with water. Due to decreased RH, the initially swelled SAP particles could release water into the cementitious matrix. Previous study by Snoeck et al. [35] showed that only mortar specimens with SAPs exhibited self-healing due to moisture uptake when exposed to an environment with relative humidity higher than 60%. Similar specimens, yet with no SAPs, showed no sign of self-healing when exposed to a similar environment. According to Snoeck et al. [35], SAP particles are capable of sustaining cement hydration reactions through releasing their absorbed moisture and providing the necessary moisture for CaCO_3 to form and precipitate. Thus, SAPs could supply moisture to activate the autogenous self-healing in dry environments [25].

Figure 5. SEM image with EDX analysis of compounds within self-healed cracks of samples with 1% SAP after exposure to an environment with a combined change in T and RH.

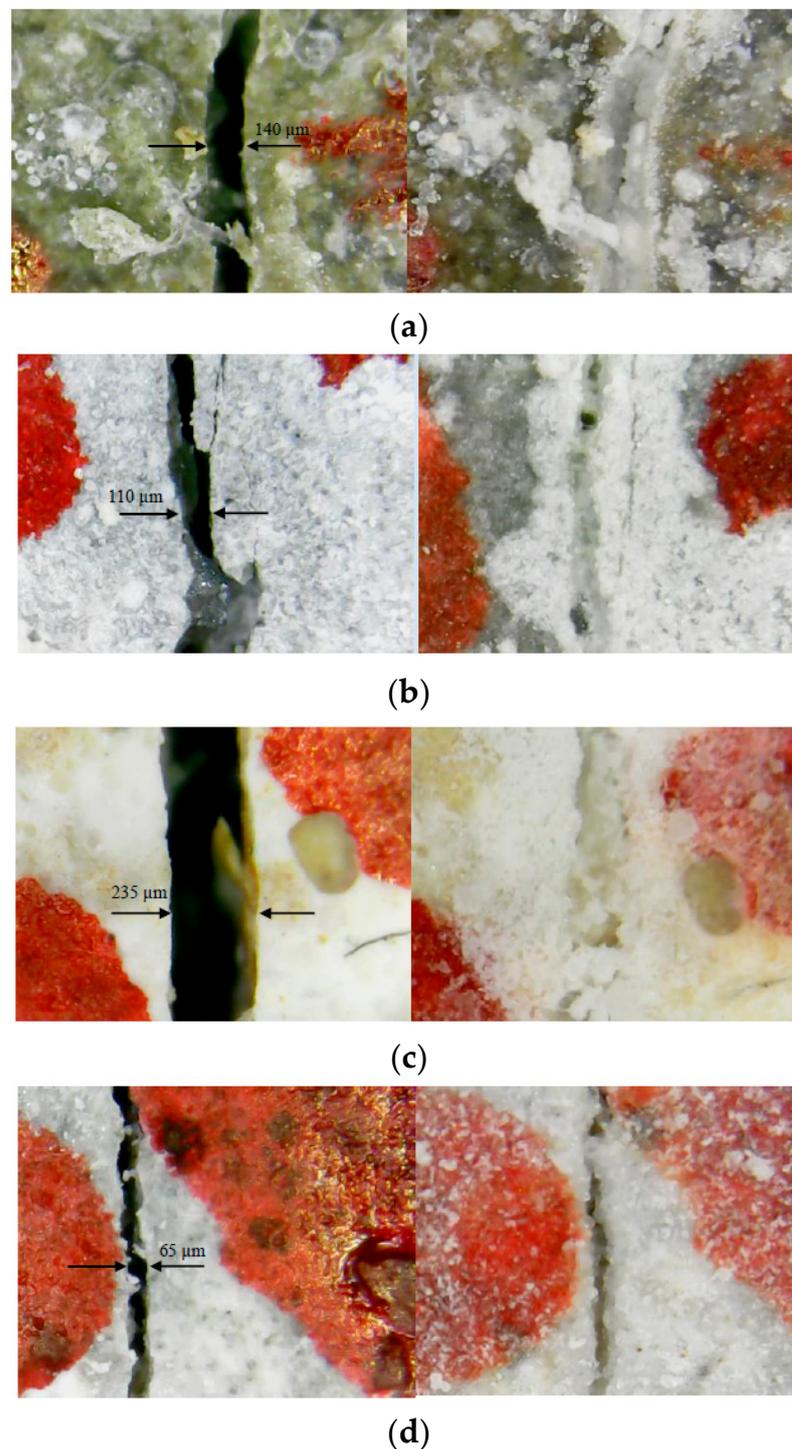
Figure 6 depicts the surface crack healing of fiber-reinforced mortar samples submerged in water for five months. For both types of samples, with and without SAPs, that were fully submerged into water, surface cracks having various widths exhibited self-healing. Healing products, which formed in cracks, consisted of white crystals. After five months of water submersion, only samples with initial crack widths of 50 to 150 μm (with and without SAPs) achieved complete surface crack healing.

Figure 6. Surface cracks prior to and after five months of water immersion of samples. (a) 0% SAP; (b) 0.5% SAP; (c) 1% SAP; and (d) 2% SAP.

For the second group of specimens having initial crack width of 150–300 μm, surface cracks were only able to heal partially. The widest initial crack width that was healed for samples submerged in water for the five months test duration was about $275 \pm 15 \mu\text{m}$, $260 \pm 10 \mu\text{m}$, $255 \pm 10 \mu\text{m}$, and $235 \pm 5 \mu\text{m}$ for the 0% SAP, 0.5% SAP, 1% SAP, and 2% SAP specimens, respectively.

For the third group of specimens having initial crack width of 300 to 500 μm, surface cracks achieved no or minor self-healing. Similar results were reported by others who found that the maximum surface crack width healed via autogenous or improved autogenous

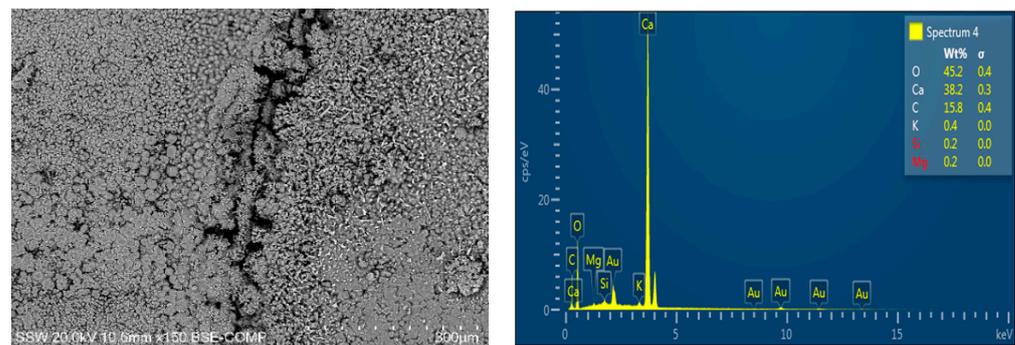
self-healing, which uses crystalline, expansive, or supplementary cementitious materials, was less than 400 μm for specimens submerged in water [36–39]. According to Van Tittelboom et al. [36], as the crack width increased, crack self-healing became more difficult to achieve, indicating that crack self-healing is inversely proportional to the crack width. To characterize the self-healing products that developed within surface cracks, SEM with EDX detector was used. Results from SEM images and EDX spectrum of the healing compounds which formed within surface cracks (Figure 7) consisted primarily of oxygen, calcium, and carbon, indicating that it mostly consisted of calcium carbonate crystals.

Figure 7. SEM micrograph with EDX pattern of self-healed compounds in cracks of samples incorporating 1% SAP after water submersion.

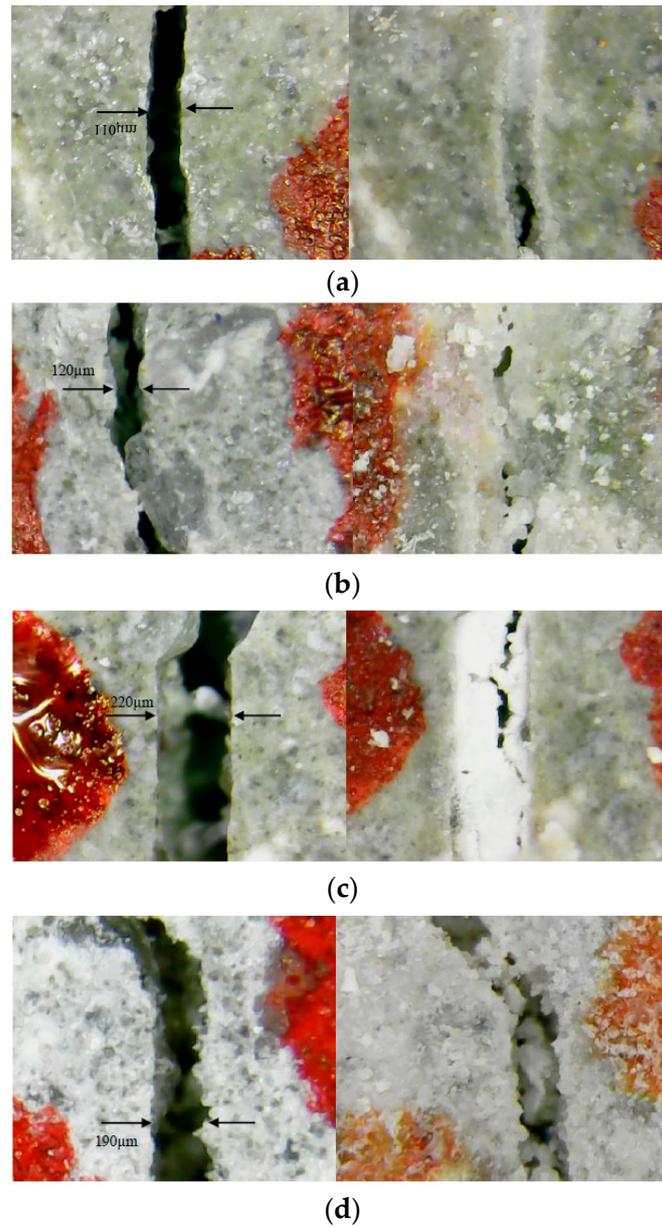
Figure 8 shows surface cracks before and after exposure to five months of cyclic wetting and drying. Results indicate that 2% SAP specimens achieved the highest self-healing rate. Surface cracks of up to around $220 \pm 10 \mu\text{m}$ in width were completely sealed. On the other hand, 0% SAP samples achieved the least self-healing rate. The highest crack width healed in 0% SAP samples was $180 \pm 10 \mu\text{m}$. For 1% SAP and 0.5% SAP samples, the highest crack width healed was $205 \pm 5 \mu\text{m}$ and $190 \pm 10 \mu\text{m}$, respectively. Therefore, the capacity of crack healing was in the order of 2% SAP, 1% SAP, 0.5% SAP, and 0% SAP, respectively.

These results can be ascribed to the fact that SAP particles were able to supply water during the dry cycle of the wet-dry process, therefore enhancing the potential of crack self-healing. A previous study by Snoeck et al. [24] investigated autogenous healing in strain-hardening cement-based composites containing SAPs. Crack healing was improved by adding SAPs in specimens exposed to wet/dry cycles. Therefore, SAPs can promote crack healing in cement-based materials exposed to cyclic wetting and drying. SEM and EDX analyses also showed that the healing products formed within surface cracks for samples exposed to wet/dry cycles consisted mainly of CaCO_3 (Figure 9). This finding agrees with previous studies [24,33,34]. Therefore, CaCO_3 appears to be the main autogenous self-healing compound of cracks in cementitious composites incorporating SAPs and exposed to cyclic wetting and drying.

Figure 8. Surface cracks prior to and after five months of cyclic wetting and drying of samples (a) 0% SAP; (b) 0.5% SAP; (c) 1% SAP; and (d) 2% SAP.

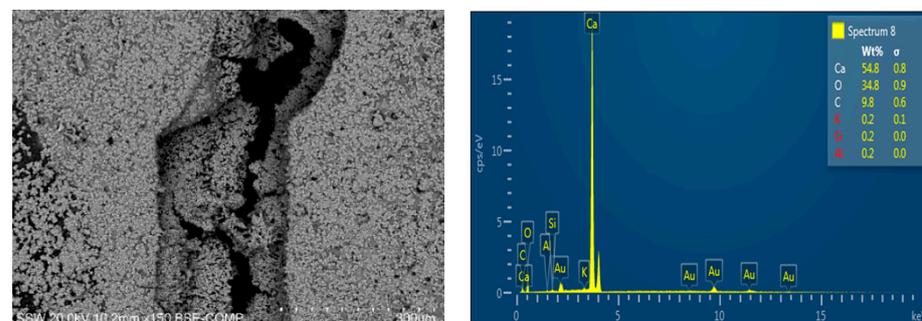
Figure 9. SEM image with EDX analysis of self-healed compounds within cracks of samples incorporating 1% SAP after cyclic wetting and drying.

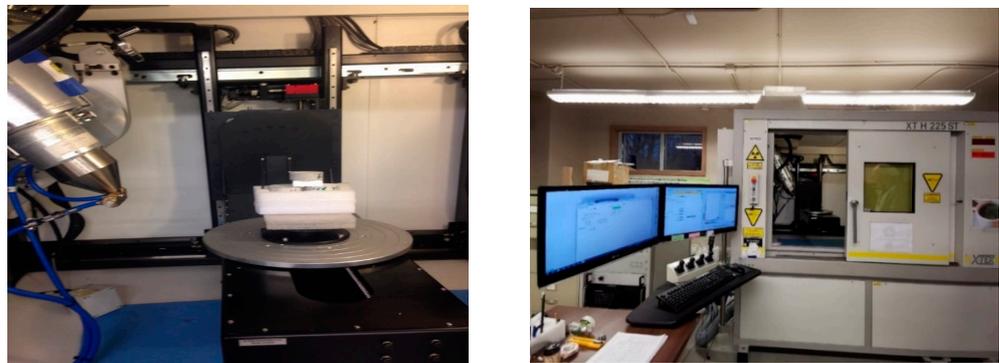
To quantify the self-healing, a Nikon XT-H-225-ST μ CT scanner housed at the Sustainable Archaeology lab, Western University, was used as shown in Figure 10. Samples made with 1% SAP having initial crack width of 150 to 300 μ m and exposed to different environmental conditions were selected for CT scan analysis. Two scans were conducted (at the cracking and after exhibiting surface crack self-healing) for each sample. Parameters of the scan were defined as follows: voltage = 215 kVp; current = 80 μ A (power of 17.2 W). A 1-mm Cu filter was used to filter the X-ray beam. A total of 3141 projections were gathered during a 56 min scan. The X-ray projections were harvested to reconstruct the exterior and interior of the sample using the Nikon's CT-Pro (v 4.4.3) reconstruction software. All CT scans were then analyzed using a 3D image processing and segmentation software (Dragonfly 3.5) to distinguish between the voids and cracks and determine the change in size of the entire crack volume owing to self-healing. For each sample, the entire crack was segmented, and the total volume was quantified before and after self-healing. The amount of the healing product was estimated by subtracting the volume of the crack before and after self-healing.

Figure 10. X-ray μ CT scanning.

To measure the change in the entire volume of the crack due to self-healing, a Nikon XT H 225-ST industrial Computed Tomography (CT) scanning system was used. The XT H

225-ST provides detailed high-resolution inner and outer 3D images. The specimens were scanned before and after each environmental exposure. An advanced segmentation and quantification analysis software (Dragonfly 3.5) was used to calculate the change in the volume of crack due to self-healing.

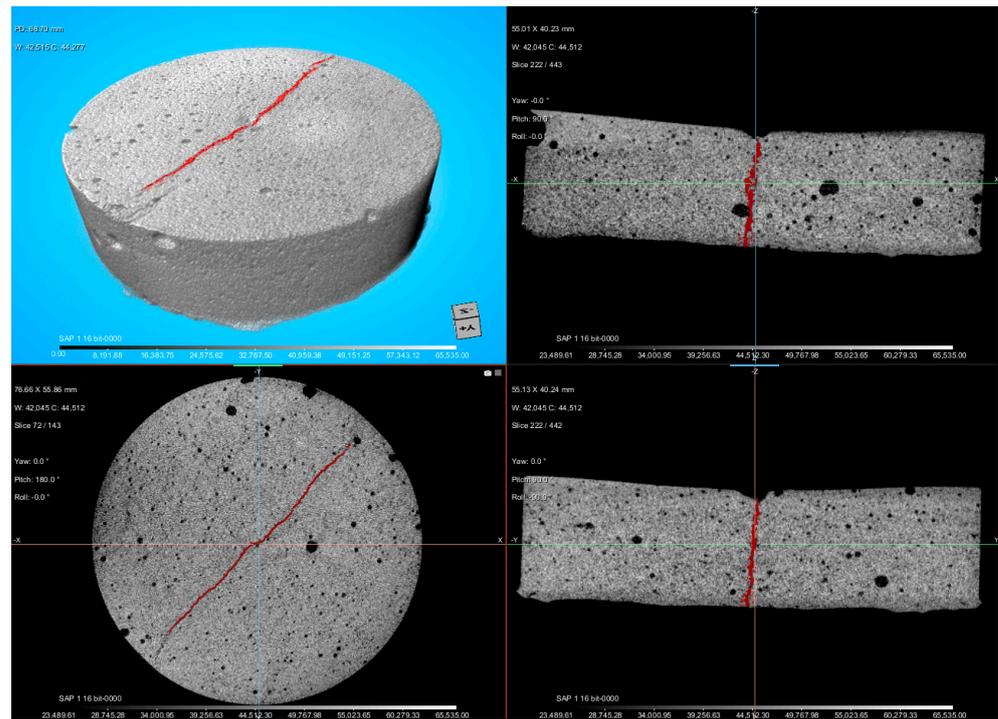
Figures 11 and 12 show the crack segmentation. Table 6 presents the results of quantification analysis of cracks using 3-D image analysis prior to and after each exposure. Results show that the healing efficacy was 26.32%, 19.11%, and 6.58% for 1% SAP samples exposed to water submersion, cyclic wetting, and drying, and an environment with a combined change in T and RH, respectively. The results indicate that the environmental condition plays a major role in autogenous crack self-healing of cement-based materials. For instance, according to the segmentation and quantification analysis, cement mortars incorporating 1% SAP and submerged in water achieved the highest crack volume reduction owing to autogenous self-healing in comparison to similar mortars that were exposed to either wetting and drying or to an environment with a combined change in T and RH.

Figure 11. CT Scans images showing crack segmentation.

CT scan images also showed that most healing compounds, which formed in specimens exposed to various environmental conditions, were essentially located close to the surface region of samples. Conversely, deeper at the interior regions of cracks, the amount of healing compounds was significantly less. Wang et al. [16] studied the self-healing behavior of concrete samples made with hydrogels encapsulated bacterial spores. Their results indicate that complete self-healing was only limited to surface cracks. Previous studies [41,42] explored the depth of autogenous self-healing in engineered cementitious composites using X-ray computed microtomography and found that self-healing was limited to the top surface of the crack until a depth of around 50 to 150 μm . Similar findings have been reported by Snoeck et al. [24]. A possible reason for this phenomenon is that the rapid formation of CaCO_3 at the surface cracks blocked water and carbon dioxide from entering deeper inside cracks, thus leading to less healing potential in the interior parts of cracks. According to Sisomphon et al. [38], locations near the crack surface region are usually the only areas that contain a significant amount of both calcium and carbonate ions. Therefore, more precipitation of CaCO_3 can be observed near the crack surface than in any other location.

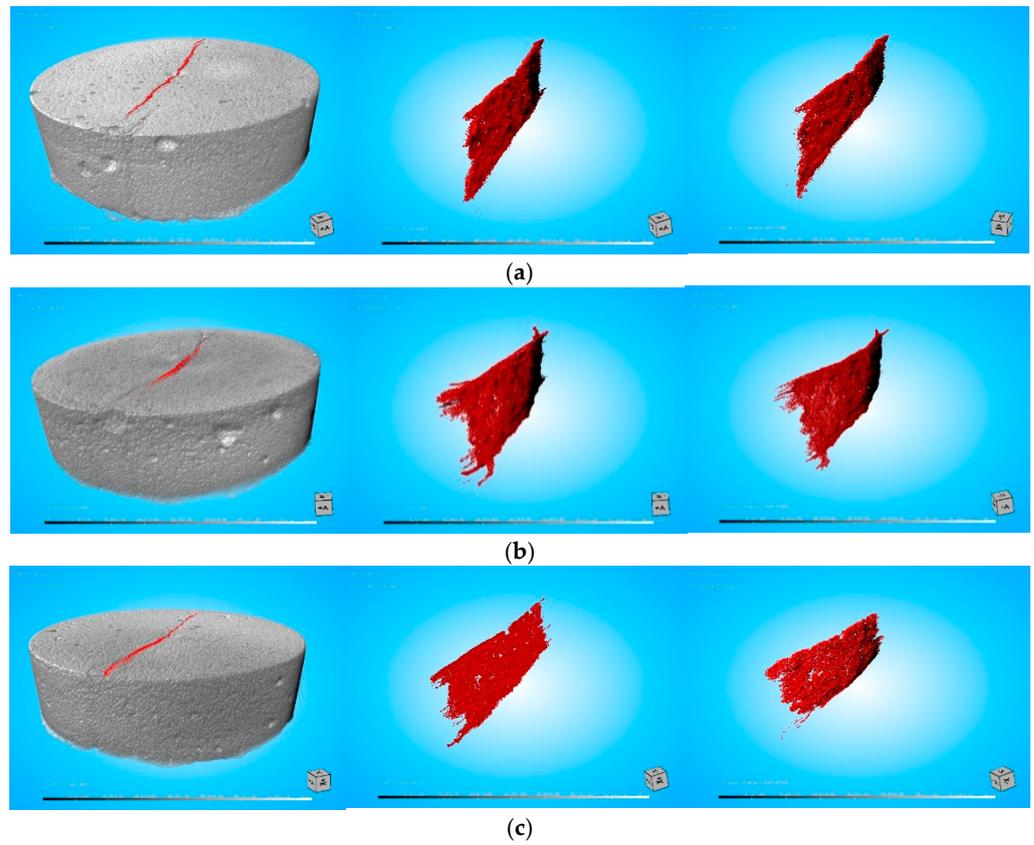
Although mortar specimens incorporating SAPs and exposed to an environment with a combined change in T and RH exhibited partial self-healing, CT scan analysis showed that their ability to self-heal was much less than that of their counterparts exposed to direct contact with liquid water. This indicates that cracks with direct contact with liquid water have a higher potential of autogenous self-healing. Similar findings were reported by Snoeck et al. [24] who investigated the autogenous self-healing behavior of strain-hardening cementitious materials containing SAP particles. They found that the autogenous self-healing was higher in specimens exposed to wet/dry cycles than in those exposed to only 90% relative humidity. Mousavi et al. [40] reported that SAPs can substantially increase the autogenous healing performance of concrete when exposed to wetting and drying cycles. According to Sisomphon et al. [38], cracks in cement-based materials exhibit autogenous self-healing when exposed to water due to CaCO_3 precipitation. For cracks to incur autogenous self-healing, both H_2O and CO_2 need to be present in the crack. As the cracked samples start to release Ca^{2+} ions, (CaCO_3) will precipitate and close the crack.

Figure 12. Crack segmentation before and after exposing to (a) an environment with a combined change in T and RH, (b) cyclic wetting and drying, and (c) continuous water submersion.
