Problems and Technical Issues in the Diagnosis, Conservation, and Rehabilitation of Structures of Historical Wooden Buildings with a Focus on Wooden Historic Buildings in Poland

Wojciech Terlikowski

Citation: Terlikowski, W. Problems and Technical Issues in the Diagnosis, Conservation, and Rehabilitation of Structures of Historical Wooden Buildings with a Focus on Wooden Historic Buildings in Poland. *Sustainability* **2023**, *15*, 510. <https://doi.org/10.3390/su15010510>

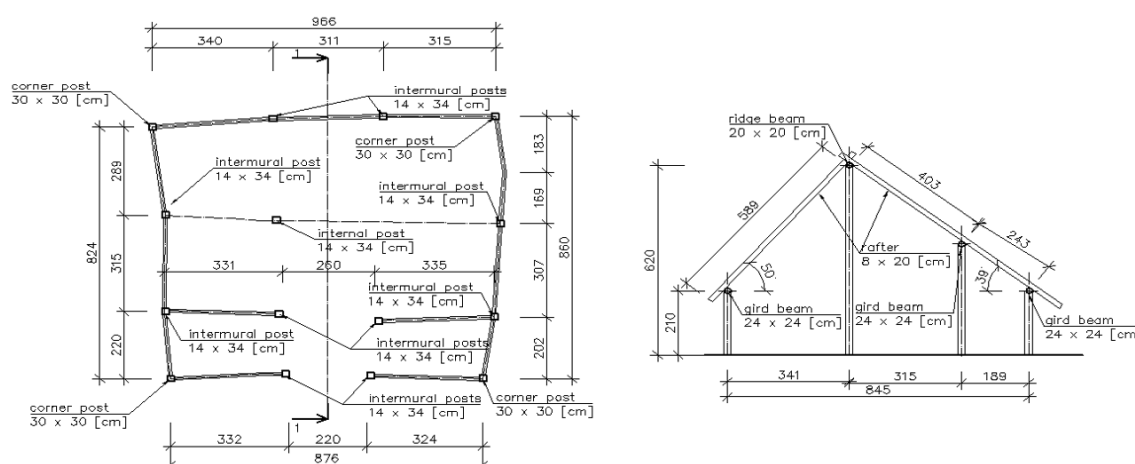
Figure 1. A projection and cross-section of an actual building in Biskupin [12,13].

Some of Poland's first materially documented wooden buildings, forming a compact urban layout, date to the early Iron Age. This is evidenced by studies of wooden logs preserved in Biskupin that show that 50 percent of the oak trees used in the construction of the defensive fortress there were felled in 748 BC, when the construction of the fortress buildings in Biskupin began [12]. The study also showed that the houses of the older phase of the fortress were made using a post and plank construction method with a roof post and a ridge beam, which was covered with a gabled, thatched roof. The roof structure consisted of rafters supported by a ridge beam and cap beams in the longitudinal walls. The wall structures consisted of rectangular posts and planks (Figure 1). Thus, it was a classic structure, still used today in wooden construction [12,13].

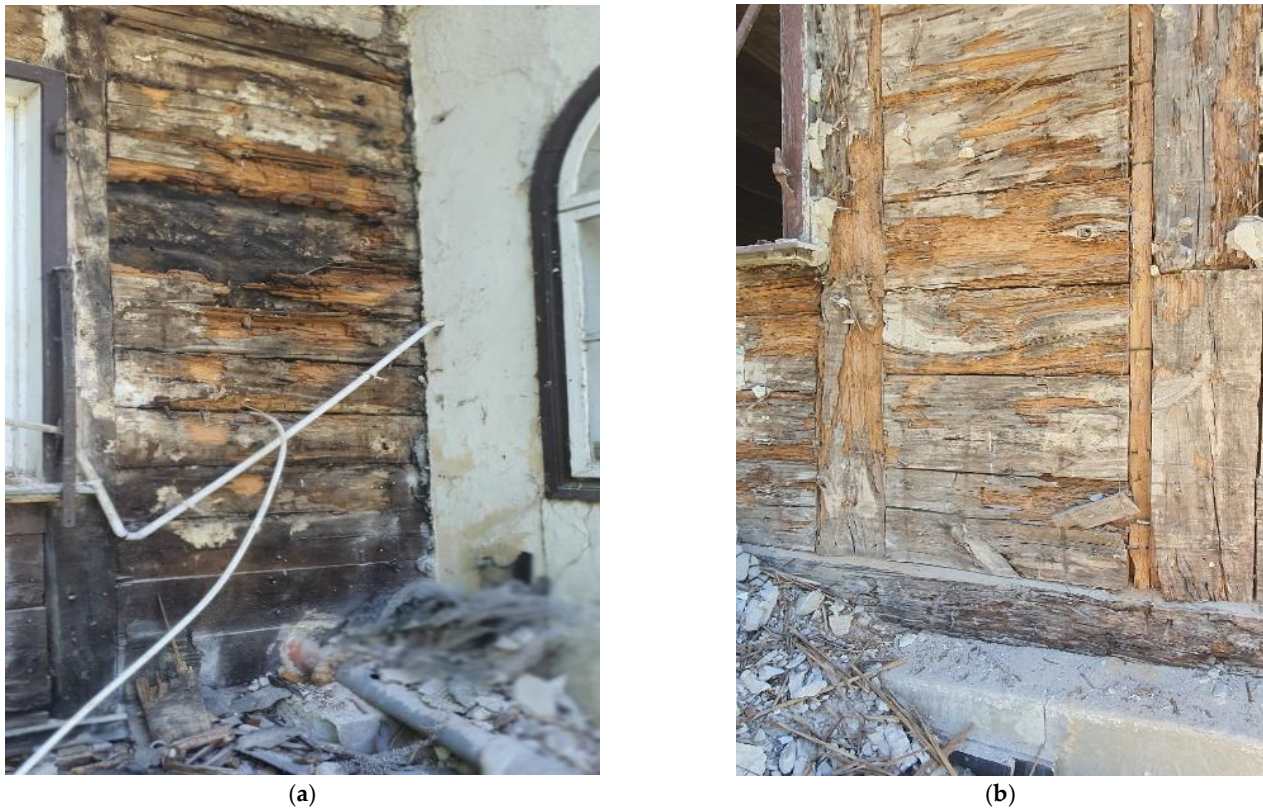
Figure 3. (a) Corroded front wall; (b) corrosion caused by insect aggression.

The diagnosis of wooden structures of historic buildings is a challenging and complex process due to the physical properties of wood and the various associated forms of possible degradation, such as those associated with moisture (or changes in moisture content) and its effect on wooden elements and the possibility of destructive effects from the environment (rain, snow, frost, wind, solar radiation, biological corrosion caused by fungi and insects, varying temperature conditions, fire, etc.). Issues related to the diagnostic process have been discussed in previous chapters. It is common for structural elements to be hidden under the facade and finish layers in historic wooden buildings. For this reason, without a comprehensive uncovering of the structural elements, assessing its technical condition based on the performance of local excavations may often not be reliable. Degradation does not develop uniformly and holistically in the building and is very often local. Thus, different forms of decay and damage to existing structural elements can occur in the building in different places. Excavations during diagnostic activities are usually local and may not provide a clear and accurate picture of the entire structural system. An example of this can be found in the case of a wooden manor house in the suburbs of Warsaw. The structure was classified as being in medium condition after diagnostics but was found to actually have a varied structure in terms of technical condition during renovation activities, with large parts of the structure in terrible condition (Figures 2–4).

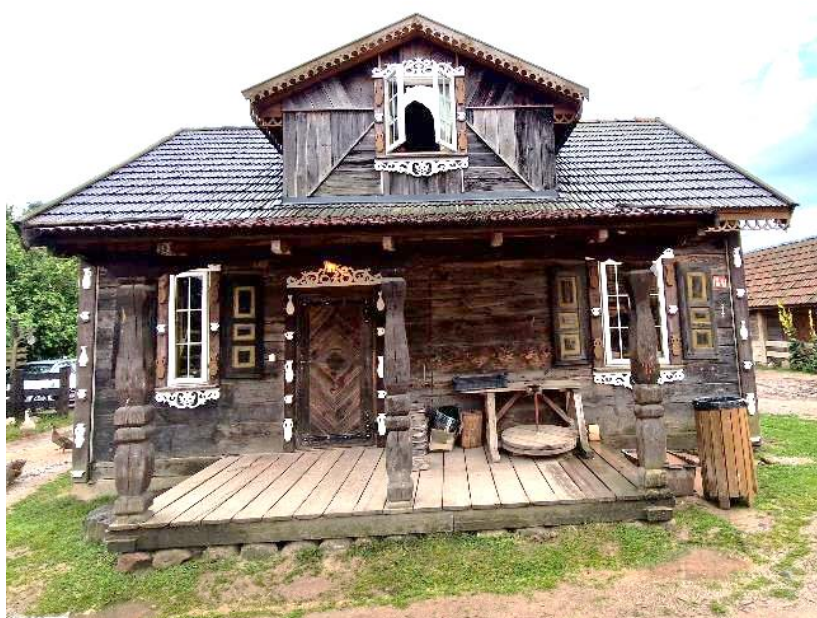
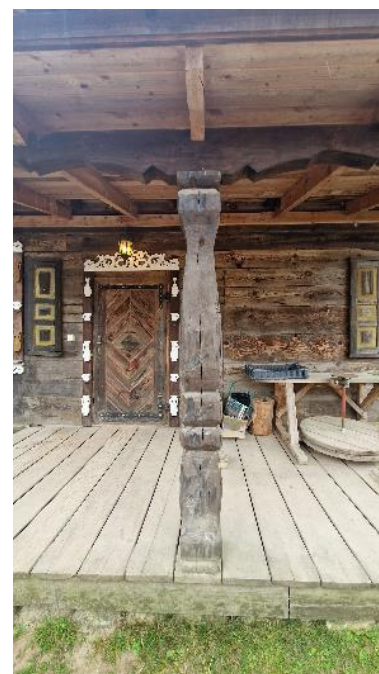
Figure 5. Examples of a wooden building in an open-air museum: (a) façade; (b) carved structural elements of the overhang.

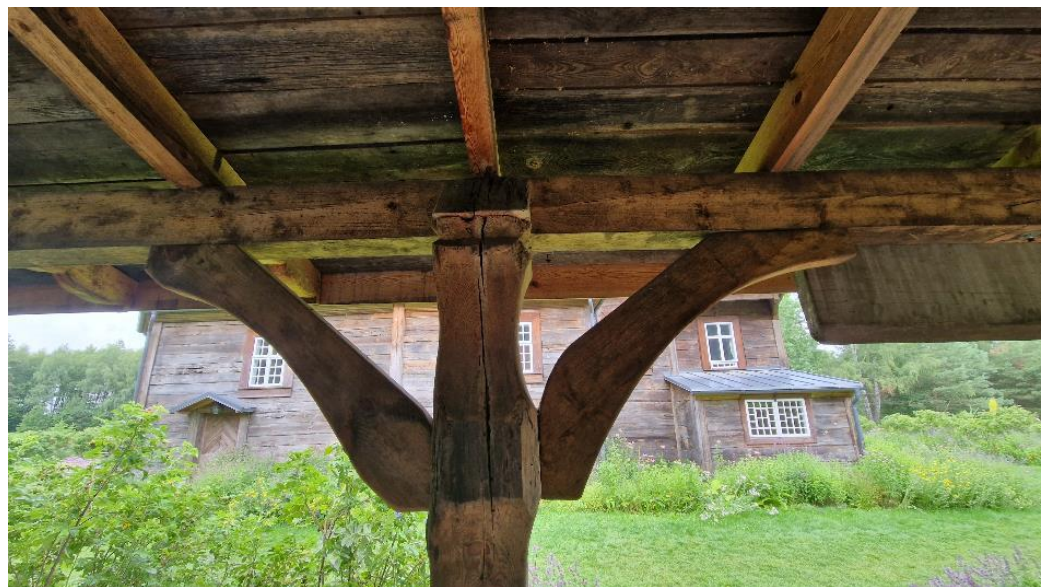
Figure 7. Carved structural elements of an overhang from historical wooden house in an open-air museum.

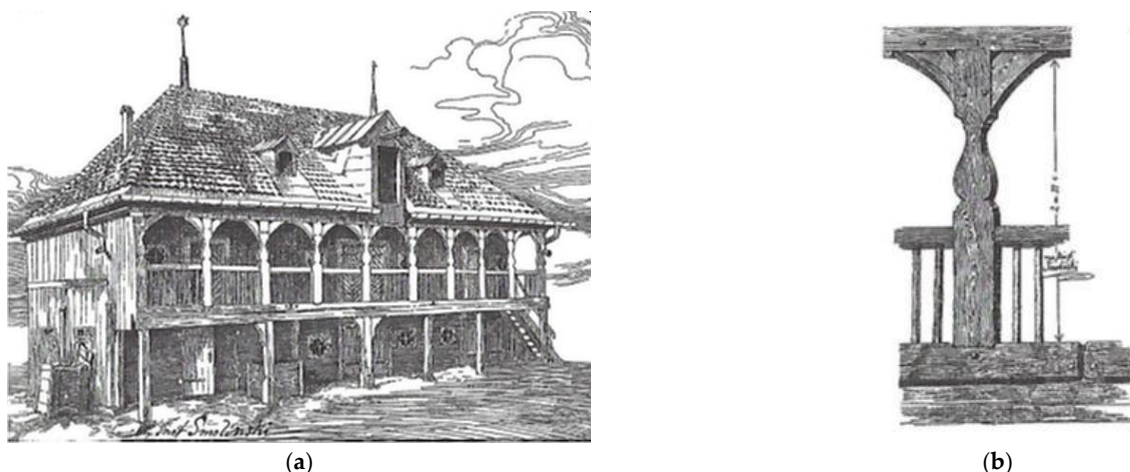
Figure 8. Riverside storehouse on Boleść Street in the Old Town in Warsaw. (a) General view; (b) details of the upper arcade column of the storehouse [44].

has resulted in a minimal number of wooden building monuments throughout the country. During diagnostic and conservation studies, when carrying out engineering, architectural, and construction work (strengthening and protection, repair, adaptation, reconstruction), it is usually impossible to relate (according to conservation practice and theory) the applied individual technical solutions to the analogous applied solutions found in existing buildings. The successful implementation of this is rare and is often found in open-air museums (Figures 5–7). A specific answer to this problem appears to be referencing early documentation, which is often published in the form of textbooks, albums, drawings, and lithographs. Interest in wooden architecture in Poland developed notably at the turn of the 19th and 20th centuries. At that time, it was recognized that historic wooden buildings are part of national cultural heritage and thus require special care, documentation, and preservation activities. At the beginning of the twentieth century and in the interwar period, textbook, guidebook, and catalog publications began to be circulated that referred to traditional building techniques, thus presenting historical, current, and modern construction methods, forms, and solutions. The publications and studies made by Professor Jan Sas Zubrzycki and ethnographer and historian Zygmunt Gloger were very significant, and today are an invaluable treasure trove of knowledge about historical wooden buildings that no longer exist and the unique architectural and construction solutions used in them [41–43]. This knowledge is valuable when making decisions related to the preservation, restoration, rehabilitation, or reconstruction of historic wooden buildings while ensuring historical continuity, integrity, and authenticity. The unique architectural and structural solutions used in historic wooden buildings require an individual approach to conservation, engineering, architectural, and construction activities. They are often adapted to local traditions, carpentry art, aesthetic trends, and ornamental traditions and are an expression of the vision of the building's creator, their skills, and their technological and material capabilities (Figure 8).

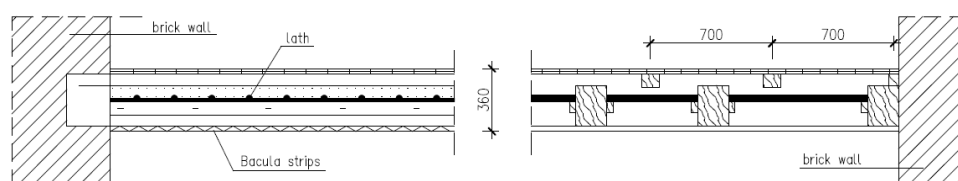
Figure 9. Joist-lath (Lviv) ceiling (on the basis of [45]) (p. 101).

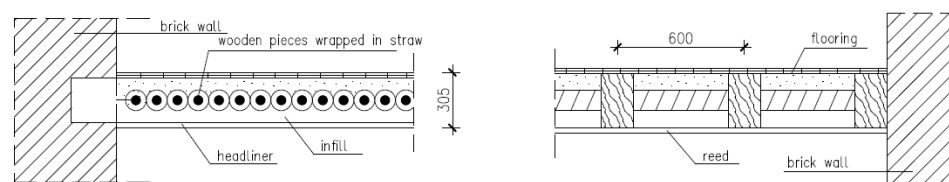
Figure 10. “Slide-in” ceiling (on the basis of [45]) (p. 101).

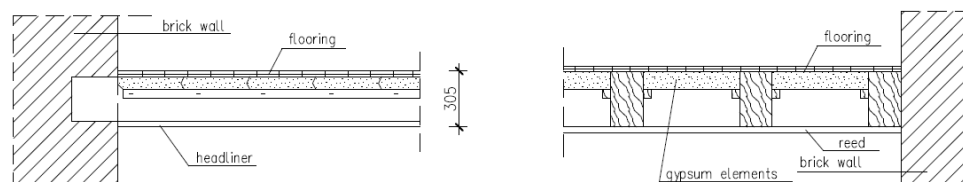
Figure 12. Lath ceiling with covering from gypsum layers [45] (p. 103).

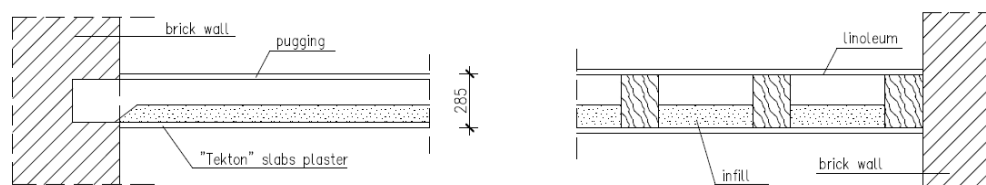
Figure 13. Ceiling covered by boards [45] (p. 103).

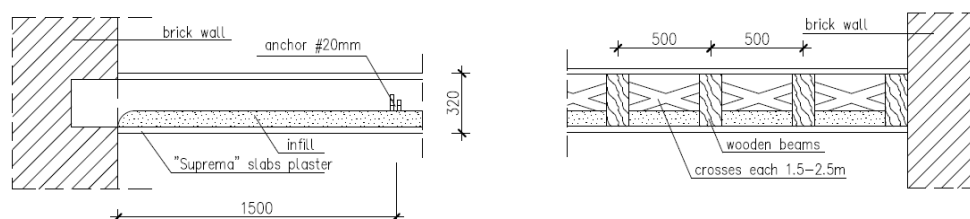
Figure 14. Ceilings with wooden beams [45] (p. 103).

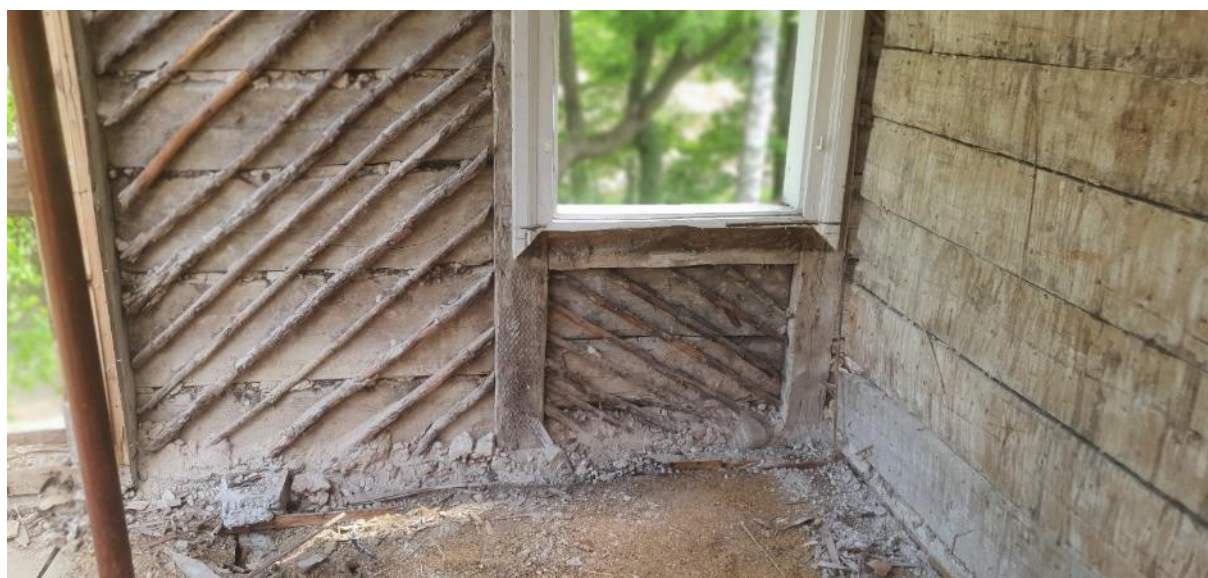
Figure 15. Historical thermal insulation installation method.

Also of interest are methods of installing thermal insulation that are no longer used, including the use of chopped straw properly attached to wooden exterior walls, which was previously common. An example of this solution is shown in Figure 15. Slats arranged in a herringbone pattern attached on the inside of the elevation bearing wall (catfish-patch construction) constitute a frame into which chaff was poured, with the interior surface then covered with boarding.

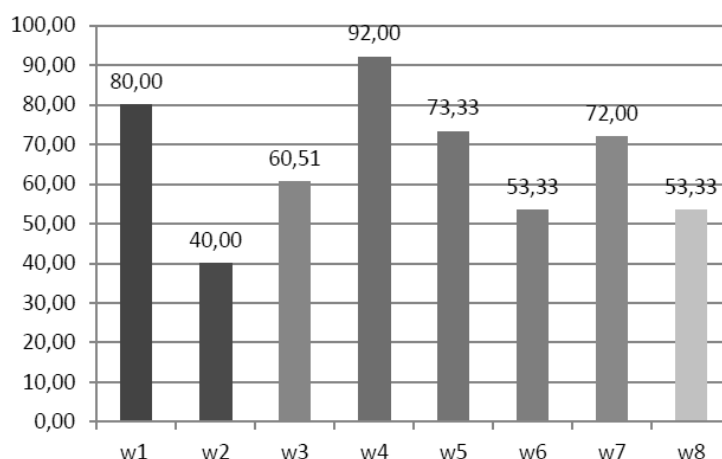
Diagnostic value of 63.8 points, —Sufficient rating, and recommended revitalization (Figure 17).

Figure 17. Indicator values for partial evaluations: diagnostic value.

W1 = 80.00%, formal and legal evaluation indicator.
 W2 = 40.00%, historical and cultural value indicator.
 W3 = 60.51%, construction value indicator.
 W4 = 92.00%, human impact evaluation indicator.
 W5 = 73.33%, external environment evaluation indicator.
 W6 = 53.33%, energy efficiency indicator.
 W7 = 72.00%, innovation indicator.
 W8 = 53.33%, impact on the local community indicator.
 Building condition index: 53%.

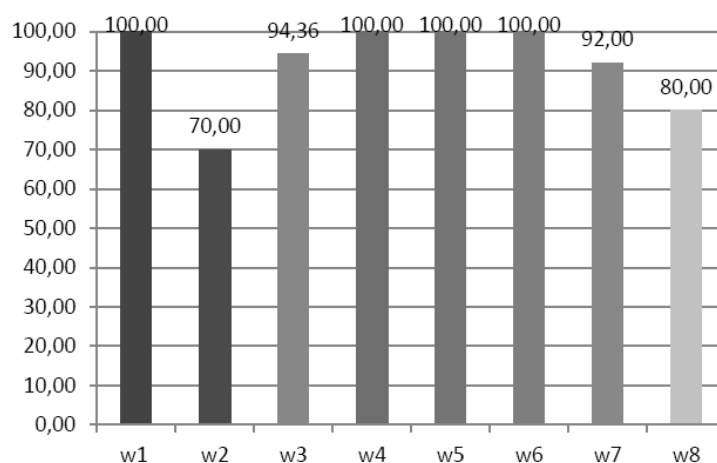
Potential value of 94.5 points, Sufficient rating, revitalization difficult with problems (Figure 18).

Figure 18. Indicator values for partial evaluations: potential value.

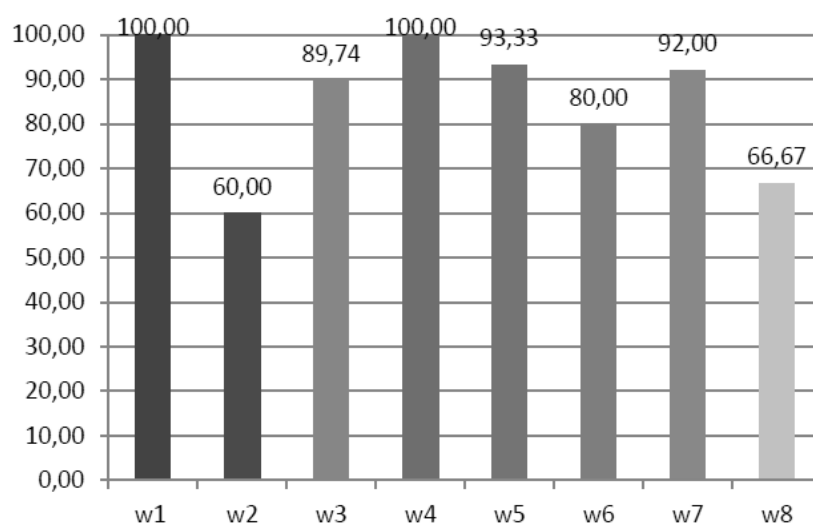
Design value of 88.9 points, Sufficient rating, revitalization difficult with problems (Figure 19).

Figure 19. Indicator values for partial evaluations: design value.

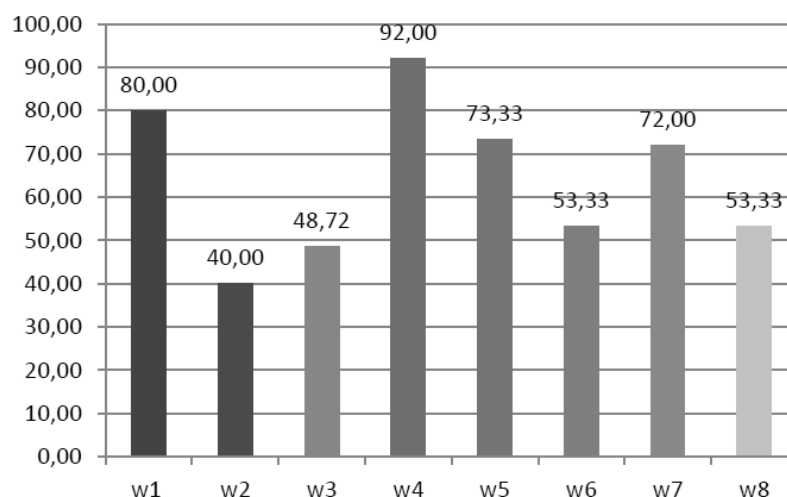
Diagnostic value (second one) of 56.8 points, Sufficient rating, revitalization difficult with problems (Figure 20).

Figure 20. Indicator values for partial evaluations: diagnostic value (second one).

W1 = 80.00%, formal and legal evaluation indicator.
 W2 = 40.00%, historical and cultural value indicator.
 W3 = 48.72%, construction value indicator.
 W4 = 92.00%, human impact evaluation indicator.
 W5 = 73.33%, external environment evaluation indicator.
 W6 = 53.33%, energy efficiency indicator.
 W7 = 72.00%, innovation indicator.
 W8 = 53.33%, impact on the local community indicator.
 Building condition index: 31%.

During the repair and restoration work, it turned out that the actual technical condition of the load-bearing walls was much worse than assessed in the first diagnosis. The wooden beams were completely destroyed in some places, rotten, and fungal. This resulted in a need for a new assessment of the building's revitalization capacity. The new diagnostic value was:

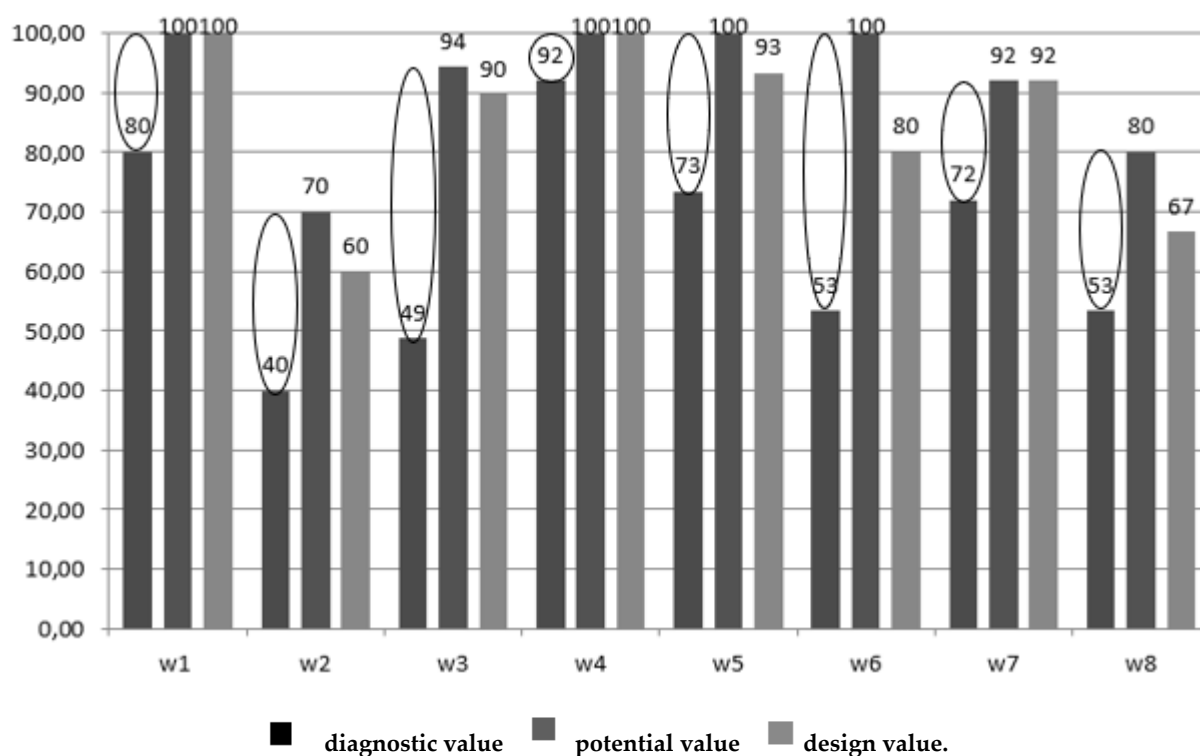
Figure 21. Comparison of the values of sub-indicators in terms of potential for revitalization actions and diagnostic values.

Diagnosis of a historic manor house located in Goszczyn near Warsaw using the original method of this paper confirms its usefulness for interdisciplinary diagnostics of historical buildings, and demonstrates consideration of the principles of sustainable development. In its premise, it analyzes the technical aspects of a building according to traditional technical diagnostics. However, it assumes that in addition to the construction value, it is necessary to take into account the non-technical aspects of historical buildings according to the principles of sustainable development. This includes formal and legal issues (in Poland this is very important due to the remnants left behind and the negligence in this area during communist rule), the historical and cultural value of the building (all recommendations and conservation rules are important here), assessment of the impact on humans, external environment assessment, energy efficiency, the degree of innovation in the adopted design, technological and material solutions, and the impact on the local community. The effects of these analyses can be seen in the form of individual assessments that affect the values of the sub-assessment indicators, which are presented in the charts in the previous section. Looking at the values of the sub-assessment indicators, we get an assessment of these values in the existing state. This provides the basis for initial evaluations that inform the intention to undertake a revitalization investment project based on its feasibility. At the same time, comparing the values of the diagnostic assessment with the values of the potential assessment (Figure 21), the areas of revitalization with the most potential are visible in terms of the individual issues. In these areas, based on local revitalization programs, revitalization measures can be designed that raise the values of the sub-assessment indicators once realized.
