Rewinding the Tape: Documentary Heritage to (Re)discover “Lost” Natural Hazards—Evidence and Inferences from Southern Italy

Citation: Gizzi, F.T.; Bovolin, V.; Villani, P.; Potenza, M.R.; Voria, S.; Amodio, A.M. Rewinding the Tape: Documentary Heritage to (Re)discover “Lost” Natural Hazards—Evidence and Inferences from Southern Italy. *Sustainability* **2024**, *16*, 2789. <https://doi.org/10.3390/su16072789>

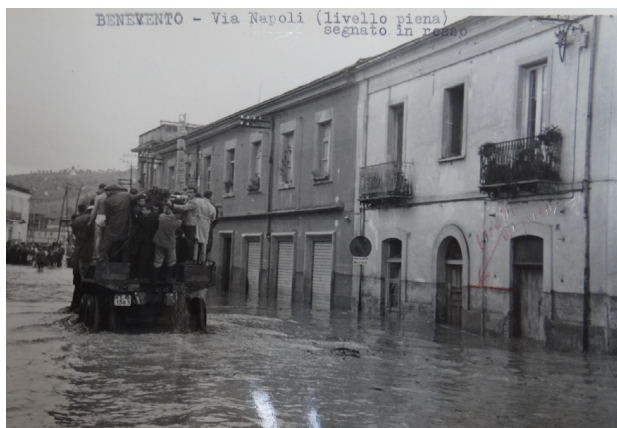
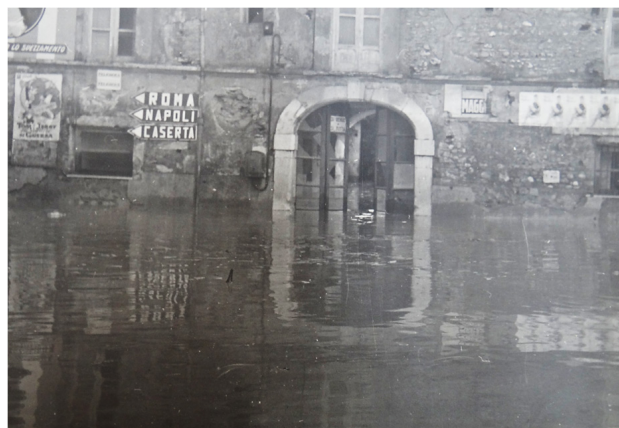
Figure 11. Photo taken in Benevento in the aftermath of the 19 October 1961 flood. (a) Left, the street most affected by the flood (Via Napoli). On the right part of the photo the maximum level reached by the overflow of the Sabato River is identifiable, (b) right, detail on the water level in the same street as (a) (sources: [60b] in Appendix A).

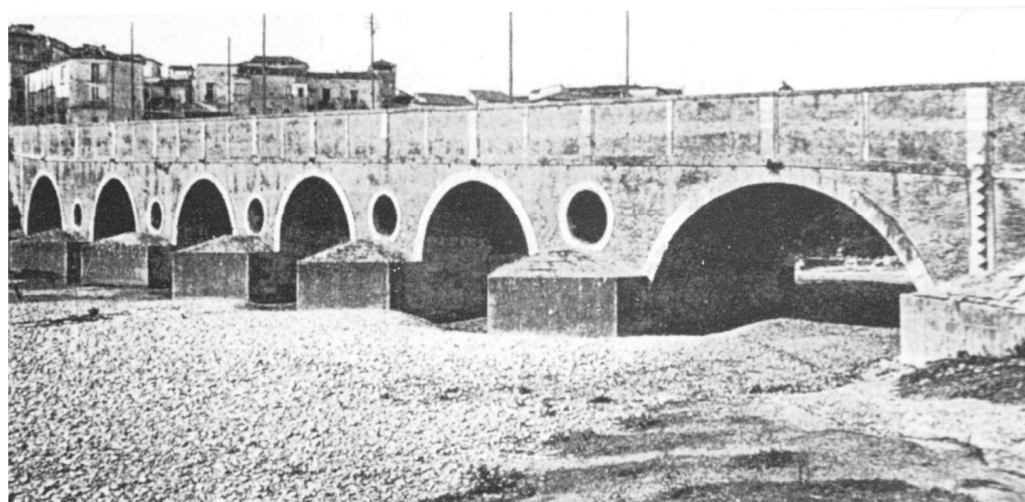
Figure 13. The bridge over the Calore in a photo taken before 1949, the year of its demolition following the high afflux effect exerted by the structure during the flood of the same year (source: [64]).

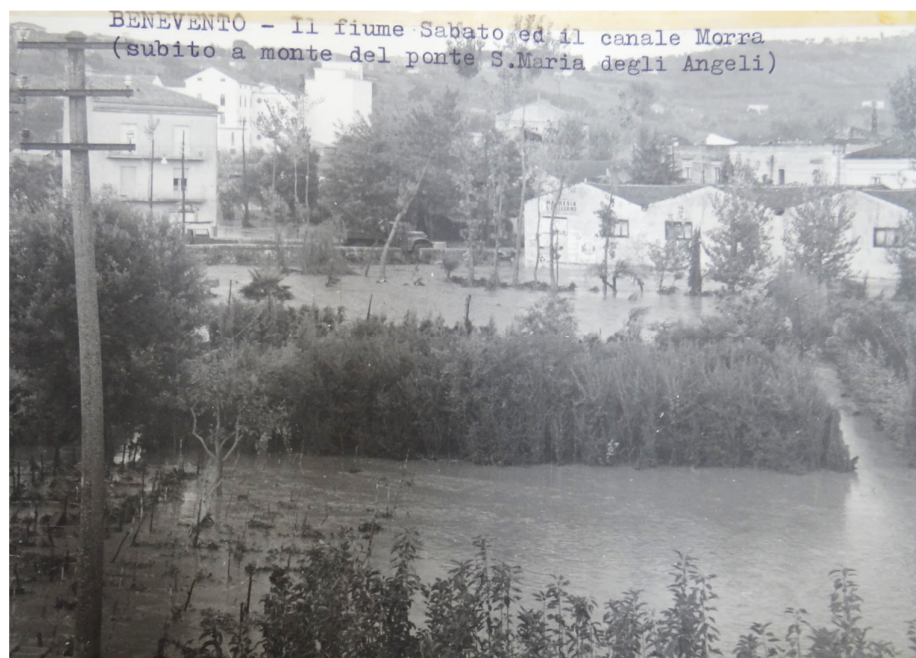
Figure 15. The Sabato River and the Morra Canal immediately upstream of the Santa Maria degli Angeli Bridge in the aftermath of the 1961 flood in Benevento (source [60b] in Appendix A).

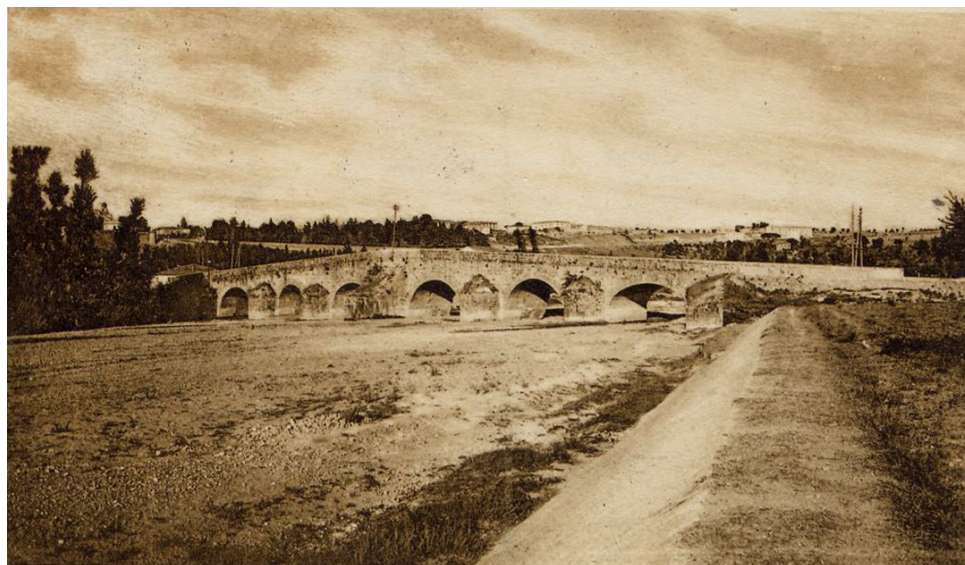
Figure 16. Santa Maria degli Angeli Bridge crossing the Sabato River in 1961 (<https://beneventoceraunavolta.blogspot.com/>, accessed on 10 December 2023).

In particular, the Sabato River breadth at the Santa Maria degli Angeli Bridge was about 76 m. The bridge had seven narrow openings that left available slightly more than 50% of overall breadth.

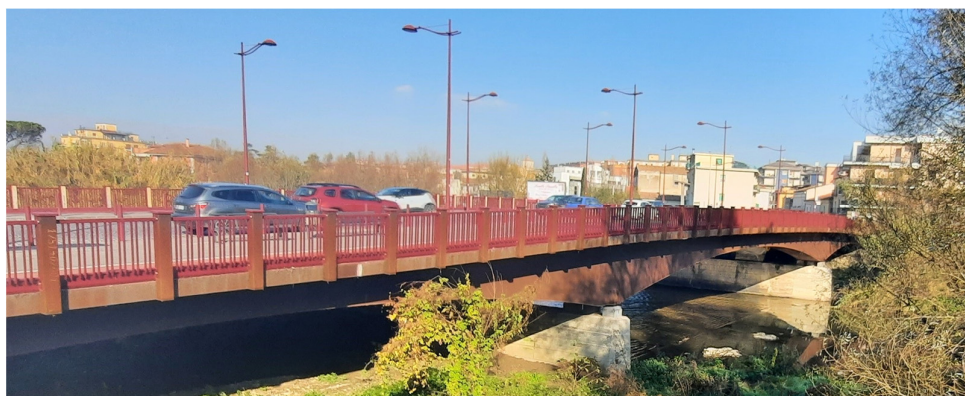
Figure 17. Santa Maria degli Angeli Bridge crossing the Sabato River today (photo by F.T. Gizzi).

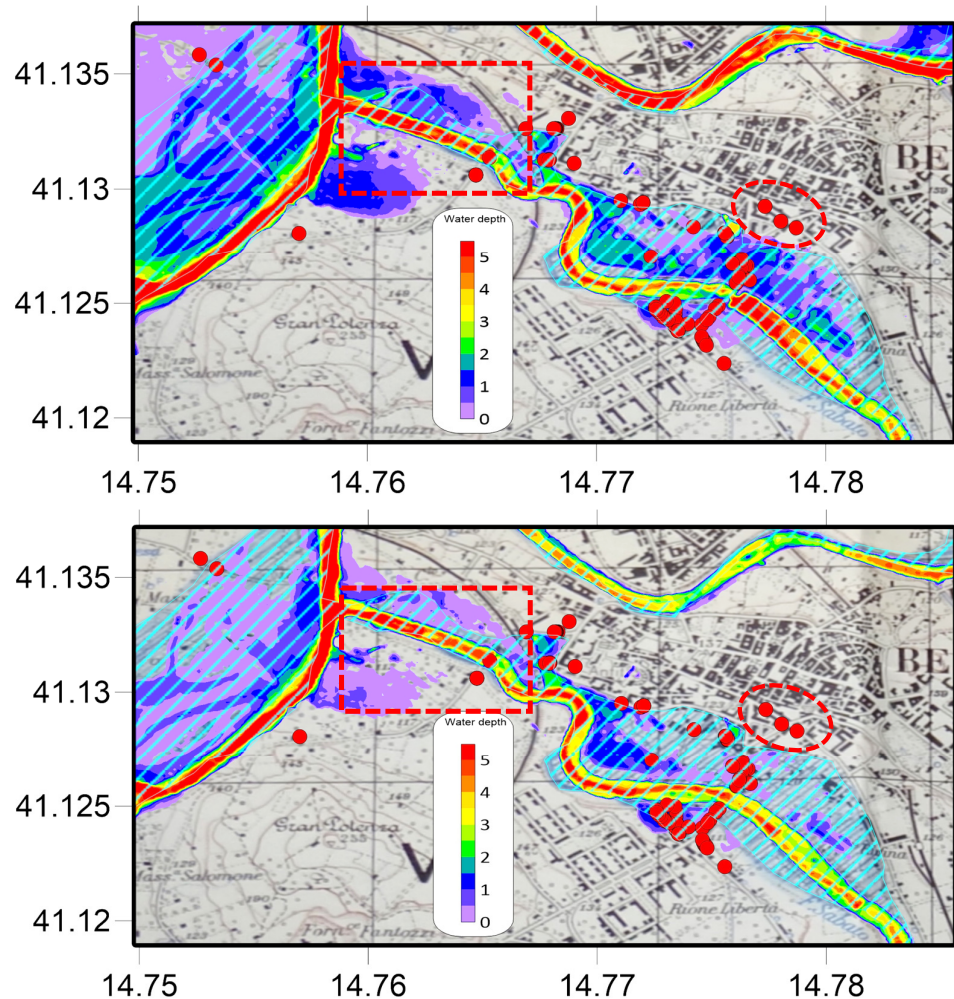
Figure 19. Comparison of water depth contours for the two sceneries: upper, 1961 scenery with Santa Maria degli Angeli Bridge (Sabato $1100 \text{ m}^3/\text{s}$ Calore Irpino $1250 \text{ m}^3/\text{s}$); lower, Sabato scenery without Santa Maria degli Angeli Bridge (Sabato $1100 \text{ m}^3/\text{s}$ Calore Irpino $400 \text{ m}^3/\text{s}$). Red dots represent buildings reported as damaged except those encircled into the oval; rectangles show the effect of the changing boundary conditions at the confluence. Water depths are in meters.

A general comparison of the lower measured depths with the hydraulic model results shows a good agreement. The observation of the hydraulic model results also show that higher measured water depths refer to premises located inside lowland pockets that may be clearly distinguished in the DTM map. Examples are Munazio Planco and Appio Cladio streets, just downstream of the railway line, where consistent water stages higher than to 2 m were measured; similarly, in Torre delle Catene Street just upstream of the railway line, water depths up to 1.6 m were measured. The effect on the recorded water depths of the presence of lowered pockets is clearly shown also in the area located just downstream of Santa Maria delle Grazie Bridge where in Galanti Street, on the left bank, water stages were only up to 1.2 m, while in Abbazia Street on the right bank, in a small, lowered pocket, water stages reached up to 2.5 m. Finally, since the historical accounts blame the old Santa Maria degli Angeli Bridge as the main cause of the flood, a specific scenery, named here the *Sabato scenery*, where the bridge was removed, was implemented. In the *Sabato scenery*, to assess the effect of the combined discharges of the Sabato and Calore Irpino rivers on the water depth in the lower stretch of the Sabato River just upstream of the confluence, the discharge into the Calore Irpino River was reduced to 400 m³/s. A comparison of the water depth contours for the two sceneries with and without the Santa Maria degli Angeli Bridge is depicted in Figure 19.

Summarizing, Figure 19 shows that the Santa Maria degli Angeli Bridge certainly made the flood consequences worse in the area close to its right bank. However, the model also shows that the afflux effect of the bridge was not extended far downstream. In the same Figure 19, the buildings encircled into the ovals were not affected by the flood coming directly from the Sabato River, but very likely, they were flooded from the water overflowing from the Morra Canal. Indeed, probably some stretches of the Morra Canal had a reduced discharge capacity due to the lack of maintenance following the closure of mills already some years before 1961. Furthermore, the area included into the rectangles shows the effect of the changing boundary conditions at the confluence: in the case of the 1961 scenery, water depths were increased by 1 m on average compared to the Sabato scenery that assumed a much lower discharge into the Calore Irpino River.
