# An Innovative, Lightweight, and Sustainable Solution for the Integrated Seismic Energy Retrofit of Existing Masonry Structures

**Keywords:** masonry buildings; integrated seismic energy coat; aluminium alloy system; experimental test

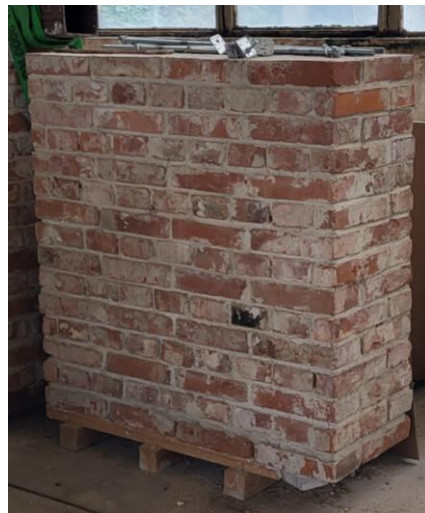
In Figure 2, the real base masonry panel ( $1.20\text{ m} \times 1.20\text{ m}$ ) is represented.

**Figure 2.** Real base panel: 1.20 m × 1.20 m.

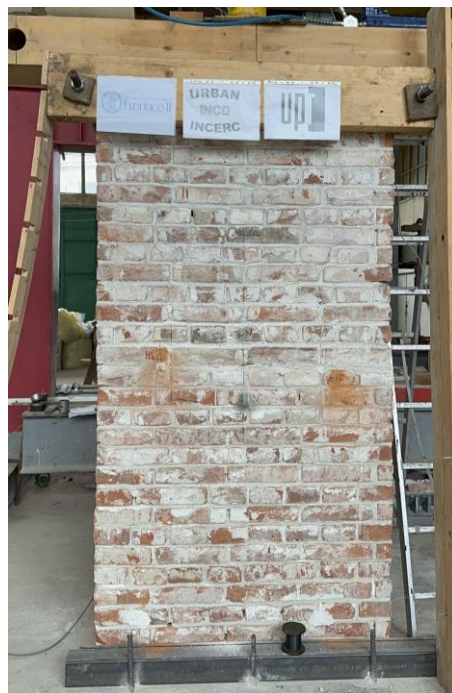
The final masonry wall obtained was anchored at the base using hooks and connected at the top to a metal frame with tie rods. It is depicted in Figure 3.

**Figure 3.** The masonry wall obtained from the union of two panels.

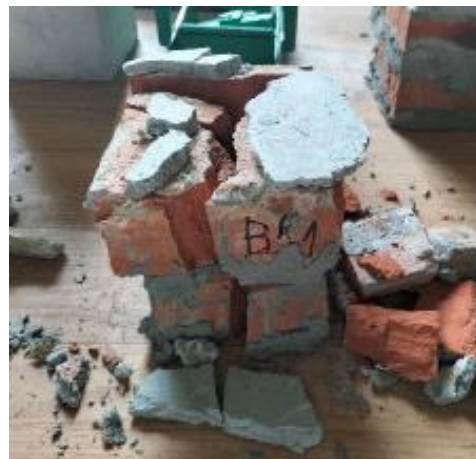
Before testing the entire masonry panel, a compression test was performed on three samples of single bricks (Figure 6) in order to evaluate their compression resistance [40].

The ceramic elements were derived using a semi-controlled manufacturing process, underwent uneven firing, and were not homogeneous in composition. They were cut in half before being tested to intercept solid surfaces. The mortar was laid on the first half, which had a perfect foreground, while the second half was rotated 90° with respect to the cutting section.

**Figure 6.** Samples of bricks.

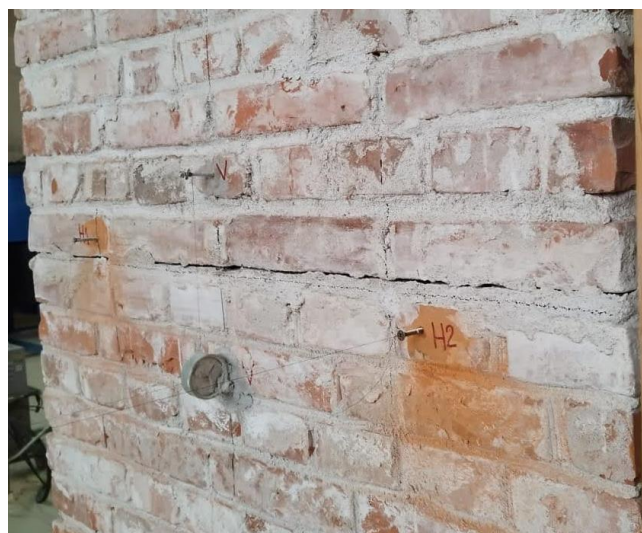
On contrary, Figure 9 displays the trend of the horizontal force and the vertical displacement, which achieved a maximum value of 3.89 mm. It corresponded to the crack which appeared in the centre line and is depicted in Figure 10.

**Figure 10.** Crack in correspondence to the middle joint.

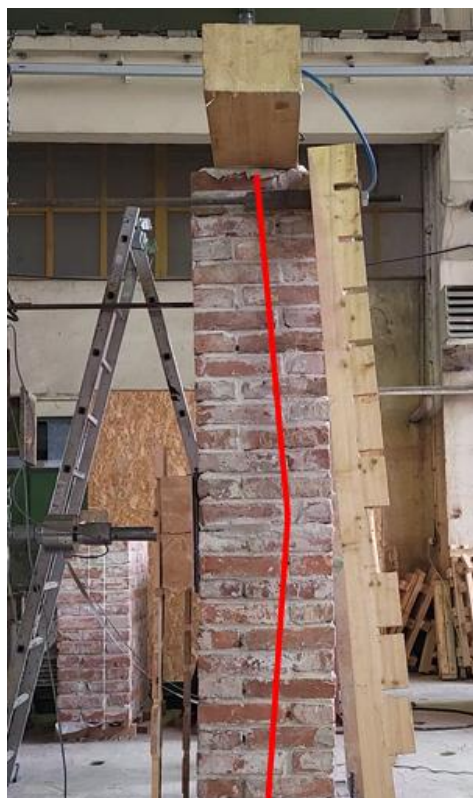
As it is possible to point out from Figure 11, the failure mechanism stood as a vertical bending mechanism, since the wall was bounded at its extremities.

**Figure 11.** Vertical bending failure mechanism.

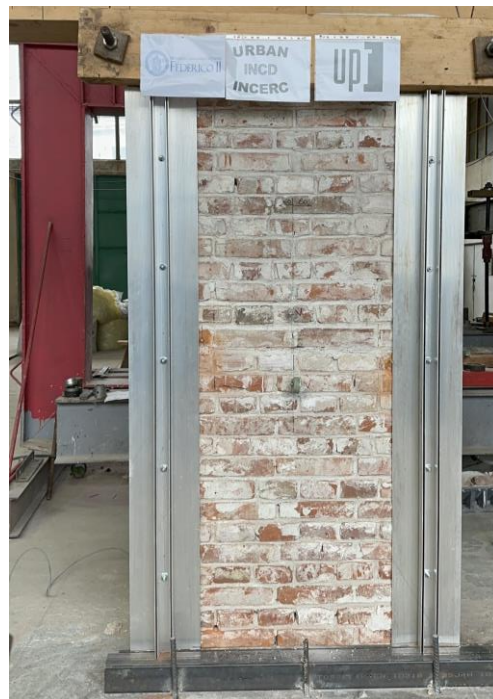
The reinforced specimen is revealed in Figure 14.

**Figure 14.** Masonry wall reinforced with aluminium profiles.

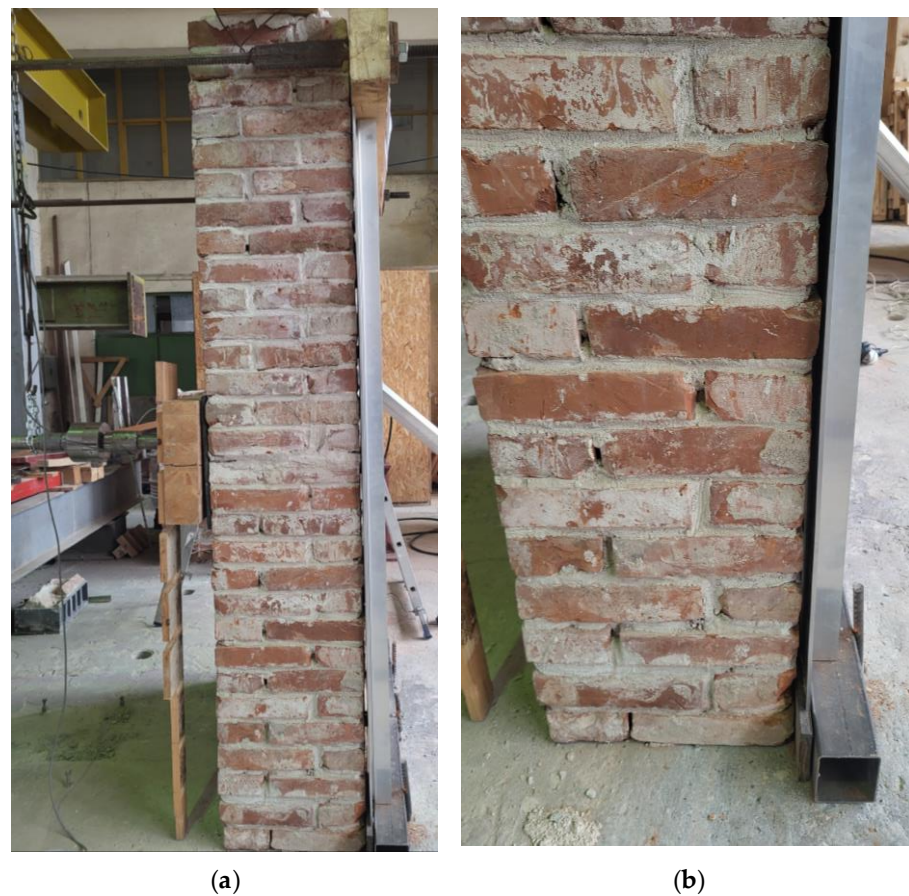
In Figure 15a, the details of the imperfect adhesion between the masonry support and the aluminium profiles is depicted.

**Figure 15.** Imperfect adhesion between masonry support and aluminium alloy profiles; (a) Lateral View; (b) A detailed view of the imperfect adhesion.

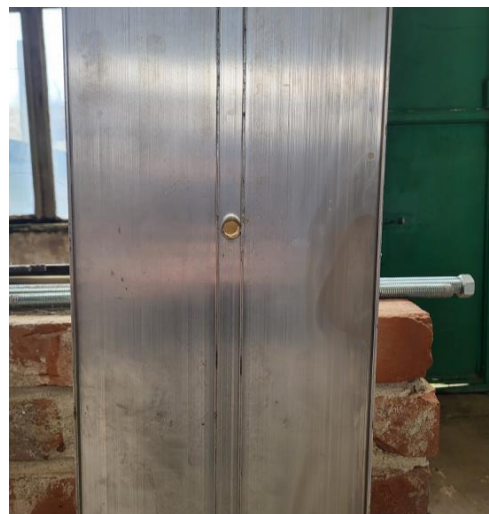
In the end, another interesting result was connected to the behaviour of the aluminium profiles. They did not show any lesions, and the holes realized for the chemical anchors maintained their circular shape without any bearing mechanism, as shown in Figure 21.

Figure 21. The aluminium profiles after the experimental test.

The comparison of the two states reveals the positive effects resulting from the placement of the profiles, which did not show any cracks or significant deformation, as was hypothesized before experimentation. In a subsequent experimental phase, even better results could be achieved by evaluating the panel's response with the entire system under investigation.
