Article

Reducing Product Loss Through Ventilation in Bourbon Maturation Warehouses

Department of Mining Engineering, University of Kentucky, Lexington, KY 40506, USA; steven.schafrik@uky.edu (S.J.S.); michael.long@uky.edu (M.W.L.); zachary.wedding@uky.edu (Z.E.W.); benjamin.diddle@uky.edu (B.M.D.)

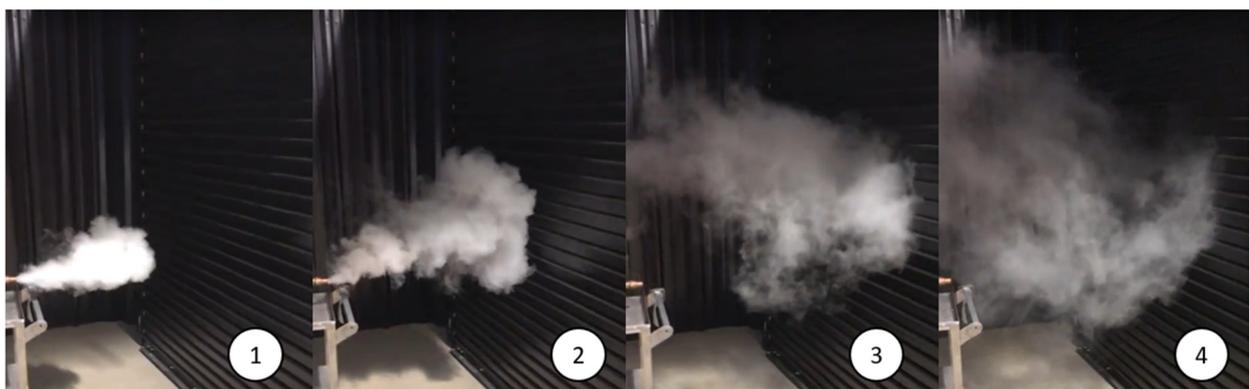
The first set of smoke tests was performed to determine the airflow into the rickhouse through the main entrance. Figure 4 shows four frames from the recorded video. In frame 1, the initial velocity given to the smoke from the machine is shown. In frame 2, the smoke conforms to the ambient airflow and halts before entering the rickhouse. In frame 3, the smoke reverses and flows away from the entrance. Frame 4 shows the smoke completely flowing away from the entranceway. This experiment was repeated on either side of the entrance with the door open and closed. In all cases, no smoke migrated in or out of the rickhouse via the main entrance.

**Figure 4.** Main Entrance Smoke Test.

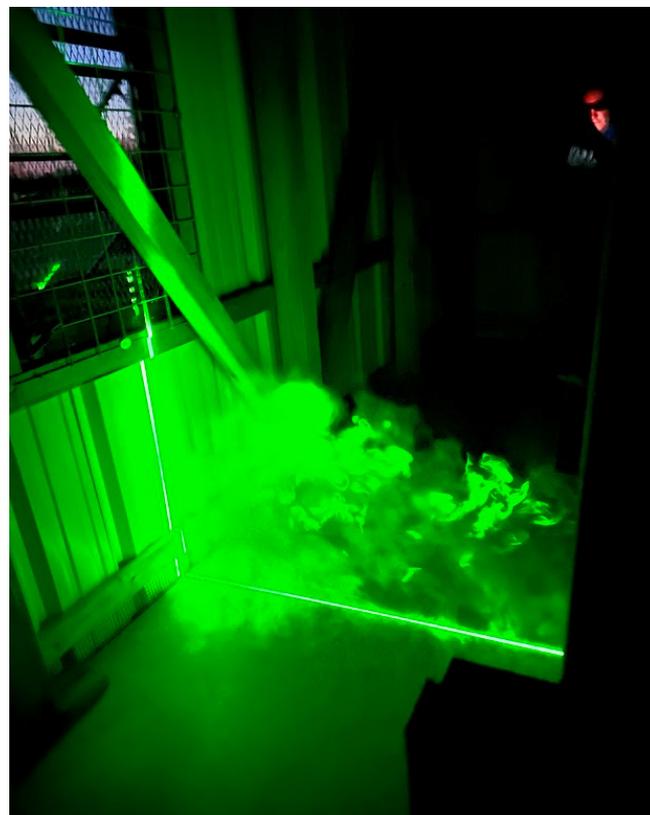
Figure 6. Perpendicular Angle for Windows and Ground Vent Smoke Test.

out of the rickhouse through another set of windows further down the hallway. While performing tests on the side walls of the rickhouse, the smoke entered regardless of the ambient wind direction. For the test shown in Figure 5, the wind direction was opposite to the direction of smoke flow into the rickhouse. This is likely due to a recirculation zone, as wind contacted the wall opposite the one shown in Figure 5. An area of low pressure was created, allowing for a recirculation zone to form and air to enter through the windows while the wind moved in the opposite direction. This is in line with the ASHRAE Handbook 1981 Edition, which provides centerline flow patterns around rectangular buildings [25]. Figure 6 displays a test with the sheet laser reoriented to be perpendicular to the hallway and shows that the smoke, when entering the rickhouse through the windows and ground vents air, does not migrate into the ricks. In the photo, smoke concentrates closer to the wall than to the rick on the right of the photo.
