# An Approach to the Environmental Impact of Rammed-Earth Dwellings in Historical Contexts and Their Interventions: The Case of the Region of Northwest Murcia, Spain

Dwellings built from rammed earth in historical contexts represent not only a heritage to be preserved but also buildings with a long service life that are still in use by the local population. Changes in urban dynamics and the revitalization of historic downtown areas have led to an increase in renovations of these buildings. However, in many cases, these projects are carried out using materials and techniques that are structurally incompatible and detrimental to sustainability. The aim of this study is to examine earthen residential architecture in the historical context of the Region of Northwest Murcia (Spain), the resources used in their construction, their building systems and their current condition. To this end, an analysis is proposed based on historical documentation, including an assessment of the costs and energy required for their construction, a visual inspection of the current condition of these buildings, and a study of the relevant building regulations. The study of their cladding, eaves, floor struct

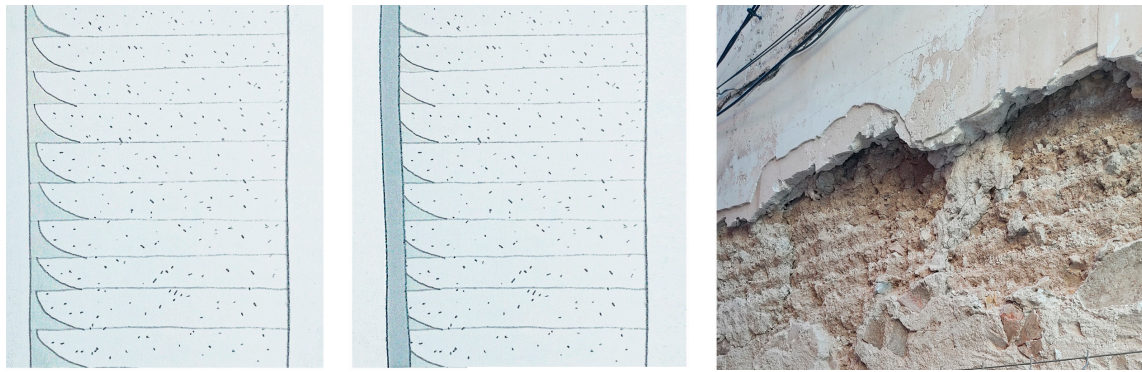
**Figure 6.** Replacement of the lime crust with a gypsum coating.

The state of preservation varies in buildings with lime-crusted rammed earth walls. Those that have lost their lime crust were covered with gypsum at some point, as shown in Figure 6. Thus, when the continuous layer of lime on these walls was lost, one or more layers of plaster or, in more recent cases, cement mortar were applied. Starting in the 1960s, plaster coatings gave way to cement finishes that differed from traditional facades. This led to the Special Plans of 1989 specifying that finishes be done “preferably in lime”. Tyrolean cement and imitations of traditional materials were expressly prohibited, and natural stone was permitted for plinths, provided that cladding was avoided. However, at the time, the stone industry was geared toward producing cladding panels a few centimeters thick. Therefore, given the results of the fieldwork and the prohibition on roughcast cement, cladding panels proliferated on plinths.

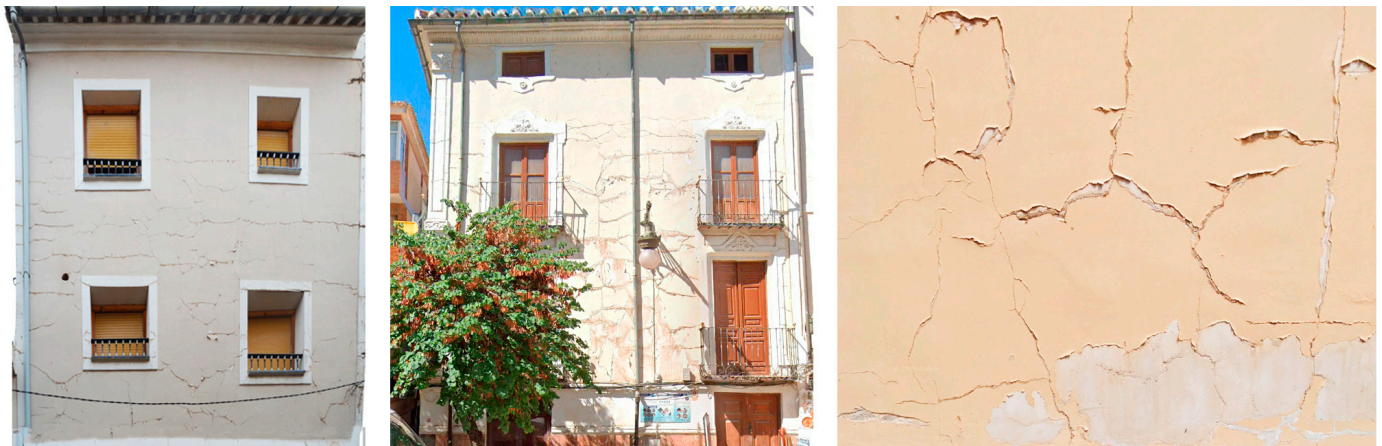
**Figure 7.** Cracking and peeling of the acrylic paint applied to the gypsum.

The regulations permit the use of brick, but not on large surfaces, as is currently the case in the region. Furthermore, the authorized colors for facades are “ochre and the natural colors of the area”. The ochre tone is based on a color study conducted in the area before drafting the regulations [24], while “natural color” is an ambiguous term without a precise hue definition. This has led to interventions using paints of various shades, often with low saturation. In other cases, primary colors have been emphasized to counter the stereotype of exclusively white Mediterranean architecture [49]. The vast majority of these paints are acrylic and have been applied primarily to two types of surfaces: traditional plaster and industrialized cement. The first type constitutes 15% of the coatings studied in this work. Of these 15 cases, 14 exhibit cracks, fissures, and material loss affecting the underlying layer (Figure 7). The paint’s impermeable nature prevents the wall and the plaster coating from breathing. The paint offers very little resistance to water vapor pressure due to its thinness, which is why it eventually cracks. In the second case involving painted cement mortar, the plaster degradation is much less severe, and sometimes the plaster remains intact since the paint interacts with the substrate layer.
