Article

Evaluating the Hydrologic Benefits of a Bioswale in Brunswick County, North Carolina (NC), USA

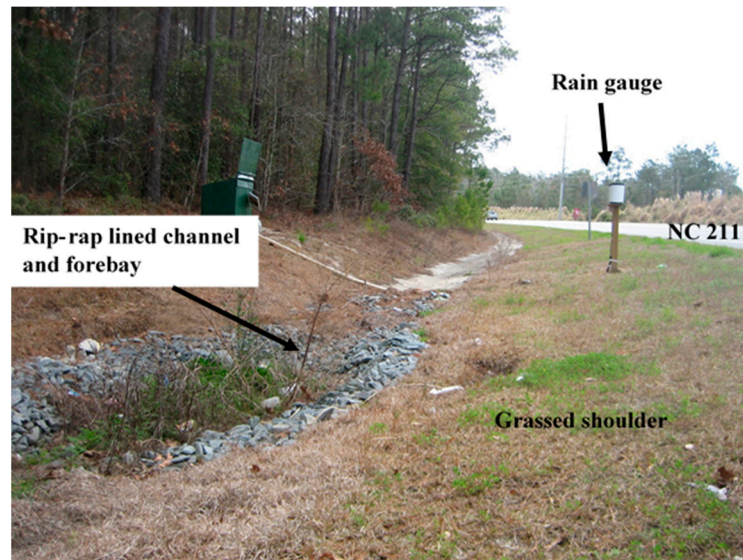
Figure 1. Watershed, grassed shoulder, and rip-rap channel and forebay [47].

The bioswale was installed in a right-of-way along state highway NC 211, near the US 17 intersection. NC 211 is a two-lane road with good condition asphalt wearing course. The catchment drainage area was 0.74 ha, with 44% impervious cover. Pervious cover was existing grassed shoulders, which had a 4:1 horizontal distance:vertical distance (H:V) slope with good condition vegetation and underlying sandy soils. Stormwater runoff from the lane adjacent to the bioswale discharged onto the grassed shoulder, which could allow for initial infiltration. Runoff then flowed into the rip-rap lined forebay and bioswale (Figure 1).

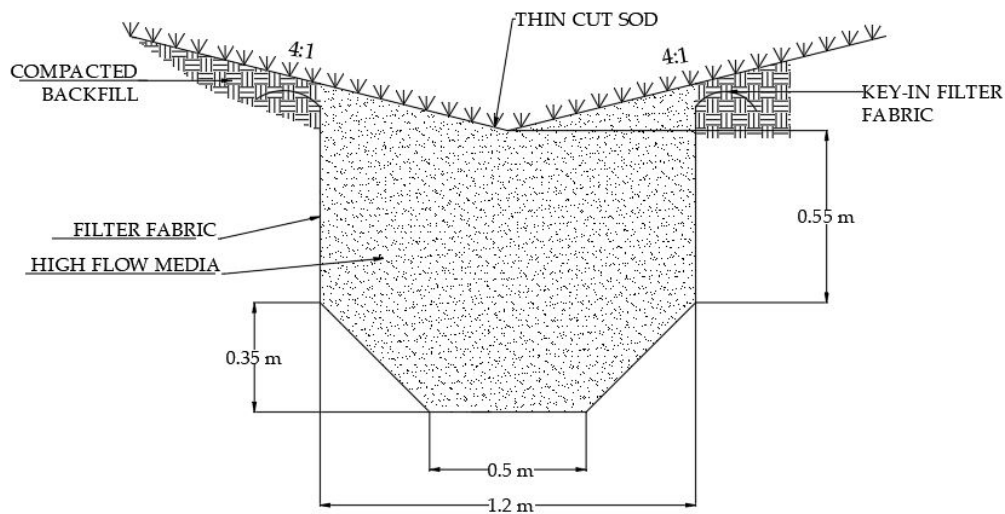
Figure 2. Horizontal cross-section of the first 23.8 m of the bioswale.

The bioswale SCM included a 10.7 m, Class A rip-rap (5.1 to 15.2 cm diameter stone [44]) lined forebay draining into the bioswale. The bioswale had a total length of 42 m, width of 1.2 m, and depth of 0.9 m. The initial 23.8 m of the bioswale trench and its trapezoidal base were filled with high-flow media (Figure 2). The remaining trench base was filled with 0.3 m of ASTM standard #57 washed stone (2.3 to 38 mm stone size [45]), designed to serve as detention through internal water storage, which studies have shown to improve runoff reduction within BRCs through the promotion of inter-event exfiltration [35,46]. An 18 m long perforated underdrain (0.2 m diameter) was placed in the middle of this stone layer. A 5 cm choking layer of pea gravel covered with a fiberglass mesh screen was used to ensure that no media mobilized to the underdrain. The remaining 0.45 m of trench depth was filled with high-flow media (Table 1) and covered with a thin-cut centipede (*Eremochloa ophiuroides*)

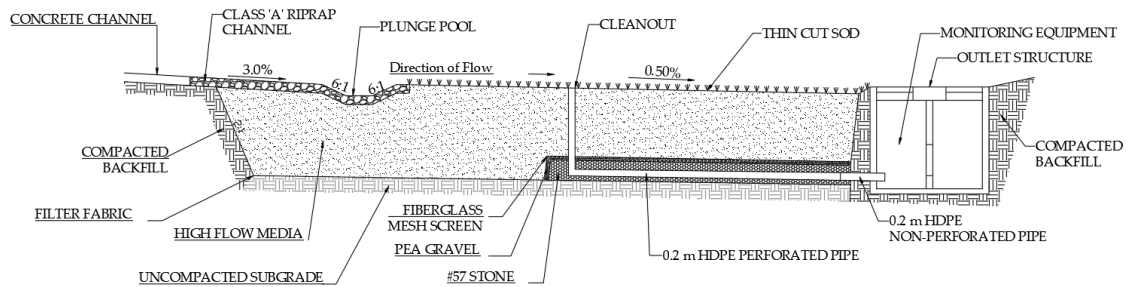
Figure 3. Bioswale longitudinal cross-section [47].

sod. The surface of the bioswale was a triangular in shape with 4:1 H:V side slopes (Figure 3 and Table 2). Previously published research on the water quality performance of this bioswale includes a full description of the bioswale construction and additional profiles [47].

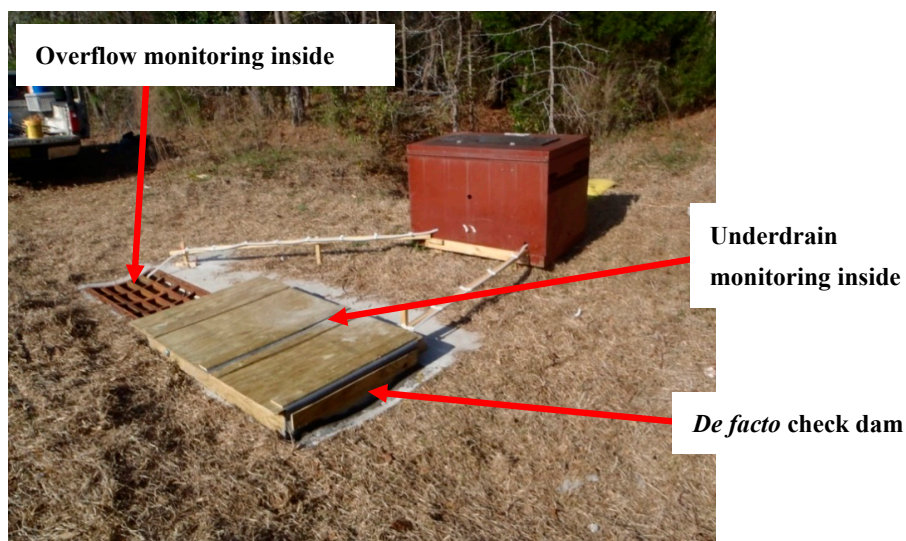
Figure 4. Outlet structure with closed portion for underdrain flow [47].

The total bioswale storage was 36.9 m³, with 22.7 m³ of media porosity storage and 14.2 m³ of surface storage. These calculations are conservative since they assume no water is leaving the SCM by exfiltration during a storm event. This calculation is similar to that of the bioretention abstraction volume (BAV) originally postulated by Davis et al. (2012b) [32]. The bioswale’s overflow and underdrain flows were discharged into the existing outlet drain structure (Figure 4). The upslope chamber of the outlet structure held the underdrain monitoring equipment, while the downslope chamber had overflow monitoring equipment to prevent mixing of the two outflow sources for monitoring purposes (Figures 3 and 4). A watertight wooden structure was built over the underdrain monitoring vault, creating a de facto 0.15 m tall check dam for surface storage in the bioswale.

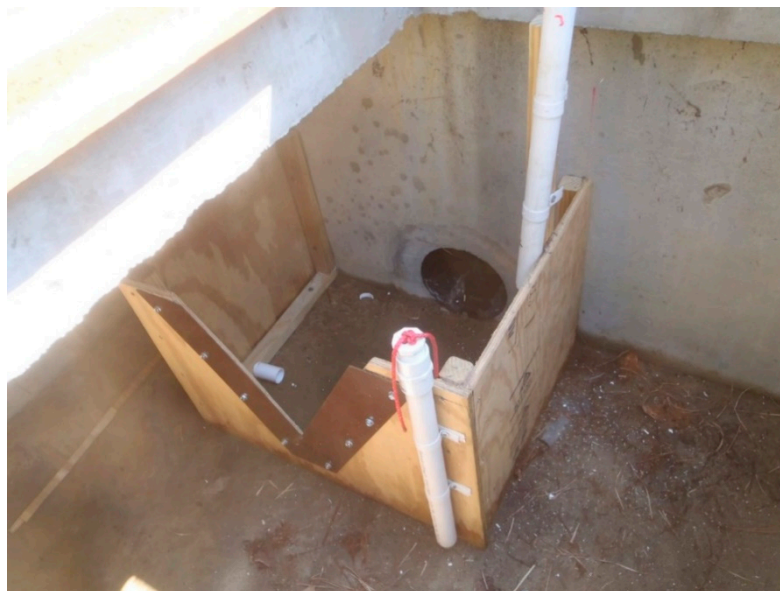
Figure 5. Underdrain outlet weir and associated HOBO logger [47].

The underdrain and overflow monitoring structures included purpose-built weirs. Each weir had a HOBO U20 [49] pressure transducer to monitor the flow depth over the weir plate (Figure 5), which was then utilized to calculate the overflow and underdrain volumes and flow rates. Since the transducers were non-vented, another U20 logger was installed by the rain gauge to measure on-site atmospheric pressure. All measurements were taken on at 2 min intervals. The pressures at each monitoring point were offset by atmospheric pressure to determine flow depth. HOBOware [49] was used to convert the pressure to a corresponding flow depth, which was then used to calculate flow rates and volumes using the same equations as Teledyne ISCO samplers (Equations (3)–(5)).

The flow depth over each corresponding weir was calculated to a flow rate using the following equations for underdrain flow (60° V-notch, Equation (3)) and overflow (90° V-notch, Equation (4)):

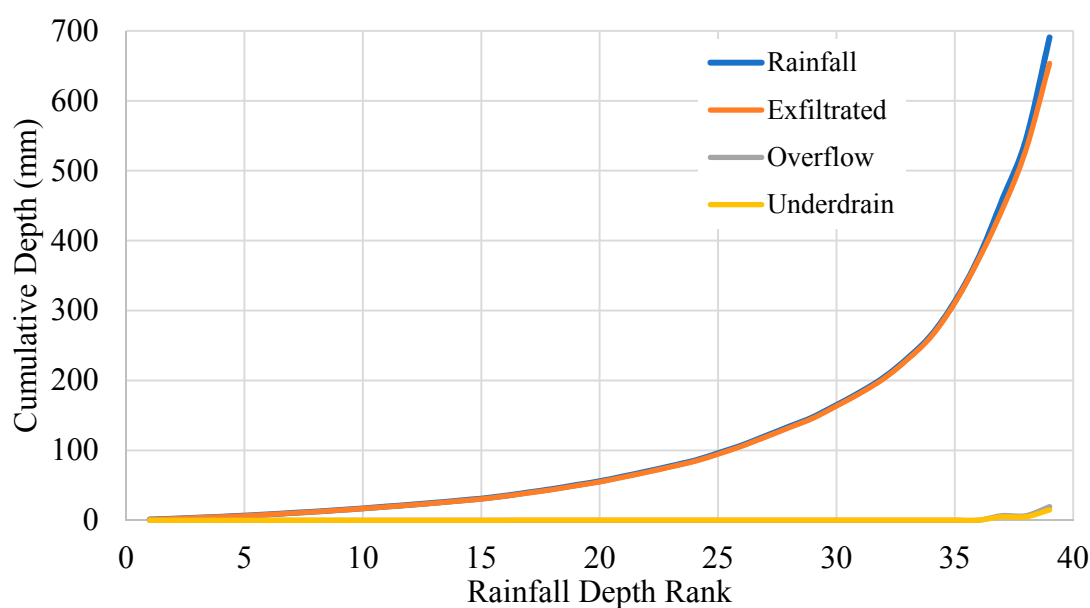
Figure 6. Distribution of rainfall into overflow, underdrain, and exfiltration.

Graphical analysis of the distribution of overflow, underdrain, and exfiltrated water supports that the majority of volume mitigation occurred through exfiltration (Figure 6). While overflow composed over one-half of outflow for the overflow events and underdrain flow was appreciable for three events, this volume was noticeably lower than the cumulative rainfall and exfiltration. In total, 99% of inflow was filtered by the soil media, providing water quality treatment [47].

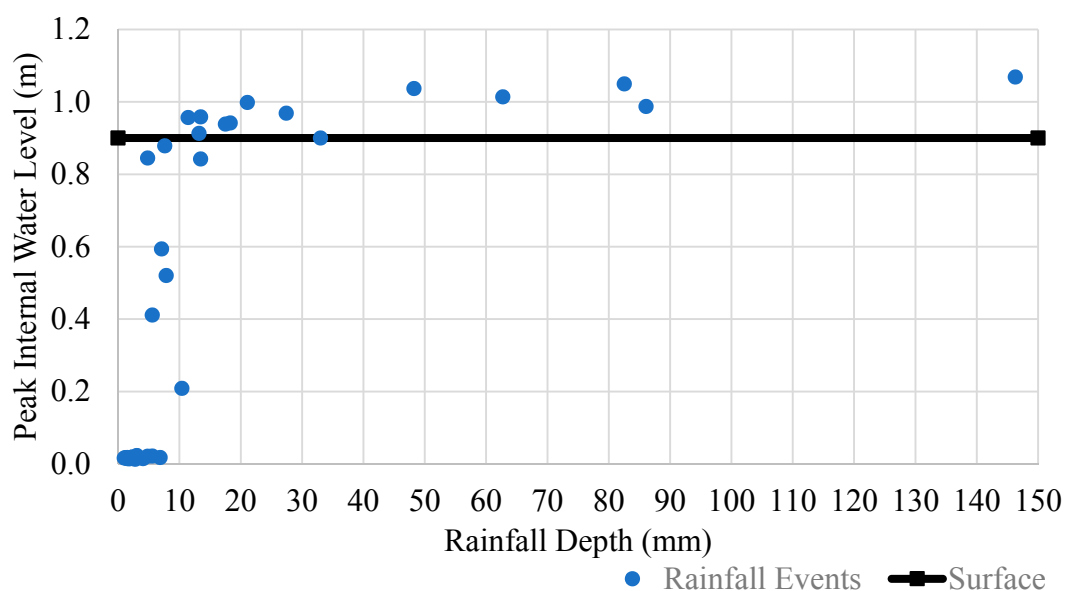
Figure 7. Positive association ($\alpha = 0.05$) between the rainfall depth and the peak bioswale internal water level. Events above the black line (surface) represent surface ponding.

Analysis of the peak internal water level compared to rain depth showed that the interval water level plateaued around 1.07 m (Figure 7). The average depth of the bioswale was 0.9 m. Thus, a depth within the well greater than 0.9 m equated to ponding along the bioswale surface. There were several events ($n = 12$) of ponding on the bioswale surface and complete saturation of the media. The smallest rainfall depth to result in surface ponding was 11.4 mm. The monitoring well was near the upstream end of the bioswale, so ponding at this location was not always representative of overflow, as runoff infiltrates along the bioswale length. Additionally, there was a de facto check dam at the end of the bioswale, allowing for surface ponding. Only two instances of ponding resulted in appreciable overflow, because surface ponding exceeded the storage volume and infiltration capacity. The average drawdown rate was approximately 0.04 ft min^{-1} .
