Article

Coastal Erosion of Arctic Cultural Heritage in Danger: A Case Study from Svalbard, Norway

Keywords: coastal erosion; cultural heritage; high arctic; monitoring; Svalbard; DSAS

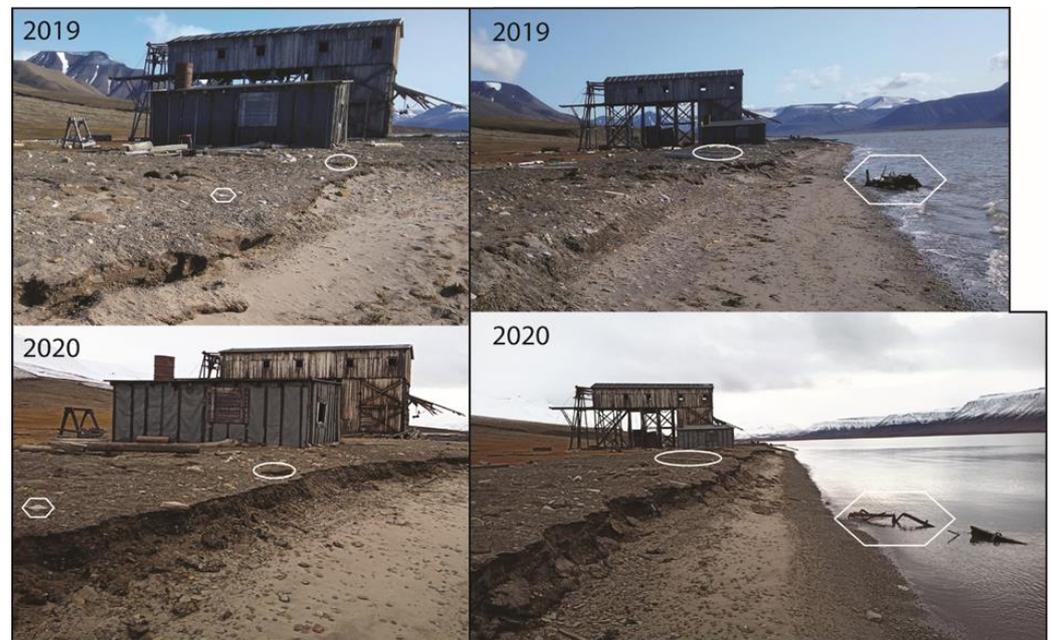
Figure 4. Comparison of shoreline position and morphology between 2019 and 2020 around some of the most important cultural heritage buildings and remnants along the sea in Sector 1 (no. 4 and no. 7). White ellipse and hexagons represent identical objects in the respective photographs.

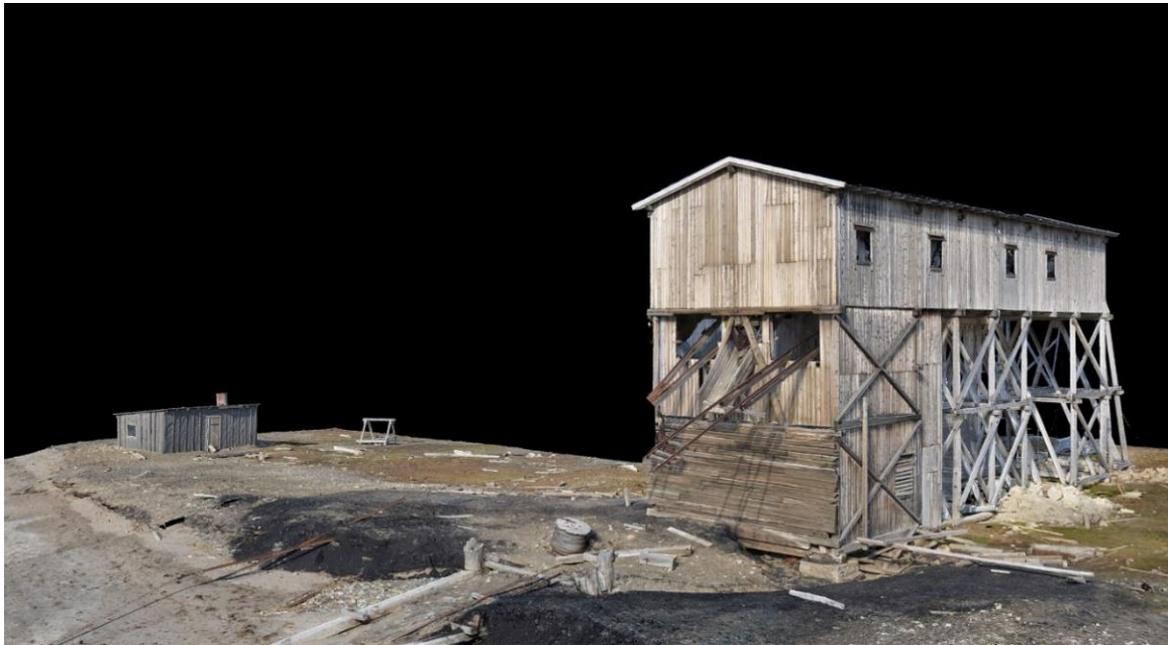
Figure 5. Textured 3D mesh model of the cultural heritage objects no. 1–7. The photogrammetric model was created using a combination of 3D laser scans and a series of single images. Geometry of the model is mainly based on laser scans, and photorealistic colour is derived from single images.

The results of the 3D scans are shown in Figure 5 and Supplementary Materials (short movie). Having a better image of the shoreline dynamics would be of great help for the local authorities in identifying and prioritizing future mitigation measures for the most endangered cultural heritage objects; further on, this work can be the start of studying multi-hazard threats [9] to endangered Arctic cultural heritage sites. Three-dimensional documentation of endangered cultural heritage sites is of high significance, as the cultural
