Article

Design and Field Monitoring of a Pile–Anchor–Brace Supporting System in a Soft Soil Area

Citation: Sun, L.; Mao, K.; Wang, Z.; Ye, S.; Su, T.; Dai, G.; Xu, G.; Sun, J. Design and Field Monitoring of a Pile–Anchor–Brace Supporting System in a Soft Soil Area. *Water* **2022**, *14*, 3949. <https://doi.org/10.3390/w14233949>

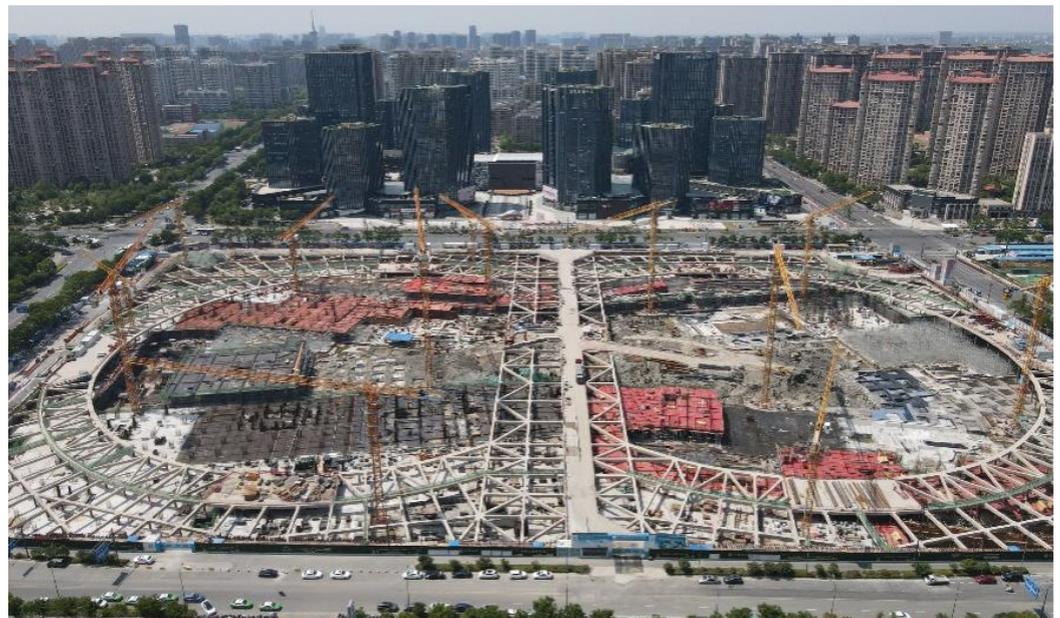
Figure 1. Aerial photograph of the foundation pit.

Considering the depth of the foundation pit, the surrounding environment, and hydrogeological conditions to ensure the stability and deformation requirements during the excavation of the foundation pit, the pile–anchor–brace supporting system (including an SMW pile, one row of concrete braces, and two rows of pre-stressed anchor cables) was selected to support this foundation pit (as shown in Figures 1 and 2).

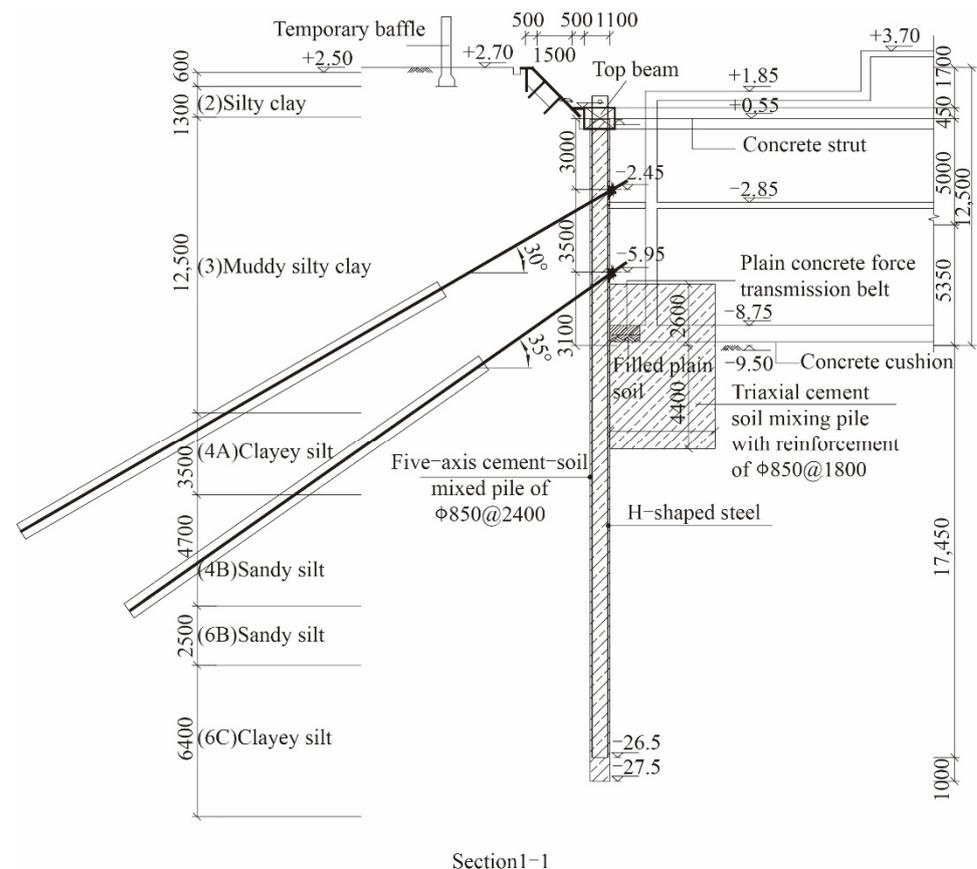
Figure 2. Typical support section (unit: mm).

According to the characteristics of the foundation pit and the technical specification for a soil mixed wall [17], the diameter of the SMW pile was 850 mm and the size of the H-shaped steel was determined to be 700 mm × 300 mm. Finally, soil-cement pile mixed by five shafts and by three shafts inserted with H700 type steel were used in the foundation pit.

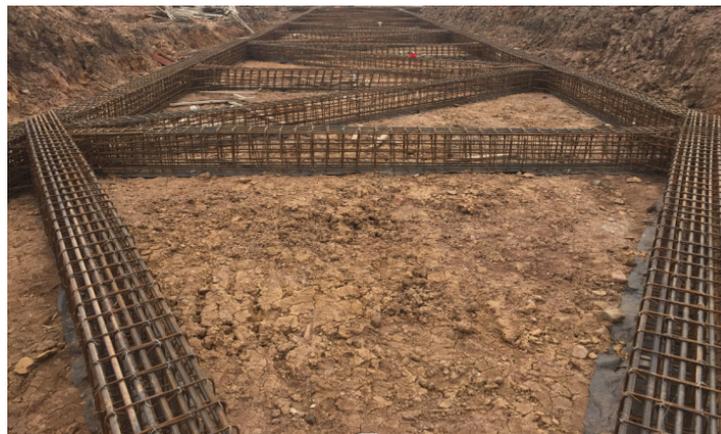
Figure 3. Steel bar binding of the inner brace.

parameters of each brace section are shown in Table 2. The concrete grade and reinforcement grade in the table are determined according to the Code for Design of Concrete Structures GB50204-2015 [19]. Figure 3 shows the steel bar binding for opposite brace types and Figure 4 shows the ring brace after construction.

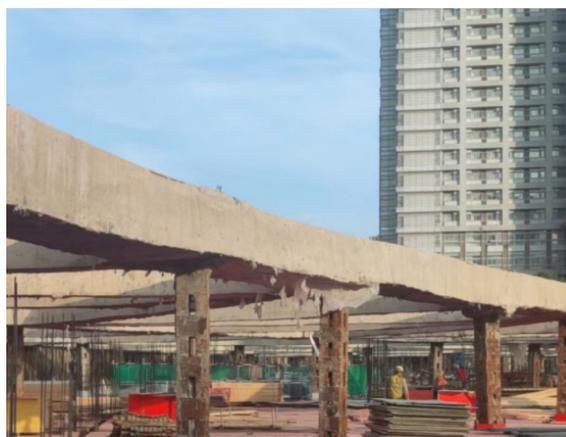
Figure 4. Ring brace.

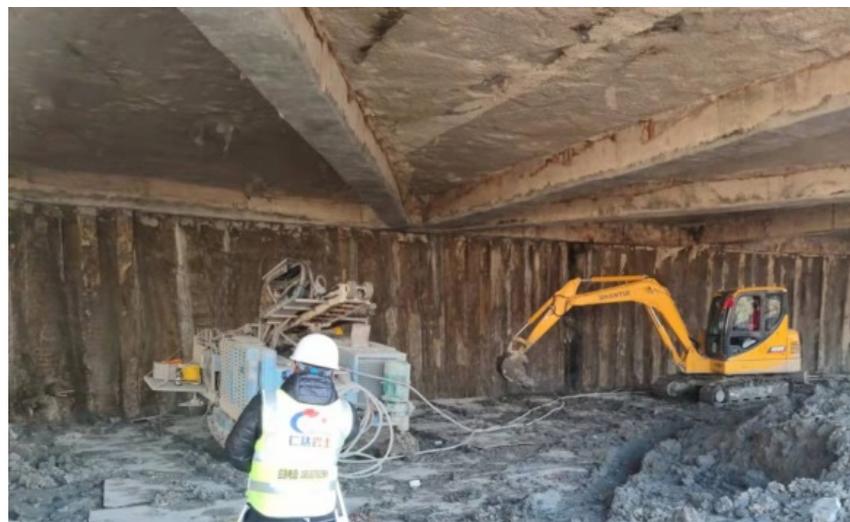
Figure 5. Drilling of the anchor cables.

for Building Foundation Pit Support [20], a large-diameter rotary jet anchor cable was selected to support the foundation pit. Both of the two rows of anchor cables are composed of four bundles of steel strands with a nominal diameter of 15.2 mm and the diameter of each anchor cable is 500 mm. The other parameters of the anchor cables are shown in Table 3. The construction of drilling and grouting of the anchor cables can be seen in Figures 5 and 6.

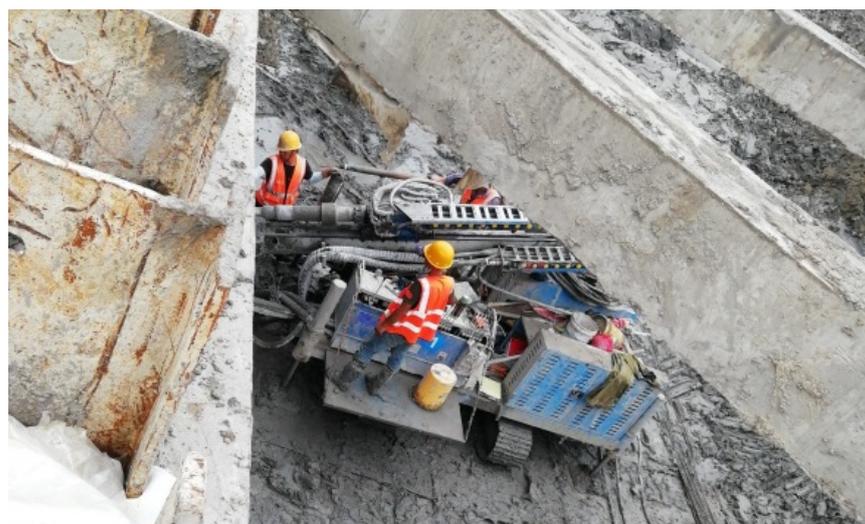
Figure 6. Grouting of anchor cables.

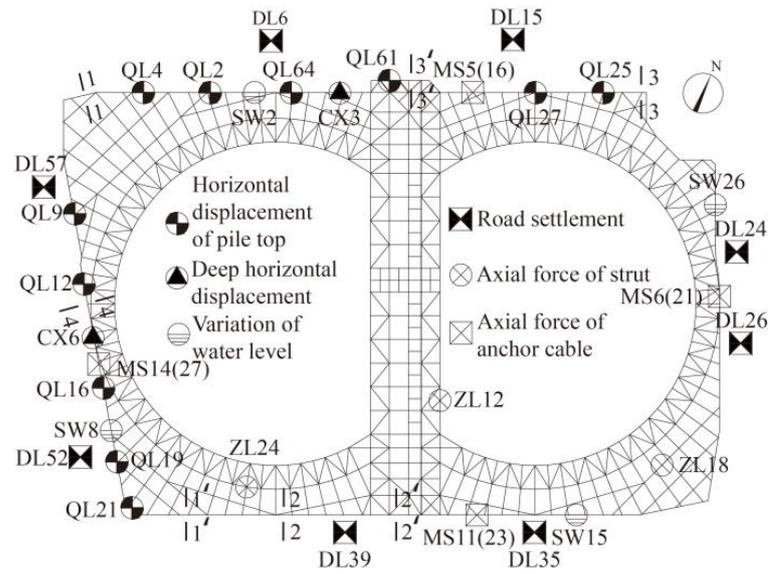
Figure 7. Layout of the monitoring points.

The layout of the foundation pit monitoring points is shown in Figure 7. According to the foundation pit design drawings and the Technical Standards for Monitoring of Building Foundation Pit Engineering, there were 65 monitoring points for horizontal displacement of the pile top, which were numbered with QLi, and i was 1 to 65. They were arranged at the top of the coping beam with a spacing of 20 m. There were 26 monitoring points for deep horizontal displacement of the soil, which were numbered with CXi, and i was 1 to 26. They were buried in the soil around the foundation pit. There were 26 monitoring points for the groundwater level outside the foundation pit, which were numbered with SWi, and i was 1 to 26. They were buried in the soil around the foundation pit with a depth of 15 m. There were 62 monitoring points for road settlement, which were numbered with DLi, and i was 1 to 62. They were arranged at a distance of 20 m along the roadside adjacent to the foundation pit. There were 27 monitoring points for the axial force of brace, which were numbered with ZLi, and i was 1 to 27. They were laid on the braces. There were 28 monitoring points for the axial force of the anchor cables, which were numbered with MSi, and i is 1 to 28. They were divided into two rows and arranged near the anchor head.

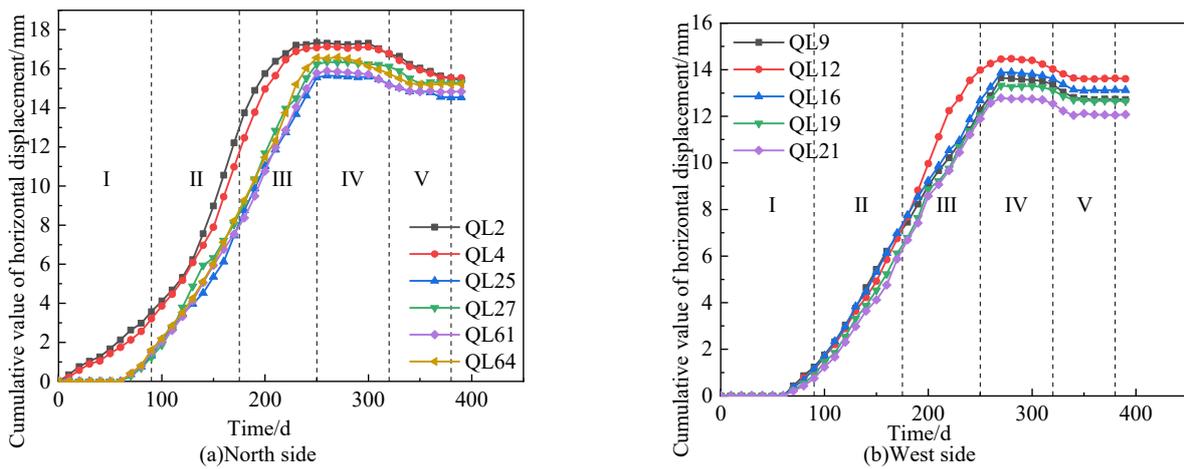
Figure 8. Horizontal displacement curve of the pile top.

Figure 8 is the horizontal displacement curve of the pile top, where a positive value indicates that the displacement faces towards the inside of the foundation pit. The Roman numerals in the figures correspond to the working conditions of each stage and are reflected in the subsequent figures.

In the early stages of excavation, the horizontal displacement increment of each pile top was increased alternately without obvious differences, and the displacement variation was within 2 mm (before the 90th day). With the increase in the excavation depth, the horizontal displacement increased gradually, and the displacement change was between 2 mm and 17 mm (from the 90th day and the 250th day). The horizontal displacement tended to be stable after the completion of foundation slab construction (from the 250th day and the 320th day). During the construction of the underground structure inside the foundation pit, the horizontal displacement decreases (reverse displacement towards the outside of the pit appeared). This is because the underground structure construction imposes additional vertical stress on the soil inside the pit, which forced the pile to move towards the outside of the pit.

During the excavation of the foundation pit, the displacement of the pile top shows an obvious spatial effect [21]. In general, no matter on the long side or on the short side, the displacement of the middle part is large, and the pit angle is small. The closer the pit angle is, the smaller the displacement is. However, QL2 and QL4 in the northwest corner (as shown in Figure 7) did not follow the above rules. The reasons for these phenomena are as follows: (1) the excavation of the two areas was earlier than that of other areas, so the displacement of the pile top occurred earlier and faster than that of other areas, and (2) the pile top position of the two was constrained by the corner brace, which was slightly weaker than the ability of the opposite brace and the diagonal brace to constrain the deformation of the pile top. Among all monitoring points, the maximum horizontal displacement on the north side appeared in QL2, which was 17.35 mm, and 14.47 mm (in QL12) was the maximum horizontal displacement on the west side. There is an obvious difference between the two values, and the average horizontal displacement of the long side is greater than that of the short side.

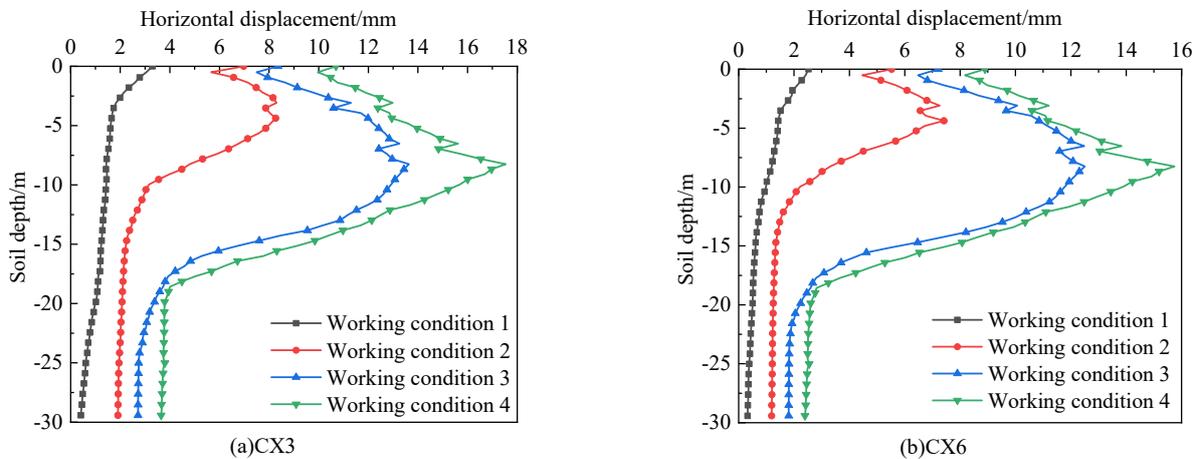
Figure 9. Deep horizontal displacement curve.

Figure 9 shows the variation curve of the horizontal displacement of the soil along the depth direction. The monitoring points were arranged near the pile, and the positive value indicates that the deformation direction is toward the inside of the foundation pit.

It can be seen from Figure 9 that under work condition 1, the deep horizontal displacement of the two monitoring points mainly occurred above the inner brace. This is because the lower soil mass had not been excavated yet, and the supporting pile acted as

the cantilever pile under the action of the brace. When it comes to work condition 2, the soil displacement mainly occurred in the soil layers 10 m below the surface, and the maximum displacement appeared at about 5 m below the surface. Under this work condition, the soil should have been excavated to 0.5 m below the first anchor cable, but due to the long construction period of the anchor cable, over-excavation was carried out, resulting in a further increase in the soil displacement and deepening of the overall soil displacement. For work condition 3, the soil displacement was further expanded in comparison to condition 2, and the overall displacement also developed deeper. Similar to condition 2, condition 3 also had a certain degree of over-excavation. Finally, for work condition 4, the overall horizontal displacement of the soil was bigger than condition 3, the maximum value of the horizontal displacement of the soil appears in the position of 8 m below the surface, and the trend of the curve was also close to condition 3. The reason for the increase in the overall horizontal displacement is that the soil stress was continuously released from condition 3 to condition 4, which led to a further increase in the displacement of the soil. The reason why the two trends are close is that the foundation mat has been poured under condition 4, and the over-excavated surface of condition 3 is also close to the bottom of the foundation pit.

In addition, the development trend of the deep horizontal displacement of the soil at monitoring points CX3 and CX6 was basically the same. At the beginning, they all showed a 'cantilever' shape, and then they showed a 'drum belly' shape with the working conditions that were going on. The average value of the overall horizontal displacement of CX3 is larger than that of CX6. This is because monitoring point CX3 is on the long side and CX6 is on the short side. The spatial effect causes the difference between the two values.

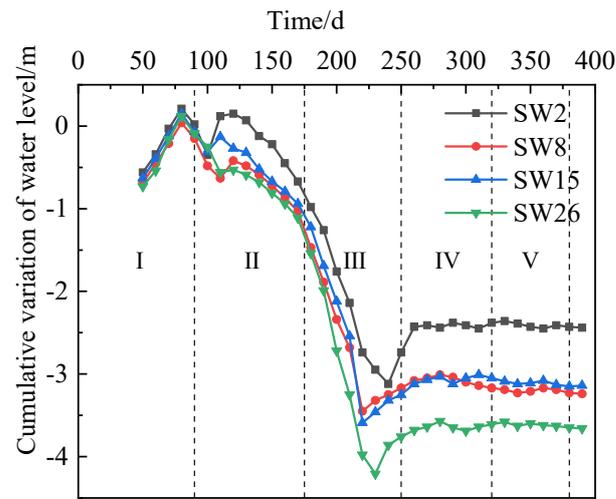
Figure 10. Change curve of the groundwater level outside the pit.

Figure 10 shows the curve of the underground water level outside the pit with time. In work condition 1 (before the 90th day), the depth of the lowered groundwater level in the pit is small, which has little impact on the groundwater level outside the pit. This condition happened to be in the rainy season, and there was more precipitation during the construction period, so the groundwater level rose. As the groundwater level in the pit continues to decrease, the groundwater level outside the pit also decreases.

It should be noted that the construction of two rows of anchor cables pierced the waterproof curtain of the foundation pit (from the 90th day and 250th day). Due to the high water head outside the pit, water leakage and sand leakage occurred at the site, of which the water leakage and sand leakage at the east side were serious. The range of the water level change was within 5 m.

With the treatment of water leakage and sand leakage, the groundwater level outside the pit gradually became stable (from the 250th day and the 380th day). Due to the differences in stratum distribution, the final groundwater level around the foundation pit was different. The groundwater level on the east side of the foundation pit was the shallowest (4.8 m below the surface), while the groundwater level on the north side of the foundation pit was the highest (3.5 m below the surface), and the west and south sides of the foundation pit were in the middle.

The warning value of the water level change is 1 m. Although the warning value had been greatly exceeded during the construction period, the project has not been greatly affected due to timely and appropriate treatment measures.

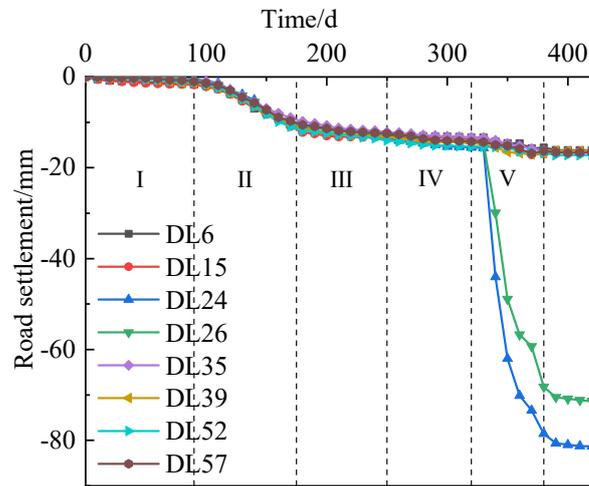
Figure 11. Road settlement curve.

Figure 11 is the road settlement curve. In the early stage of excavation, the settlement of the road around this foundation pit increased slowly. During the construction of the first row of anchor cables (in working condition 2), the largest road settlement reached to -15 mm, which was smaller than the alarm value (20 mm), and results of all monitoring points have the same change rule. However, the road settlements of different monitoring points showed obvious differences with the construction of the second row of anchor cables (working condition 3). At this stage, the settlement of the east road increased rapidly; the

cumulative settlement of monitoring point DL24 on the east side of the foundation pit reached -80.64 mm from -17.35 mm, which accounted for 89.6% of the total settlement. While the roads settlement of the other three sides of this foundation pit showed a trend of steady growth.

The main reason for the difference in settlement is that relatively serious water leakage and sand leakage occurred during the construction of the second anchor cable on the east side. The flow of water and soil from outside into the pit provided space for road settlement outside the pit. In addition, the road on the east side is the main urban road with a large traffic flow and large additional load, which also aggravated the rapid increase in road settlement. With the effective disposal of the water leakage and sand leakage, the road settlement was stable after the completion of the second anchor cable construction, and the development of road settlement for the east side was not obvious under the fourth working condition. Although the total settlement value of the east side road exceeded the alarm value, this phenomenon did not have a significant impact on the entire project due to the implementation of road maintenance, the control of precipitation outside the foundation pit, and the setting of warning signs to prohibit the operation of large vehicles and heavy vehicles.

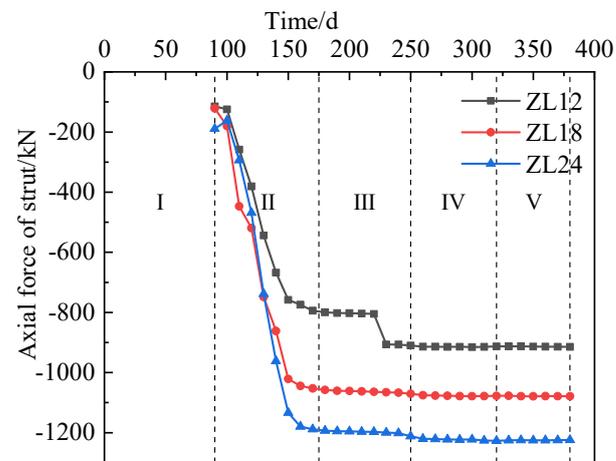
Figure 12. Variation curve of the axial force of the brace.

Figure 12 shows the change curve of brace axial force, in which a negative value means pressure. The monitoring of the axial force of the brace began in work condition 2, so all the curves started from the 90th day.

Axial force of all kinds of braces during work condition 2 (dig the second layer of soil to 6.5 m below the surface and construct the first row of anchor cable) grew rapidly. However, for the work condition 3 (dig the third layer of soil to 9.5 m below the surface and construct the second row of anchor cable), the axial force remained stable and no longer increased. The reasons for this phenomenon may be as follows: at the beginning of excavation of the soil below the brace, the support structure of the foundation pit bore more unbalanced earth pressure. Since the anchor cable had not been constructed yet, the braces had to bear more force. With the completion of the construction of the first row of anchor cables, the unbalanced earth pressure caused by the excavation of the soil under the first row of anchor cables was borne by the anchor cable. At this time, the axial force would not change any more. So, the following conclusion can be drawn whereby the excavation of the foundation pit will only increase the axial force of the adjacent braces or anchor cable and will not affect the axial force of remote braces and anchor cables.

Among all kinds of braces, the axial force of the ring brace is the largest, reaching about 1250 kN, the opposite brace is the smallest, about 910 kN, and the angle brace is in the middle, about 1080 kN. Generally, the axial force of the opposite brace should be the maximum, but the excavation road is arranged on the opposite brace of this foundation pit, which was partially strengthened, so the maximum axial force appeared on the ring brace.

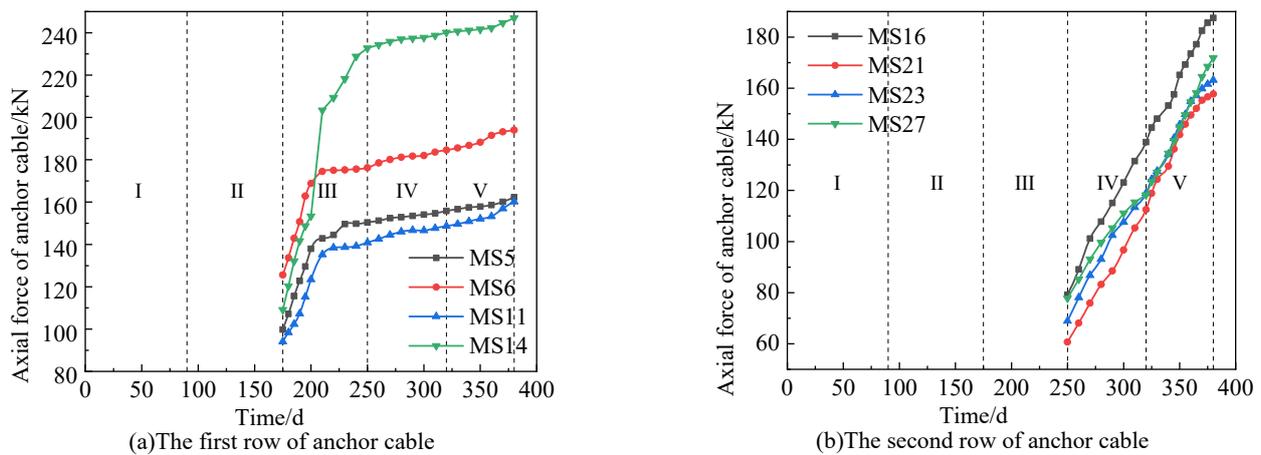
Figure 13. Variation curve of the axial force of the anchor cable.

Figure 13 shows the change curve of axial force for the anchor cables. Since the monitoring of the axial force of the first row and the second row of anchor cables started in work condition 3 and work condition 4, the monitoring results of anchor cables were introduced from the 175th day and 250th day. It can be seen from Figure 13 that the axial force of the first row of anchor cables is generally greater than that of the second row of anchor cables. This is because during work condition 2, the water leakage and sand leakage reduced the water and soil pressure outside the foundation pit at the position of the second row of anchor cables.

With the excavation of the soil below the second row of anchor cables, the axial force of the first row of anchor cables tended to be stable, while the axial force of the second row of anchor cables increased, which is consistent with the conclusion in Section 3.5. After excavation to the bottom of the foundation pit, the axial force of the second row of anchor

cables still increased, which was related to the time effect of the foundation pit. The soil outside the pit needed time to consolidate and deposit after construction disturbance.

According to the statistics of the results of all measuring points for anchor cables, it can be seen that the axial force of the first row of anchor cables ranged from 97.5 to 245.7 kN, and their average axial force was 171.6 kN, which is only 66% of the designed axial force (260 kN). The axial force of the second row of anchor cable varied from 62.4 to 187.5 kN, with an average of 124.9 kN, which is only 60.95% of its designed value (205 kN).

The maximum axial force of the two rows of anchor cables did not exceed the design value and there was a large margin, indicating that the anchor cables in some soil layers in soft soil areas can still play a very good supporting role and can be used as an alternative structure for foundation pit support in soft soil areas.
