Study on the Characteristics and Evolution Laws of Seepage Damage in Red Mud Tailings Dams

Keywords: red mud tailings dam; seepage damage; infiltration line; soil pressure; pore water pressure

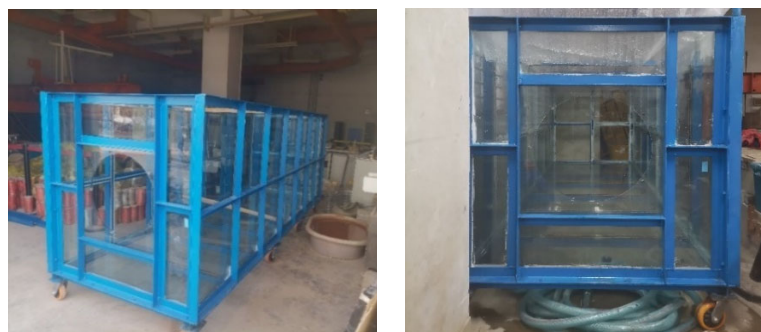
The dimensions of the model tank were as follows: 3.5 m in length, 1.2 m in width, and 1.2 m in height. To facilitate observation, the model tank was constructed with 5 panes of tempered glass on its four sides and bottom, as illustrated in Figure 1.

Figure 1. Laboratory test tank.

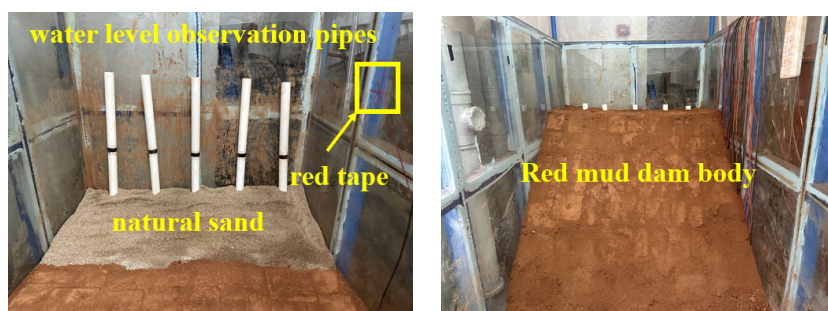
The water level control system comprised natural sand to realize rapid changes in water level, and five water level observation pipes were submerged at the base of the natural sand. During the water injection procedure, the infiltration line was monitored from the tempered glass side, and the water injection speed was regulated according to the water level in the observation pipe, as illustrated in Figure 2. The monitoring system included a pin, locating line, level, steel ruler, etc., as shown in Figure 3.

Figure 2. The water level control system.

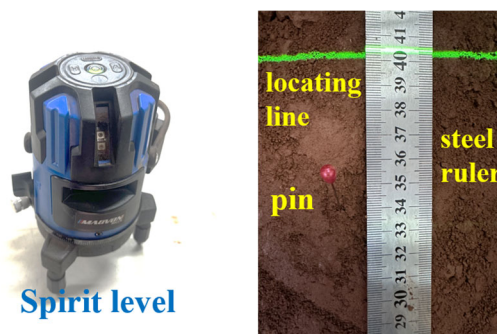
Figure 3. Spirit level, pin, and steel ruler.

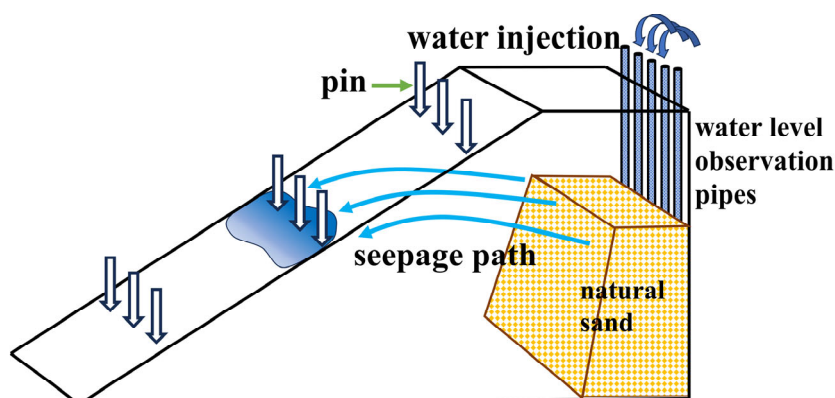
Three pins were placed at the top, middle, and bottom of the red mud slope in alignment with the experimental specifications. Benchmark points were established on either side of the slope model with the aid of red tape, guiding the precise placement of the pins using a level. These pins were located uniformly along a horizontal axis. When the water level rises and seepage-induced failure appears on the slope’s surface, the pins will experience displacement in conjunction with the slope. Slope displacement can be determined by measurement of the pins’ deviation distance, as shown in Figure 4.

Figure 4. Layout of benchmarks.

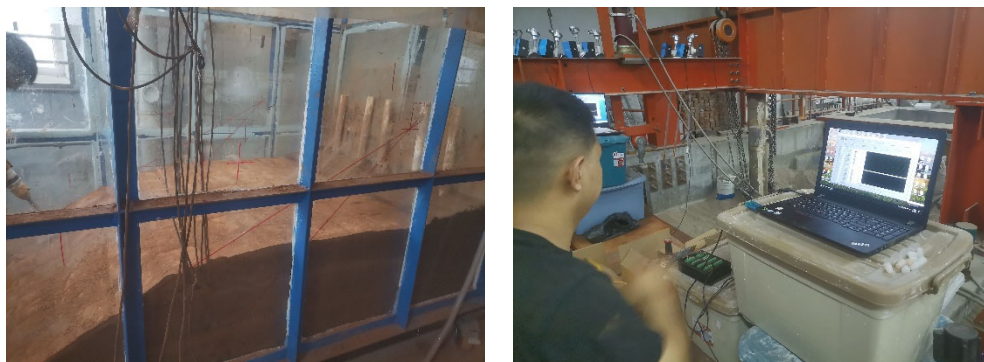
The compaction test was conducted using a small 990 W electric tamper, with a body weight of about 6 kg and tamping plate size of 150 × 150 mm. The red mud tamping and data monitoring process is shown in Figure 5.

Figure 5. Red mud tamping and data monitoring.

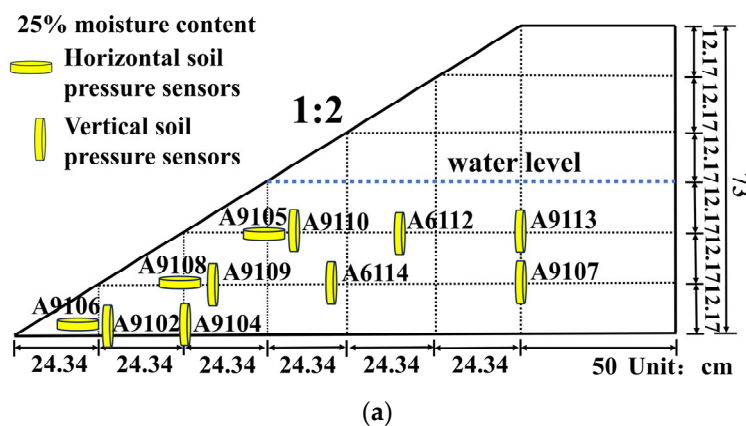
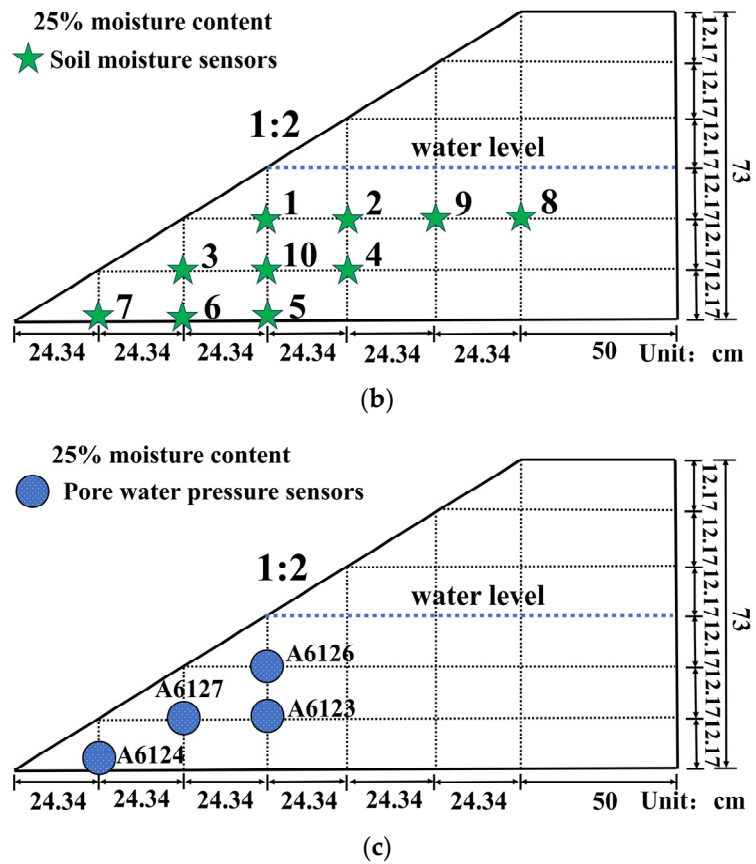
The preset water level height in condition T1 was 36.51 cm, and the sensors were located below the water level, which were used to monitor the evolution patterns of soil pressure, volumetric water content, and pore water pressure during the low water level change. Among them, the soil pressure boxes were arranged as shown in Figure 6a, the soil moisture sensors were arranged as shown in Figure 6b, and the pore water pressure sensors were arranged as shown in Figure 6c.

Figure 6. Location of sensor burial for working condition T1. (a) Layout location of soil pressure sensors. (b) Location of soil moisture sensor arrangement. (c) Pore water pressure sensor burial location.

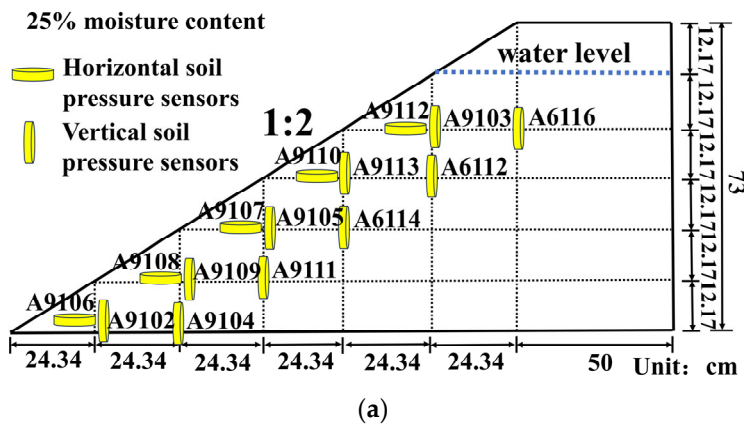
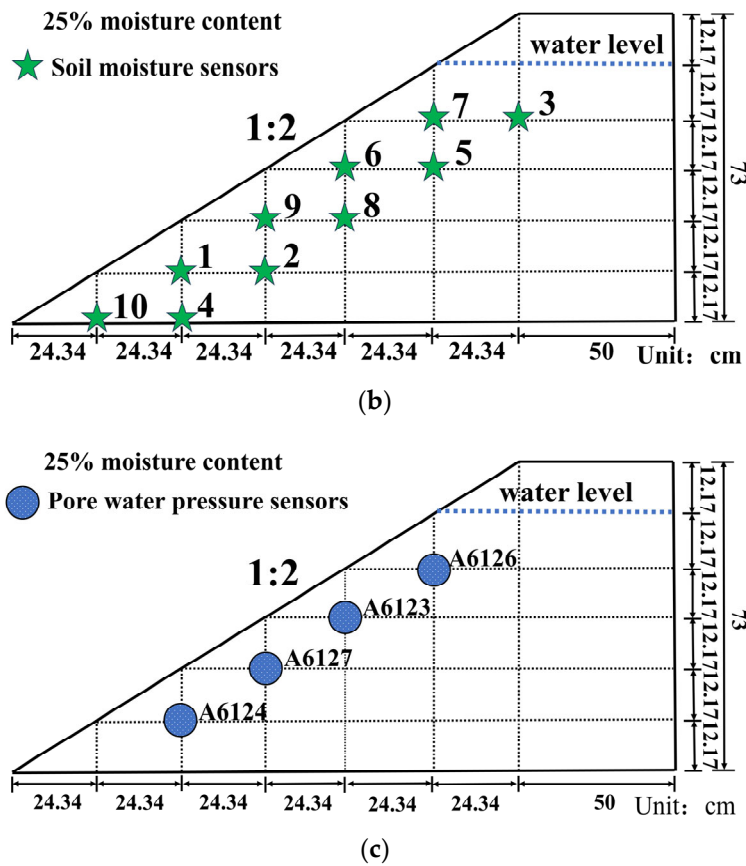
The preset water level height in working condition T2 was 60.85 cm, and the sensors were buried below the water level, which were used to monitor the evolution patterns of soil pressure, volumetric water content, and pore water pressure during the high water level change. Among them, the soil pressure box was arranged as shown in Figure 7a, the soil moisture sensor was arranged as shown in Figure 7b, and the pore water pressure sensor was arranged as shown in Figure 7c.

Figure 7. Location of sensor burial for working condition T2. (a) Layout location of soil pressure sensors. (b) Location of soil moisture sensor arrangement. (c) Pore water pressure sensor burial location.

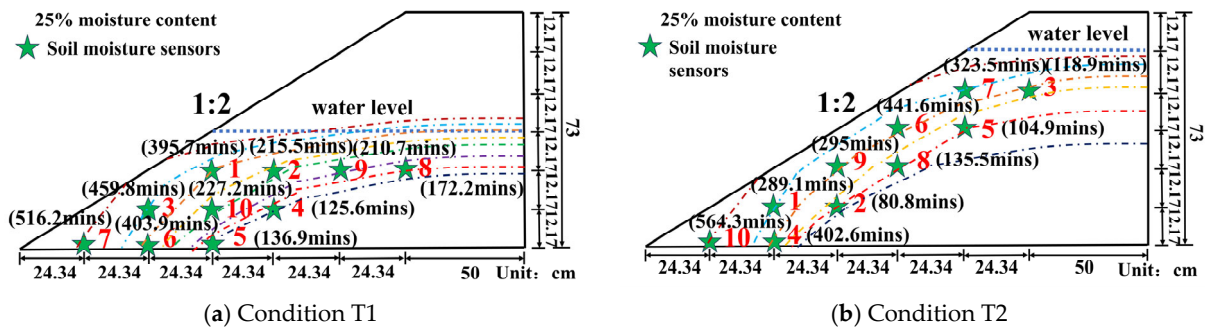
Combined with the sequence and arrival time of infiltration lines to each monitoring point under conditions T1 and T2, the evolution laws of infiltration lines are plotted in Figure 9. Figure 9a shows the evolution law of the infiltration line as the water level gradually increased from 0 to 36.51 cm for condition T1, and Figure 9b shows the evolution law of the infiltration line as the water level gradually rose from 0 to 60.85 cm for condition T2. It can be seen from Figure 9 that the higher the water level is, the higher slope surface position the infiltration line reaches, increasing the risk of landslides and potential damage. Given that red mud is a type of fine-grained tailing with poor permeability, the infiltration line was higher compared to the coarse-grained tailings reservoir; there is consequently a higher likelihood of seepage damage on the dam slope. Therefore, strict control over the water level height in red mud dams is imperative.

Figure 9. Evolution law of infiltration line under working conditions T1 and T2.

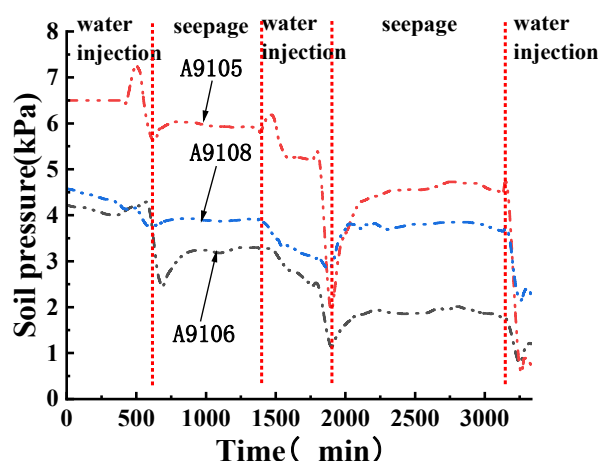
The distribution of vertical soil pressure near the slope surface in condition T1 is depicted in Figure 10. It is evident that before water level changes, the highest vertical soil pressure appears at monitoring point A9105 near the slope toe, followed by monitoring point A9108, while the lowest vertical soil pressure appears at monitoring point A9106 of the slope toe.

After the water level changes, water injection was conducted between 0–598 min; the vertical soil pressure at monitoring points A9108, A9106, and A9105 all show obvious decrease trends after basic stabilization (or increase). Combined with the distribution of volumetric moisture content in Figure 8a, during the water injection period, the infiltration line gradually extends to the slope surface, the pore water gradually increases

at the monitoring points near the slope surface, and the vertical soil pressure decreases due to the buoyancy of the soil pressure box. Between 598 min and 1401 min, water injection was stopped and smooth seepage dominates inside the dam. The vertical soil pressure at monitoring points A9108 and A9105 show very small changes, and there is a significant rise of vertical soil pressure at monitoring point A9106. This is because the pore water at the slope foot seeps into the slope surface, reducing the volumetric moisture content at the slope foot. Consequently, the buoyancy of the soil pressure box at monitoring point A9106 decreases, and the vertical soil pressure reading increases. Between 1401 min and 1910 min, water injection was conducted again, with vertical soil pressures at monitoring points A9108, A9106, and A9105 showing a rapid decreasing trend, with decreasing values of 21.15%, 62.16%, and 60.7%, respectively—relatively high decreasing values at monitoring points A9105 and A9106. Between 1910 min and 3145 min, the water injection was stopped again; this period is the seepage stage, where the vertical soil pressures at monitoring points A9105, A9106, and A9108 all show increasing trends, which is due to the fact that the pore water keeps seeping out of the slope surface, the pore water pressure decreases, and the buoyancy of soil pressure box decreases. Between 3145 min and 3333 min, the water injection was conducted again, with the vertical soil pressures at monitoring points A9108, A9106, and A9105 showing rapid decreasing trends, with decreasing values of 40.32%, 43.56%, and 87.04%. The vertical soil pressure at monitoring point A9105 decreases the most, indicating that the pore water pressure at monitoring point A9105 is the largest.

Figure 10. Distribution of vertical soil pressure near the slope in condition T1.

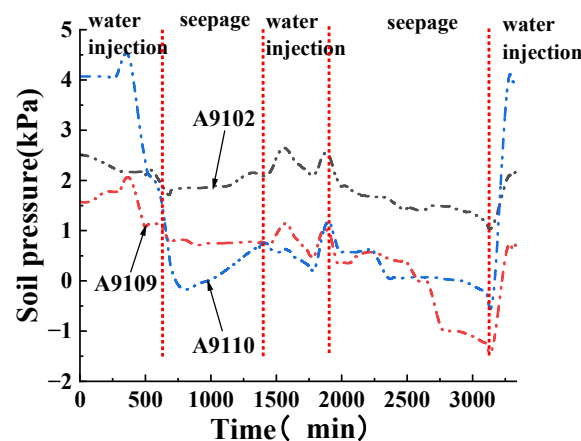
The distribution of horizontal soil pressure near the slope surface in condition T1 is shown in Figure 11. It can be seen that the horizontal soil pressure at the monitoring point A9110 is the largest, followed by the monitoring point A9102 at the slope foot, and the horizontal soil pressure at the monitoring point A9109 near the foot of the slope is the smallest.

at monitoring points A9110, A9102, and A9109 show the fluctuating trends of increase–decrease–increase–decrease, which is because the pore water decreases at the previous stable seepage stage, the pore water increases again after water injection, resulting in a self-weight increase of red mud. The buoyancy on the soil pressure box appears with the increase of pore water; the water injection is still ongoing when the pore is full of water, the pore water cannot be discharged quickly, and then the horizontal soil pressure increases again due to the pore water. Between 1910 min and 3145 min, water injection was stopped again, and the horizontal soil pressures at monitoring points A9102, A9109, and A9110 show decreasing trends in this seepage stage, which is because these three monitoring points are near the slope surface, and the pore water near the slope surface flows out continuously; the horizontal soil pressures then decrease due to the weakening effect of the pore water. Between 3145 min and 3333 min, water injection was conducted again; horizontal soil pressures at monitoring points A9102, A9109, and A9110 all show rapid increase trends due to the pore water effect. Compared with the unchanged period water level, at the end of the second seepage, the horizontal soil pressure at monitoring point A9110 decreases the most. Compared with the end of the second seepage, at the end of the third water injection, the horizontal soil pressures at monitoring points A9102, A9109, and A9110 increase by 107.2%, 211.1%, and 450.7%. The increased value of horizontal soil pressure at monitoring point A9110 is the highest.

Figure 11. Distribution of horizontal soil pressure near the slope in condition T1.

From Figures 11 and 15a, it can be seen that the change trend of horizontal soil pressure in condition T1 is consistent with the change trend of pore water pressure in condition T1. At the end of the third water injection, the pore water pressures at monitoring points A6123, A6124, A6126, and A6127 all increased compared to the

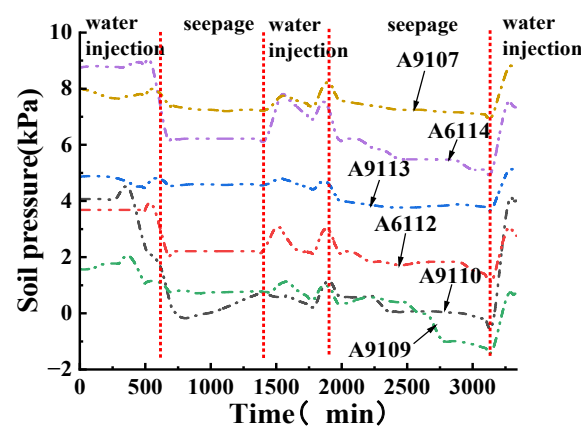
From the transmission of horizontal thrust under condition T1 in Figure 12, it can be seen that the first row of monitoring points from the inside of the red mud dam to the slope surface are monitoring points A9113, A6112, and A9110, respectively. The second row of monitoring points are monitoring points A9107, A6114, and A9109, respectively. Before the water level changes, the greatest horizontal soil pressures are at monitoring point A9110 in the first row and at monitoring point A6114 in second row, respectively.

pressures at three monitoring points rapidly increase. Among them, the horizontal soil pressure at monitoring point A9110 increases the most.

After the water level change, the change trends of horizontal soil pressures at monitoring points of the second row are similar to those of the first row. At the end of the first water injection, the horizontal soil pressures at monitoring points in descending order is A9107, A6114, and A9109. During the seepage stage, the horizontal soil pressures at three monitoring points remain stable. When water injection is conducted again, the horizontal soil pressures at three monitoring points show similar fluctuations due to pore water changes. At the end of the injection, the descending order of horizontal soil pressures at monitoring points is A9107, A6114, and A9109. At seepage stage when water injection is stopped again, the horizontal soil pressures at three monitoring points show decreasing trends. During the third water injection stage, the horizontal soil pressures at three monitoring points increase rapidly; the highest increase appears at monitoring point A6114.

Figure 12. Transmission of horizontal thrust in condition T1.

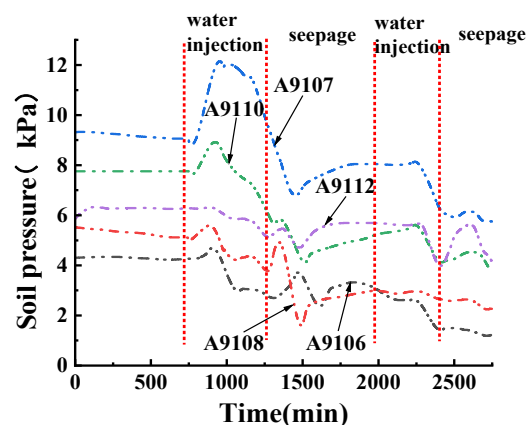
The distribution of vertical soil pressures near the slope in condition T2 is displayed in Figure 13. Before the water level change, the vertical soil pressure at monitoring point A9107 is the highest, follow by A9110, and the vertical soil pressure at monitoring point A9106 at the foot of the slope is the lowest.

After the water level change, water injection was conducted between 730 min and 1260 min, and the vertical soil pressures at monitoring points A9112, A9110, A9107, A9108, and A9106 show increasing–decreasing change trends. At the end of the first water injection, the vertical soil pressures at monitoring points A9107, A9106, A9108, A9110, and A9112 increase by 7.4%, 34.19%, 25.68%, 20.08%, and 17.63%, respectively, compared with the pressures before water injection. Between 1260 min and 1993 min, the water injection was stopped; the vertical soil pressures at the monitoring points show increasing–decreasing–increasing change trends at this seepage stage. Between 1993 min and 2382 min, water injection was conducted again, and all the vertical soil pressures at the monitoring points show basic stability–decrease changes. At the end of the second water injection, compared to the pressures before the water level change, the descending order of vertical soil pressures at the monitoring points changes is A9107, A9112, A9110, A9108, and A9106. At the end of the second water injection, the vertical soil pressures at monitoring points A9107, A9106, A9108, A9110, and A9112 decrease by 34.4%, 64.89%, 49.48%, 45.59%, and 22.13% respectively. Among them, the most significant decreases in vertical soil pressure are observed at monitoring points near the slope foot. Between 2382 min and 2666 min, water injection was stopped, entering the seepage stage again.

Figure 13. Distribution of vertical soil pressure near the slope in condition T2.

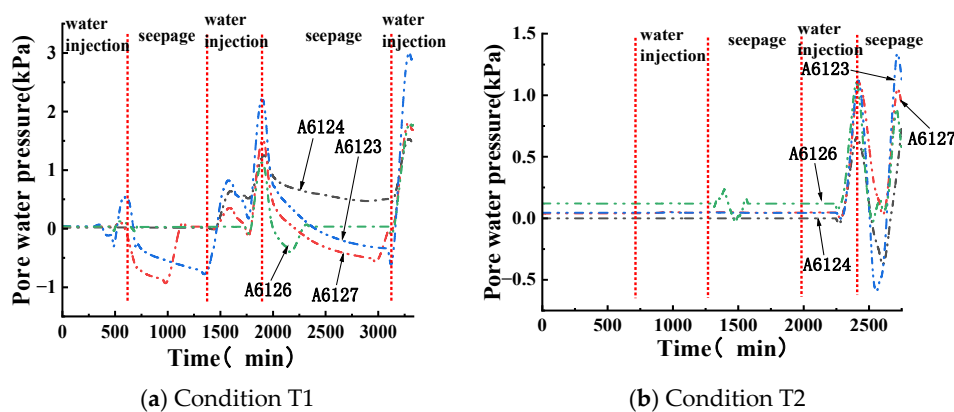
pressures at the end of the second seepage. Notably, the highest pore water pressure is recorded at monitoring point A6126 near the slope surface, and the most significant increase is observed at monitoring point A6123. Based on the distribution of horizontal soil pressures near the slope surface in condition T1 in Figure 11, it can be seen that monitoring point A6126 corresponds to monitoring point A9110, with the highest increase in horizontal soil pressure. Monitoring point A6124 corresponds to monitoring point A9102, with the lowest increase in pore water pressure at the foot of the slope and the lowest increase in horizontal soil pressure.

From Figures 14a and 15b, it can be seen that the change trend of horizontal soil pressure in condition T2 is consistent with the change trend of pore water pressure in condition T2. As displayed in Figure 15b, at the end of the second water injection in condition T2, the pore water pressures at monitoring points A6124, A6127, A6123, and A6126 increase by 0.5761 kPa, 0.786 kPa, 0.8435 kPa, and 0.9752 Pa, respectively, compared with the pressures at end of the first seepage. Based on the distribution of horizontal soil pressures in the first column of condition T2 in Figure 14a, it can be seen that monitoring points A6126 and A6123 correspond to monitoring points A9103 and A9113, respectively. The horizontal soil pressures at monitoring points A9103 and A9113 increase the most, while the horizontal soil pressure at monitoring point A9109 increases the least.

From the change trends of pore water pressures under conditions T1 and T2, it can be seen that the pore water pressure increases most near the water level line. Combined with the change rule of soil pressure with time under the water level change in conditions T1 and T2, it is evident that the horizontal soil pressure near the water level line increases the most. The change of pore water pressure directly affects the soil pressure value; a higher pore water pressure reduces effective stress between red mud particles, weakens shear strength, and compromises dam body stability.

Figure 15. Trend of pore water pressure change in working conditions T1 and T2.

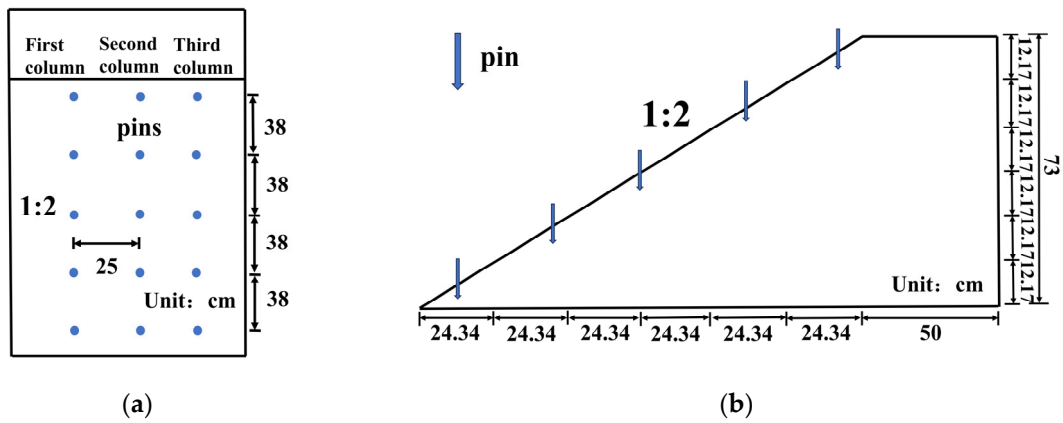
Five rows of pins were located for the displacement measurement of the red mud dam under the water level change, and each row of pins were located in three columns, which were used to observe the upper, middle, and bottom displacements of the red mud dam, respectively. The arrangements of pins are shown in Figure 16.

Figure 16. Location of pin embedding. (a) Horizontal arrangement of pins. (b) Vertical arrangement of pins.

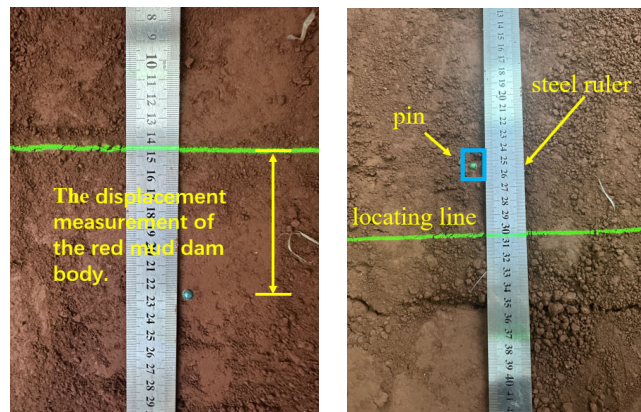
The displacement at each position was measured with a steel ruler close to the slope surface. Figure 17 shows the displacement measurement of the red mud dam body.

Figure 17. The displacement measurement of the red mud dam body.

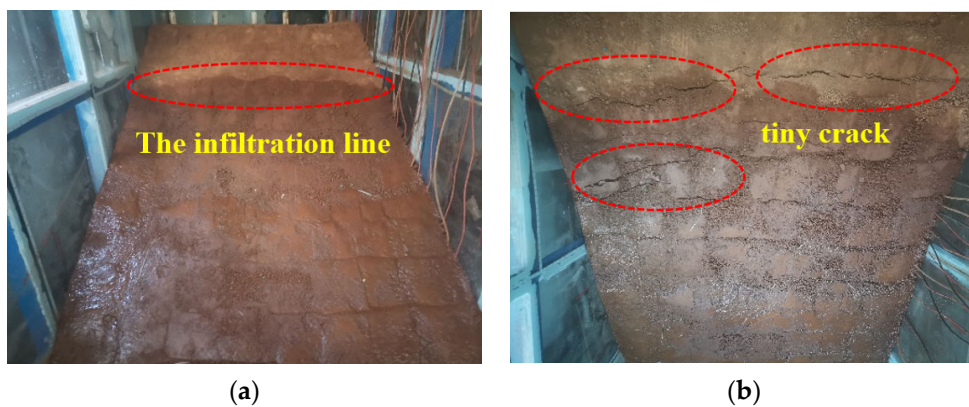
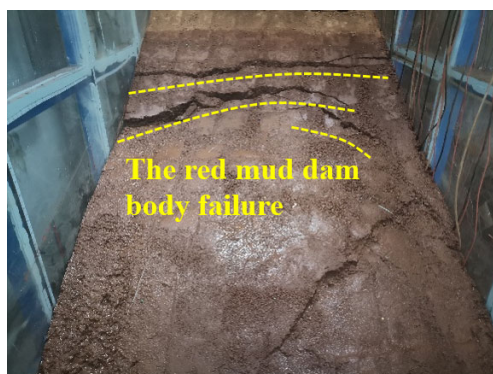
Figure 18 illustrates the displacement of the dam body where seepage failure occurs under condition T1. The infiltration line extends to the surface of the slope, causing visible cracks to emerge, and subsequent monitoring of dam body displacement. Consequently, these cracks progressively widen, leading to increased displacement along the slope.

Figure 18. Displacement of red mud dam body with seepage failure in condition T1. (a) The infiltration line reaches the slope surface. (b) Tiny cracks appear on the slope surface. (c) Red mud dam damage.

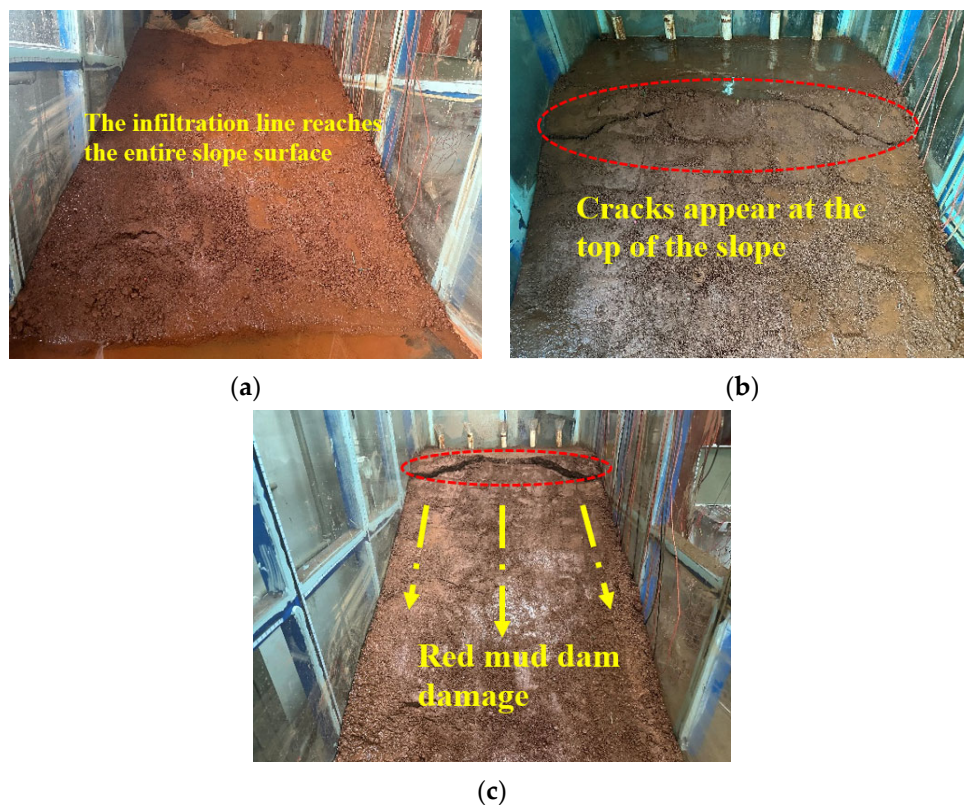
Figure 20 illustrates the displacement of the dam body where seepage failure occurs under condition T2. The infiltration line reaches the entire slope surface, and the cracks appear at the top of the slope. Subsequently, these cracks progressively widen, causing a continuous increase of displacement.

Figure 20. Displacement of red mud dam body with seepage failure in condition T2. (a) The infiltration line reaches the slope surface. (b) Cracks appear at the top of the slope. (c) Red mud dam damage.

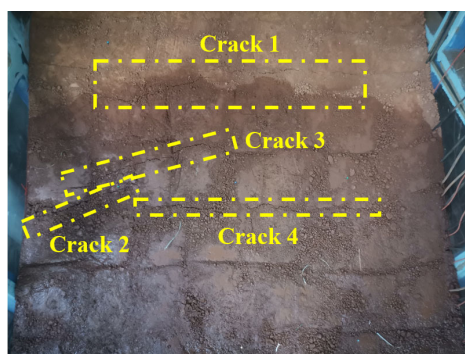
In Figure 22 under Condition T1, micro cracks are observed on the slope. When the water level was set as 36.51 cm, the infiltration line does not completely cover the entire slope. During the initial development phase, four longitudinal cracks primarily appear near and below the slope, and they are parallel to the axis of the red mud dam body. These cracks are respectively labeled as Crack 1, Crack 2, Crack 3, and Crack 4. When micro cracks appear, the widths of Crack 1, Crack 2, Crack 3, and Crack 4 are approximately 2–3 mm. Crack 1 and Crack 4 are relatively longer, exceeding half of the slope width, while Crack 2 is the shortest and is located close to the model tank edge. The development and expansion of micro cracks can be observed from Figure 23. Crack 1 almost runs through the entire red mud dam body, Crack 2 extends towards the middle section of the dam body, Crack 3's length exceeds more than half of the slope width, and Crack 4 shows minimal change.

Figure 22. The occurrence of micro cracks on the slope in condition T1.

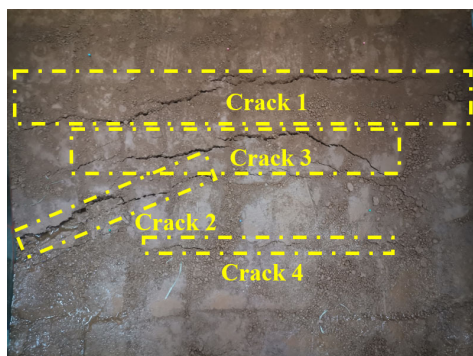
Figure 23. Development and extension of microcracks in condition T1.

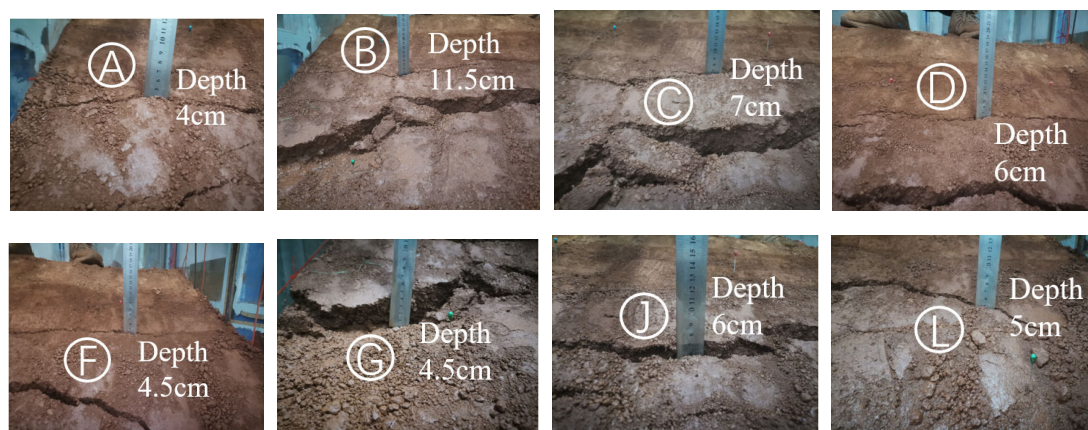
From Figure 24a, the longitudinal cracks expansions are as follows: Crack 1 runs through the red mud dam body, and the width significantly increases; the width of Crack 2 also significantly increases and extends along the length direction to Crack 3; for Crack 3, the length remains basically unchanged, but the width increases most significantly; however, Crack 4 remains almost unchanged. In order to summarize the crack expansion laws, the depths of points A, B, C, D, F, G, J, and L were measured. According to the dates in Figure 24b, the depth of point A is 4 cm, point B is 11.5 cm deep, point C is 7 cm deep, point D is 6 cm deep, points F and G are both 4.5 cm deep, point J is 6 cm deep, and point L is 5 cm deep.

Figure 24. Longitudinal crack propagation in condition T1. (a) Longitudinal crack propagation in condition T1. (b) Crack depth during the longitudinal crack propagation stage of condition T1.

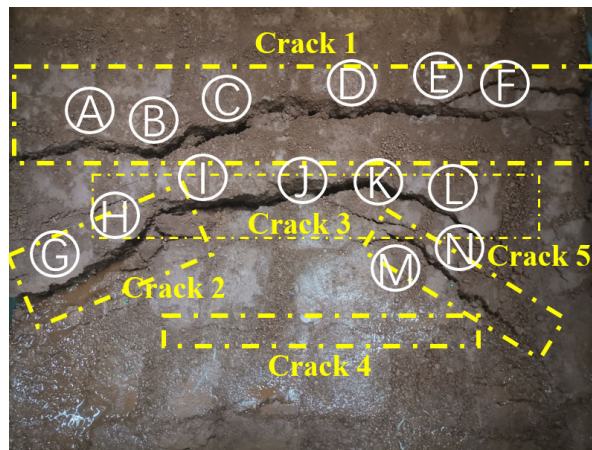
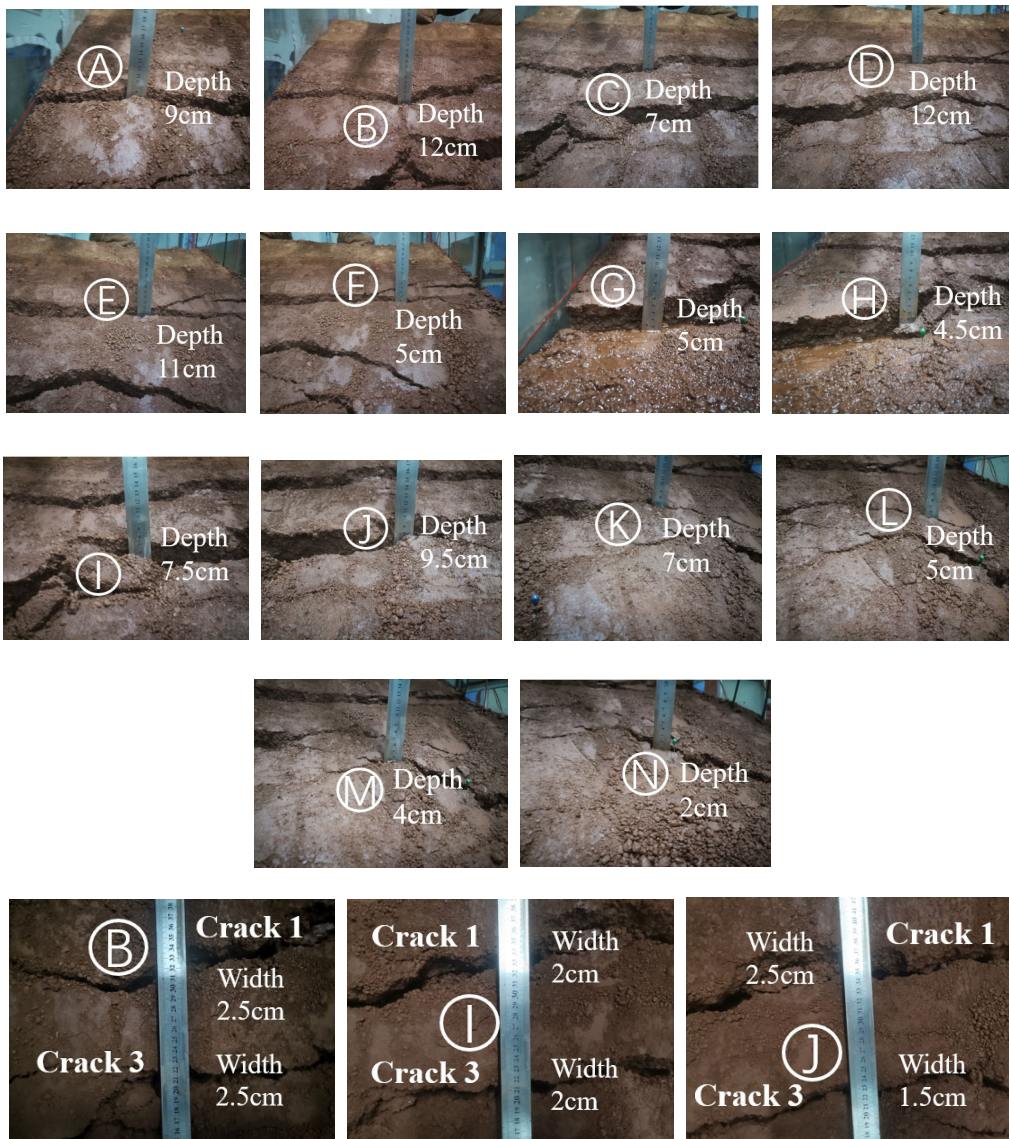
From Figure 25a, it can be seen that the width of Crack 1 has significantly increased; Cracks 2 and 3 are connected, with significant increases in width and noticeable height difference between the cracks. Crack 4 remains basically unchanged, while Crack 5 significantly expands. In order to summarize the crack expansion laws, the depths of points A to N were measured. According to the dates in Figure 25b, the depth of point A is 9 cm, point B is 12 cm deep, point C is 7 cm deep, point D is 12 cm deep, point E is 11 cm deep, point F is 5 cm deep, point G is 5 cm deep, point H is 4.5 cm deep, point I is 7.5 cm deep, point J is 9.5 cm deep, point K is 7 cm deep, point L is 5 cm deep, point M is 4 cm deep, and point N is 2 cm deep. Compared with Figure 24b, the depths of points A, B, D, F, G, and J increase by 5 cm, 0.5 cm, 6 cm, 0.5 cm, 0.5 cm, and 3.5 cm, and the depths of points C and L remain unchanged. In the middle of the slope, the increases of crack depths are most significant, while the increases on both sides are less, and some cracks even do not increase. In addition, the widths of Cracks 1 and 3 at point B are 2.5 cm and 2.5 cm; the widths of Crack 1 and 3 at point I are the same at 2 cm; and the widths of Crack 1 and 3 at point J are 2.5 cm and 1.5 cm. It can be observed that the widths of Cracks 1 and 3 have significantly increased.

From the crack expansion laws of seepage failure in condition T1, it can be seen that during the seepage failure process, Crack 1 gradually penetrates through the width direction of the red mud, and the width and depth increase significantly. Cracks 2 and 3 finally connect, with a significant increase in width and height difference. At this time, the red mud slope has obvious displacement, Crack 4 has no significant change, and Crack 5 appears in the later stage of seepage failure. With the intensification of seepage failure, Crack 5 also shows significant expansion, and eventually Cracks 1, 2, and 3 develop into the main cracks, which are the main cracks causing the damage to the red mud dam.

Figure 25. Final morphology of longitudinal cracks in condition T1. (a) Final morphology of longitudinal cracks in condition T1. (b) The depth and width of the final stage of longitudinal cracks in condition T1.

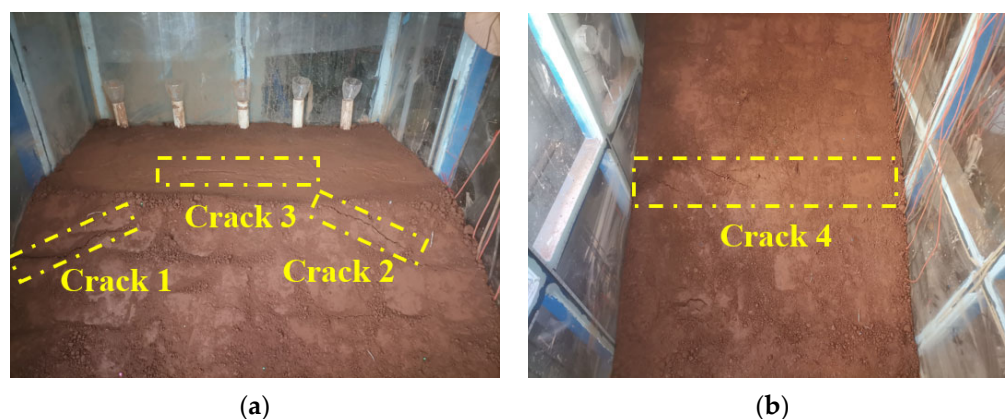
According to Figure 26, the water level change under condition T2 causes the generation of micro cracks on the slope surface. The preset water level line for condition T2 is 60.85 cm, and after the infiltration line reaches the slope surface, it completely covers the entire slope surface. In the early stage of longitudinal crack development, four cracks mainly appear at the top and middle of the slope: Cracks 1 and 2 appear near the slope top, Crack 3 appears at the slope top platform, and Crack 4 appears in the middle of the slope.

Figure 26. The occurrence of micro cracks on the slope in condition T2. (a) At the top of the slope. (b) In the middle of the slope.

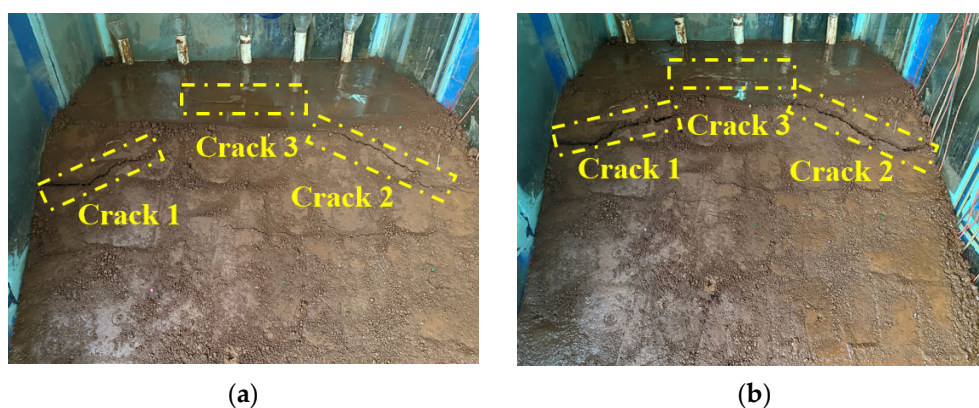
From Figure 27a–c, it can be seen that as water injection continues, Cracks 1, 2, and 3, located at the slope top, begin to develop and expand. Among them, Cracks 1 and 2 expand the most significantly, with their length developing longitudinally towards the slope top and their width continuously increasing. From Figure 27d, it can be seen that Cracks 1, 2, and 5 finally connect and form longitudinal cracks parallel to the axis of the red mud dam at the slope top. At this time, the slope has already shown significant displacement. From Figure 27c–d, it can be seen that Crack 6 appears in the later stage of water injection, and as the water injection continues, Crack 6 also shows significant expansion. Further analysis from Figure 27b,e indicates that the growth rate of Crack 4 is comparatively slower although it appears earlier.

Figure 27. Development and propagation of microcracks in condition T2. (a) The appearance of micro cracks at the top of the slope. (b) The development of cracks at the top of the slope. (c,d) Expansion of cracks at the top of the slope. (e) The final stage of slope top cracks.

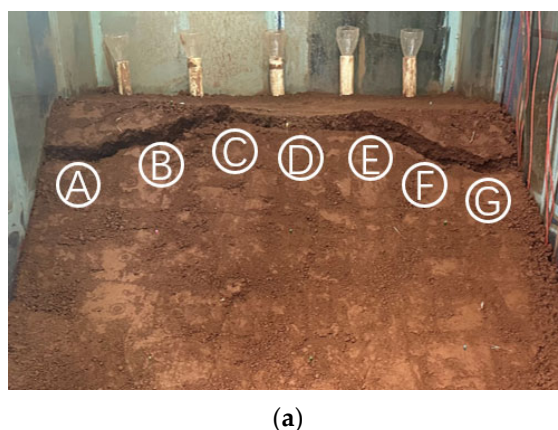
In Figure 28a, the longitudinal cracks parallel to the axis of the red mud dam have already formed at the top of the slope. In order to summarize the crack expansion laws, points A, B, C, D, E, F, G were selected and their depths were measured. From Figure 28b, it can be seen that the depths of points A, B, C, D, E, F, and G are 7 cm, 9.5 cm, 13 cm, 2 cm, 7 cm, 7 cm, and 5 cm. Among them, the depth of point D in the middle of the slope top is the shallowest, and the depths on both sides are deeper.

Figure 28. Longitudinal crack propagation in condition T2. (a) Expansion of longitudinal cracks in condition T2. (b) Crack depth during the longitudinal crack propagation stage of condition T2.

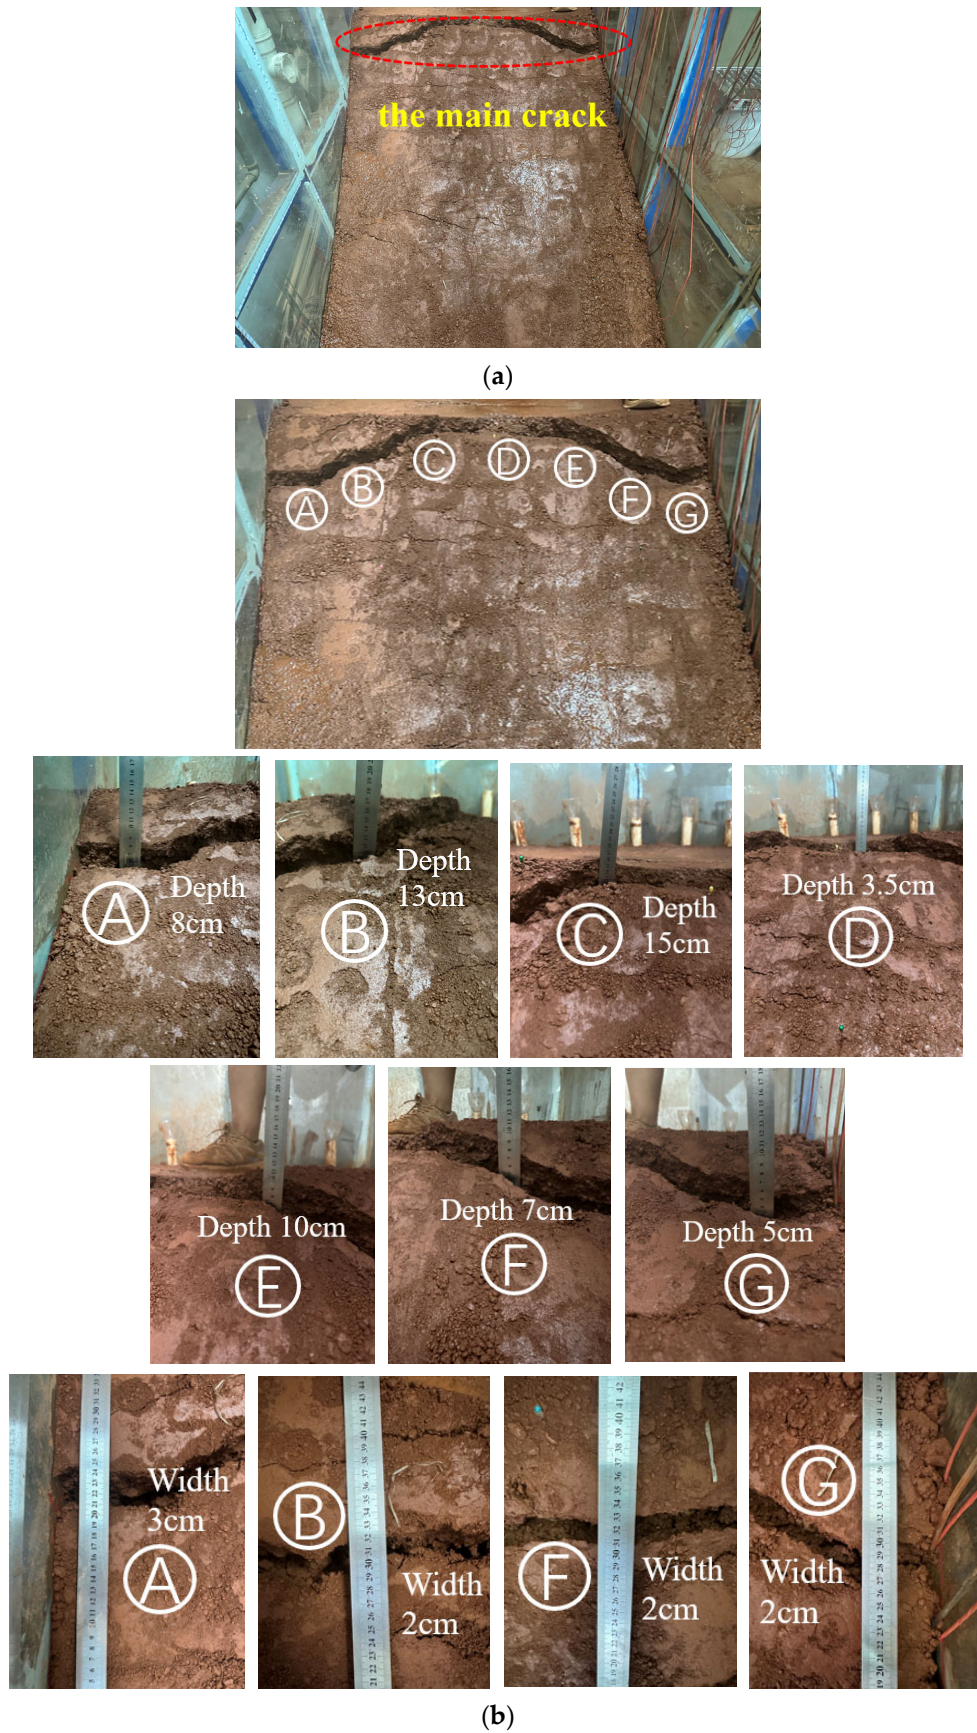
In Figure 29a, there is a more obvious height difference in the longitudinal cracks that run through the slope top. From Figure 29b, it can be seen that in the final form, the depths of points A, B, C, D, E, F, and G are 8 cm, 13 cm, 15 cm, 3.5 cm, 10 cm, 7 cm, and 5 cm. Compared with Figure 28b, the depths of points A, B, C, D, and E increase by 1 cm, 3.5 cm, 2 cm, 1.5 cm, and 3 cm, and the depths of points F and G remained unchanged. The depths of points in the middle and left side increase significantly. In the final form, the widths of points A, B, F, and G are 3 cm, 2 cm, 2 cm, and 2 cm. Compared with the early stage, the depths and widths of the longitudinal cracks at the top of the slope have significantly increased, and the displacements have also increased significantly, moving from the cracks at the slope top downwards as a whole. From the crack expansion laws of seepage failure in condition T2, it can be seen that micro cracks appear at the top and middle of the slope during the seepage failure process. With the continuous water injection, Cracks 1, 2, and 5, located at the slope top, expand most rapidly, and finally the three cracks penetrate into longitudinal cracks parallel to the axis of the red mud dam, which are the main cracks causing the damage to the red mud dam.

Figure 29. Final morphology of longitudinal cracks in condition T2. (a) Final morphology of longitudinal cracks in condition T2. (b) The depth and width of the final stage of longitudinal cracks in condition T2.

The crack evolution laws of the red mud dam caused by seepage damage in conditions T1 and T2 reveal that the cracks generated by seepage damage mainly appear below the infiltration line. During the continuous seepage process, the seepage force drives the movement of red mud particles, forming water channels inside the dam body. Cracks appear on the surface of the dam body, and the fastest expanding crack is the main crack. The main cracks in conditions T1 and T2 are longitudinal cracks parallel to the dam axis, and the higher the water level line is, the higher the position of the main crack is. The main cracks continuously expand until they penetrate the entire width direction of the dam. With the continuous water injection, the width and depth of the main crack increase, and the sliding occurs at the lower part of the dam body of the main crack.
