**Abstract:** The present paper addresses the litho-dynamic and morpho-dynamic processes in the coastal zone of Babie Doły (KM 93.6–93.9), Poland. As a background, the history of coastal engineering measures in this area is described. The impact of post-war structures on the seashore is analysed on the basis of historical maps, supported by results of the sediment transport modelling. Shore regression is caused by the so-called downstream erosion behind the headland with remains of rock palisade structures. The possible consequences for the seashore resulting from the removal of the analysed revetment are discussed. The paper also presents recommendations to the relevant authorities for the future.

Citation: Szmytkiewicz, P.; Ostrowski, R.; Cerkowniak, G.R. Impact of the Revetment on the Seashore in the Region of Babie Doły (KM 93.6–93.9), Poland. *Appl. Sci.* 2022, 12, 668. https://doi.org/ 10.3390/app12020668

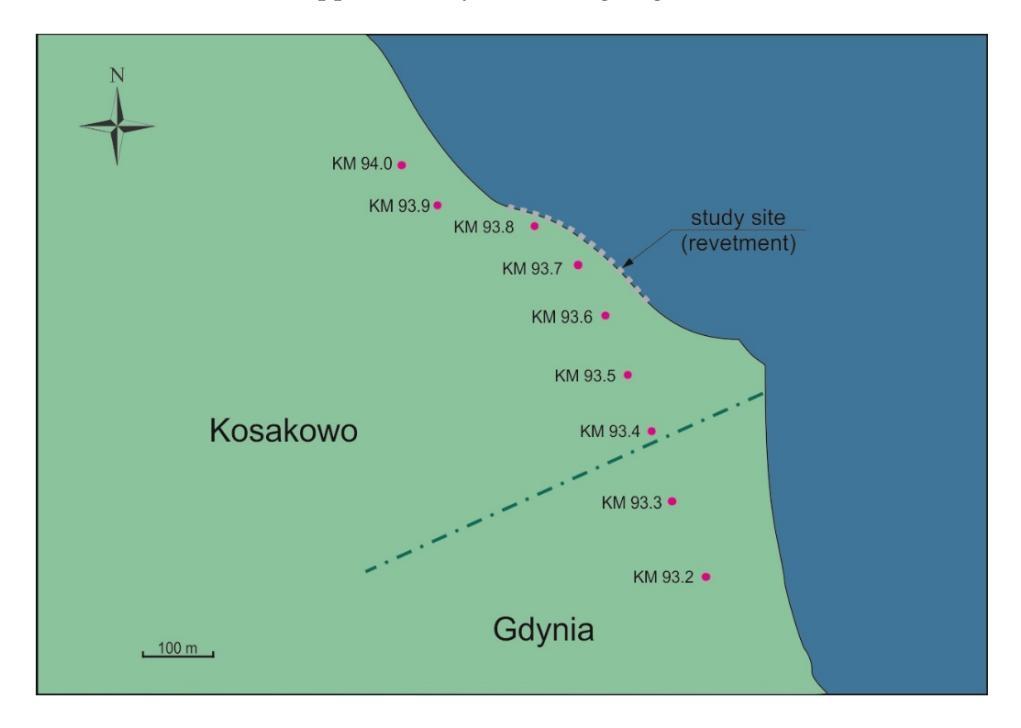
Figure 3. The analysed section of coastline.

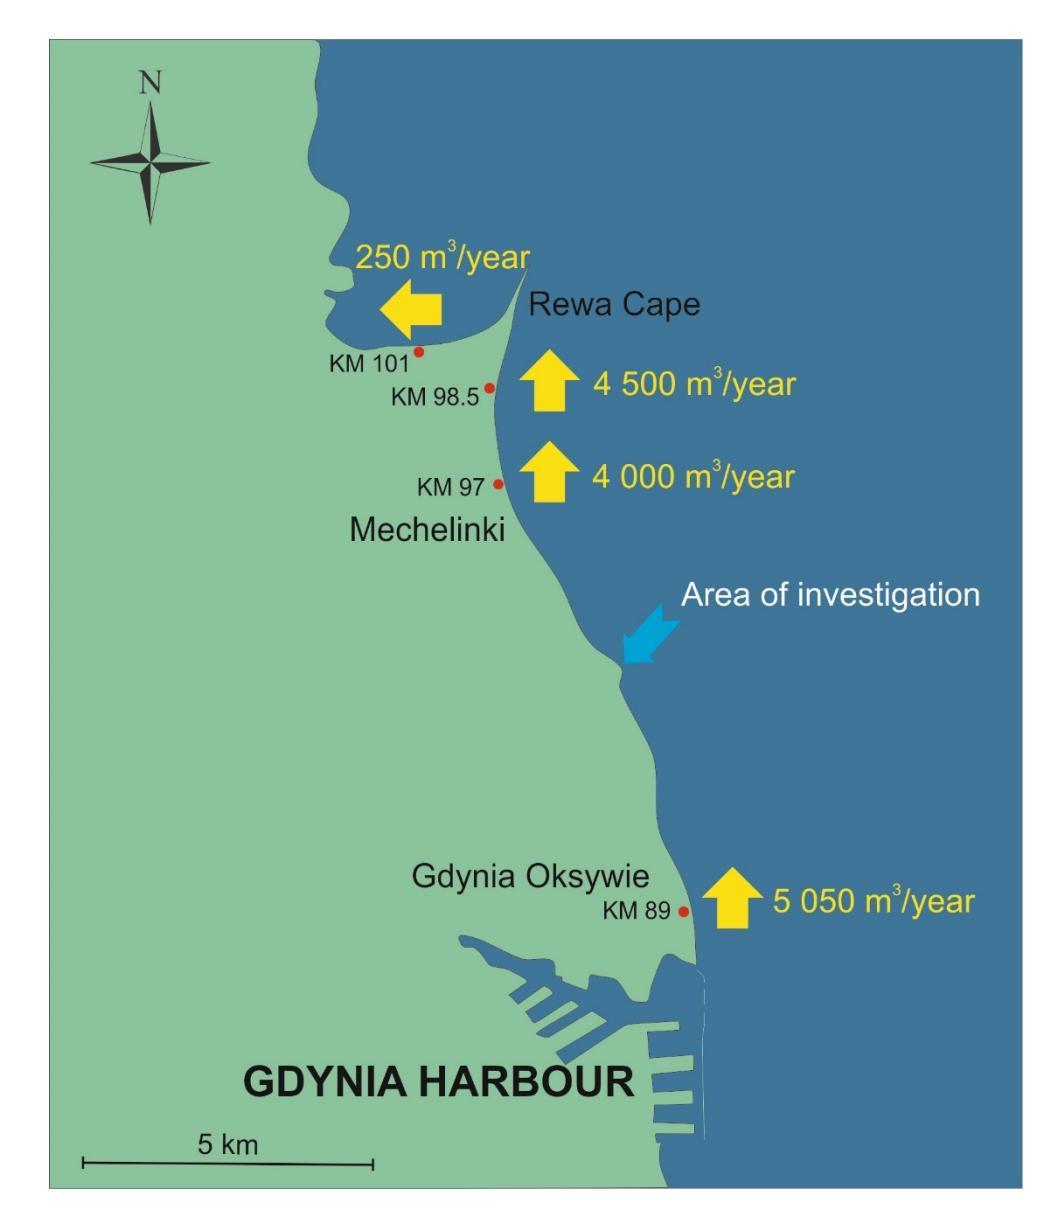
In order to quantitatively assess the rates of longshore sediment transport along the stretch of shore between KM 83.6 and KM 102.5, the authors of [10] calculated the volume of sediment transport in four representative bathymetric profiles located at KM 101.0 (western side of the Rewa Cape), KM 98.5 (eastern side of the Rewa Cape), KM 97.0 (near the village of Mechelinki) and KM 89.0 (near the district of Oksywie), in an average statistical year. Calculations of sediment transport rates were performed for all onshore wind directions, i.e., N, NE, E and SE directions. Calculated rates of longshore sediment transport are, on average, 5000 m<sup>3</sup>/year, with transport moving towards the north (Figure 6).

**Figure 6.** Directions and approximate volumes of mean annual longshore sediment transport. The blue arrow indicates the approximate location of KM 93.6–93.9 [10].

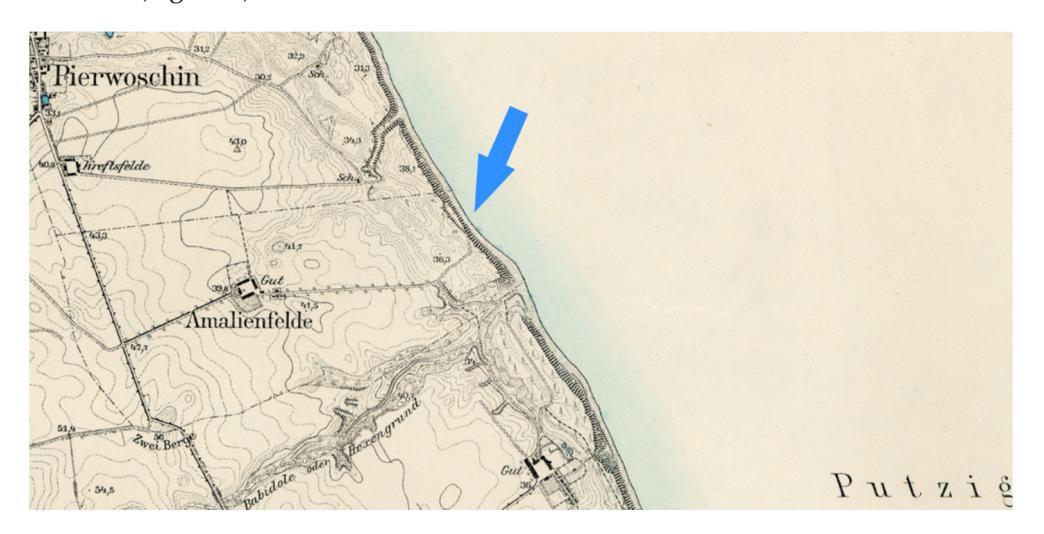
The available historical maps show a small protrusion within the analysed section of the seashore in the early 20th century. The shape and location of this protrusion can indicate that the site may have been the estuary section of a former river, which, as a result of fluvial processes, gave rise to a small delta (Figure 7), a feature still visible on the map from 1940 (Figure 8).

**Figure 7.** The analysed section of coastline on the map from 1908 (1:25,000). The blue arrow indicates the approximate location of KM 93.6–93.9.

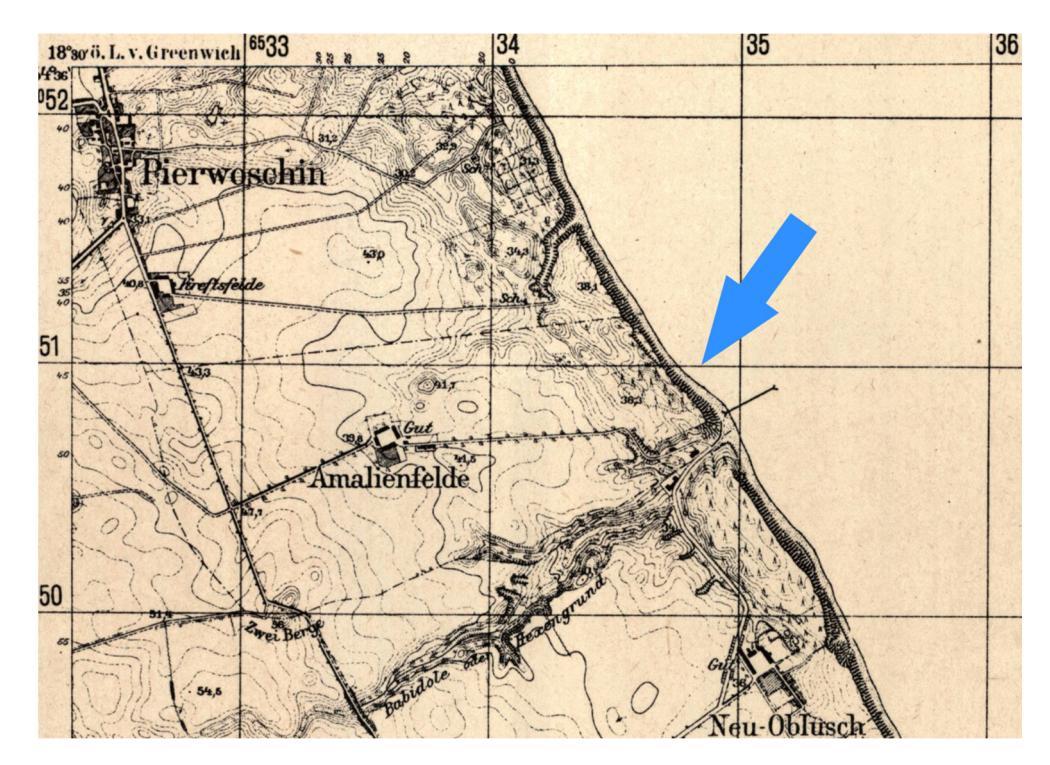
**Figure 8.** The analysed section of coastline on the map from 1940 (1:25,000). The blue arrow indicates the approximate location of KM 93.6–93.9.

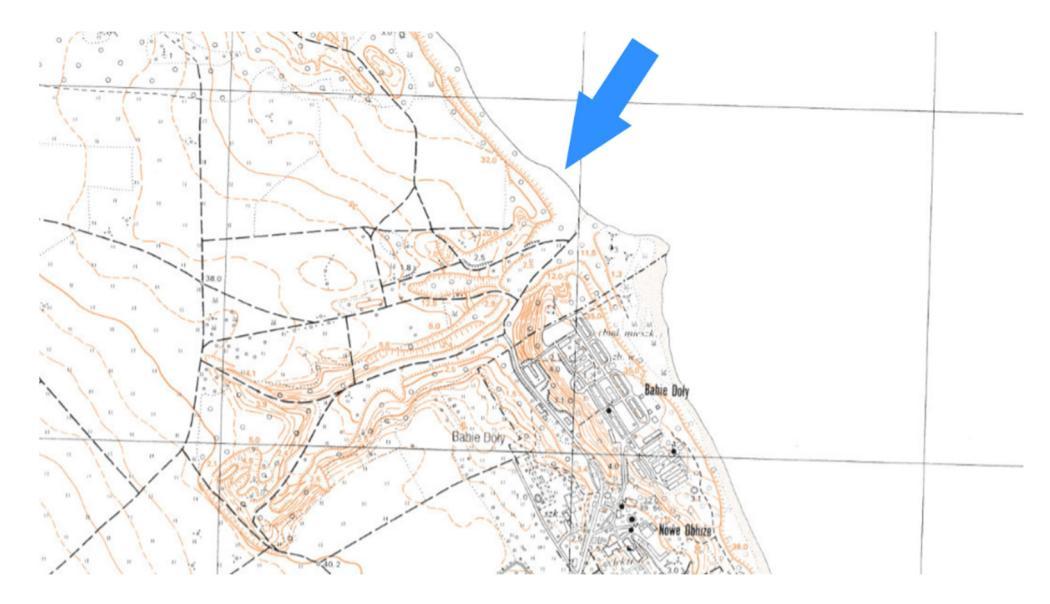
large-scale shoreline protrusion observed in this area since the 1960s was not present here in the first half of the 20th century (Figures 3 and 9).

**Figure 9.** The analysed section of coastline on the map from 1965 (1:10,000). The blue arrow indicates the approximate location of KM 93.6–93.9.

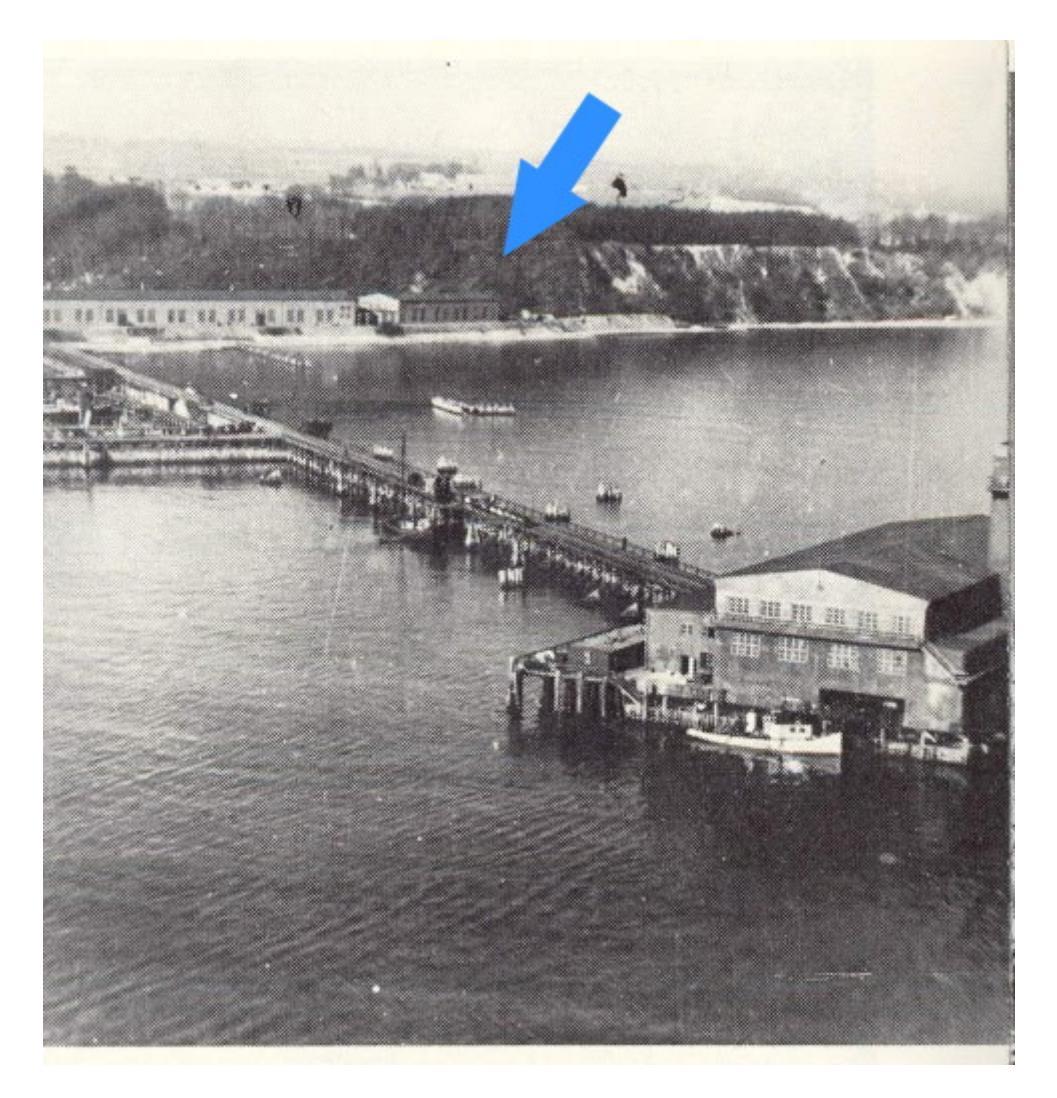
The formation of this large-scale protrusion is most likely directly related to a torpedo station built here from 1940–1942, and then destroyed after WWII (Figures 10 and 11). The building was connected with the shore by a wooden pier. The pier was destroyed as a result of warfare and miscellaneous post-war activities. The structure has the same effects on the seashore as those observed in the vicinity of groynes, i.e., the shore accretion on the upstream side and erosion on the downstream side. Due to the predominant direction of the sediment transport (Figure 6), accretion occurred on the southern side of the timber palisade, while erosion occurred on the northern side.

**Figure 10.** Torpedo station put into service in 1942. The blue arrow indicates the approximate location of KM 93.6–93.9.

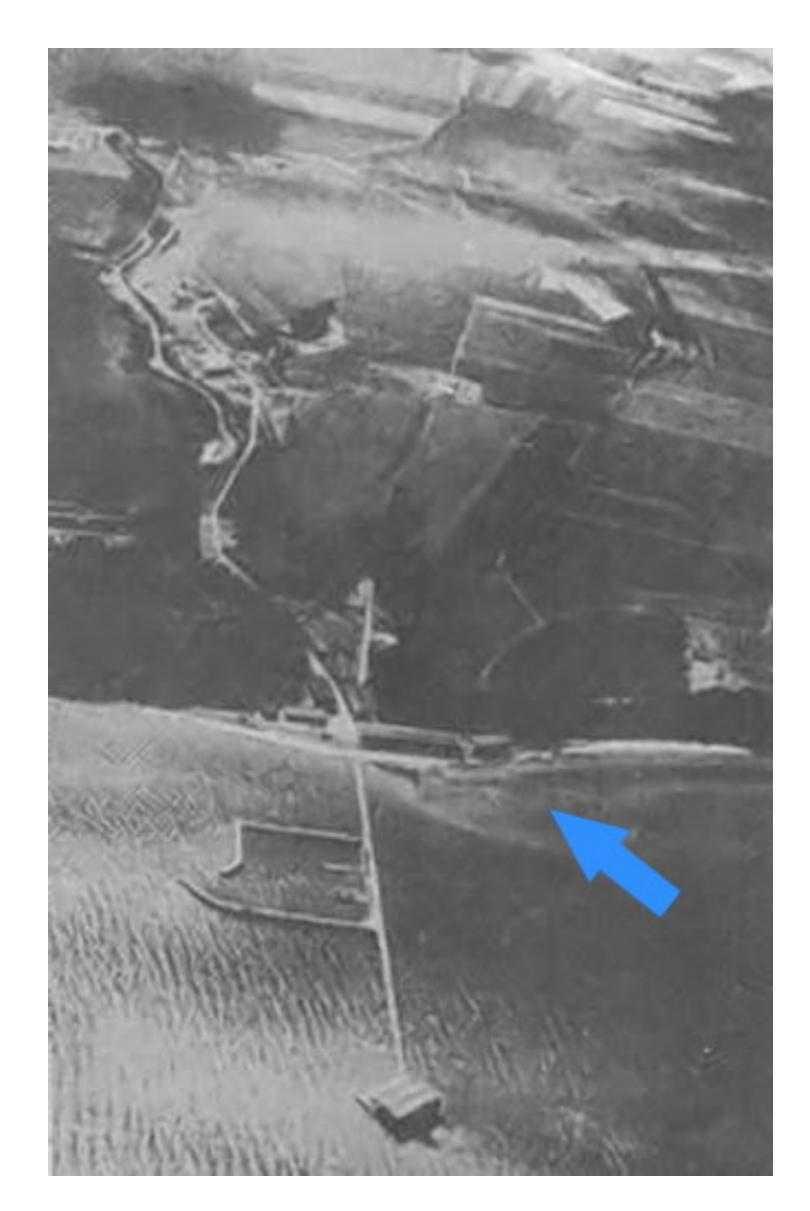
**Figure 11.** Torpedo station put into service in 1942. The blue arrow indicates the approximate location of KM 93.6–93.9.

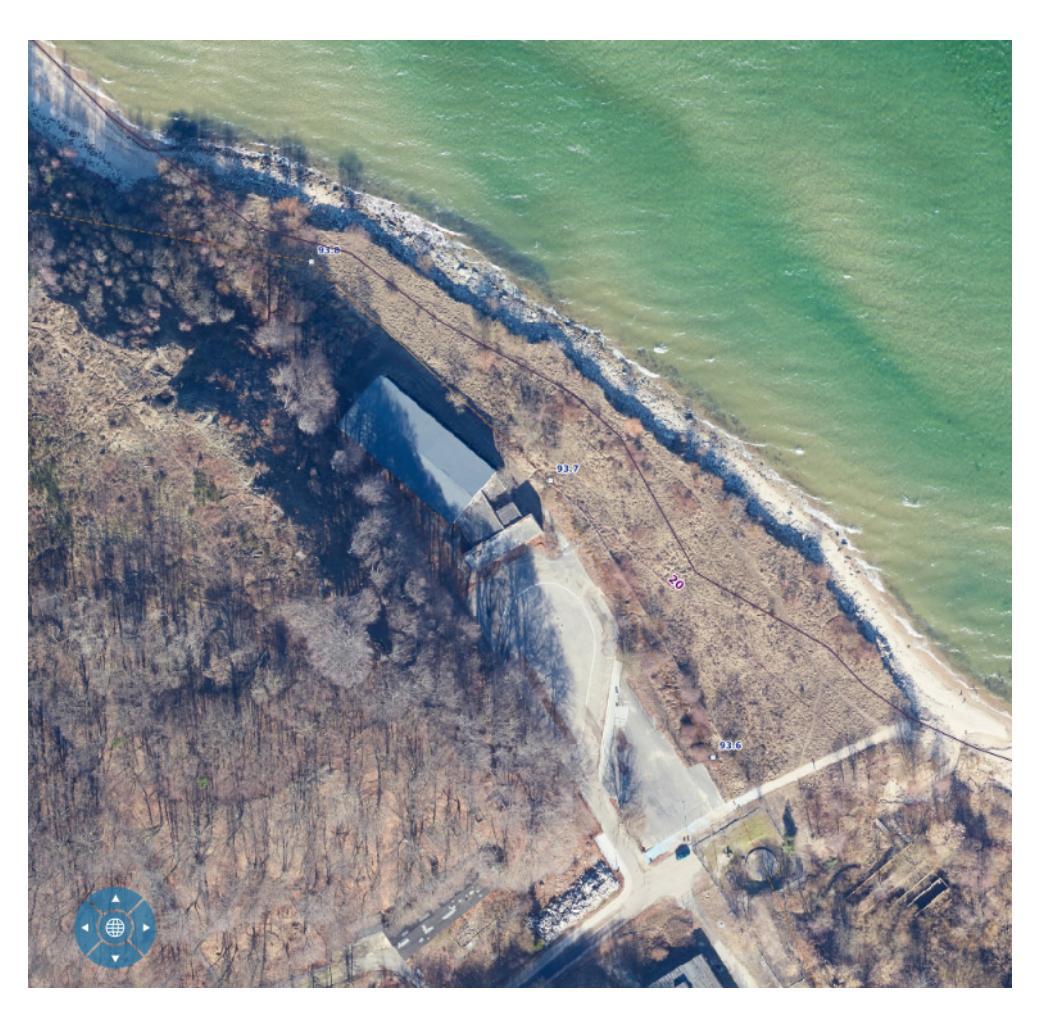
Pursuant to the Act of 25 September 2015 amending the Act on establishing the longterm Coastal Protection Programme ("Program ochrony brzegów morskich"; Dz.U. of 23 October 2015, item 1700), the shore stretch from Oksywie to Mechelinki (KM 89.1–96.6) is protected by beach nourishment and hard coastal protection structures. The functioning of revetments along this section—including the rubble revetment within the shore stretch of KM 93.6–93.9—is therefore in compliance with the recommendations of the aforementioned Act. However, none of the documents of the shoreline development records held by IBW PAN (Institute of Hydro-Engineering of Polish Academy of Sciences, Gdańsk, Poland) contains information on the described revetment. Furthermore, according to the materials available at IBW PAN, the theoretical shoreline defined according to the Coastal Protection Programme, runs in the landward part of the top of a local small coastal cliff (Figure 12). This would mean that the rubble revetment in question is not included in the register of the shore protection structures kept by the Maritime Office in Gdynia.

**Figure 12.** Shoreline (purple), protection borderline (dashed purple line) and requirements of the Coastal Protection Programme in the analysed shore section (https://sipam.gov.pl/geoportal (accessed on 16 June 2021)).
