Analysis of Tram Traffic-Induced Vibration Influence on Earthquake Damaged Buildings

Ivo Haladin ^{1,*}, Marijan Bogut ² and Stjepan Lakušić ¹¹ Faculty of Civil Engineering, University of Zagreb, 10000 Zagreb, Croatia; stjepan.lakusic@grad.unizg.hr² Končar—Electrical Engineering Institute Inc., 10000 Zagreb, Croatia; bogut@koncar-institut.hr

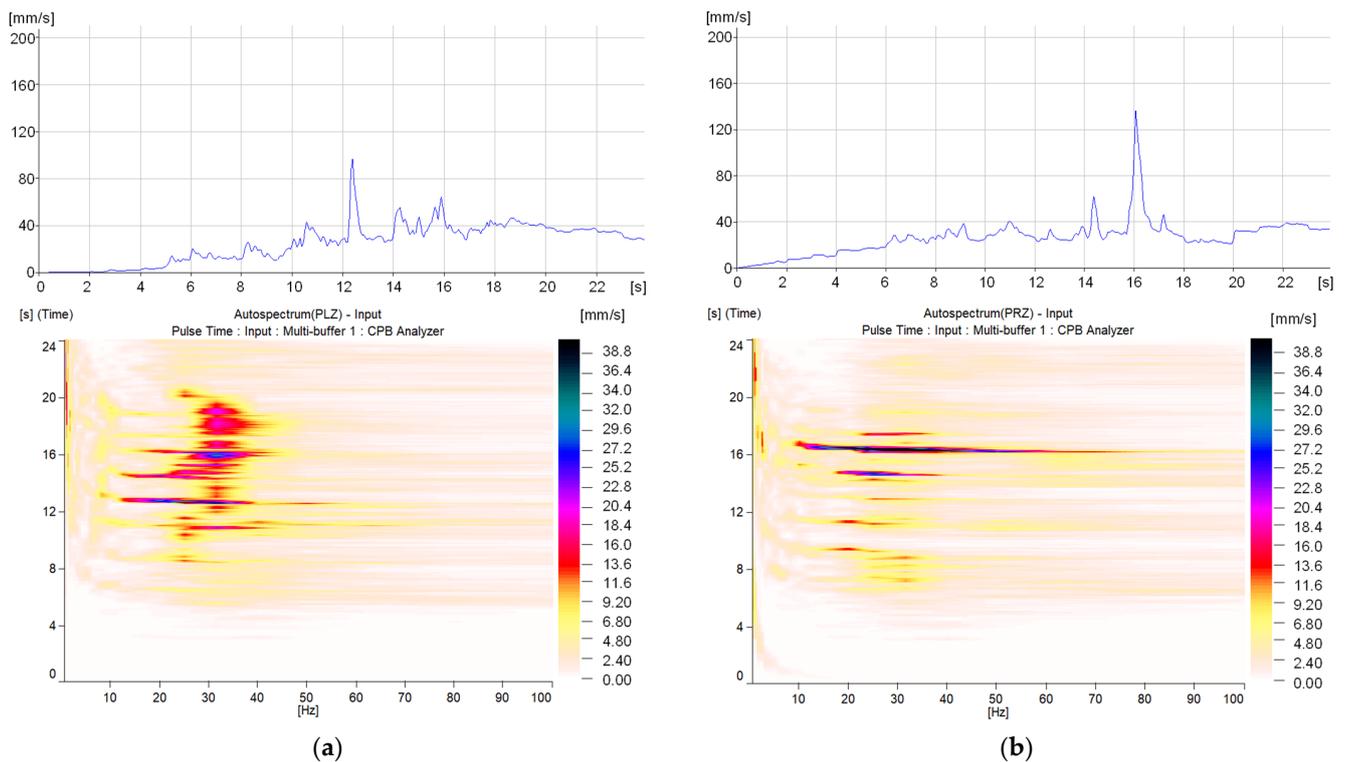
For all pass-bys, dominant recorded vibrations were in the vertical axis (PLZ and PRZ). The higher vibration levels were recorded on pass-bys 2 and 4 (closer to the building). The highest vibration levels were recorded on the second pass-by when the vehicle performed intensive braking at a traffic light west of the building (intersection with Miramarska street). At that moment, prominent vibrations of the bogie were observed in the transverse direction at the frequency of around 1 Hz. Three-dimensional spectrograms show that dominant frequencies vary from 25 Hz to 40 Hz, Figure 9.

Figure 9. Vibration trend (top) and 3D spectrogram (bottom) of vertical vibration velocities in the second pass-by: (a) left side—PLZ; (b) right side—PRZ.

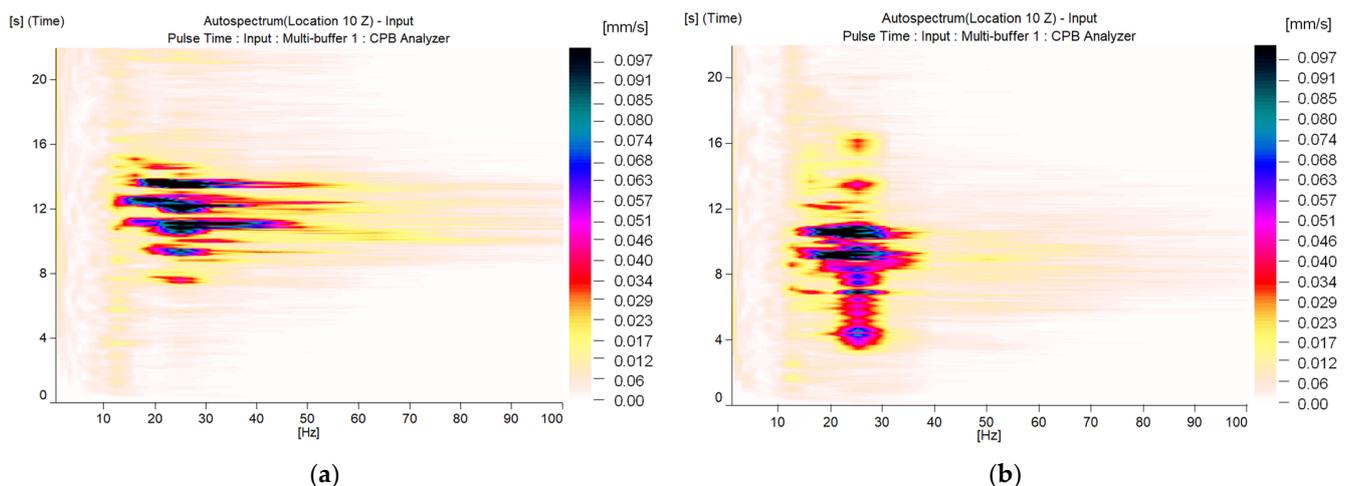
If 3D spectrograms for two tram types that induce the highest levels of vibrations are observed, a clear distinction can first be observed in the bogie placement and tram length, Figure 13. In addition, similar levels of vibrations occur at similar frequencies, but it can be observed that TMK 2200 induces a broader spectrum of vibrations in the building (12 Hz to 50 Hz), while TMK 301 induces a narrower spectrum of vibrations (15 Hz to 32 Hz).

Figure 13. Three-dimensional spectrograms of vibration velocities at M10, vertical direction (Z), for trams (a) TMK 2200 and (b) TMK 301.

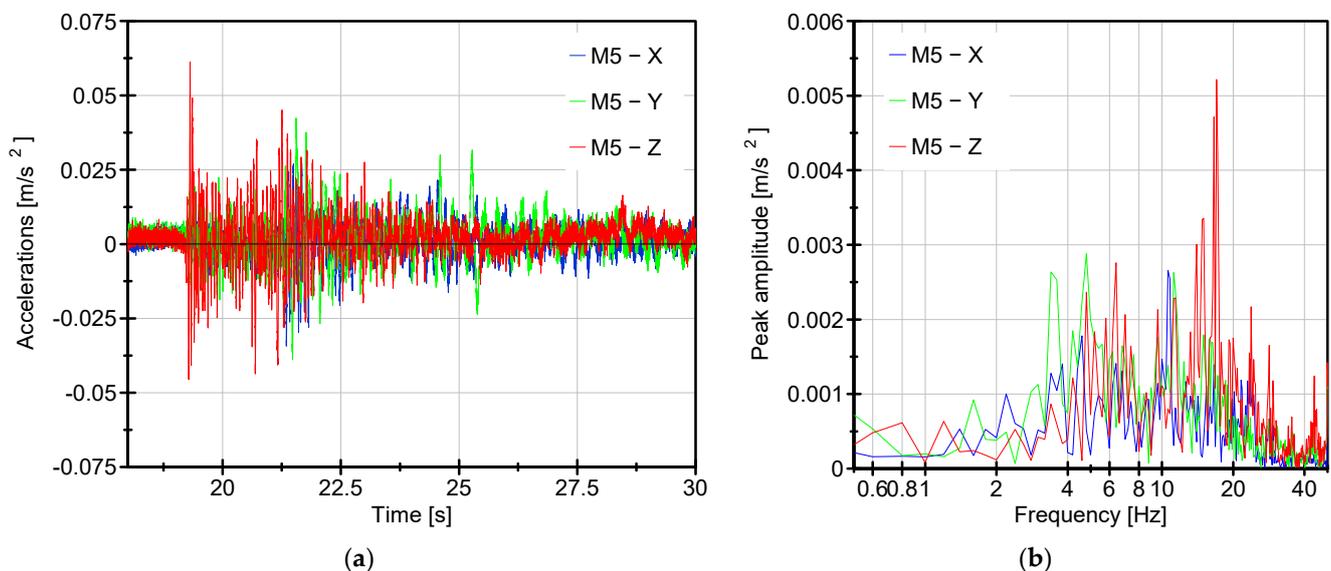
Figure 14. Accelerations represented in (a) time and (b) frequency domains, 3.1 (ML) earthquake action at the level of building foundations, M5.

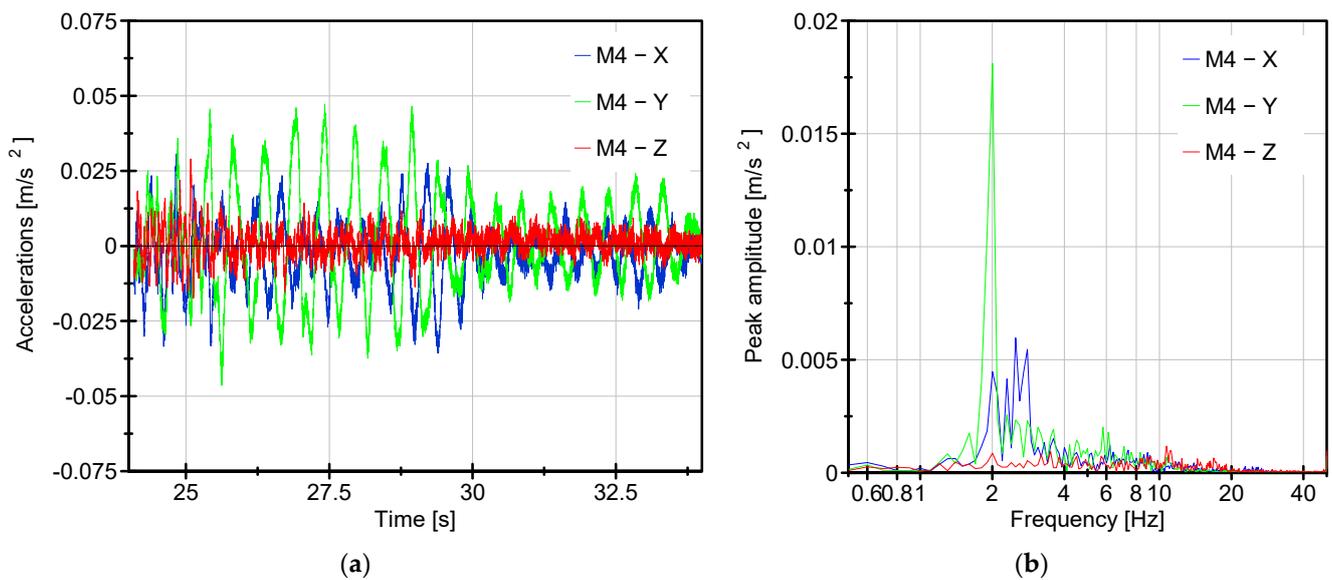
Figure 15. Accelerations represented in (a) time and (b) frequency domains, 3.1 (ML) earthquake structure response on the 3rd floor, M4.

If the 3.1 (ML) response is analysed in terms of PPV according to [19], a direct comparison to the acquired tram response can be made. The results presented for M1 to M5 clearly indicate how even small-intensity earthquake-triggered vibrations are considered harmful for historic masonry structures, Figure 16, while maximum tram vibrations trigger a much smaller response.
