# Enhanced Documentation and Evaluation of Grouting Process, through the Fusion of Non-Destructive Testing and Evaluation Information—The Case Study of the Katholikon of the Monastery of Panagia Varnakova

**Abstract:** The restoration of historic buildings and structures involves a wide range of scientific and technical fields. The grouting process is among an array of rehabilitation and preservation interventions and aims to homogenize the structure after the implementation of strengthening measures. The process can provide important information regarding the state of preservation of the examined structure and correlate the progress of the process with the pathology of the monument. To achieve this, the analysis of typical raw grouting data is progressively fused with additional information from the diagnostic studies, non-destructive testing, geospatial information, and from the calculation and analysis of grouting indices. The restoration project of the Katholikon of the Monastery of Panagia Varnakova in Fokida, Greece was selected as the case study, due to its large scale and the severe earthquake damage it has sustained, which has necessitated comprehensive strengthening inte

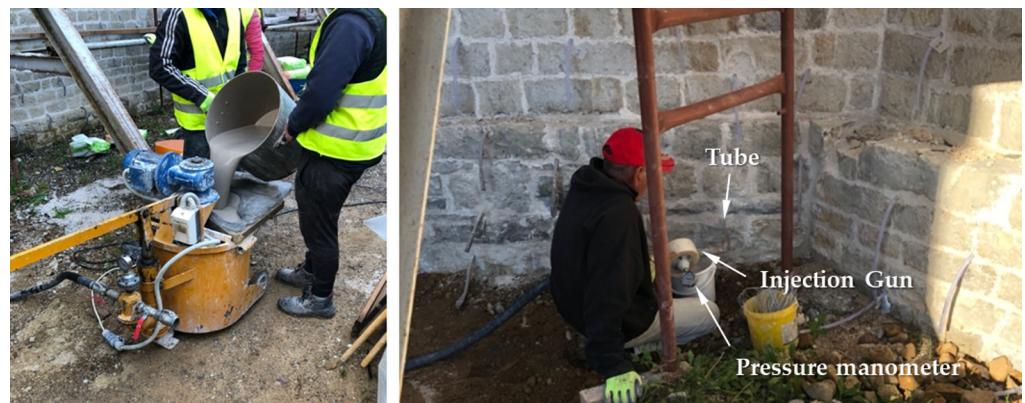
**Figure 3.** (Left) The mixing tank and pump with pressure manometers, where the grout was mixed with the appropriate amount of water. The mixture is filtered to remove coagulated particles. (Right) Grouting at the eastern masonry at an exterior tube position and monitoring of pressure on the manometer of the gun.

Based on the above, a commercial lime–metakaolin grout, MasterInject 222 from Master Builders Solutions, was used in the restoration of the Katholikon. It is a cement-free, lime–pozzolan (metakaolin) grout with a very fine particle size ( $<12\ \mu\text{m}$ ), high flowability, and excellent sustainment of its workability. The presence of the metakaolin—a highly reactive pozzolan—in the composition of both the restoration mortar and the grout material, ensures a fast consumption of the free calcium hydroxide of the lime, while, in parallel, allows for an early attainment of the grout’s mechanical strength [40,51]. The grout expands in the plastic phase; thus, it can fill even the smallest voids within the reinforced structure. Furthermore, it does not release water-soluble salts, it does not induce the development of efflorescence, and it presents excellent resistance to sulphates. This is important, because the results of the diagnostic study revealed the presence of soluble salts ( $>3\%$  TSS) at the highly porous stones of the upper structure (arches), as well as at the mortar samples at the floor levels, where the presence of  $\text{Cl}^-$  and  $\text{SO}_4^{2-}$  is favored due to rising damp. The selected commercial grout develops a compressive strength  $>10\ \text{MPa}$  and may therefore be classified as an M10 type according to EN 998-2:2016. The dry grout was added to the appropriate amount of water, according to the manufacturer’s directions (1 kg dry grout plus 0.3 kg of water) and mixed in the grouting vessel (Figure 3).

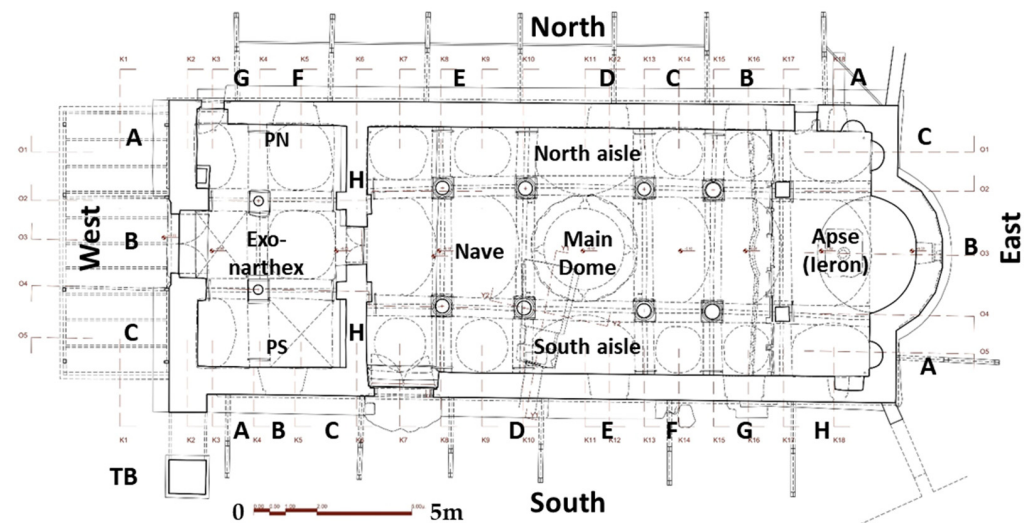
**Figure 4.** Plan of the Katholikon with indication of the grouting sub-areas and the main features of the church (adapted from [58]).

Worth noting is the large amount of grout injected in sub-area NE. However, this specific sub-area is the largest sized and contains some structural cracks that are attributed to the thrust of the dome towards the north direction (during earthquake—see discussion in previous section) and the presence of a transverse wall (initially the west façade of the original church) and the corresponding cracks on the north masonry [58,60].

Table 3 summarizes the grouting indices for tubes Ne135 and PN30. This pair is located on either sides of the junction of the transverse historical masonry (H) with the north part of the Katholikon (sub-area NE, Figure 4).
