# Evolution of Galvanized Steel Pipe Corrosion in Hot Water Supply Systems

Valentin Chukhin, Nikolay Makisha \*

Research and Education Centre “Water Supply and Wastewater Treatment”, Moscow State University of Civil Engineering, 26, Yaroslaskoye Highway, Moscow 129337, Russia

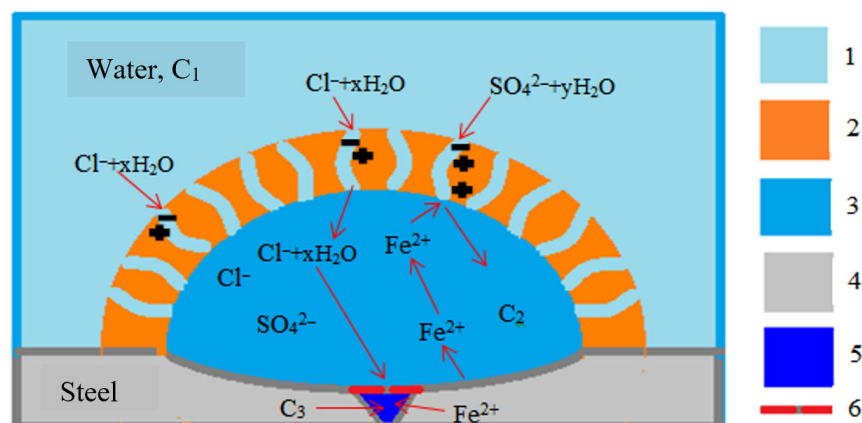
Figure 4 schematically represents the tubercle structure to explain the role of a dense layer in the formation of a high concentration of solution inside the tubercle. After the tubercles have formed, the surface of the metal underneath becomes the anode, and the outer surface of the dense layer becomes the cathode. The total concentration ( $C_2$ ) of the solution inside the tubercle increases in proportion to the transferred current (which is confirmed by experimental data). Due to this, the transfer of anions (chlorides and sulfates) through a dense layer to the anode (i.e., inside the tubercle) and iron cations (from the tubercle into the external solution) becomes unbalanced. Such imbalance occurs when a dense layer has selective properties and allows only anions to pass through (similar to an anion exchange membrane or solid electrolyte in the presence of fixed cations in the membrane structure).

**Figure 4.** Schematic representation of a tubercle: 1—an external solution (tap water); 2—a dense porous layer forming the structure of the tubercle and with selective properties; 3—the core of the tubercle (see Figure 2d); 4—the steel base of the pipe; 5—fistula; 6—porous coating of pitting; “+”—fixed charges (cations); “−”—counter-ions (anions);  $C_1$ ,  $C_2$ ,  $C_3$ —concentrations of solutions in the tap water, in the core and in the fistula, respectively ( $C_3 \gg C_2 \gg C_1$ ).

An equilibrium concentration of iron salts  $C_2$  (Figure 4) was established inside the tubercles, corresponding to the density of the corrosive current and the structure of the layer forming the shell of the tubercle. Moreover, the high concentration of the solution inside the tubercle is associated with the concentration of fixed charges in the dense layer. Fixed ions (cations) are embedded in the voids of the crystal lattice of a dense layer, forming metal–cationic complexes. In this case, the properties of the dense layer

It should be assumed that pitting corrosion in stainless and carbon steels may work via a similar mechanism [42–45]. The role of the coating over the pitting (Figure 4, pos. 6) demands further study; however, it acts also as a selective barrier that increases the transfer of chlorides.
