## Article

# Post-Fire Inspection, Material Testing, Repair, and Field Load Testing of a Full-Scale Concrete Box Girder Bridge: Delta Bridge Case Study

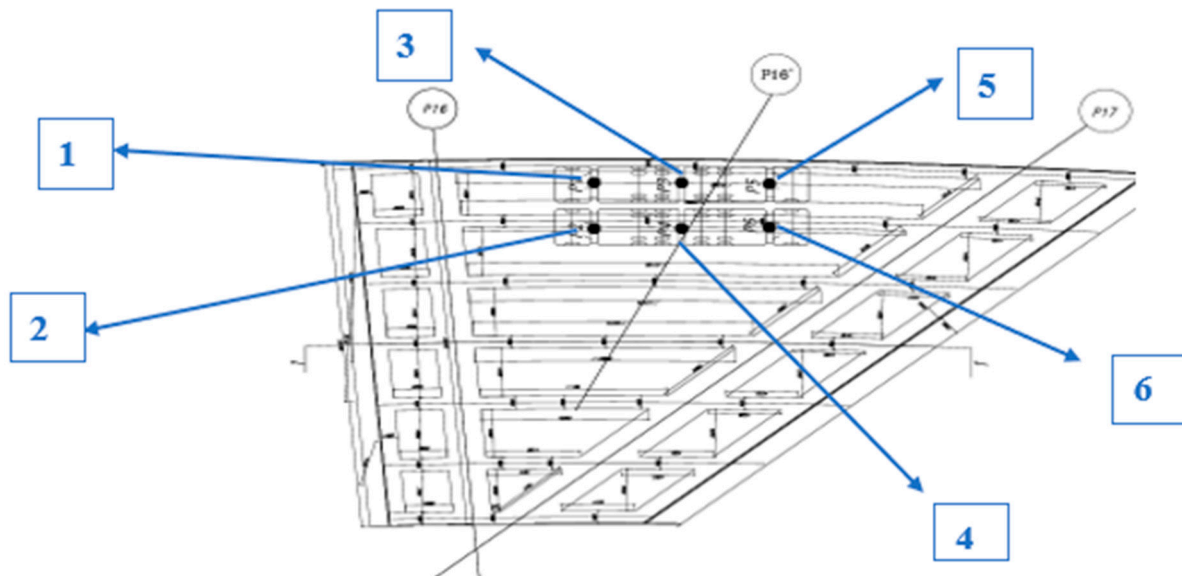
Figure 8. Loading between axis 16 & 17.

In December 2024, the static load tests were performed by the Concrete Research Laboratory (Cairo University, Cairo, Egypt). The critical mid-span sections were selected for testing, as these locations represent the maximum bending moment regions in simply supported bridge spans under live loading. The post-fire spans located between axes 16

and 17 (spans 8 and 9) were tested using four tri-axle trucks with a gross weight of 40 tons each, as illustrated in Figure 8. In addition, span 7 (between axes 17 and 18) was tested using nine tri-axle trucks, as shown in Figure 9. For each tested span, six measurement points (labeled P1–P6 in Figures 8 and 9) were instrumented to record midspan deflection and micro-strain in the longitudinal reinforcement.
