# Effect of Wave Process of Plastic Deformation at Forging on the Fatigue Fracture Mechanism of Titanium Compressor Disks of Gas Turbine Engine

Andrey A. Shanyavskiy <sup>1,2,\*</sup>, Alexey P. Soldatenkov <sup>1</sup> and Alexandr D. Nikitin <sup>2</sup>

**Citation:** Shanyavskiy, A.A.; Soldatenkov, A.P.; Nikitin, A.D. Effect of Wave Process of Plastic Deformation at Forging on the Fatigue Fracture Mechanism of Titanium Compressor Disks of Gas Turbine Engine. *Materials* **2021**, *14*, 1851. <https://doi.org/10.3390/ma14081851>

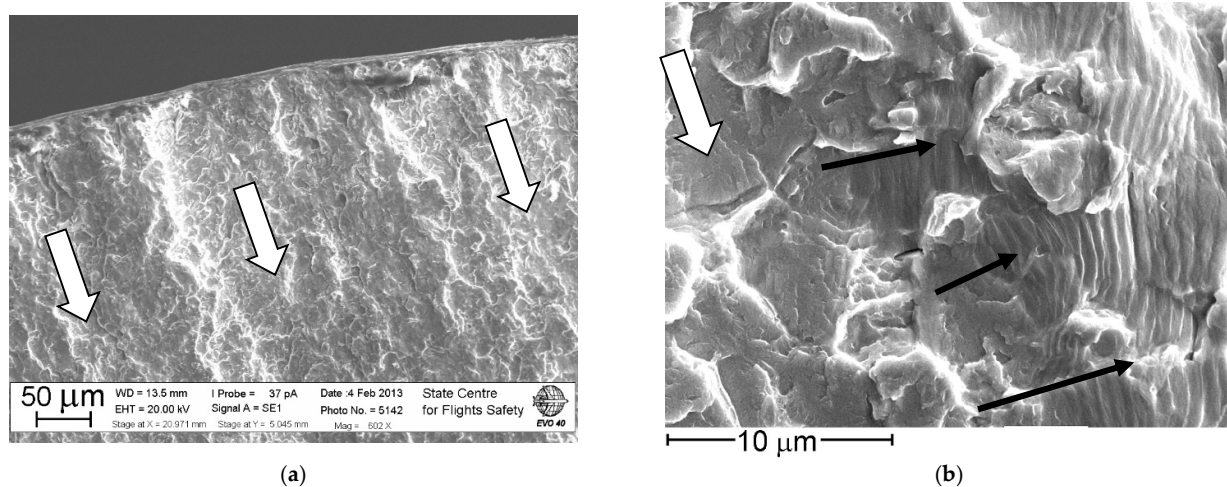
This concerns primarily specimens tested with the triangular cycle waveform at a maximum strain level of 0.0073. In the fracture surfaces, the filament type structure of the material was revealed, inherited from the forging of disks. A similar situation was found in some specimens tested with the trapezoidal shape of the cycle waveform at the same maximum strain level of 0.0073 (Figure 4). The crack propagated in the specimen along the filaments with pronounced tunneling and the formation of a predominantly quasi-brittle fracture surface relief. The connection of meso-tunnels along the bridge between them led to the formation of local areas with groups of fatigue striations oriented almost perpendicular to the main direction of crack growth (Figure 4b). It follows that in those zones of crack propagation where the quasi-brittle fracture occurred, the material had a reduced resistance to crack growth. During loading, the crack initially propagated along the filaments on the uploading part of a cycle, while during the formation of fatigue striations, the crack grew on the unloading part of a cycle [16].

**Figure 4.** Meso-tunnels (indicated by hollow arrows) near the fracture origin (a) and at a several distance (b) in the crack growth direction for specimen tested at the trapezoidal shape of cycle waveform with  $\varepsilon_{\max} = 0.0073$  and  $N_f = 10,902$  cycles. Dark arrows indicate the direction of crack growth during the formation of fatigue striations.

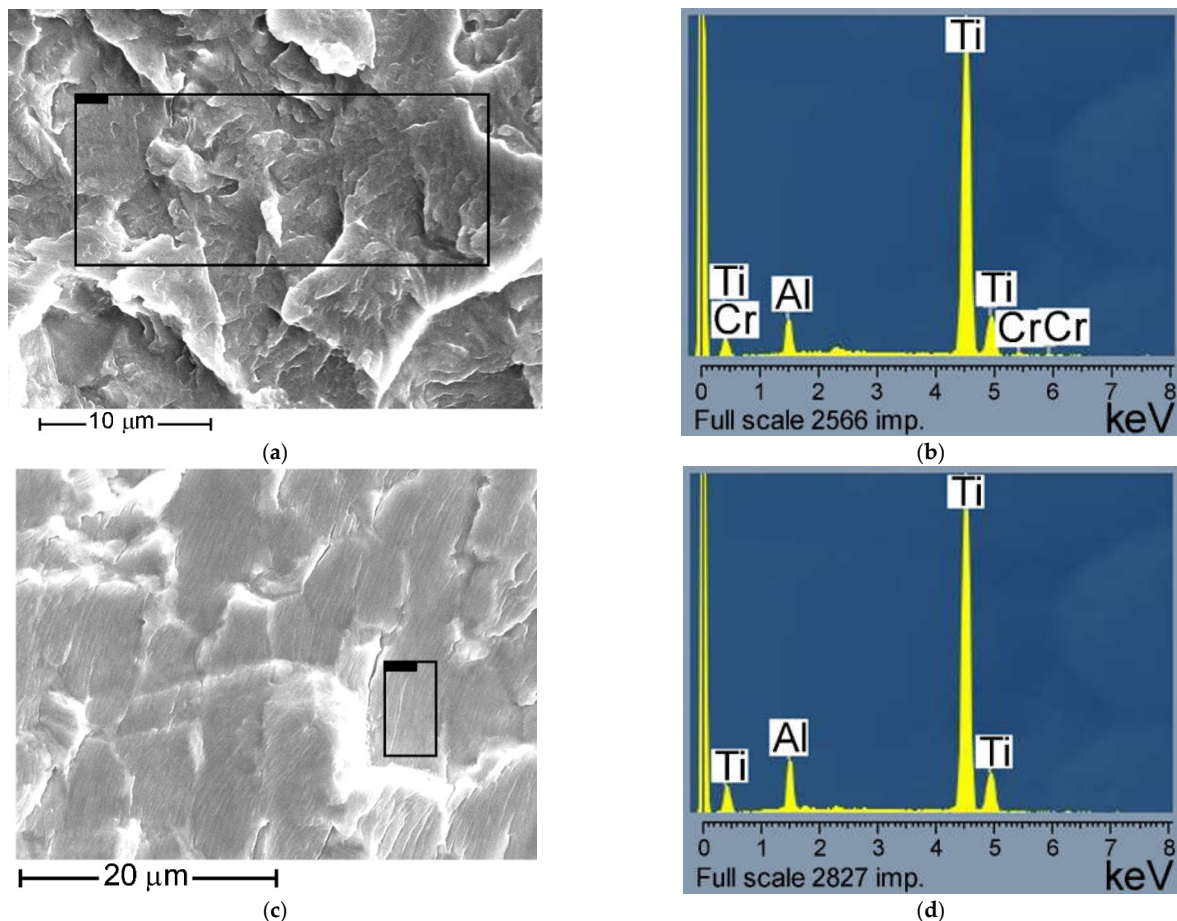
The indicated distribution of chemical elements does not affect the regularity of the formation of a particular fracture relief along the  $\alpha$ -phase (Figure 6). No fundamental differences in the chemical composition of the alpha phase are observed during the formation of both faceted patterns and relief with striations. Therefore, there is no phase difference in chemical composition for different types of fracture surface relief. The difference in the crack growth mechanisms is determined only by the local plastic characteristics of the material state.

**Figure 6.** (a) Region of fracture surface with quasi-brittle pattern; (b) the spectrum of the main alloy elements distribution over the rectangular area of fracture surface on (a); (c) region of fracture surface with striations; (d) the spectrum of the main alloy elements distribution over the rectangular area of fracture surface on (c).

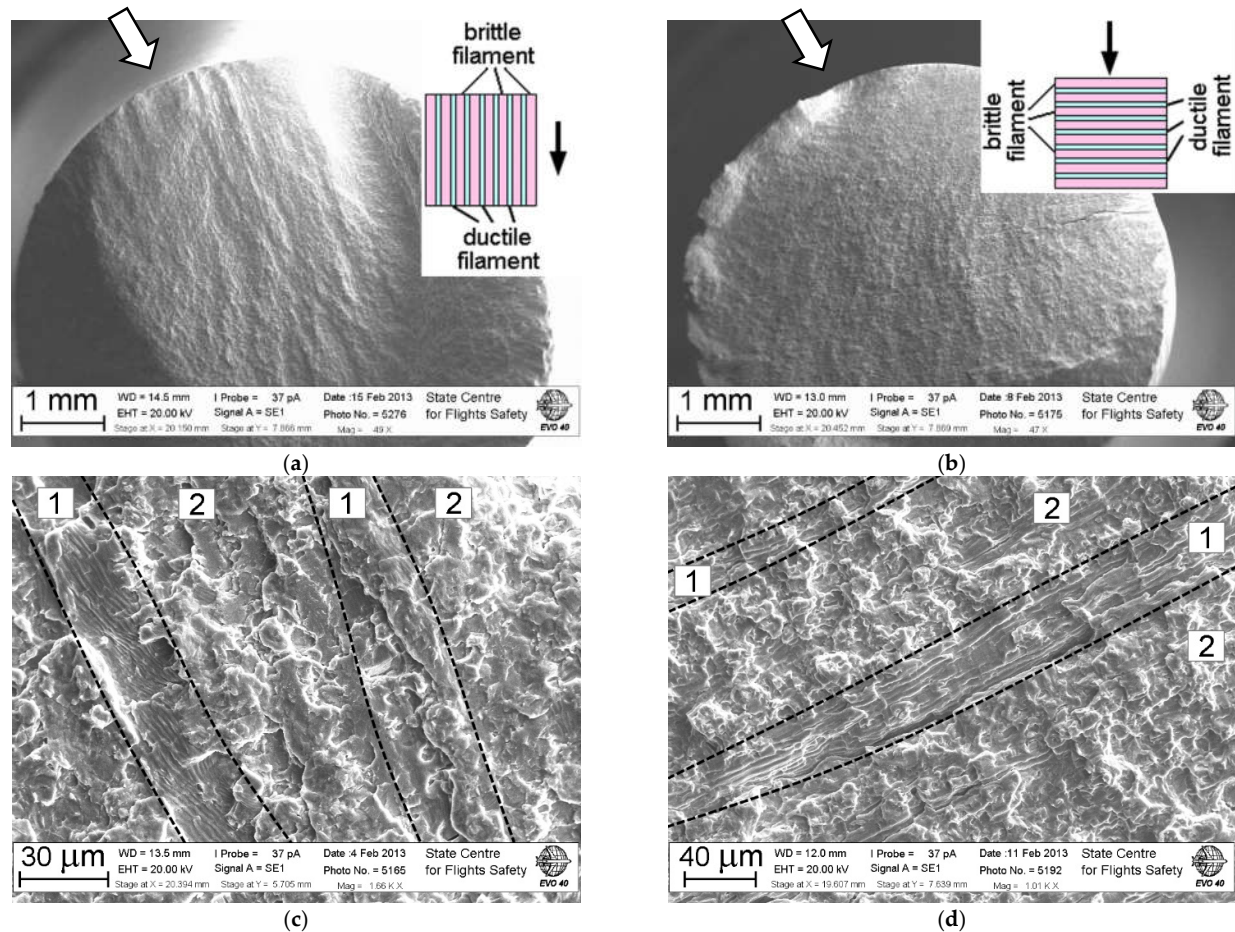
This indicates that in some filaments, the material behaves as quasi-brittle, and the propagation of a crack through them is not accompanied by the formation of fatigue striations (Figure 7). In other filaments, the material is more ductile, and the propagated crack leads to the formation of fatigue striations.

**Figure 7.** Fracture surfaces with the sketch of crack propagation (a, c) along and (b, d) across the filaments in a two-phase ( $\alpha + \beta$ ) structure of specimens tested with a triangular shape of the cycle waveform and the durability  $N_f$  of 16,566 cycles and 64,860 cycles, respectively. The dark arrow on the sketch indicates the direction of crack growth. The fatigue crack initiation zone is shown by the hollow arrow. Regions 1 and 2 correspond to fracture of ductile and brittle filaments, respectively.
