Metallographic Testing of 19th Century Steel in an Operating Water Tower

Eugeniusz Hotała ¹, Rajmund Ignatowicz ^{1,*} and Maciej B. Lachowicz ^{2,3}
¹ Department of Building Structures, Faculty of Civil Engineering, Wrocław University of Science and Technology, Na Grobli 15, 50-421 Wrocław, Poland; eugeniusz.hotala@pwr.edu.pl

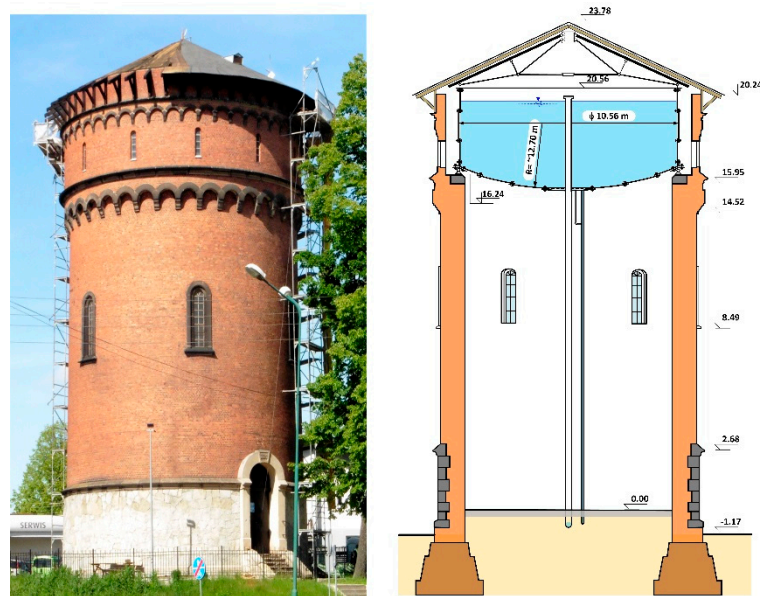
Figure 1. View and section of the pressure tower.

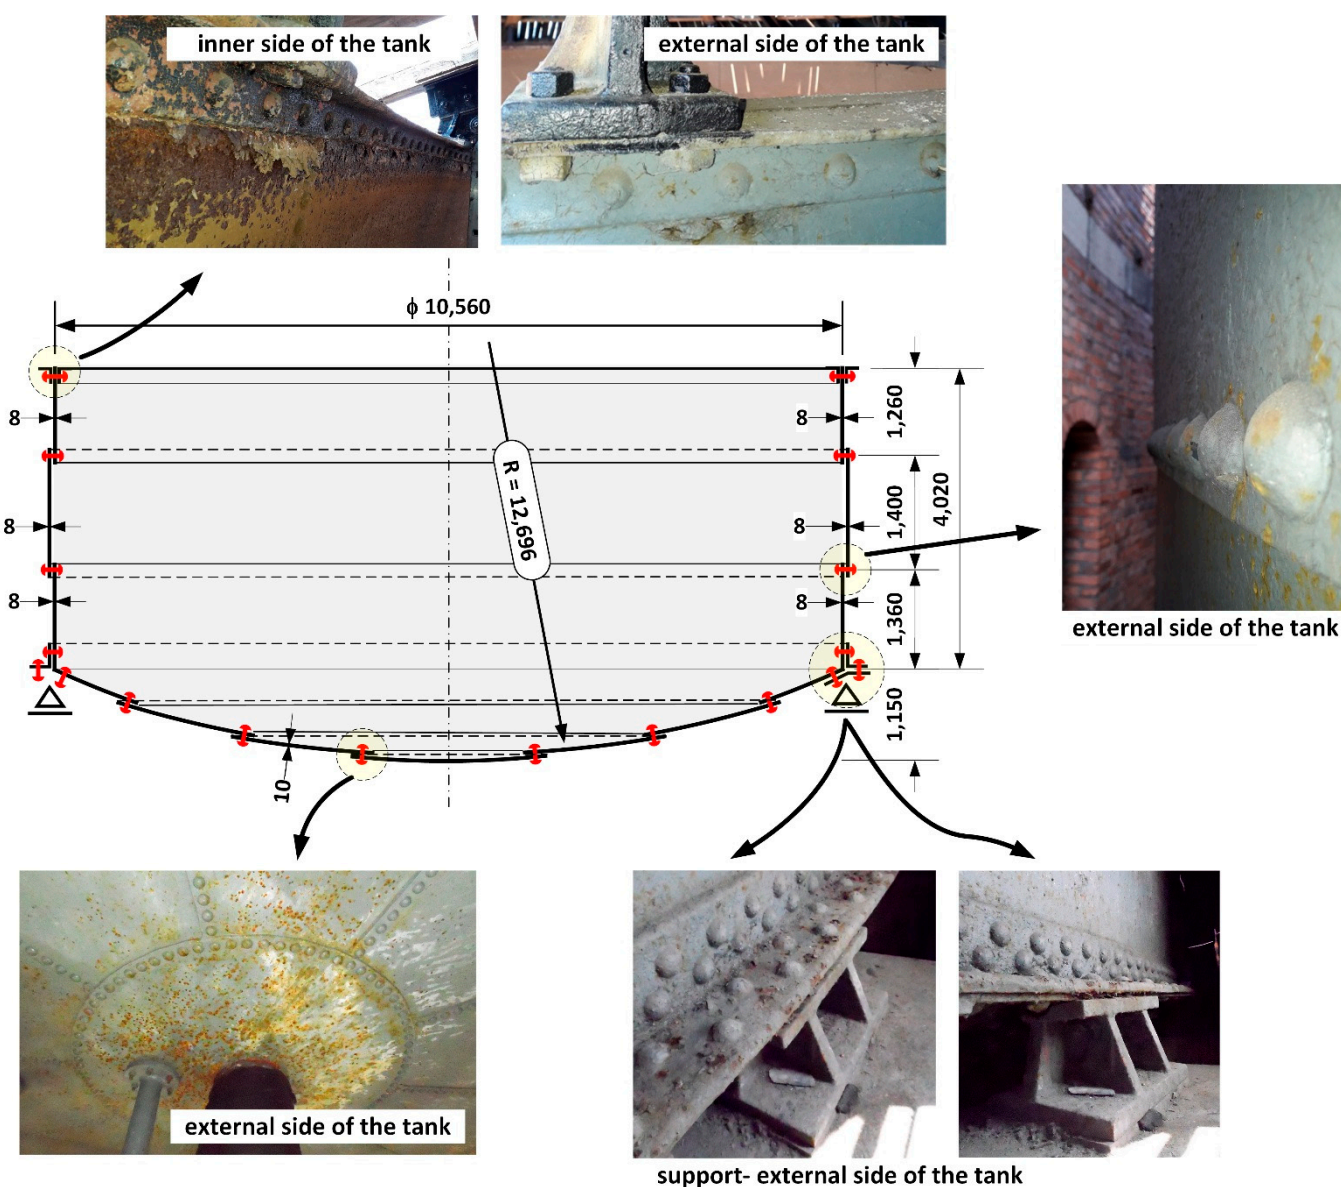
Testing concerned a steel cylindrical tank of diameter $D = 10,560$ mm and shell height $H = 4020$ mm and a bottom spherical-shaped cap of radius $r = 12,696$ mm (Figure 3). The shell of the tank was made of metal sheets $t = 8$ – 10 mm thick and the bottom comprised metal sheets of $t = 10$ mm thick. The sheets were joined together with rivets with pin diameter of $d = 22$ mm.

Figure 3. Geometry of the steel water tank. The design steel sheet thickness is indicated.

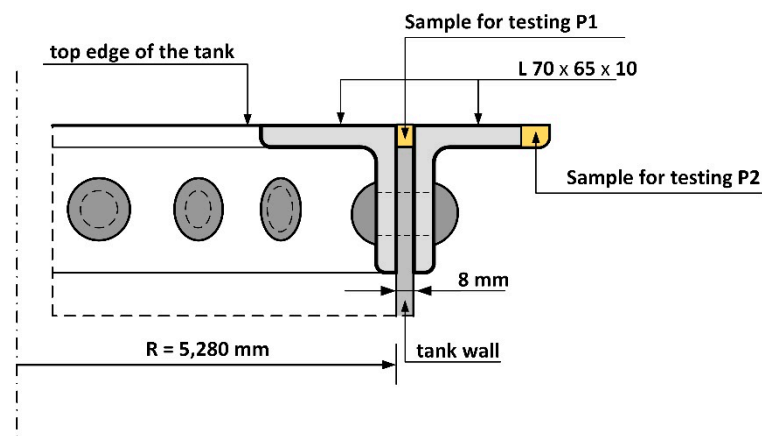
A spectral analysis was carried out to assess the material type of the tank band. The tank owner allowed steel sampling only in the top edge of the tank, but it is highly likely that the material test results obtained are representative for the tank as a whole (Figure 5). Based on the analysis, it was determined that the chemical composition was consistent with that of puddled steel used in the 19th century. The test results obtained for the band material of the tank are presented in Table 1. The values presented are an average of four individual analyses. There is no currently available equivalent to this type of steel. The carbon content obtained from the four analyses ranged from 0.011% to 0.072%, which is a significant spread. However, the results obtained correlate with localised microstructure changes in the tested material, which is mostly a ferritic microstructure containing approx. 0.0218% carbon. A ferritic–perlite microstructure with a higher carbon content can be found in some areas. Segregation of some elements is a characteristic feature of puddled and cast steels, especially carbon, phosphorus and sulphur. A very high phosphorus content was found in the steel tested, exceeding by three times the amount of phosphorus in structural steels produced today. High phosphorus content in puddled steel has been observed by other researchers [1,2,7,9,10]. The authors of the paper [9] found that the high silicon

Figure 5. Steel sampling locations P1 and P2 on the upper edge of the tank.

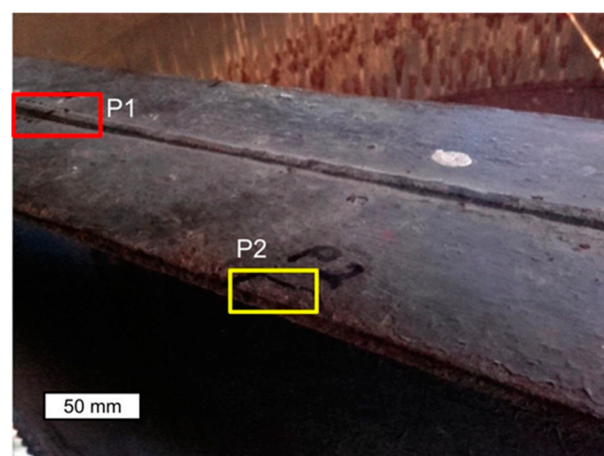
Material tests were carried out after long-term exposure. Samples for testing were taken in locations indicated in Figure 6. Microscope analysis indicated the presence of significant amounts of slag impurities in the material microstructure of the angle section tested (different in size and morphology), which is a characteristic feature of old weldable steels (Figures 7 and 8). The chemical composition of the steel is conducive to the formation of precipitations composed mainly of phosphorus and sulphur. However, oxide inclusions are also common in these materials [7]. Slag inclusions are distributed in bands, longitudinally to the direction of metal forming. The transversal cross-section provided a visible orientation of the microstructure in the direction of plastic deformation, resulting most probably from the shaping of the tank shell edges. A corrosion products layer is visible on the surface. They locally penetrate deep into the material of the tank wall (Figure 8).

Figure 6. Sampling locations P1 and P2 from the tank wall for samples used for material testing. The dashed line indicates cross-sections designated for microscope observation: longitudinal cross-section—red colour; transversal cross-section—yellow colour.
