Assessment of Destructive Impact of Different Factors on Concrete Structures Durability

Janusz R. Krentowski

Assessment of Destructive Impact of Different Factors on Concrete Structures Durability. *Materials* **2022**, *15*, 225. <https://doi.org/10.3390/ma15010225>

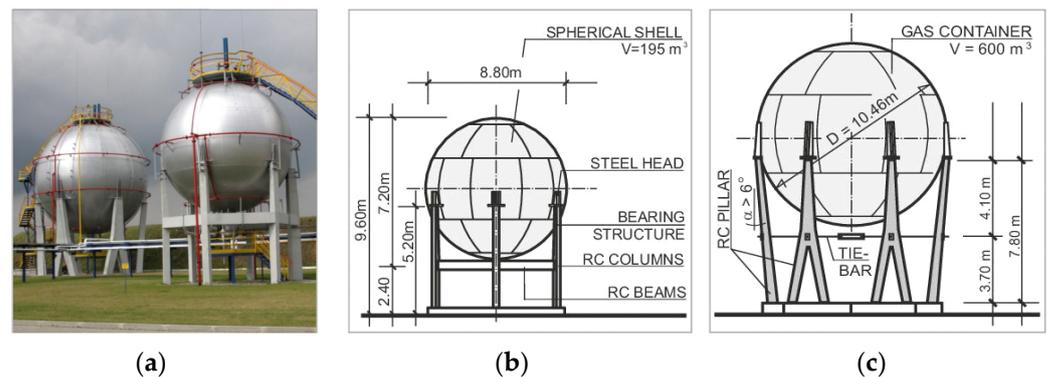
The supporting structure of the tanks with a capacity of 195 m³ was shaped as six reinforced-concrete vertical columns, braced with a horizontal reinforced-concrete ring connecting the columns. The foundations under the columns were in the form of a reinforced-concrete foundation slab with a regular hexagonal shape. The supporting pillars were placed around the circumference of a circle (Figure 1a,b). The lower segments of the columns were fixed in the foundations, and their upper parts remained free.

Figure 1. Tanks' construction details: (a) overview of the tanks; (b) design details of a 195 m³ tank; (c) design details of a 600 m³ tank.

Spherical tanks with a capacity of 600 m³ were placed on supports shaped as six supporting trestles inclined at an angle of approximately 6° to the vertical axis, resembling an inverted letter 'Y' (Figure 1a,c). The branches of the supporting trestles were placed at the top of the reinforced-concrete base, shaped as a regular dodecagon, located at the ground level. The lower segments of the trestles were articulated with the ring. The ring was stabilized by means of six columns anchored in the lower foundation ring, transmitting the loads to the subsoil. The retaining plates of the tank shell were placed on the column heads in a sliding manner, and the stability of the contact zones was ensured using the action of frictional forces.
