Visual Exploration of the Spatiotemporal Evolution Law of Overburden Failure and Mining-Induced Fractures: A Case Study of the Wangjialing Coal Mine in China

In this article, the borehole television approach is applied on the working face 20105 of the Wangjialing Mine in China to visually detect (1) mining-induced fractures in overburden strata; (2) movement failure of coal seam-overburden stratum-ground surfaces; (3) temporal and spatial evolution of mining-induced fractures, exfoliation, and caving of overburden strata.

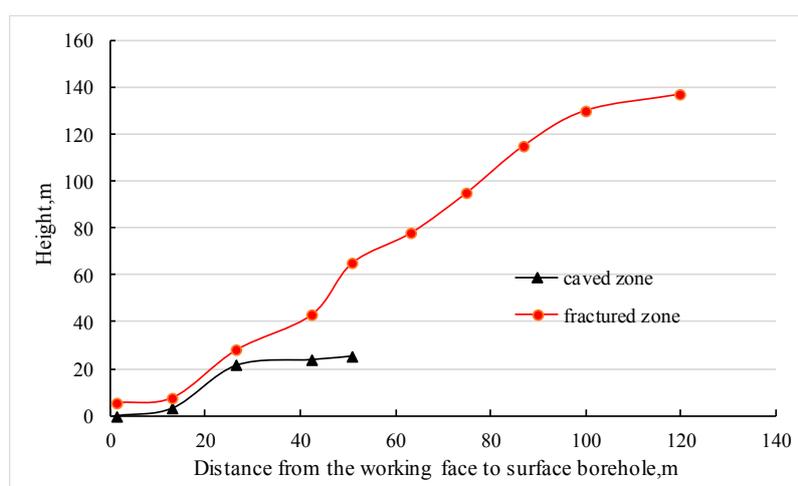
Figure 13. Change of the caved zone and fractured zone in boreholes.

The heights change of caved zone and fractured zone in the boreholes during the mining process is shown in Figure 13. The cutting and caving heights of panel 20105 were 3.0 and 3.2 m, respectively; the height of the fractured zone was 120–137.6 m (see Table 1). The height of the caved zone was 21.6–25.5 m, while the height of the caved zone in borehole #1' was not obtained as it didn't reach the coal seam. The heights of the caved zone and fractured zone in boreholes #3 and #4 were 18.5 and 30 m, respectively. Notably, the measured heights of caved zone and fractured zone appeared to be smaller than the actual values due to the early deformations and blocking in the underground boreholes caused by the abutment pressure. The measured heights of the caved zone and the fractured zone were 2.9–4.11 and 19.35–22.19 times the mining height.

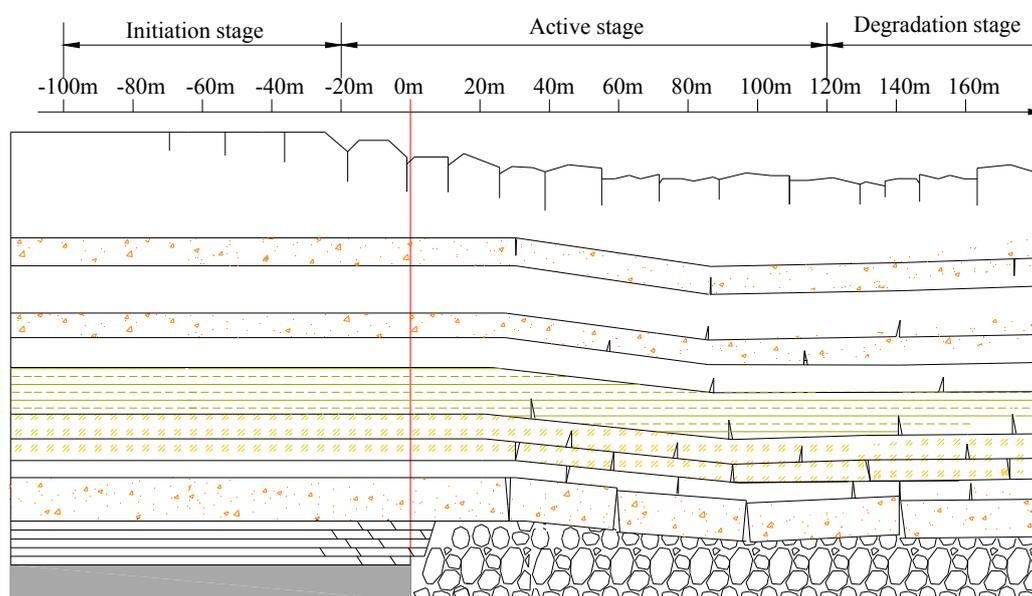
Figure 15. Three stages of the overburden movement.

Roof caving, as well as separation and dislocation, were observed as a result of underground mining. Mining-induced fractures were propagated and overburden strata movement was transferred upwards to the ground surface in this process, resulting in surface deformation. Eventually, the movable basin area exceeded the mined-out area. Based on the differences of surface subsidence velocity, extent of strata movement and propagation of fractures, the whole process can be divided into three stages (Figure 15):

- (c) **Degradation stage:** This stage started when the working face was 120 m past the borehole. During this stage, the movement of the overburdened strata degraded (there was a slow subsidence due to gravitation). The bed separation and fractures that had developed in the overburden strata were partially closed to compaction and the rate of surface deformation slowed down. Surface cracks and step subsidence were partially mitigated.

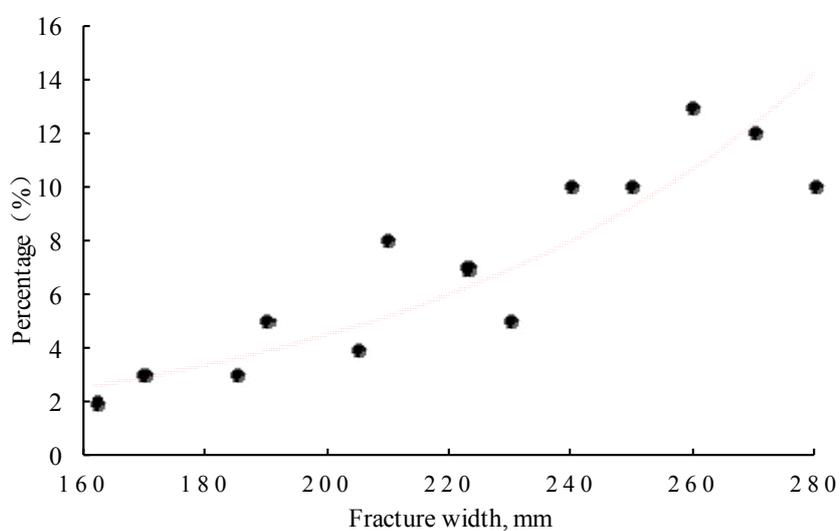
(a)

The number of mining-induced fractures can reflect the degree of influence by mining to the rock mass. As shown in Figure 16a, with the increase of drilling depth, the degree of mining influence deepening, fracture number has increased dramatically. The width of fractures reflects the propagation degree. As seen in Figure 16b, the fracture number decreased with the increase of width. Fractures with width between 0 and 20.0 mm account for 76% of fractures, which proves that fractures are mainly of low width. As shown in Figure 16c, the number of fractures at all orientations was relatively average, the interval of 40° – 90° accounted for 62%. It can be concluded that most of the mining-induced fractures are vertically oriented.

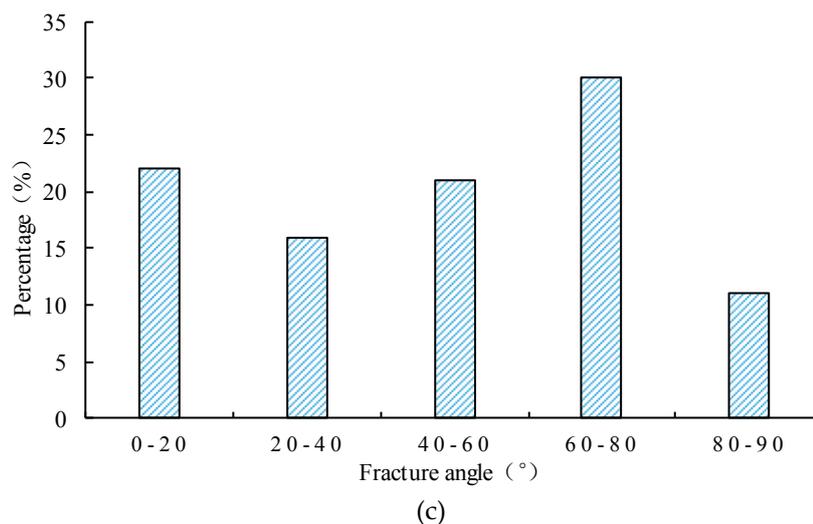
Figure 16. Fracture attributes: (a) number of fractures versus borehole depth; (b) proportion of fractures versus fracture width; (c) proportion of fractures versus fracture angle.

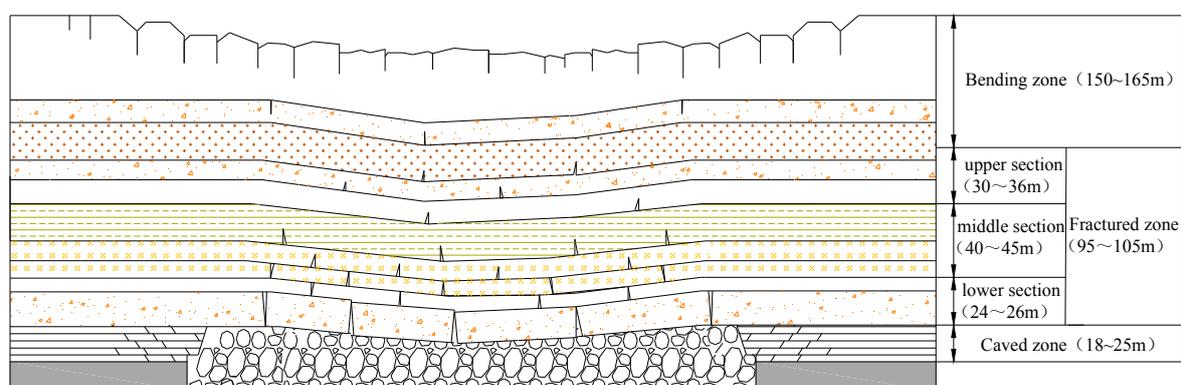
Figure 17. Distribution of fractures in the overburden strata.

The fractured zone can be divided into three parts: rock blocks, through-going vertical fractures and horizontal fractures caused by bedding layer separation. According to the different attributes, with the field observations, we confirm the range of the three parts (see Figure 17). In most cases, fractures in the bending subsidence zone exhibited small apertures. However, fractures with large apertures were also observed due to the limited tensile strength of certain strata, especially those near the ground surface (large fractures and step subsidence).
